ATWATER KENT MODEL 708 RESTORATION

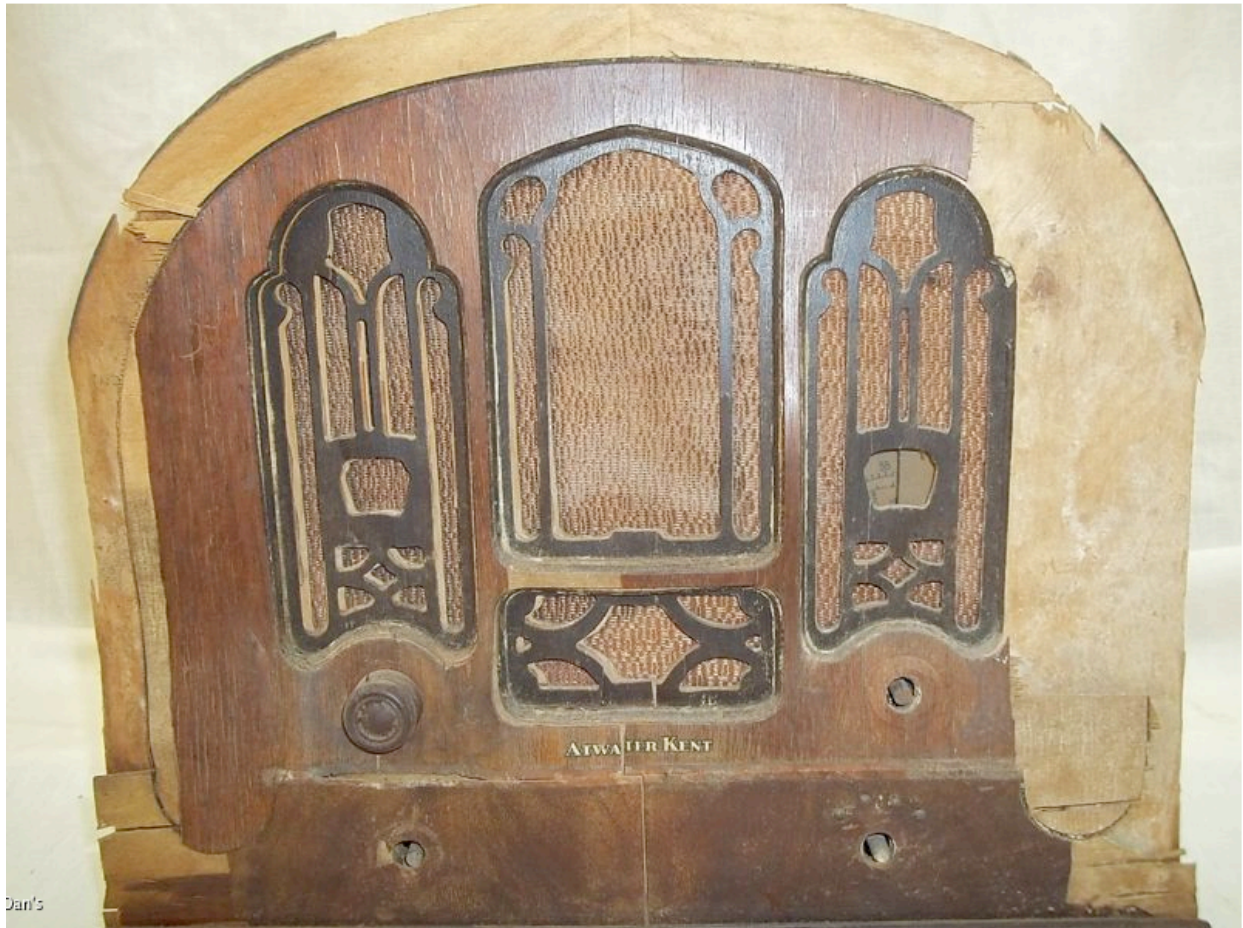
As Received - Front View

The cabinet consisted only of the base and the front panel. All the remaining cabinet was missing. The front panel had much missing/damaged veneer and the grillwork had delaminated in many places although almost all of it was present. The decorative horizontal molding strip just under the grillwork was missing. The front bottom molding was present, but the side pieces were missing. Two knobs were missing. The base was also delaminating, and came apart into more than six pieces.

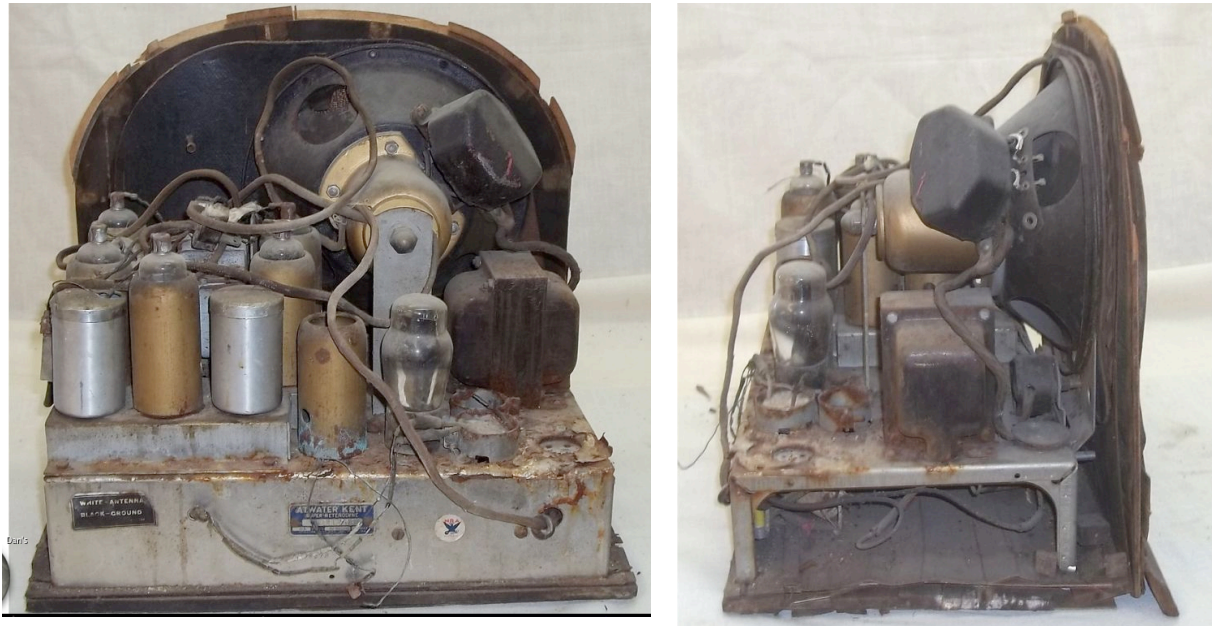
As Received - Back/Side View

The chassis was very dirty and the right rear section (viewed from the back) was very rusty and large pieces of the plating were flaking off. The two electrolytic can capacitors (C-20 and C-21) were missing. A dual 8 MFD electrolytic replacement had been installed under the chassis, but only half was connected. An 8 MFD electrolytic was installed as a replacement for the 4 MFD electrolytic (C-19). A .25 MFD capacitor appeared to be installed for the xx MFD (C-XX) in the Multiple By-Pass Capacitor (J14). All the rubber wiring on the top of the chassis was completely deteriorated with bare wire everywhere. The power cord was cracked and exposed wire was present. The plug was not original. The speaker cone had a pretty large hole near the 1 o'clock position with several tears radiating from this hole toward the center. The speaker grill cloth and cardboard backer were both in god shape. The tuning dial was in good shape, but the rubber drive wheel was deteriorated and had been wrapped in adhesive tape. It did not work. The original dial indicator lamp socket was disconnected and an additional dial light socket was wired into the circuit. Not sure why, because the original socket appeared to be in good condition. The NRA label was in good condition, but the Antenna/Ground label was partially missing. One tube shield was missing. One grid cap was smashed. A double 8 MFD electrolytic capacitor was installed under the chassis, but only one side was connected. No other repairs were apparent. The antenna and ground leads were connected to something called a Magna-Aerial which had one lead coming out of it. All of the rubber coated wiring had deteriorated. The underside of the chassis was dirty, but everything appeared to be there.

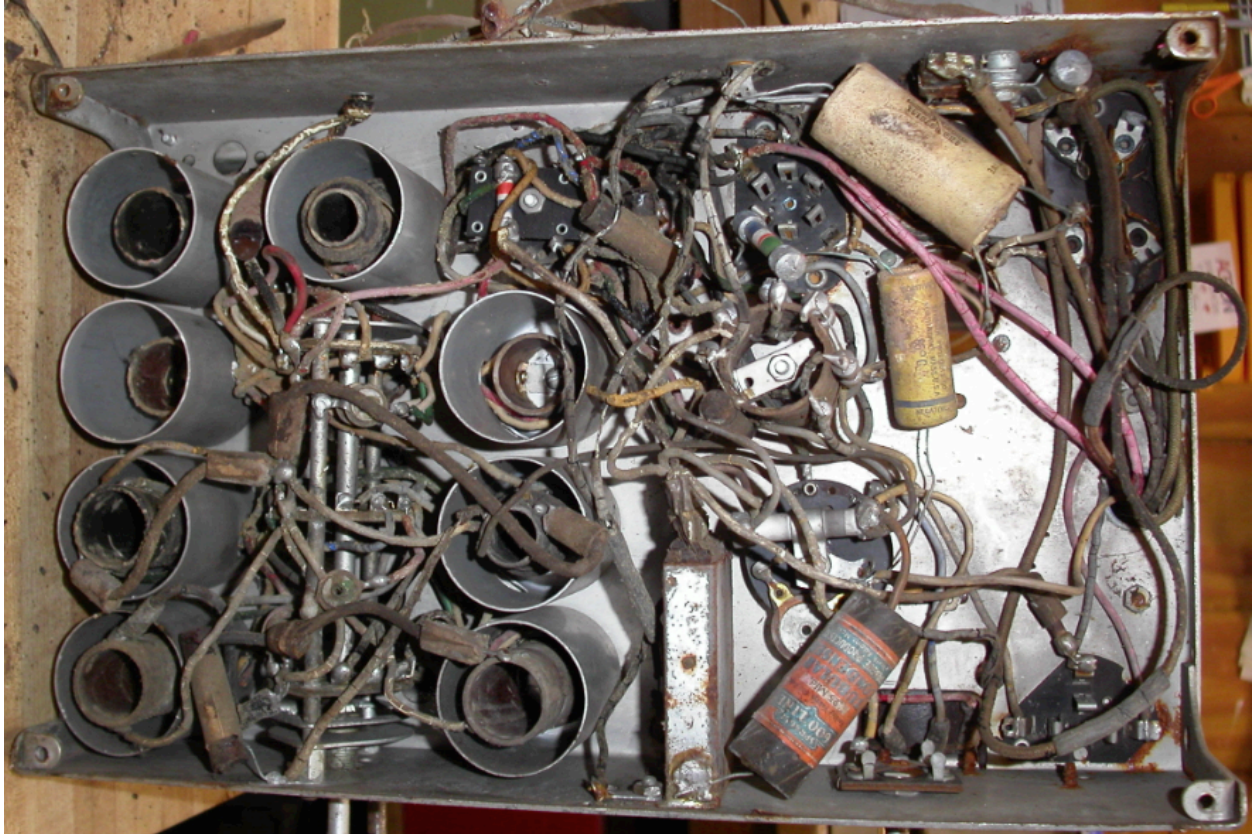
As Received Chassis – Bottom view

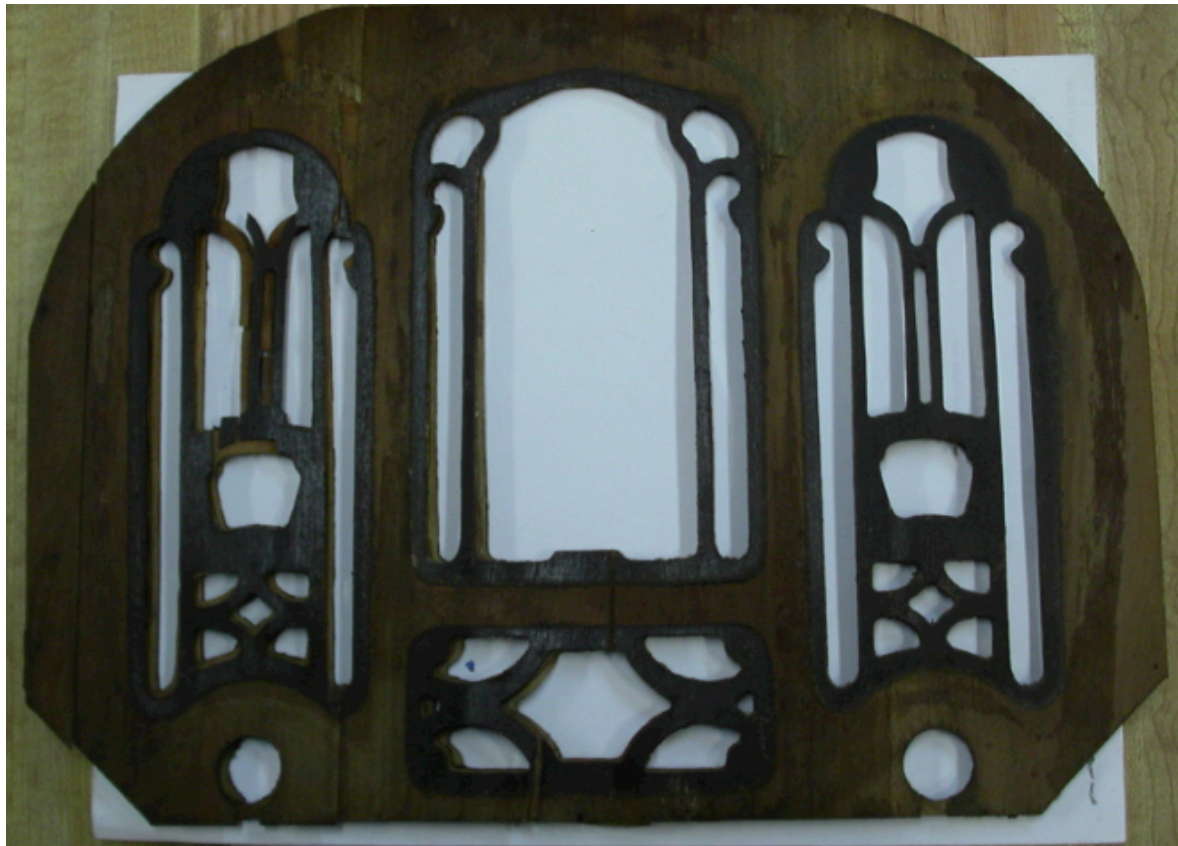
Grillwork Before Re-gluing (Backside)

The first repair attempted was the grillwork. The grillwork consisted of a 3 layer plywood, most which were delaminating in various places. This required gluing all the layers back together. I was able to match most of them back in place pretty closely, but water damage had caused some distortion and not all the layers were able to be matched perfectly back together. Careful filing/sanding after gluing resulted in obtaining a pretty close appearance to the original design. All cracks in the grillwork were then filled with wood putty, sanded and sprayed with several coats of sanding sealer to provide a smooth surface for the black lacquer finish.

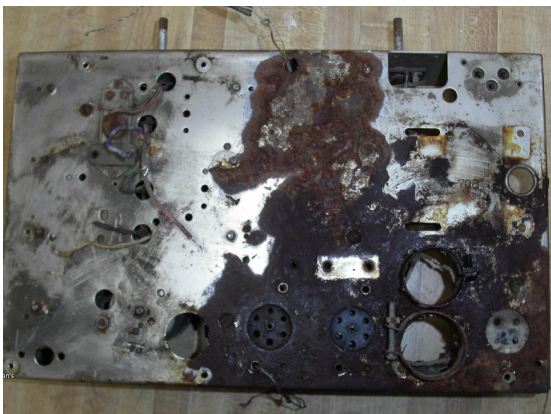
Chassis Before Cleaning/Re-plating

The rust was then cleaned from the chassis. The chassis was first washed with a degreaser and then Naval Jelly was applied to all rusted areas and a stainless steel wire brush used to remove the rust. Several applications were required. The rust had severely pitted the chassis in places so I used a wire brush wheel on a dremel tool. This still wasn't able to get rid of all the rust, so I then used a small grinding wheel on the dremel. This persistence finally paid off. After washing down the cleaned areas, I used a Caswell nickel plating Plug-and-Plate Kit. While this plated area of the chassis is not as shiny as the rest of the chassis, it has an antique look and should not be subject to further rusting.

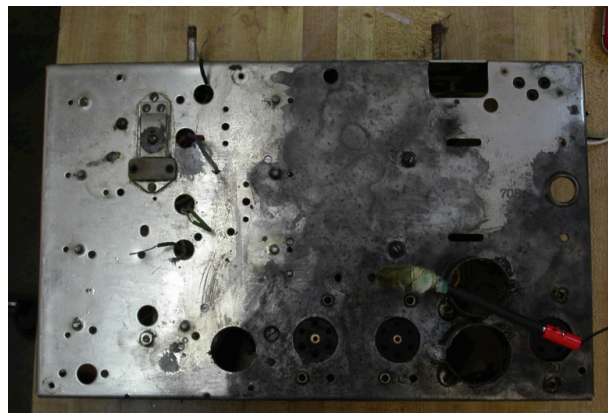
Chassis After Cleaning/Re-plating

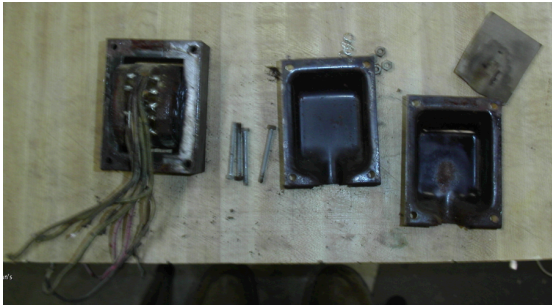
Transformer Disassembled

The transformer was opened up and new leads were soldered to the windings. The case was cleaned of rust and painted black. After removing the rust from several areas of the laminations, the transformer laminations were sprayed with insulating varnish and reassembled.

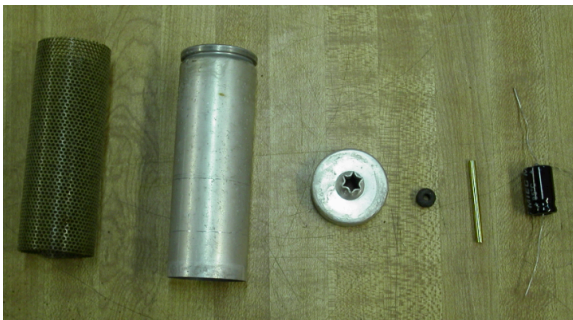
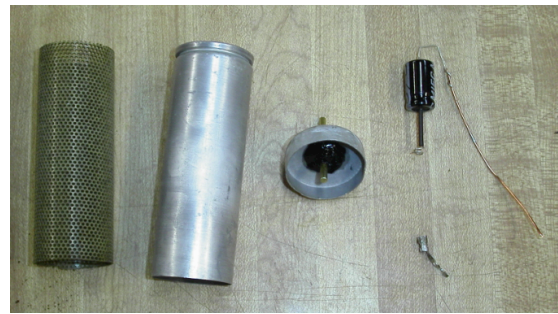
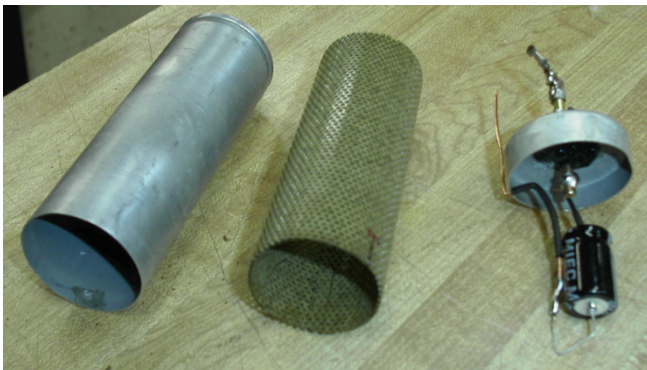
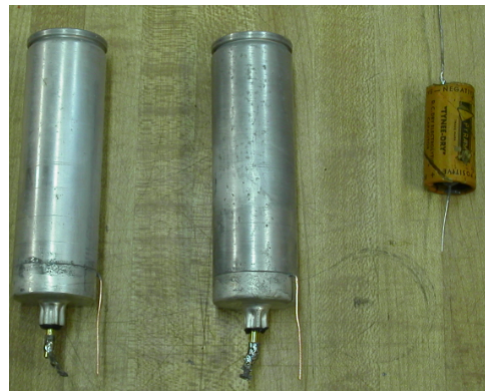
Electrolytic Condenser Rebuilding

The Electrolytic capacitors (C20 and C21) that were missing were replaced with a couple of discards from other chassis. Each can was opened up about ½ inch from the bottom using a scroll saw, cleaned out, and the center aluminum rod replaced with a brass rod to which the positive end of a new 8 MFD 450VDC electrolytic capacitor was soldered. A copper wire was soldered to the negative end and led out through a small hole was drilled in the bottom of the can in order to ensure a positive connection to the negative end of the electrolytic. The plastic insert inside the can was reinstalled and epoxied in place providing a means of joining the can back together. This joint is hidden inside the mounting bracket. The cans were reinstalled in the mounting brackets and the wire from the negative end was soldered to a nearby grounding point. Capacitor (C19) a 4 MFD 50V electrolytic capacitor was re-stuffed in a similar manner. The only difference being this capacitor also had a paper sleeve over the aluminum can.

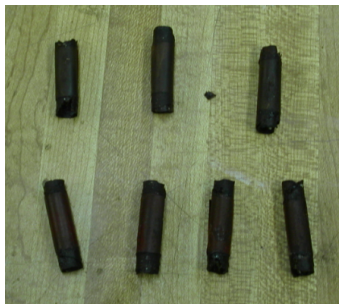
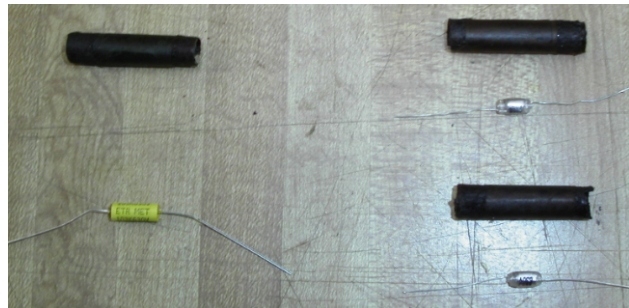
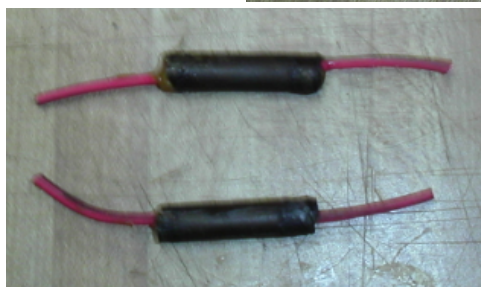
Paper Capacitor Re-stuffing

The paper capacitors were re-stuffed with appropriate value 630V polypropylene capacitors. This was harder than normal since all the capacitors had leads coming out the side vice the end of the paper tubes. While removing the internals even after cutting all the wire leads, most of the ends of the tubes were damaged. I wound paper around a pencil and added an insert to rebuild the ends. These were inserted and holes drilled through the sides with a 1/16" drill. The new capacitors were then carefully inserted with leads coming out the new holes and glued in place with a hot glue gun. The ends were painted black and when dry, beeswax was melted and poured in the ends to match the originals. One .01 MF capacitor (C11) required a new paper tube, which was made the same way as the inserts and was painted and assembled as previously described. A new label was made using Microsoft PowerPoint. I first peeled the label of the original capacitor, then scanned it and copied it into PowerPoint. This allowed me to match the font, spacing and background color.

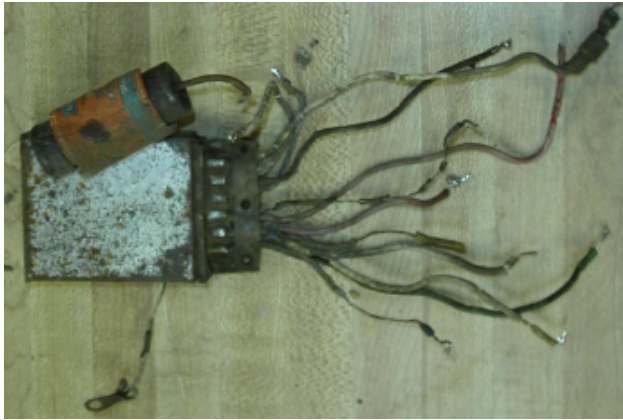
Removed Bypass Capacitor

The main chassis was tackled next. The Multiple Bypass Capacitor (J-14) was removed first and re-stuffed. This involved heating the capacitor on my outdoor grill at about 250 degrees F until all the wax was removed. I was able to pull the guts out in one piece with a little effort. The foil was unwrapped and the three fish paper dividers were set aside. These would be reused. The tin case was cleaned but still had many darkened spaces (rusted??). I decided not to try and re-plate the case.

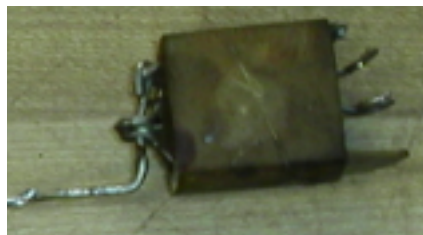
The tracking capacitor (C6) was removed. The values were checked using an EICO Model 950 Resistance-Capacitance meter and found to be somewhat out of tolerance compared to the schematic, which I thought unusual for mica capacitors.

Removed Capacitor (C6)

After heating the capacitor in my outdoor grill, I removed the four mica capacitors from the paper cover. I rechecked the tolerance and they now read pretty close to the schematic values. I therefore decided to just clean these up and reassemble the capacitor even though I had a set of replacement mica capacitors which I could have re-stuffed the paper case. I used new cardboard separators and filled the void spaces with bees wax. Checking the capacitance again, I found no change, so it was reinstalled in the chassis.

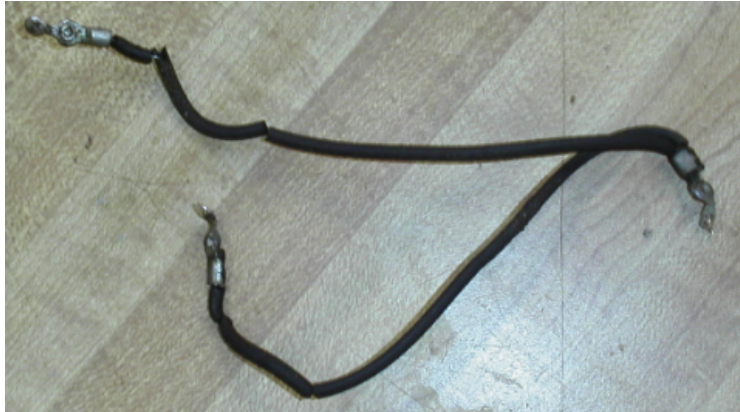
Removed Flexible Filament Resistor

The filament flexible resistor was removed and all the hardened rubber coating was removed. The terminal edges were filed down slightly to allow new rubber tubing to be slid over the terminals and cover the wire. I placed shrink tubing was placed over the terminals and the ends of the rubber tubing to secure them in place and reinstalled the resistor.

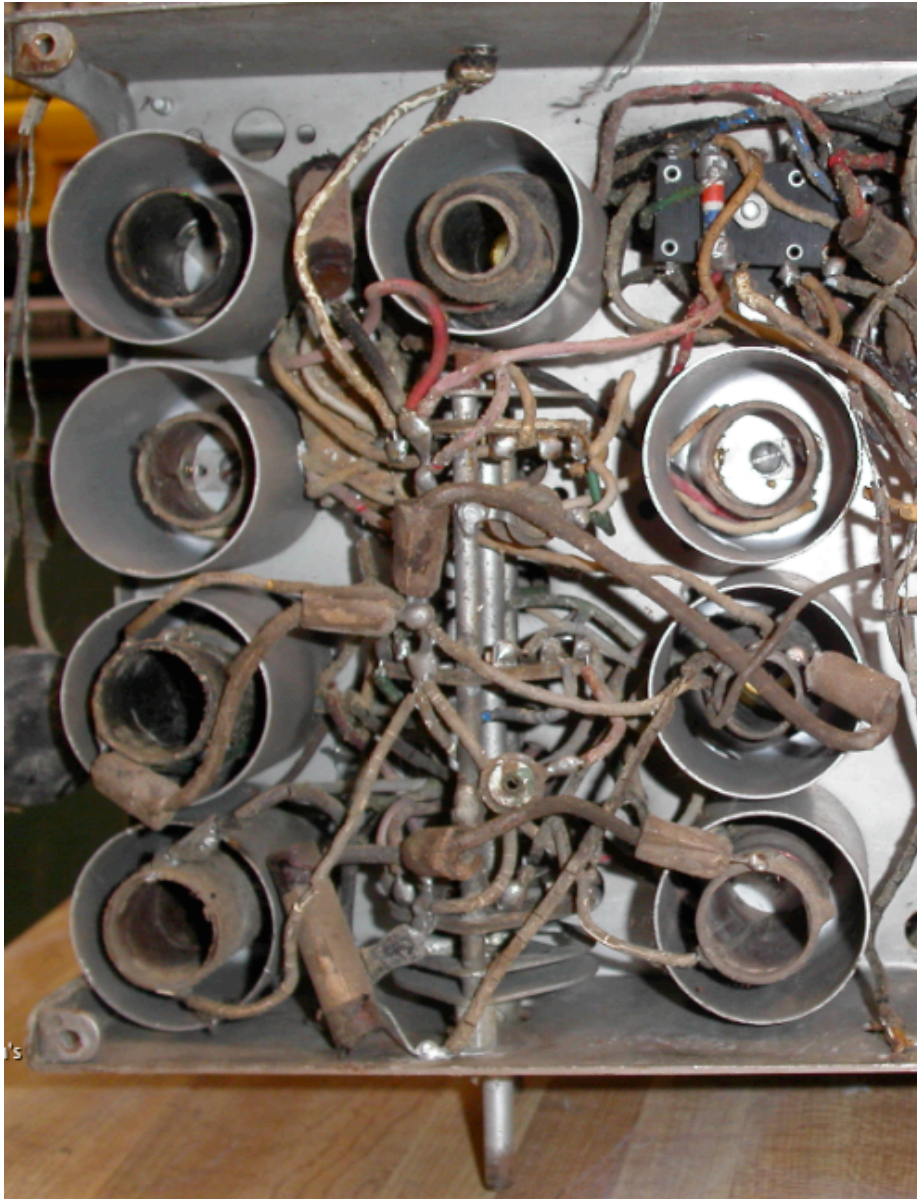
The next challenge was replacement of the rubber coated wiring on the band selector switch and eight coils along with the four flexible resistors and two paper capacitors. After a long deliberation among the possible choices including (1) disconnecting and replacing the wires for each coil individually, (2) removing the switch and all the coils at the same time and then reconnecting all the wires, or (3) removing the switch and coils all at the same time and then replacing wires on one switch segment at a time, I choose option three. One of the problems that drove me to this decision was that the switch connects were very dirty/corroded and they would need cleaning.

Band Switch And Coils As Received

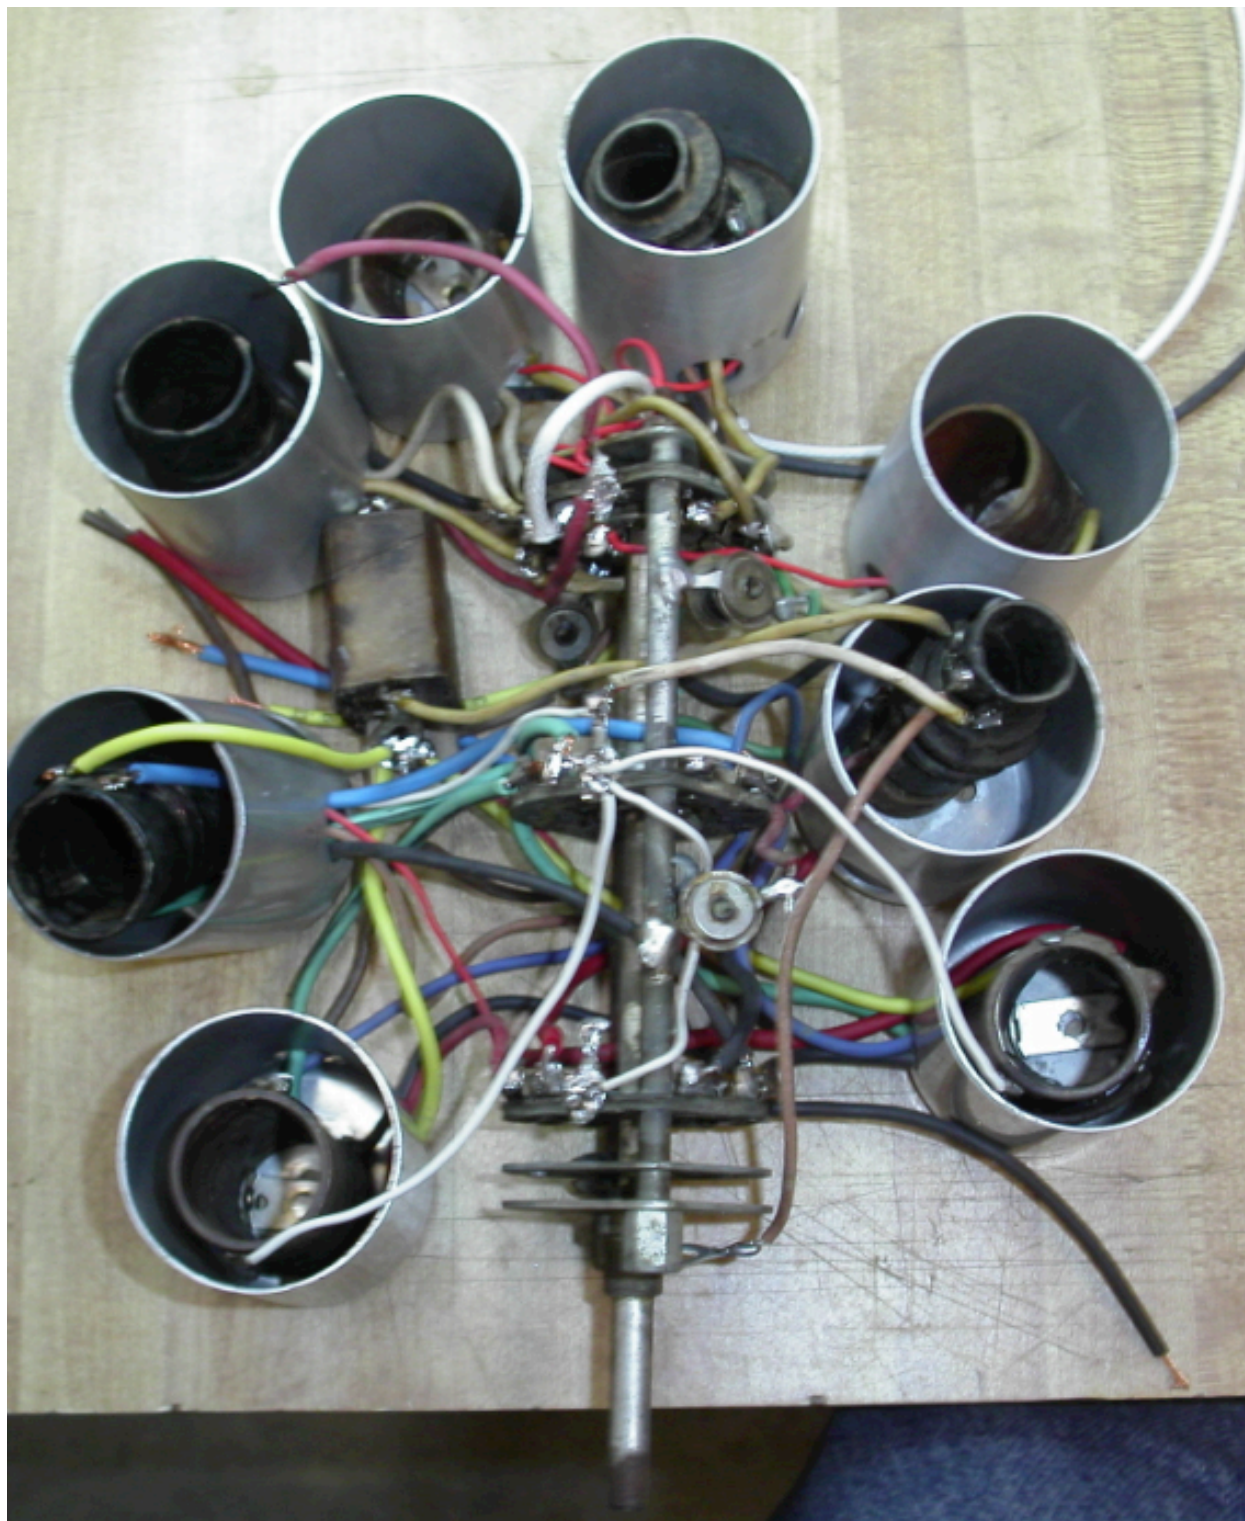
Rewired Band Switch And Coils

I carefully drew wiring diagrams for each switch segment and coil combination before disconnecting anything more. I then started with the rearmost segment and disconnected the wires both from the switch and coil/etc. and replaced them with new rubber coated wires after I cleaned this segment's switch contacts, and followed a similar repair on the rest of the coils and switch segments. In this process another discrepancy between the AK 708/808 and AK 808A schematic became evident. Two of the windings on T8 (No.2 H.F. coil, 3rd range) had their connections reversed on the two schematics. The connections as found matched the AK 808A schematic. I remade these connections in the as found conditions after conferring with members from the Mid-Atlantic Antique Radio Club (MAARC). Testing after completion will show if this was the right decision.

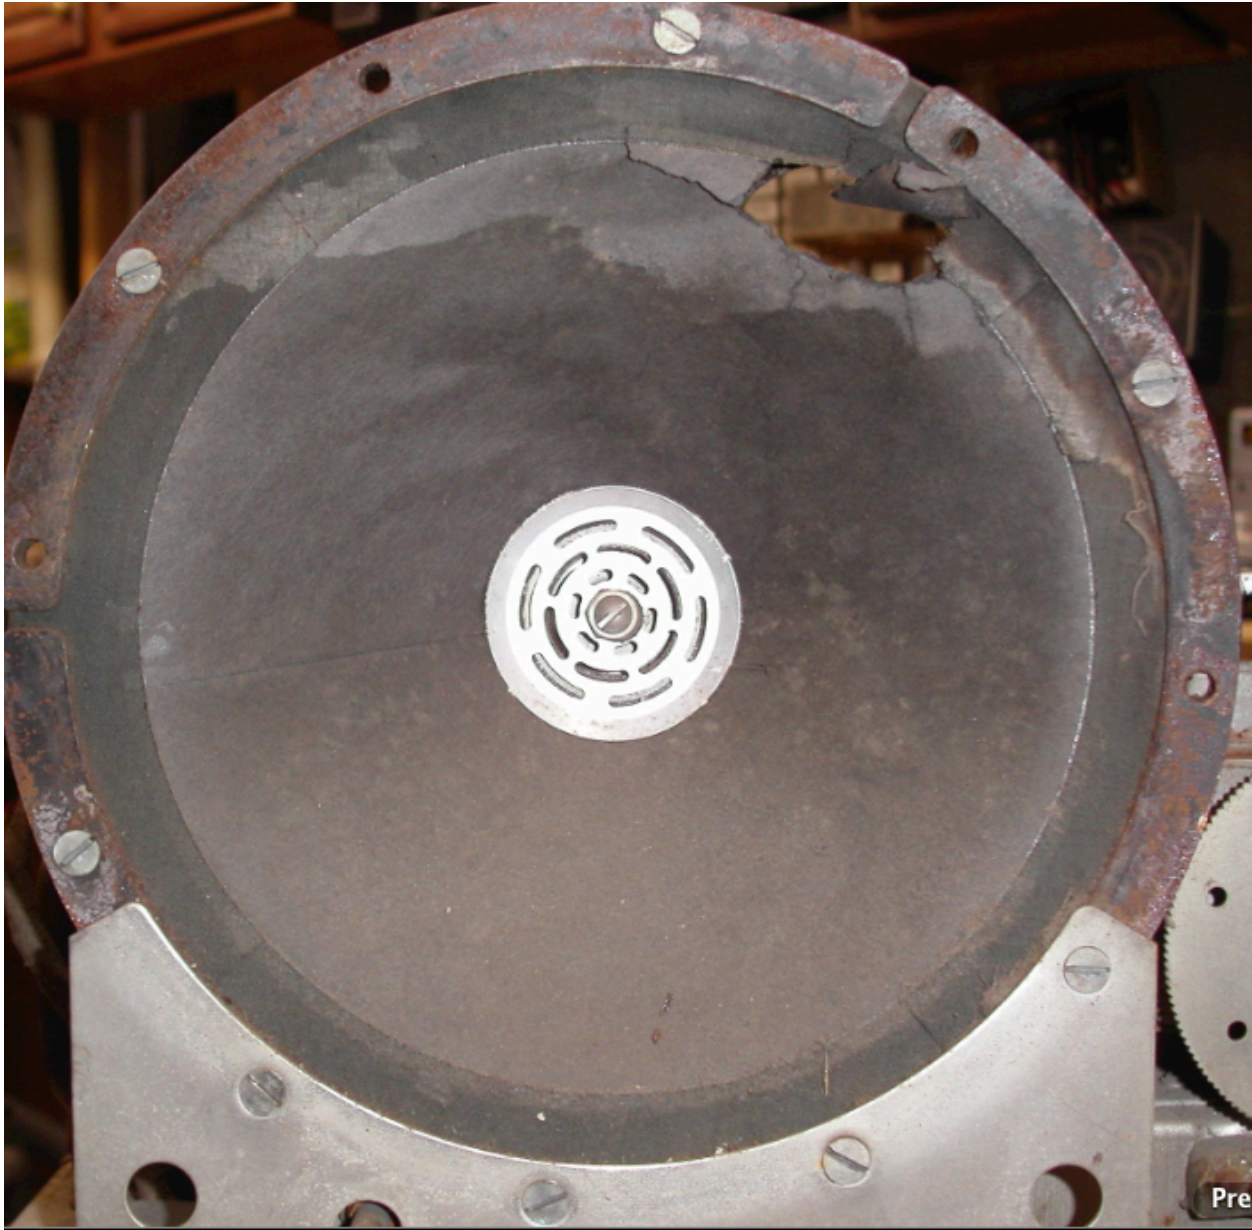
The speaker had a fairly large hole in it and a tear from the outer edge to the center. The metal pieces surrounding the outer edge were also severely rusted and the insulation on the rubber-coated wires from the audio transformer was hard and cracking off. The wiring to the speaker plug was in good shape. I originally was going to only patch the speaker cone, but in checking the resistance of the field coil, I found the coil was open. This meant disassembly of the speaker to try and determine why the coil was open.

Speaker As Found

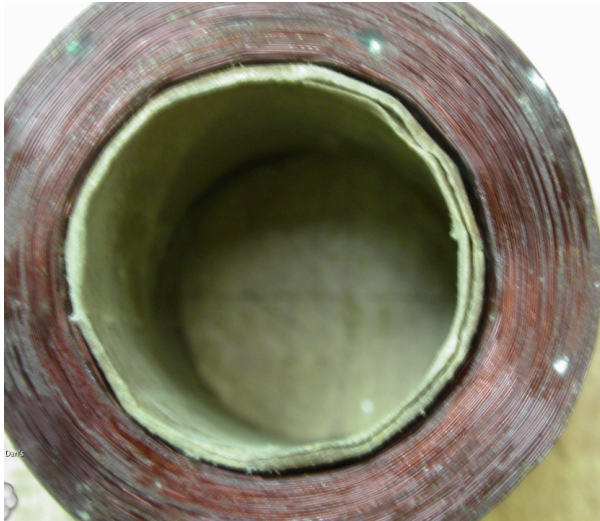
Previously, I have found that sometimes the solder connection between the coil and the connecting wires is corroded. After removing disconnecting the wires from the audio transformer, unsoldering the voice coil leads, removing the speaker cone, and unbolting the frame, the field coil was slid out. Inspecting the connections to the field coil revealed they were all good. I removed all the paper covering from the coil and the coil looked good. Another problem I found during some of my previous repair efforts was that the winding had corroded wires on one of the ends of the coil. I carefully removed the top and bottom cardboard pieces covering the ends of the coil. The top side of the coil had several tiny blue/green spots indicating copper corrosion. I used some copper cleaner (Copperbrill) to clean the corrosion off using a Q-tip stick (stiff, but not hard enough to damage the fine wire). This revealed 3 broken wires. I cleaned the broken ends, and soldered a short piece of enameled copper wire to bridge the

Field Coil With Corroded Windings

breaks. I measured the resistance of the coil and it now read 2200 ohms. This matches the field coil resistance of 2000 ohms on the schematic pretty close. I felt confident that there were no shorted turns. I taped the connections with glass cloth electrical tape and sprayed the ends with insulating varnish. I reinstalled the cardboard end pieces, covered the coil with fish paper, taped everything in place with more glass cloth electrical tape and sprayed the whole coil with insulating varnish.

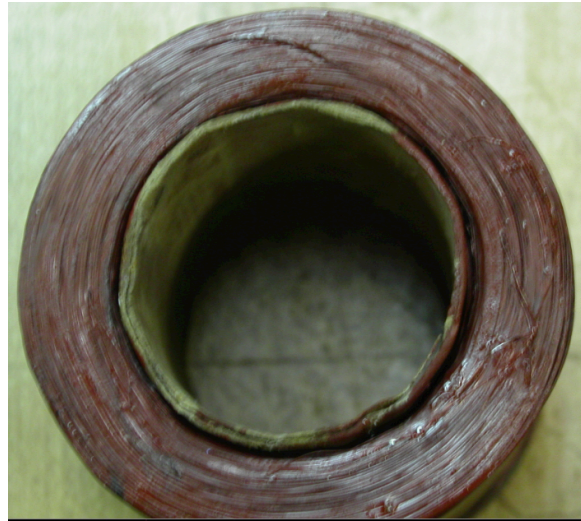
Repaired Field Coil Wires
