Remler Model 72

Restoration Project

Elmo Giovannetti

January 2012

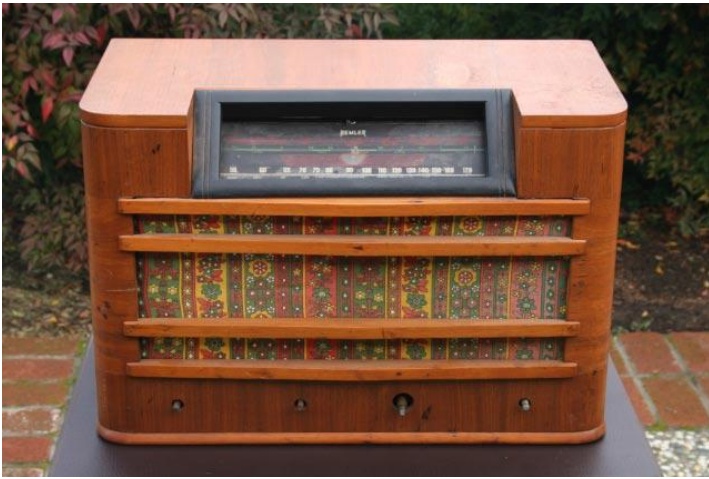
General Condition Front View

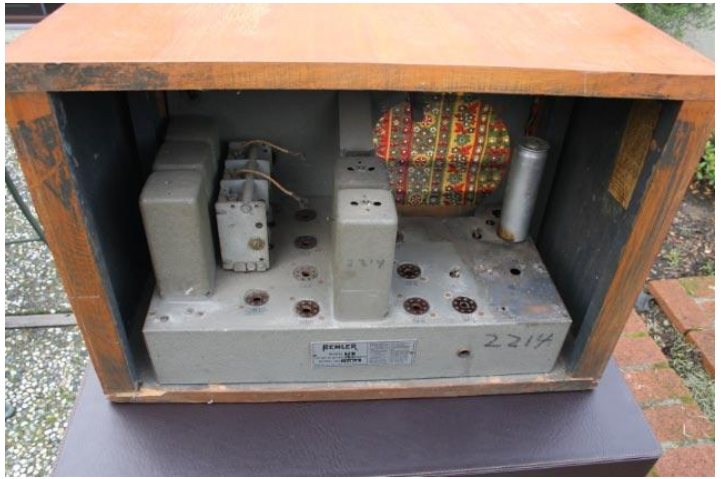
General Condition Back View

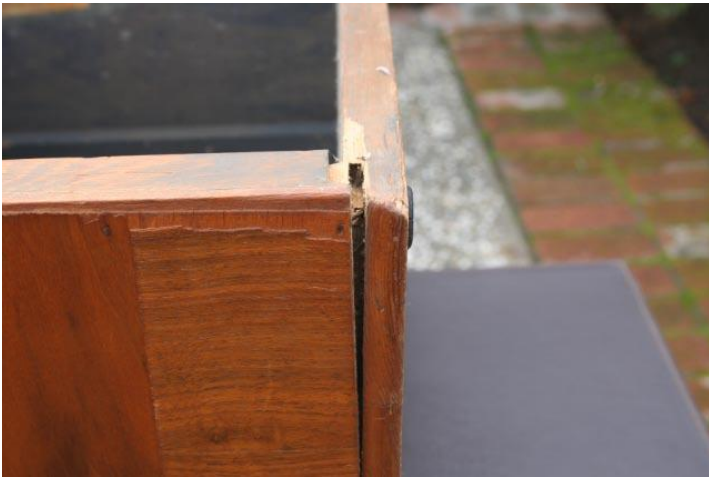
Split Back Left Corner

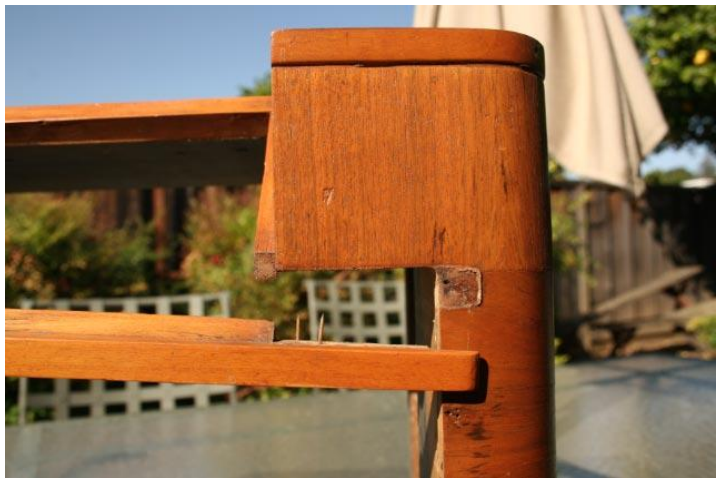
Broken Loose Grill Element

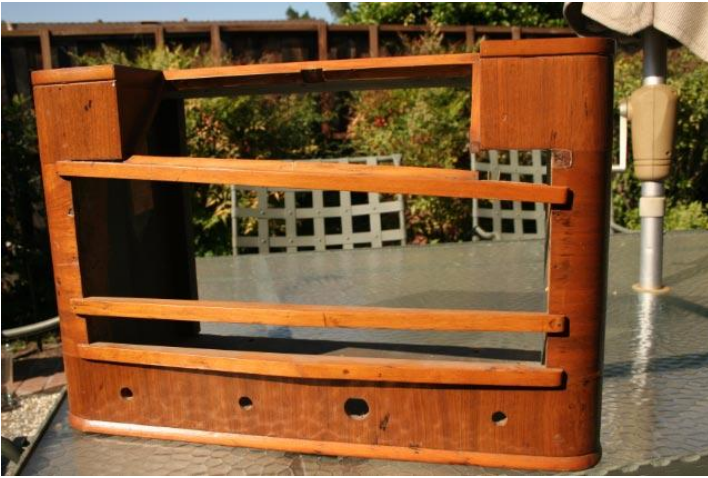
Missing Grill Elements

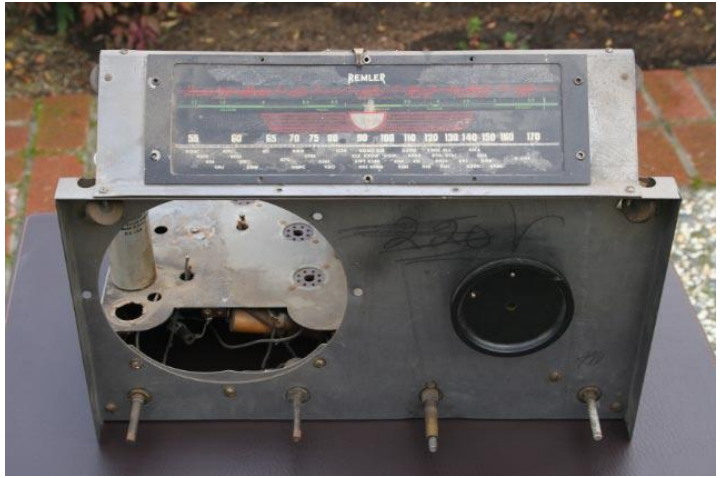
Dial Mechanism & Scale

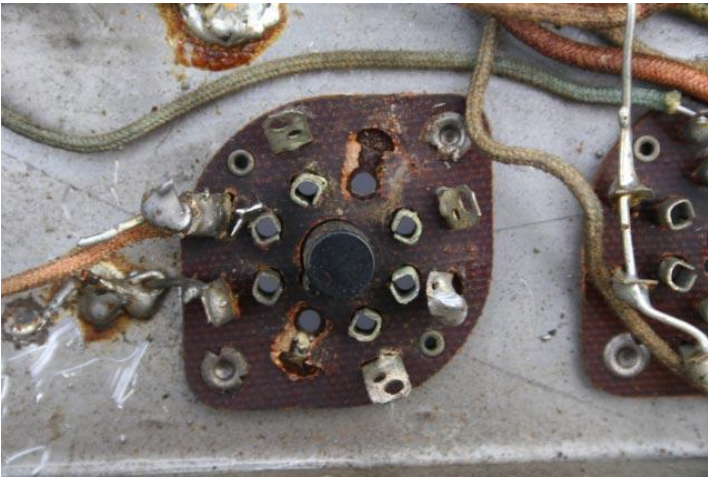
Broken Rectifier Socket

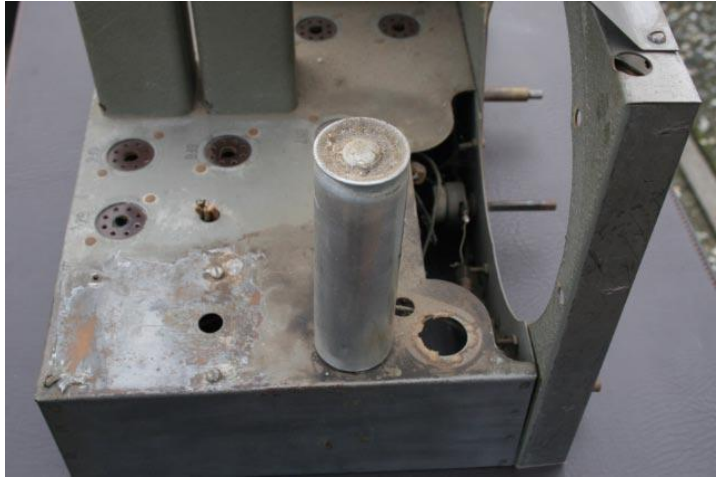
No PWR Transformer - Missing Cap

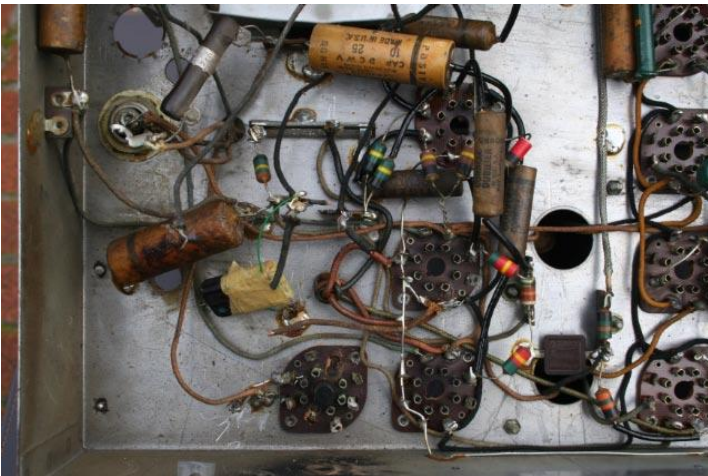
Cut Wires under Chassis

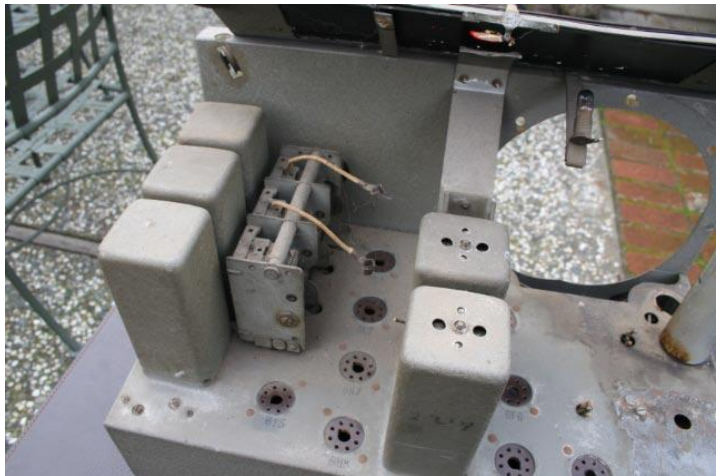
No Speaker No Tubes

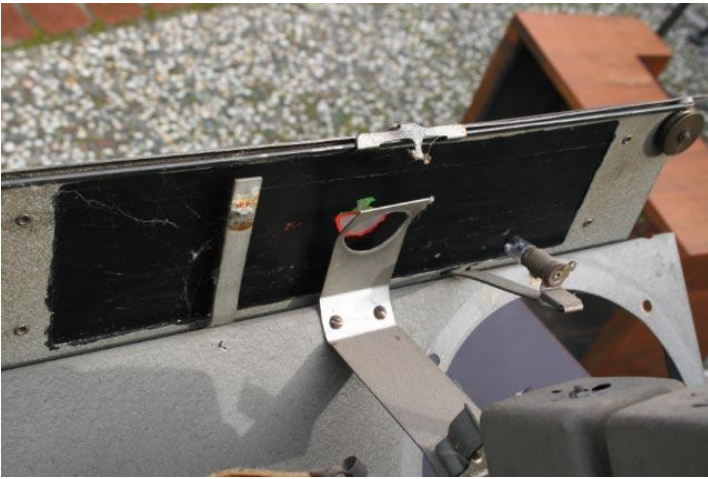
Pilot Lamps & Tuning Indicator

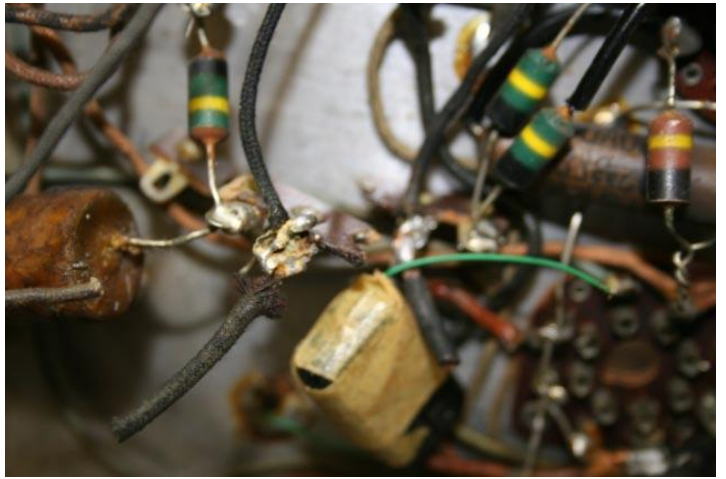
Broken Lug Strip Under Chassis

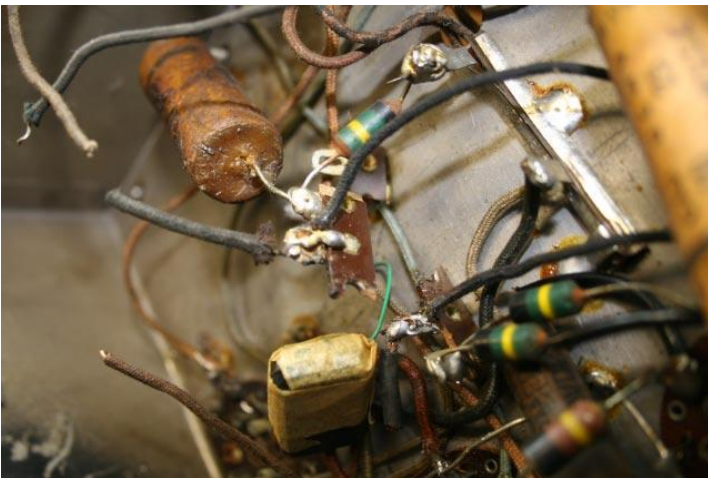
Broken Lug Strip Under Chassis

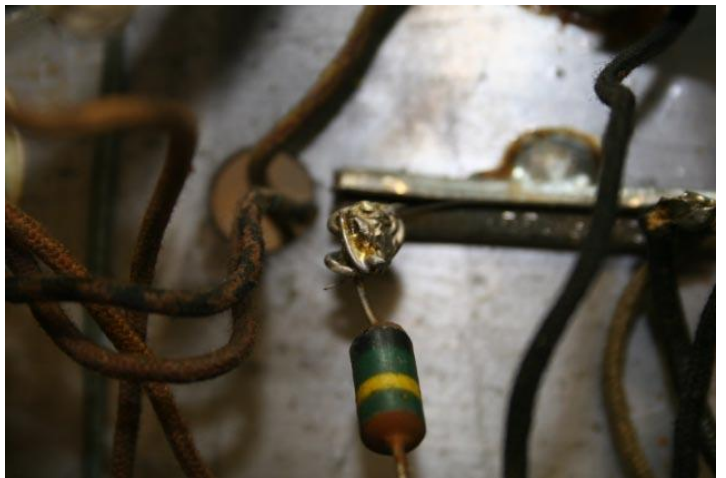
Bad Connection & Soldering

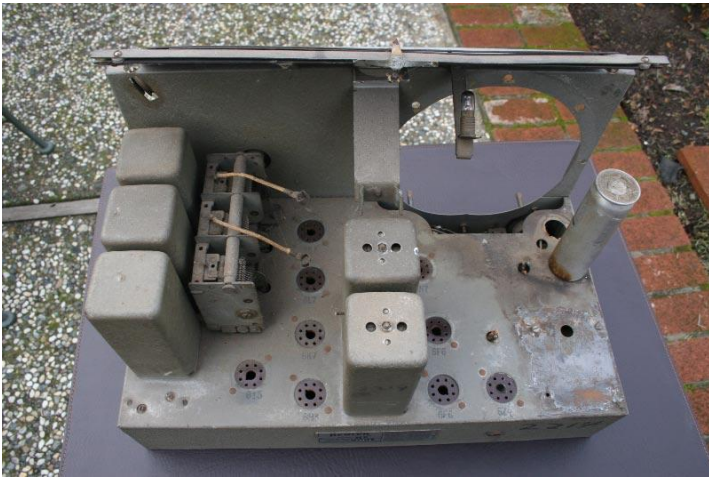
One of the initial conditions was that all nine of the tubes were missing from the chassis. Replacements were not hard to find. Six were found in my personal tube collection and three were found in the CHRS collection. In staying with a restoration goal of "as original as possible" the tubes were replaced with metal shield types as implied in the tube inventory list that is printed on the schematic. The tubes were tested and found to be in good condition.

Tubes Missing

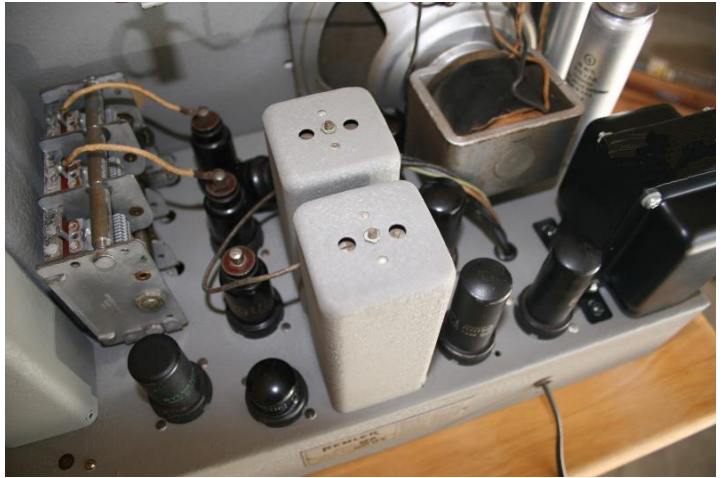
Tubes Replaced

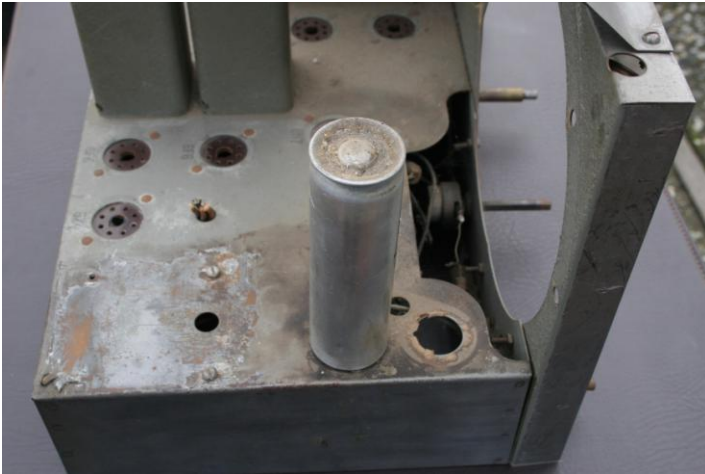
Missing PWR Transformer

After looking through many transformers in my collection and at CHRS it became apparent that I was going to have to buy a transformer. Locating a suitable power transformer was made easy by the huge selection of transformers available though Hammond Electric. Sizing the transformer for the 5 and 6-volt supply was straightforward. The high voltage required some adjustment as the replacement speaker I was going to use has an inductor with more than double the resistance of the original. The transformer I used is a Model 276X (640 VCT @173ma. 5 VCT @ 3A. 6.3VC @ 5A.)

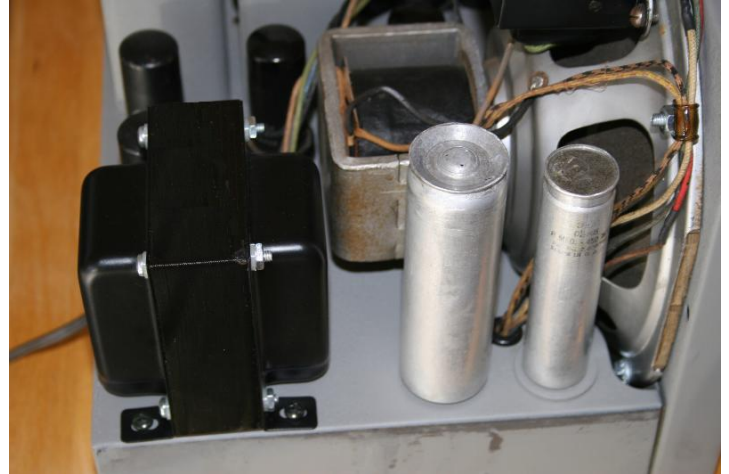
Installed PWR Transformer

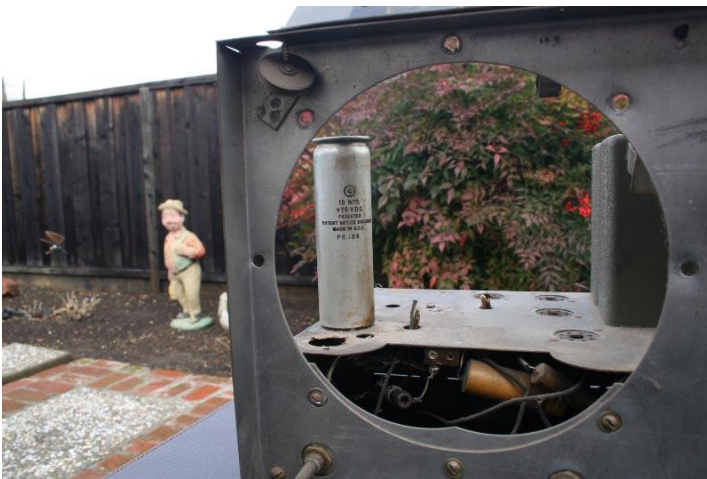
Speaker Missing

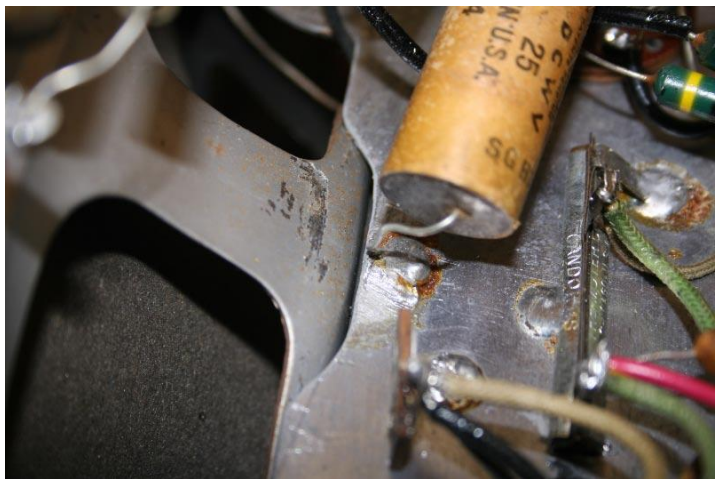
Chassis relieved to Accommodate New Speaker

With only a little cutting and shaping of the chassis the speaker fit perfectly into position.

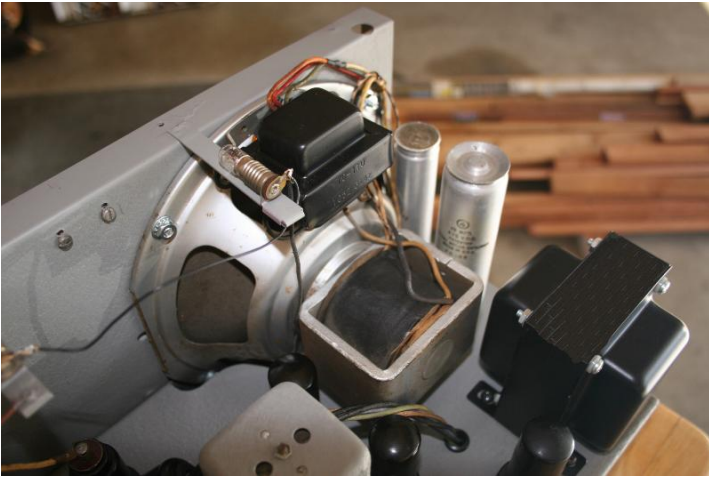
New Speaker Installed

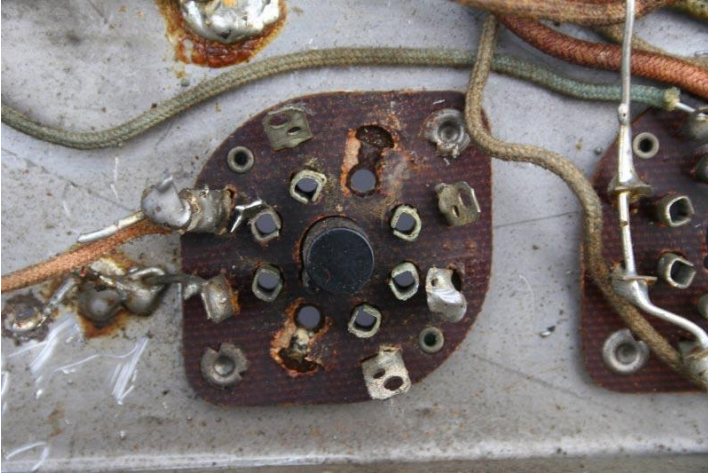
Damaged Socket

The photos show the steps taken to replace the damaged rectifier socket.

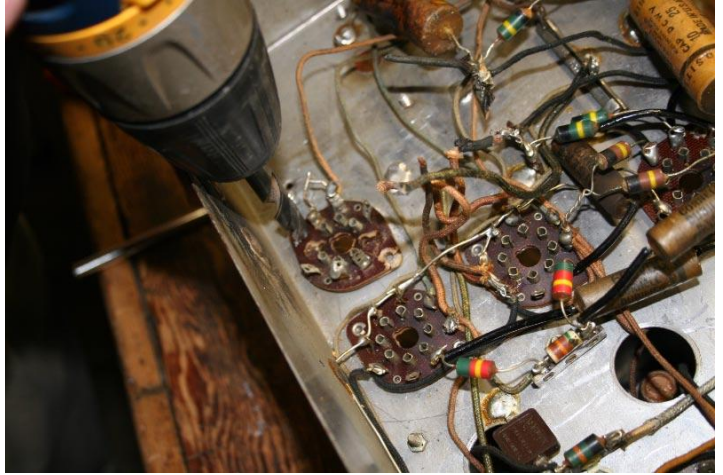
Removing Socket

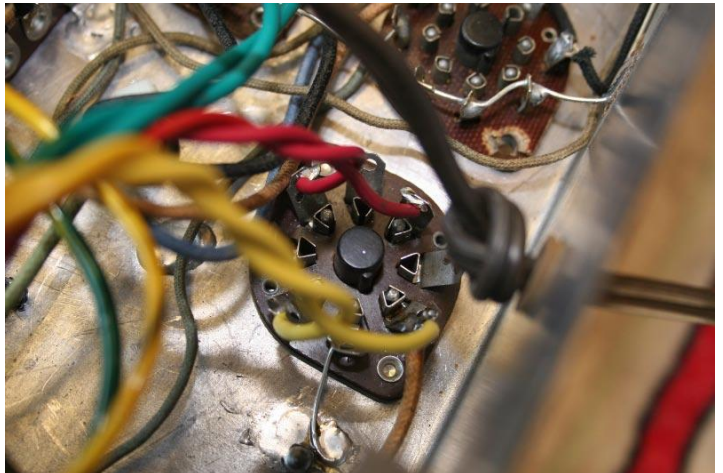
New socket installed & wired

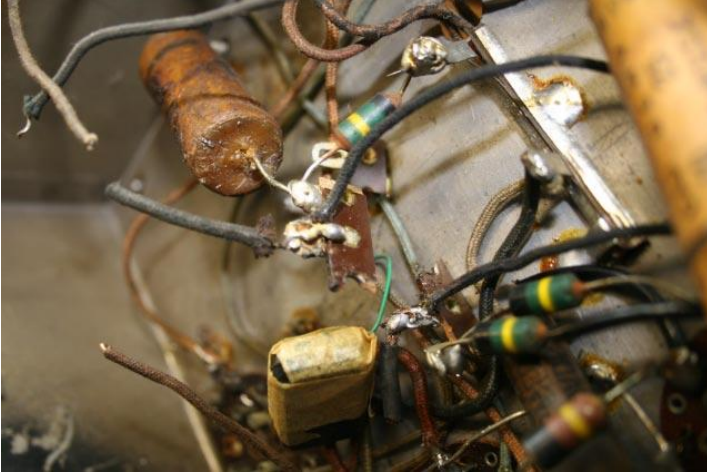
Broken Lug Strip

The repairs and replacement of the broken lug strip are shown in the following photos.

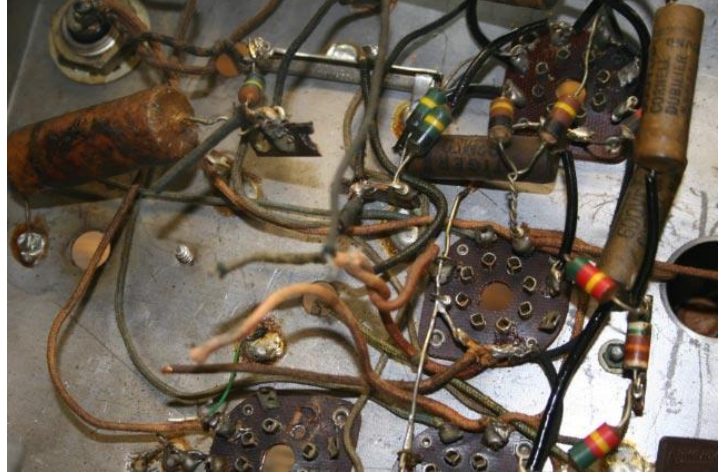
Broken Lug Strip

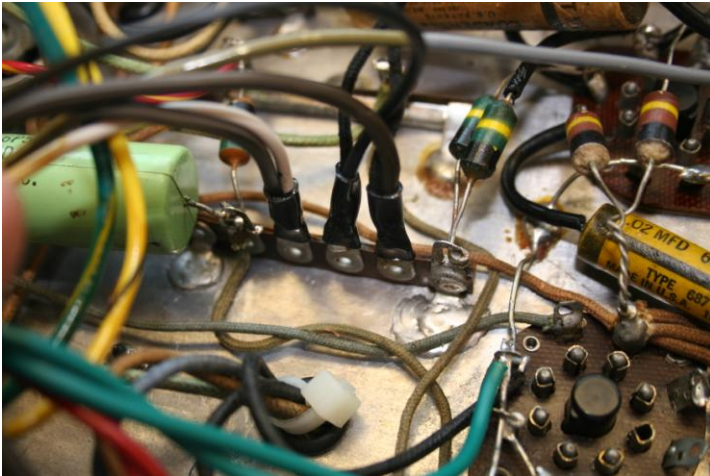
Lug Strip Replaced

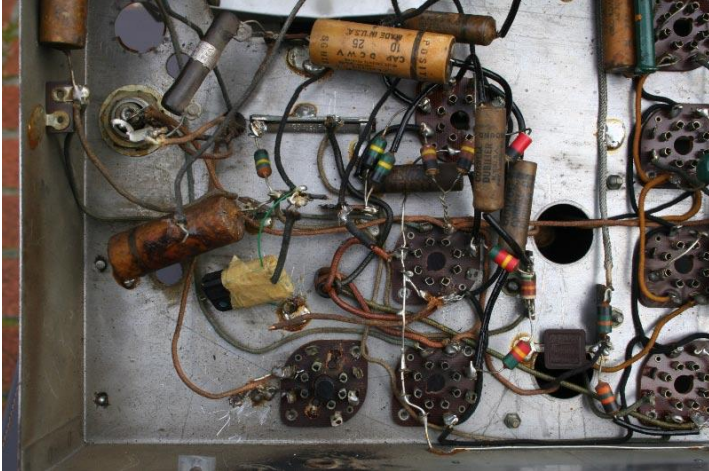
The photos show the many cut wires under the chassis. Wires that were cut included: all power transformer leads, speaker and Inductor, dial lamps, rectifier circuit, tuning eye circuit, grid cap circuit, power cord and power switch connections.

Cut Wires Under Chassis

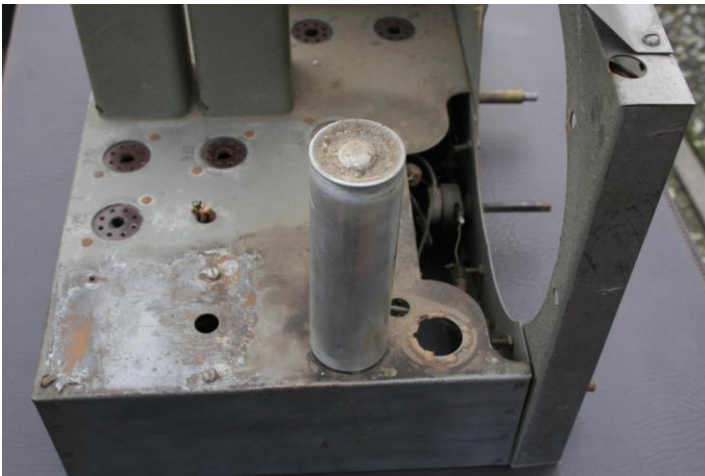
One Missing & One Very Bad Capacitor

The major components of the power supply in this radio were missing. This includes the power supply capacitors. One of the filters was missing. The remaining capacitor was unusable. After finding a suitable replacement I decided to empty the containers and replace the innards with axial lead 22 mf 450v caps.

The capacitors were opened by grinding away the crimp at the top of the container. The contents were removed by pushing out the old capacitor through the electrode connection at the bottom. I then washed out the container with Chem-Tool to remove the residual goo. After collecting up the necessary screws, washers, lugs and insulators I assembled the caps and epoxied the top back onto the container.

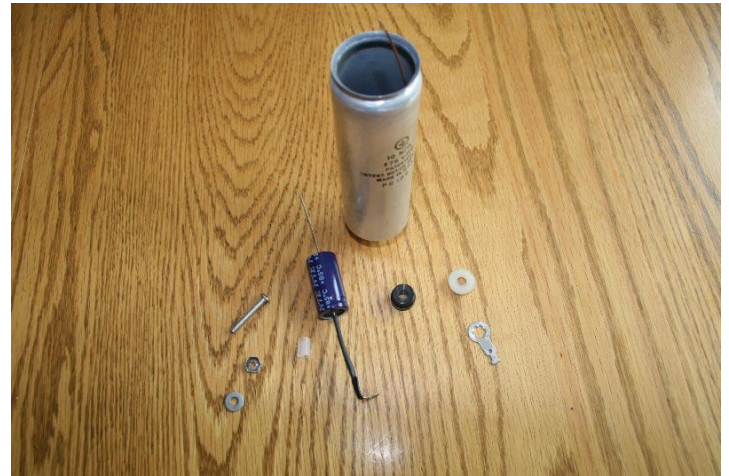
Capacitor Ready for assembly

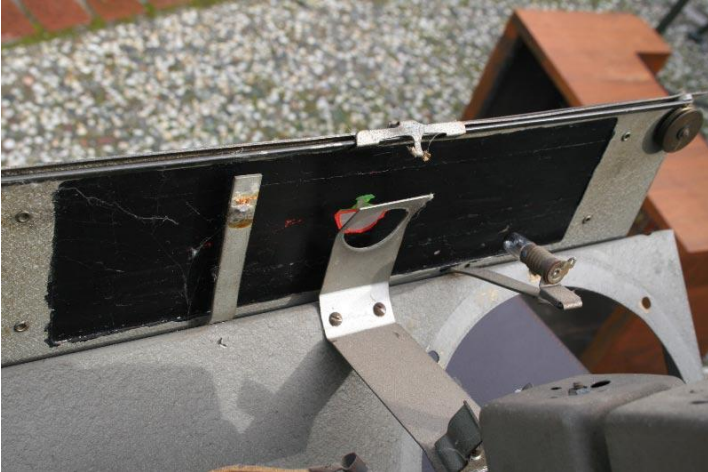
Pilot lamp missing bracket bent

The dial lamp wiring in this radio was missing as well as one of the lamp sockets. The lamp holder bars were bent and coming loose from the chassis. Found a replacement socket straightened and resoldered the holders to the chassis. Rewired the sockets and replace the lamps. I kept with the original screw base # 40 lamp.

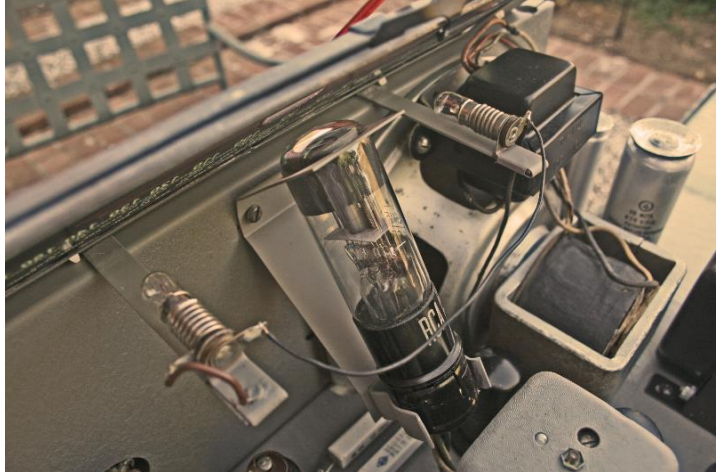
Pilot lamps restored

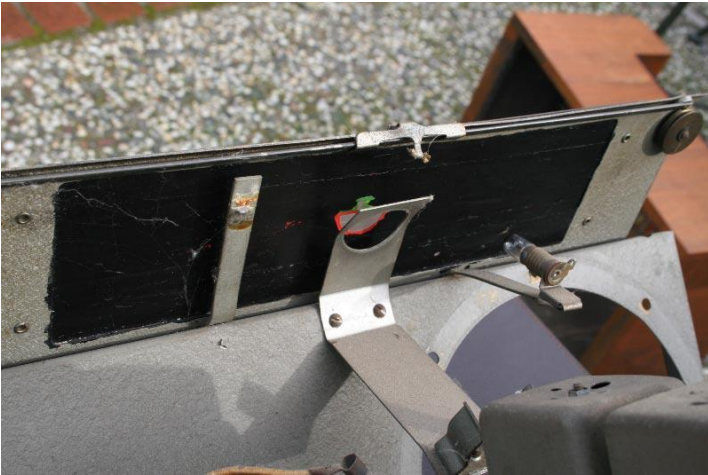
Tuning Eye missing

The tuning eye circuit had been completely removed from the chassis. The only part left was the bracket that held the 6U5 in place behind the dial scale. I gathered the components I needed (6U5, socket assembly, period wire, and resistor) from both my collection and from CHRS. I soldered the resistor and wires to the socket then wired the indicator assembly back into the chassis circuitry.

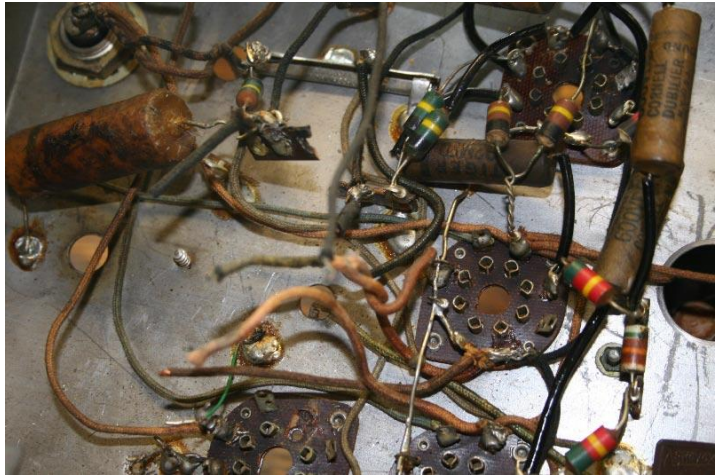
Entire Eye circuit had been removed

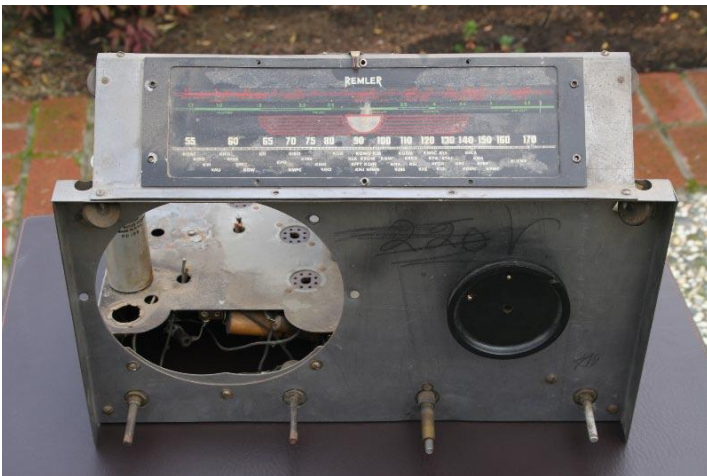
Dial Cord Missing & Broken Cursor

The scale and dial mechanism on this radio had problems. The back of the dial scale had been painted with a black opaque paint and was flaking. The cursor had been broken off of the shuttle, the dial cord was missing, the dial chord pulleys were stiff, and the concentric tuning shafts were gummed up. I was fortunate to find a soft copy of the dial scale graphics for the model 72 and had *Fast Signs* print this image as a decal. I then applied the decal to a cut to size clear piece of acrylic and reassembled the scale frame. The broken off cursor was fixed by using a 4" X 1/8" piece of acrylic rod. I shaped the end to fit into the shuttle then dyed the rod using a red sharpie. Replacing the dial cord was fun. I purchased 6 feet of cord, found a spring and figured out how to thread the mechanism. Another issue was that the dial cord pulleys were stiff with one being almost frozen. Using different solvents, *Brasso* and elbow grease I was able to free up the pulleys without having to remove them. The last issue with this mechanism was that the concentric tuning shafts were gummed up. I was able to separate the shafts and thoroughly clean the ball bearings, raceway and shafts.

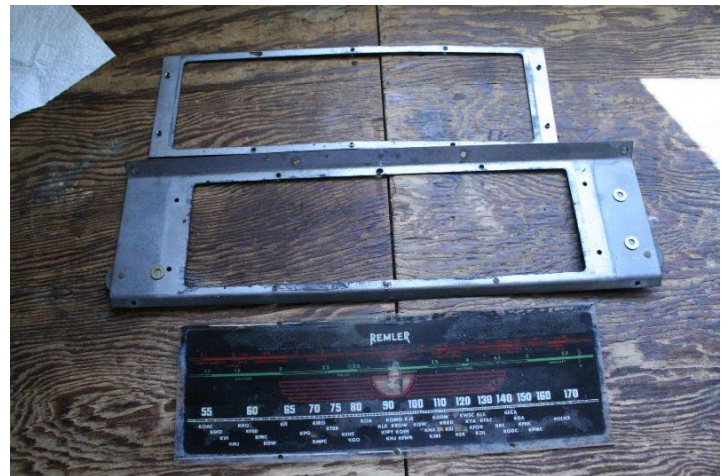
Bad Condition Of Dial Scale

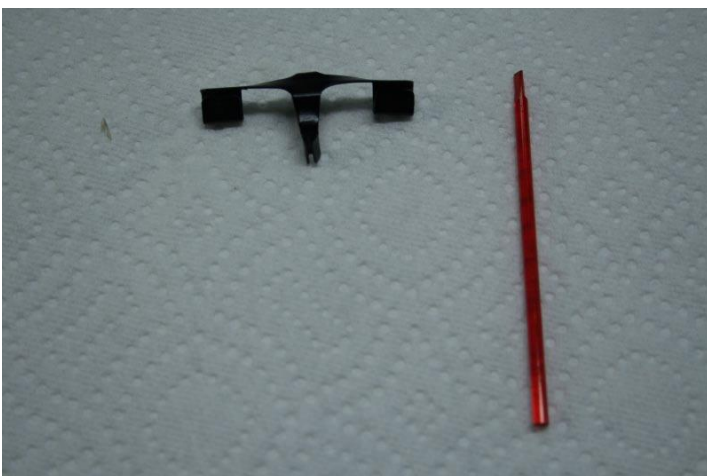
New Cursor and Painted Shuttle

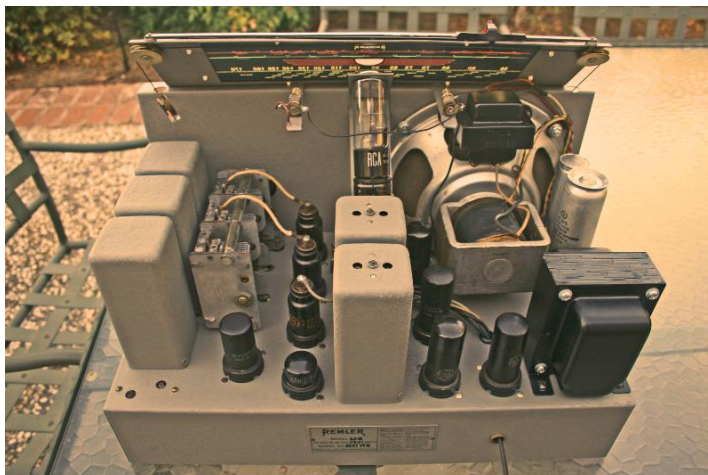
Chassis restored

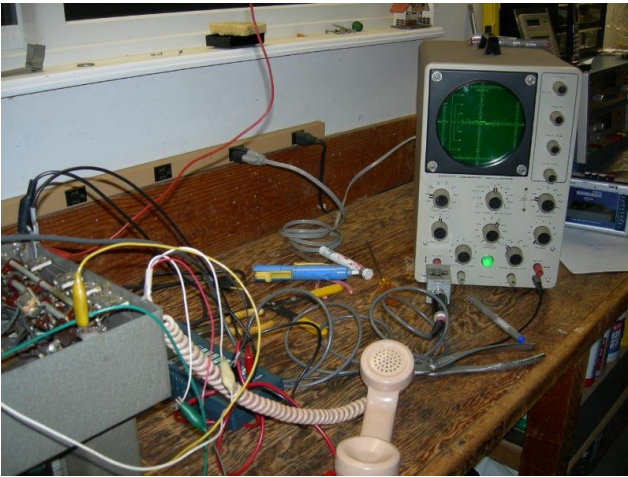
General Troubleshooting

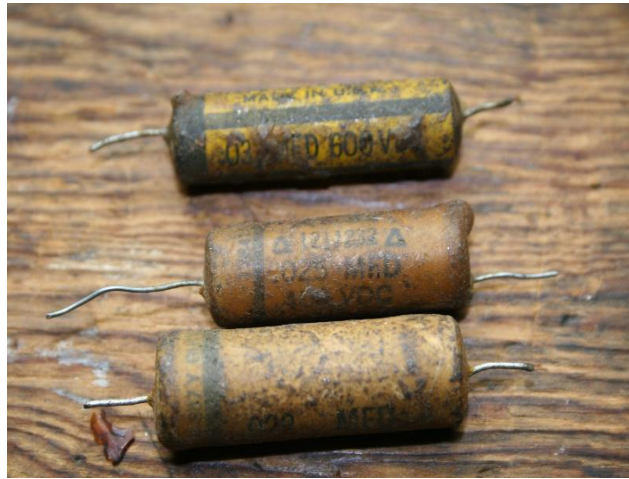
Replacement Capacitors before re-waxing

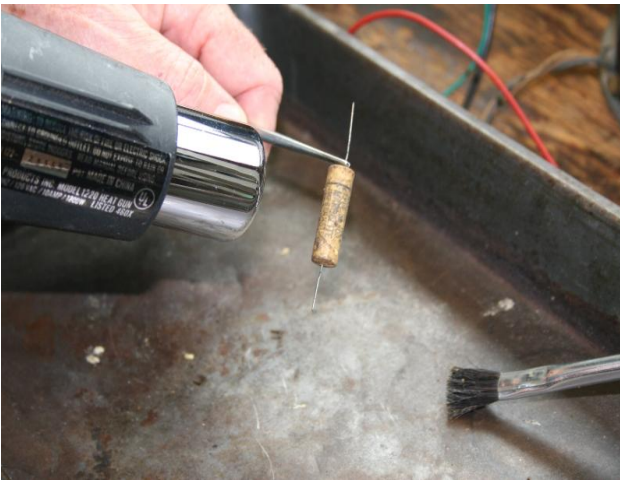
Removing old wax

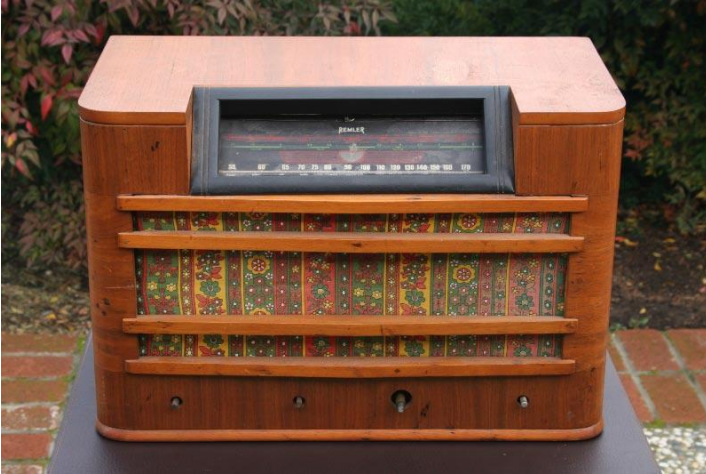
Don't know the history of this radio but it looked like at some time someone refinished the cabinet with an orange/reddish finish. Not sure what the finish actually was, but it was difficult to remove. In fact, I was never able to completely remove it. After using lacquer thinner, multiple applications of paint remover, sandpaper and steel wool, enough of the old finish had been removed so that the new finish could be applied. To help prevent blotchiness, I first applied a pre-stain wood conditioner followed by the finish stain. The stain used is a *Minwax Red Mahogany*. After a few days of drying I hand waxed the cabinet with *Minwax Paste Finishing Wax*.

Initial Condition

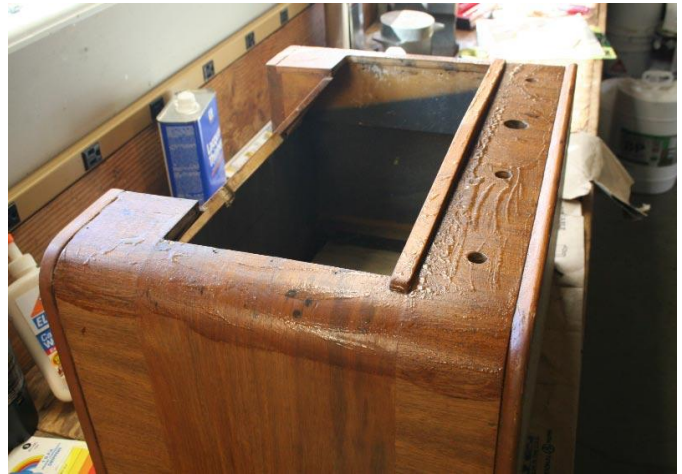
Cabinet Stripping

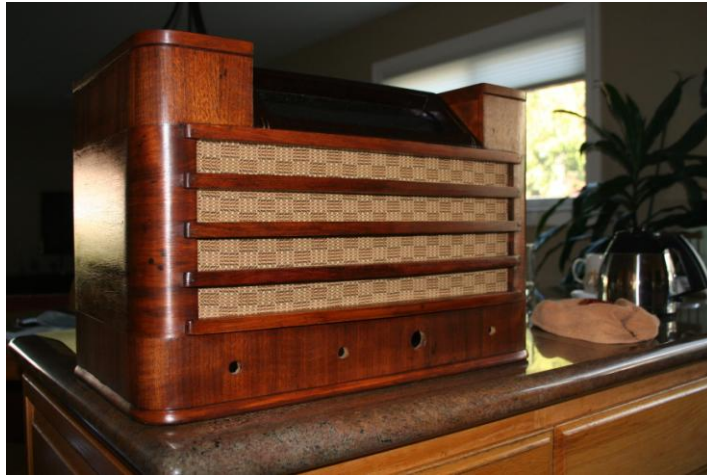
Completed Cabinet

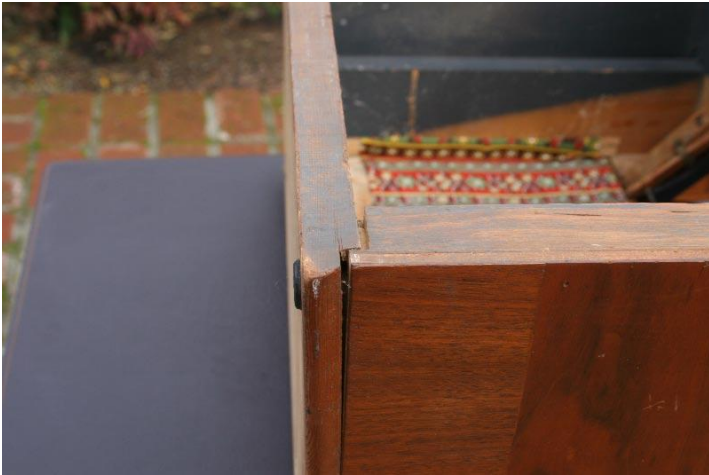
Back right Corner Split

The two lower back corners of the cabinet had pulled away from the cabinet base. To repair this, I screwed two wooden runners to the inside base of the cabinet on the left and right sides. I then peeled back the veneer on both sides of the cabinet applied glue, compressed the joints then put screws through the sides of the cabinet into the runners. The final step was to glue the veneer back into place.

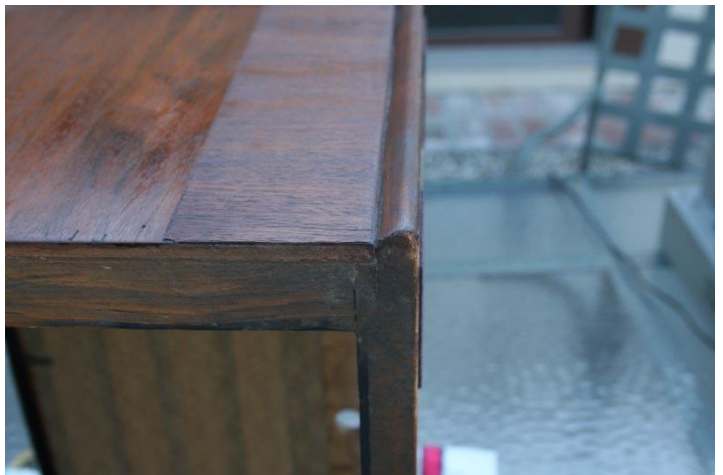
Back Right Corner Repair

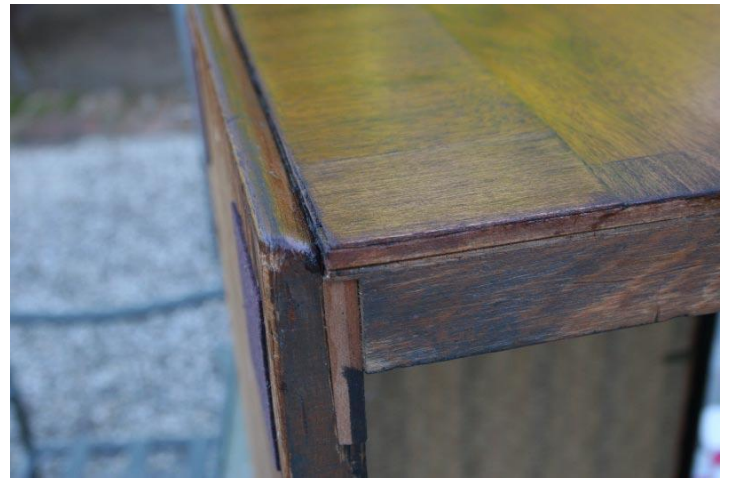
Back Left Corner Repair

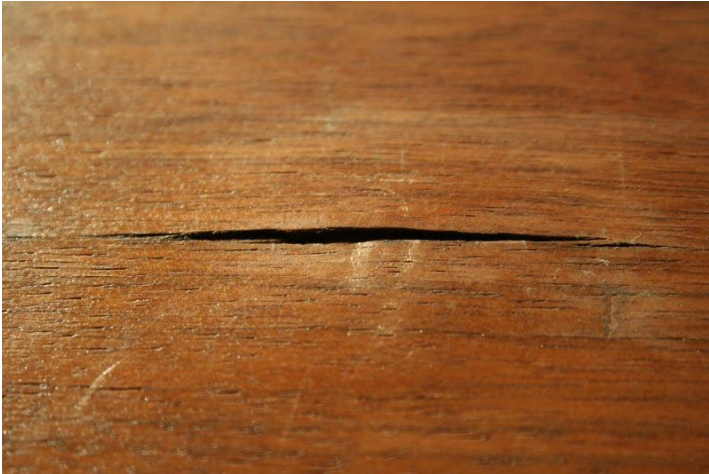
On the top of the cabinet the veneer had split and began to de-laminate. This as well as other problems with the veneer and finish led me to believe that the cabinet and chassis had been exposed to water. To correct this problem, I injected glue under the veneer pushed it down into position then clamped it in place over night.

Cabinet Top Veneer Damage

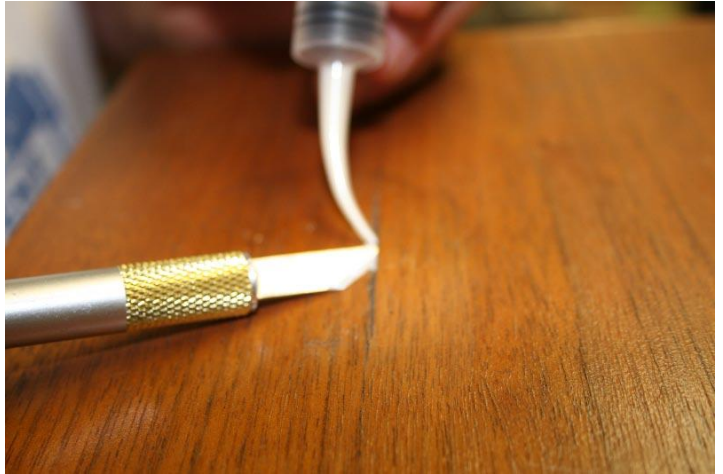
Cabinet Top Veneer Repair

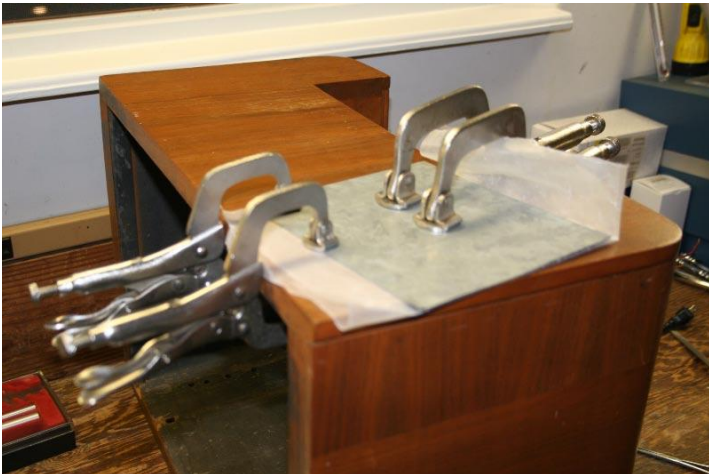
Cabinet Top Veneer Repair

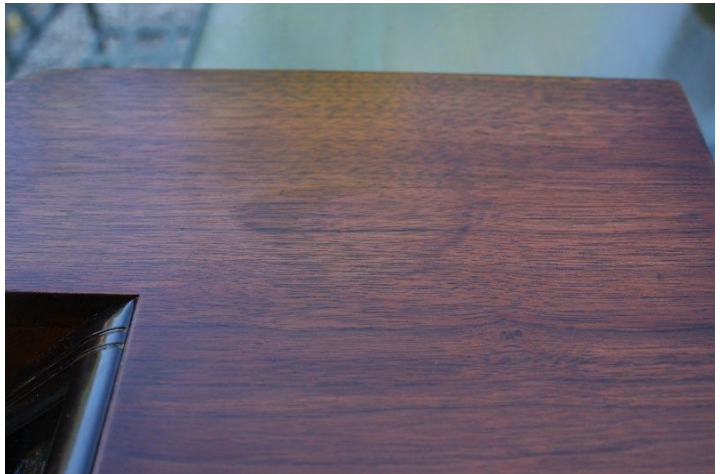
Cabinet Top Refinished

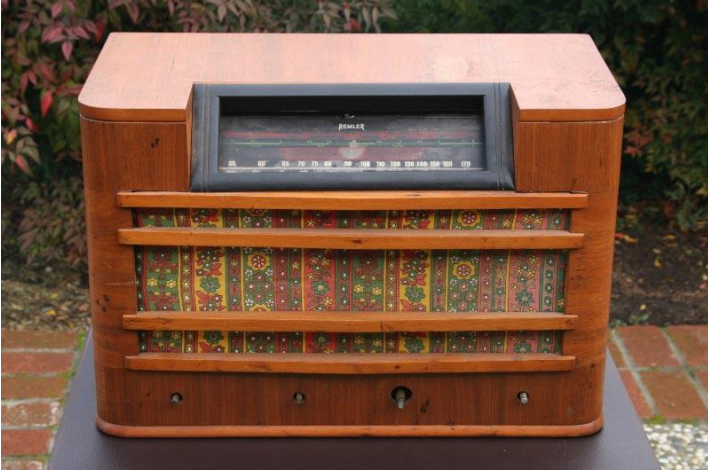
Initial Grill Cloth

The grill cloth that had been replaced sometime in the history of this radio gave the set a festive look but didn't seem period appropriate. On line my wife found a site that had a great selection of grill cloths. We picked one that we liked that complemented the cabinet.

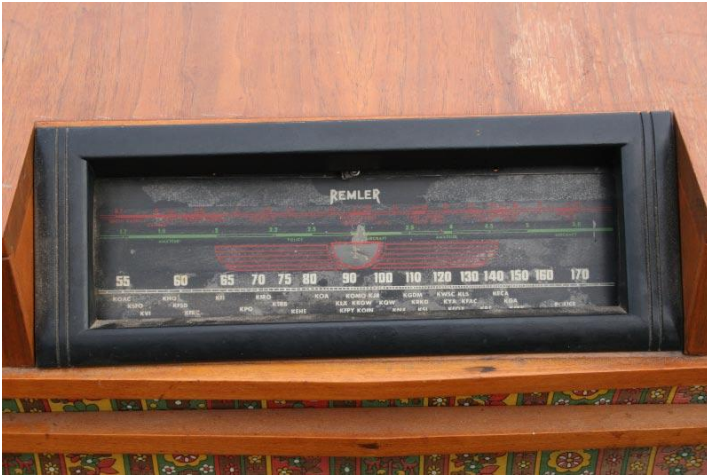
Painted Over Bezel

At sometime the bezel had been painted black. The paint was thick and not evenly applied. After giving some thought on how to remove the paint, I decided to test the bezel material to see if it could withstand paint remover. Much to my surprise the paint remover did not attack the plastic like material. After removing the paint and polishing the bezel, I replaced the missing window with a piece of 1/16" thick acrylic plastic. The final touch was to put gold leaf tape into the trim along the sides of the window.

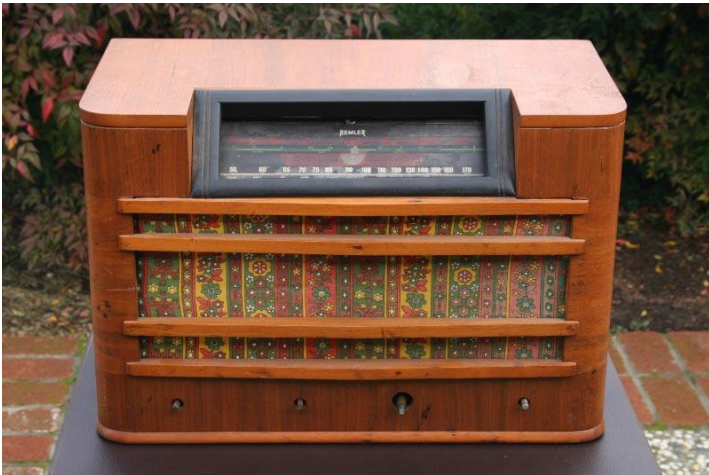
The wooden speaker grill had suffered some damage over the years. One of the 5 horizontal elements was missing; another had broken loose from the cabinet on the right side. The others were barely attached.

Initial Condition

In order to replace the missing element, I had to fabricate one. I took one of the grill pieces to a local woodworking shop and tried to match the wood species. I found a piece that closely matched the grain and density of my sample. I then traced the outline of my sample on to the wood and did a rough cut out using a band saw. I contoured the piece to shape using a wood rasp, electric sander and sandpaper.

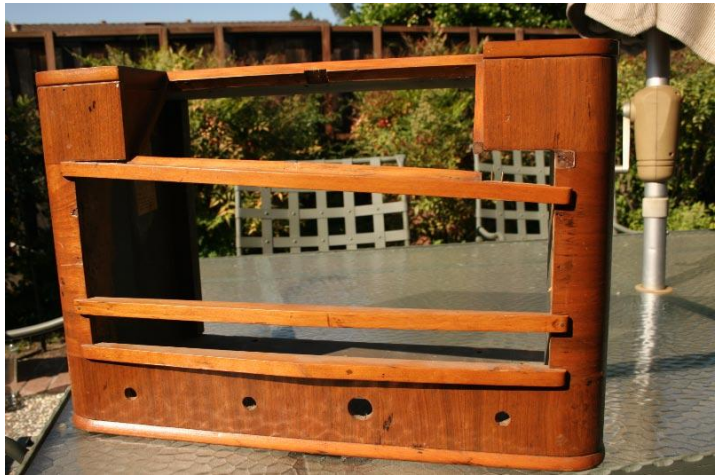
Initial Condition

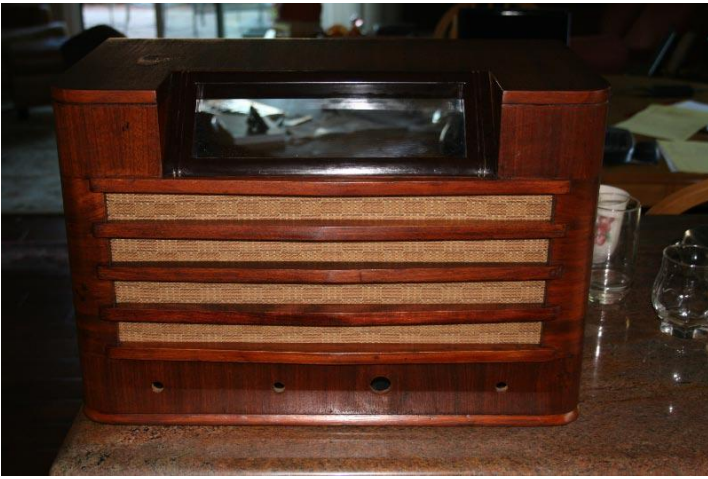
Restored Grill

My final step was to attach the grill pieces to the cabinet, equally spacing them. I used small finishing nails and wood glue to secure them.

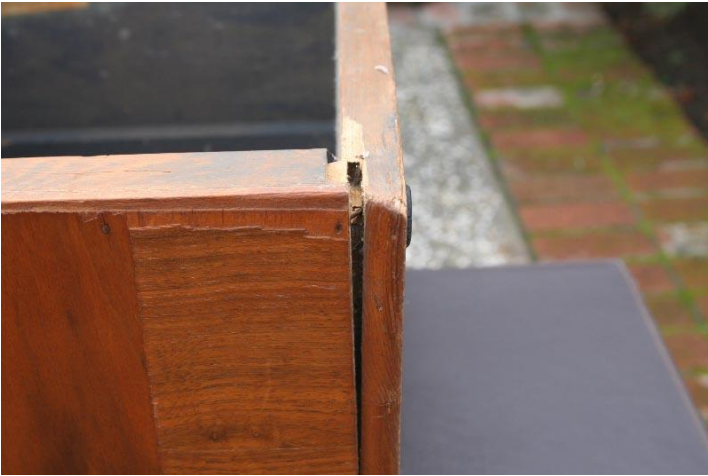
On the back left side of the cabinet the veneer had been damaged. The only way to repair it was to cut out the bad sections and replace them. I found usable pieces of veneer that closely matched the cabinet at CHRIS. I then removed the damaged veneer from the cabinet. I matched the grain, sanded and fitted the pieces together. I glued them into position and clamped them overnight. The following day I removed clamps trimmed the pieces and sanded the matching joints.

Damaged Veneer

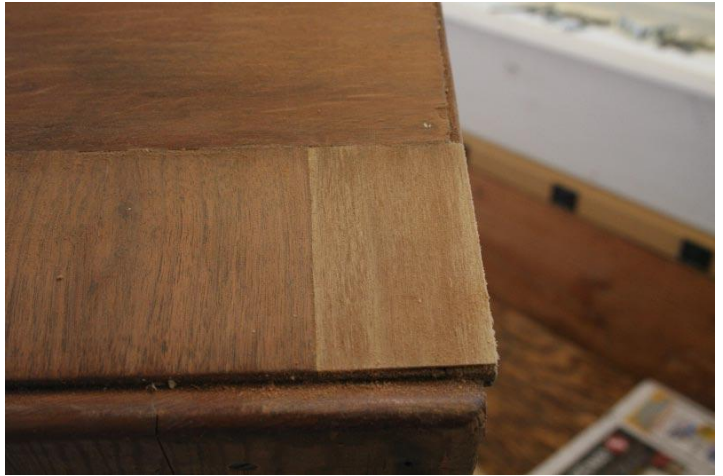
Damaged Veneer Replaced

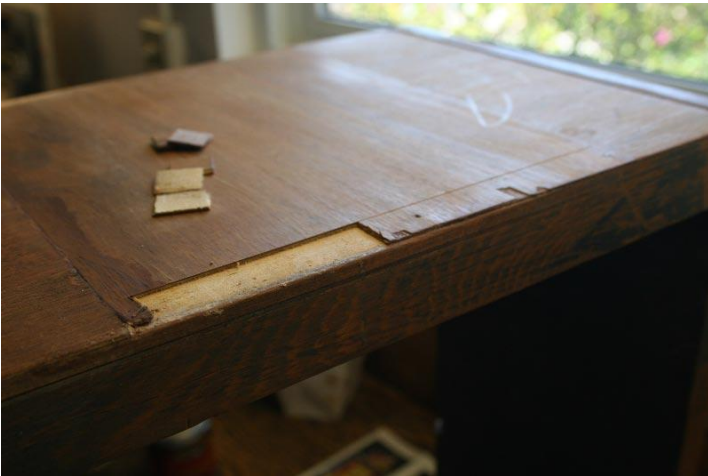
Damaged Veneer

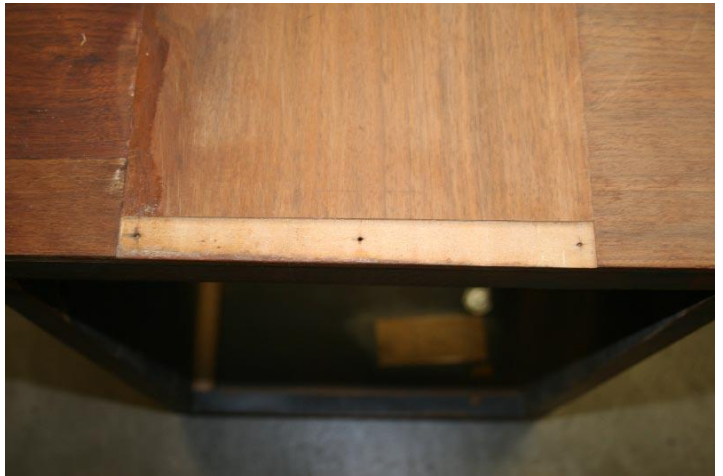
Damaged Veneer Removed

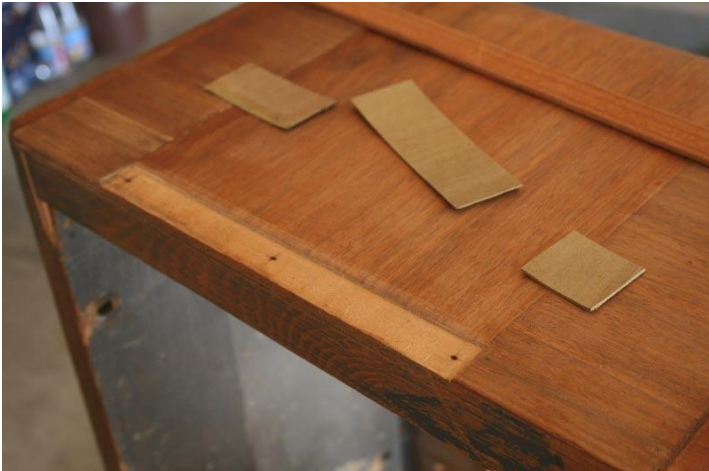
Replacement Veneer Pieces
