Remler Model 72

Restoration Project

Elmo Giovannetti

January 2012

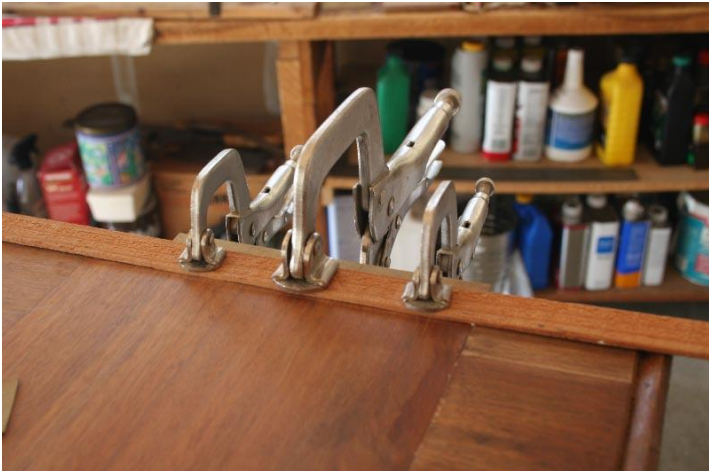
Replacement Veneer Glued

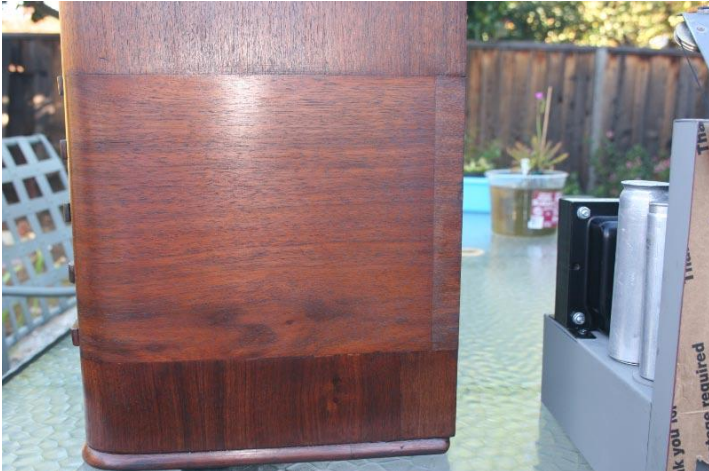
Veneer Replaced & Finished

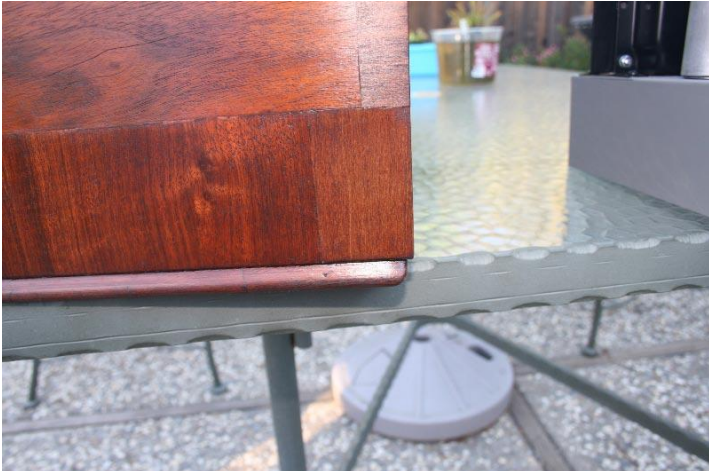
Veneer Replaced & Finished

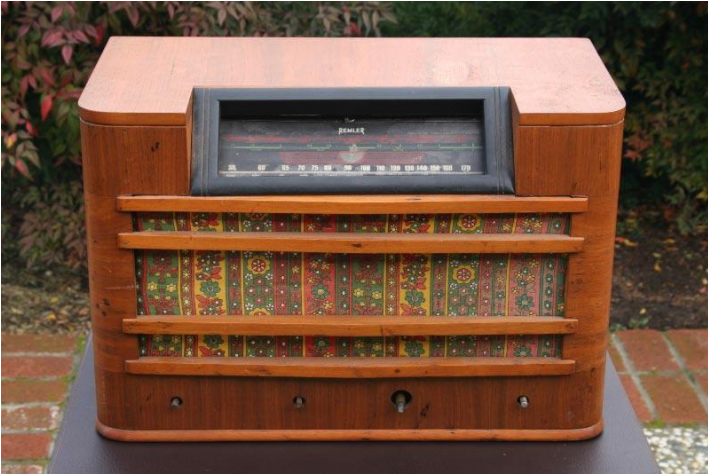
One of the initial conditions was that all five knobs were missing from the radio. I was fortunate that a fellow CHRS member, Jamie Arbona, has a complete Model 72. Jamie was kind enough to allow me to use his knobs as masters for duplication. Jamie referred me to Larry Bordonaro who had previously cast knobs for other CHRS members. Unfortunately, when I contacted him, he had given up reproducing knobs due to health issues. I then searched the Internet looking for someone that could do castings. Again, I was fortunate that I found someone locally that was in the business of mould making and casting. It took less than a week and I had the replacement knobs I needed.

Initial condition no knobs

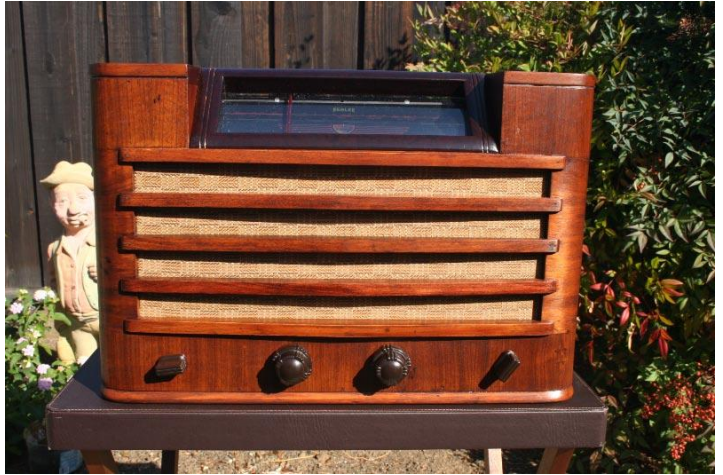
New Knobs Installed
