Restoration of a Philco Model 18 (Code 124) Cathedral Radio

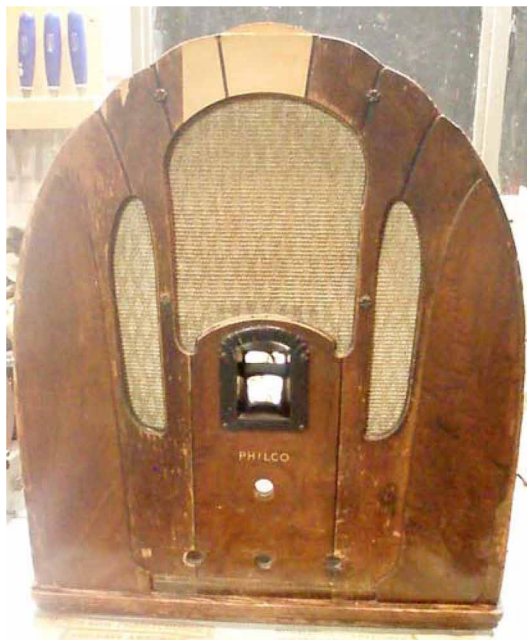
I purchased this radio via Trademe in November 2010. It was described as needing “lots of TLC”. How true that was! This model is a single band, eight valve superhet using valve types: RF-78, Mixer/oscillator-6A7, IF-78, Detector/1st audio-75, Audio driver-42, Output-push pull 42s, Rectifier-80. The three 42s are triode connected and, according to Ron Ramirez, produced a “Super Class A” audio with an output of fifteen watts which gave the radio better fidelity. I suspect it hadn’t been heard for a long time! It is equipped with a shadow meter.

The cabinet was missing veneer and some of the laminate on the front and back of the front panel, the moulding around the bottom was badly mutilated and the bakelite escutcheon had pieces missing around the shadow meter. The ply had also delaminated in many places. The chassis was badly corroded and, as I was to find out later, most of the components were faulty. A 5Z3 had been substituted, incorrectly, for the original 80 but the rest of the valves were at least correct. The power cord, 2 core only, and plug looked like the originals and were very unsafe. The whole set looked as though it had sat in the corner of a barn for many years. Inside the cabinet was the original chassis layout diagram and a service label from Begg’s, Christchurch. Unfortunately only the dates are readable.

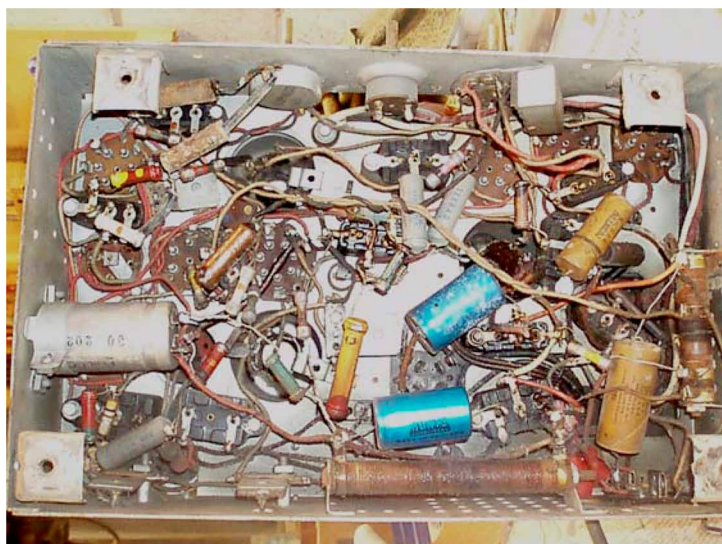
First up was to carefully document and strip the chassis. Once again Nostalgia Air provided valuable circuitry, layout and alignment information. From the photo below it is evident that over the years faulty components, mainly the bakelite block capacitors and power supply electrolytics, had been replaced with individual units. The underside of the chassis was a mess. Fortunately all the original cans and blocks were still present. There are two wire wound resistors, one in the bias chain and the other in the main HT line, both of which were open circuit. The mixer and oscillator coils both had open circuit primaries, the shadow meter coil was open circuit and most of the carbon resistors were wildly different from their stated values. There wasn’t

one capacitor in the whole set that was able to be reused!

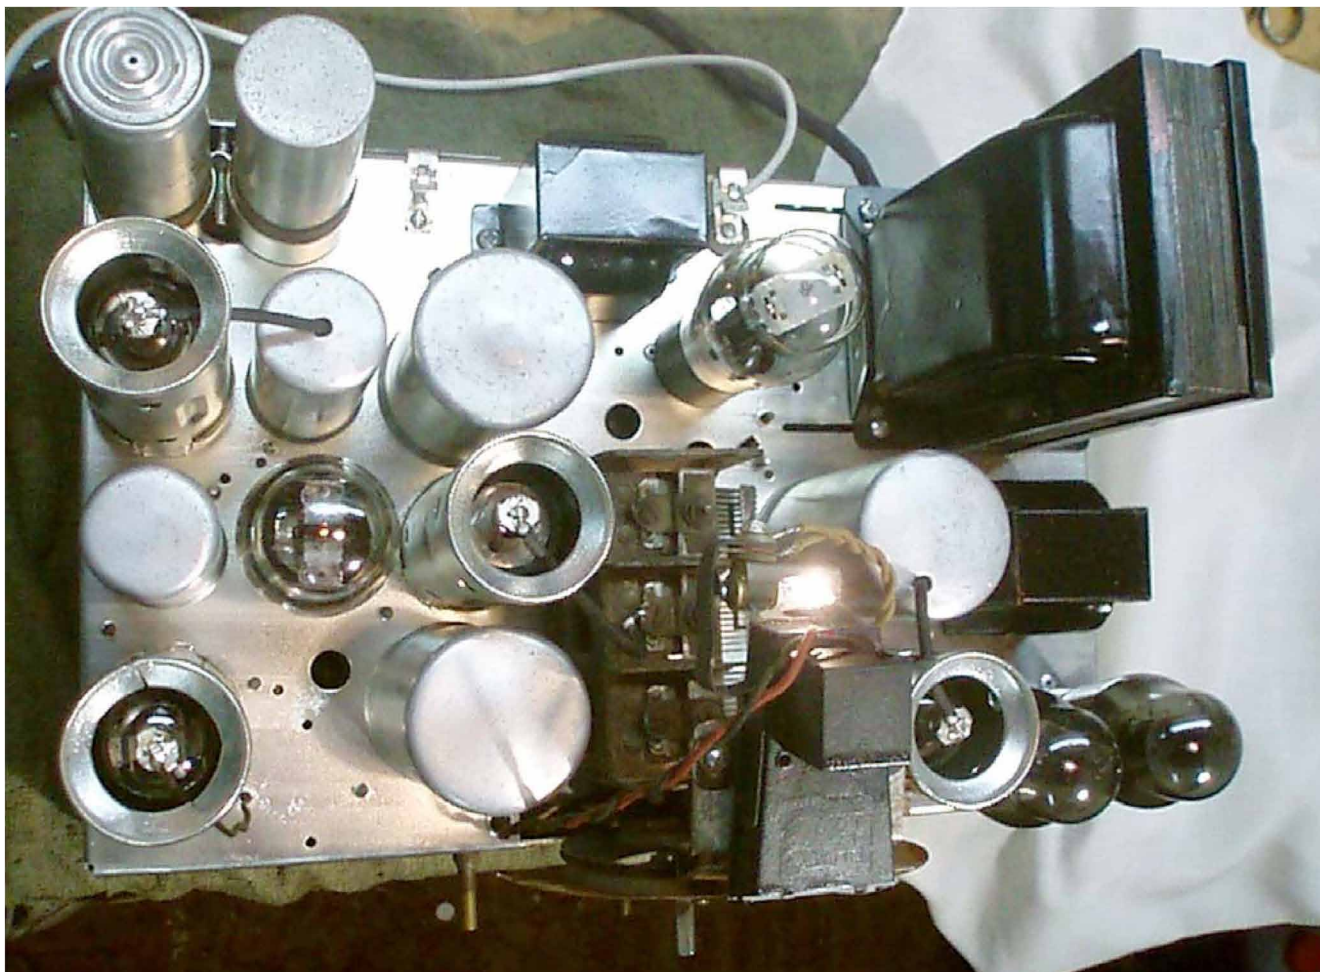
During the February earthquake, the completed chassis was thrown off the bench and it landed upside down on the valve shield in the bottom left of the photo. (the 75). The shield was bent and suffered a small split as can be seen but, despite the valve being inside the shield and the set being very heavy, this was the only damage the set sustained. – remarkable.

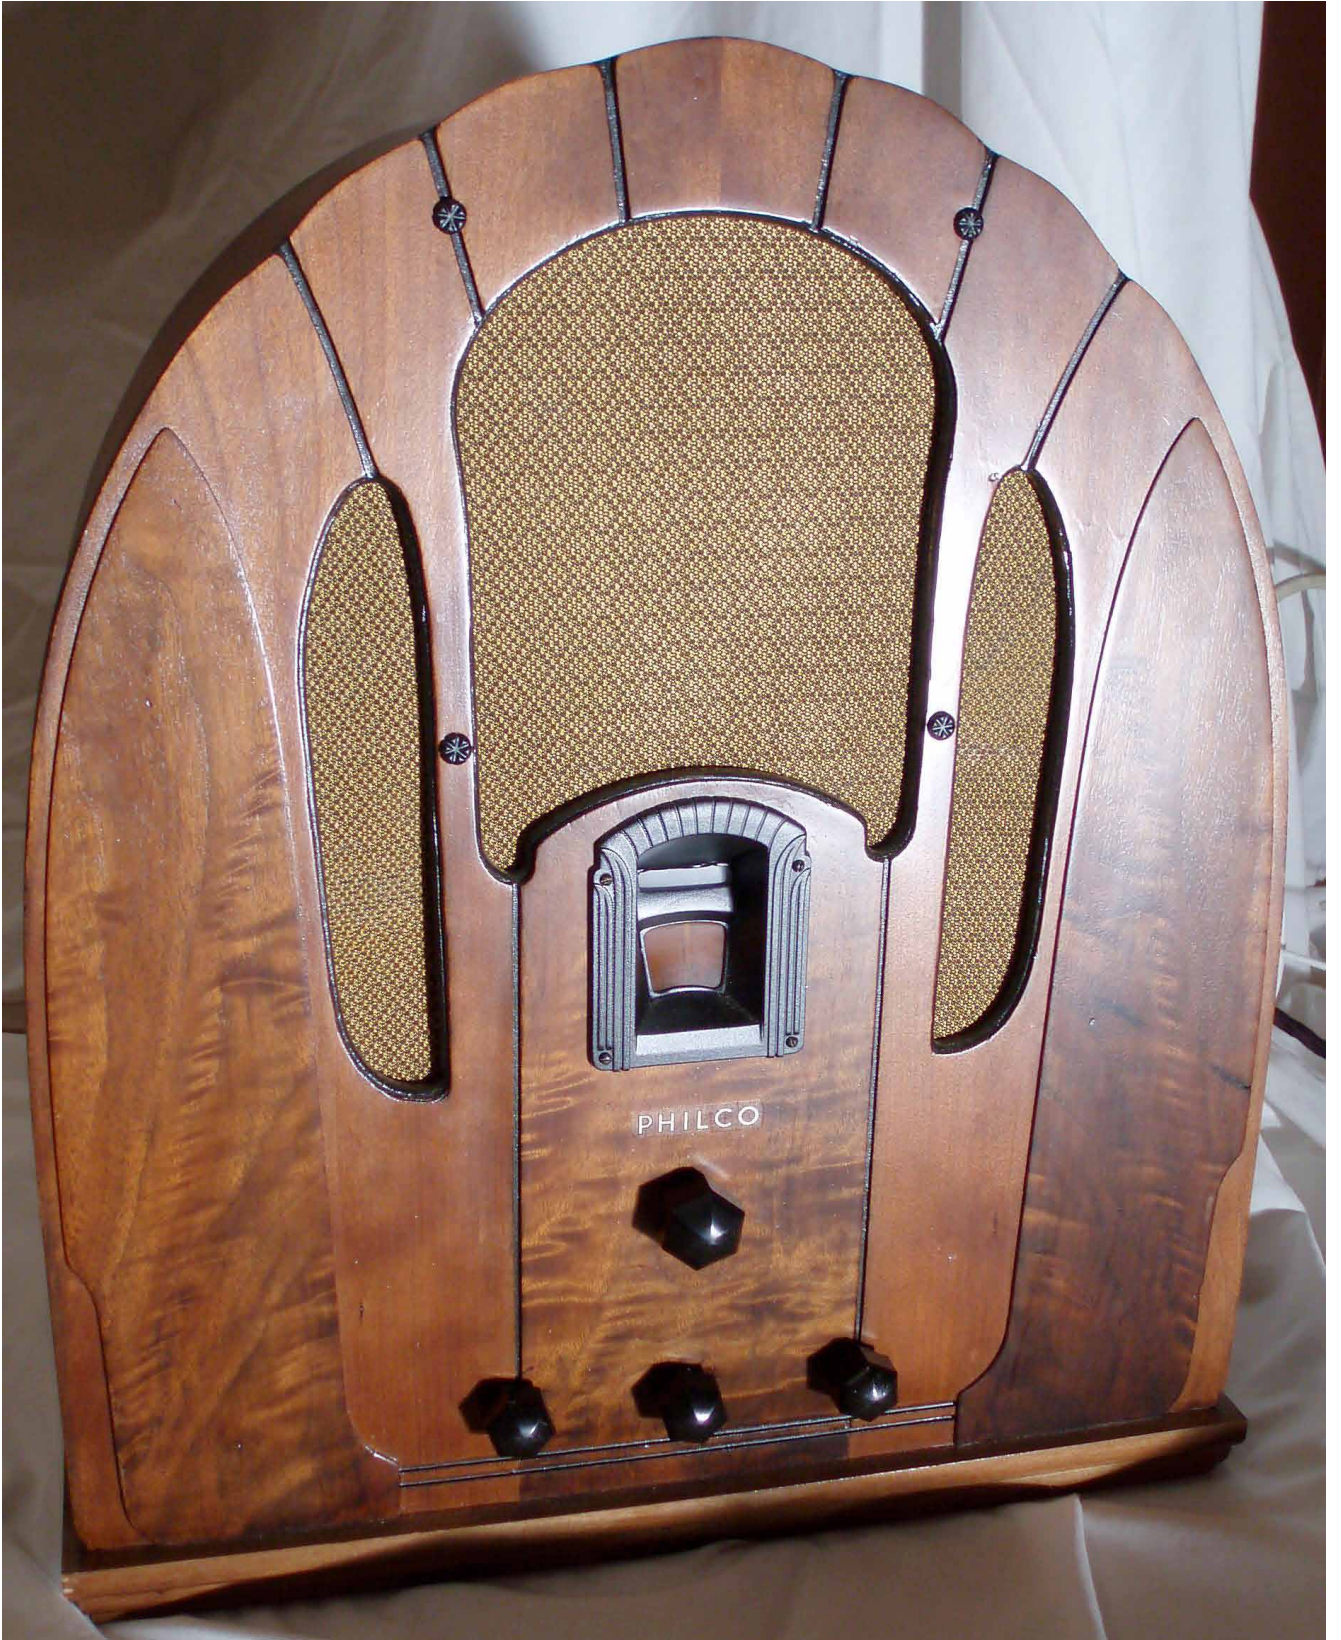
The finished 'Philco Model 18'

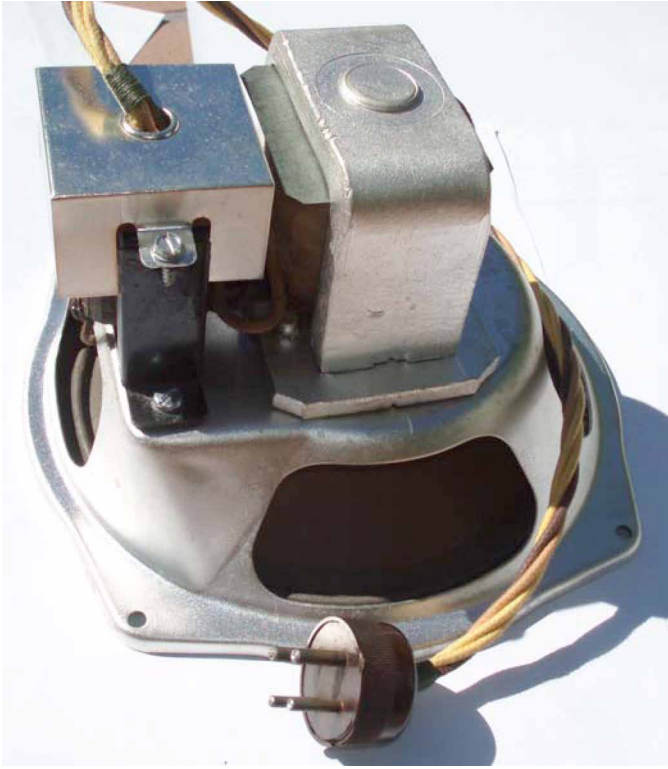
Restored speaker

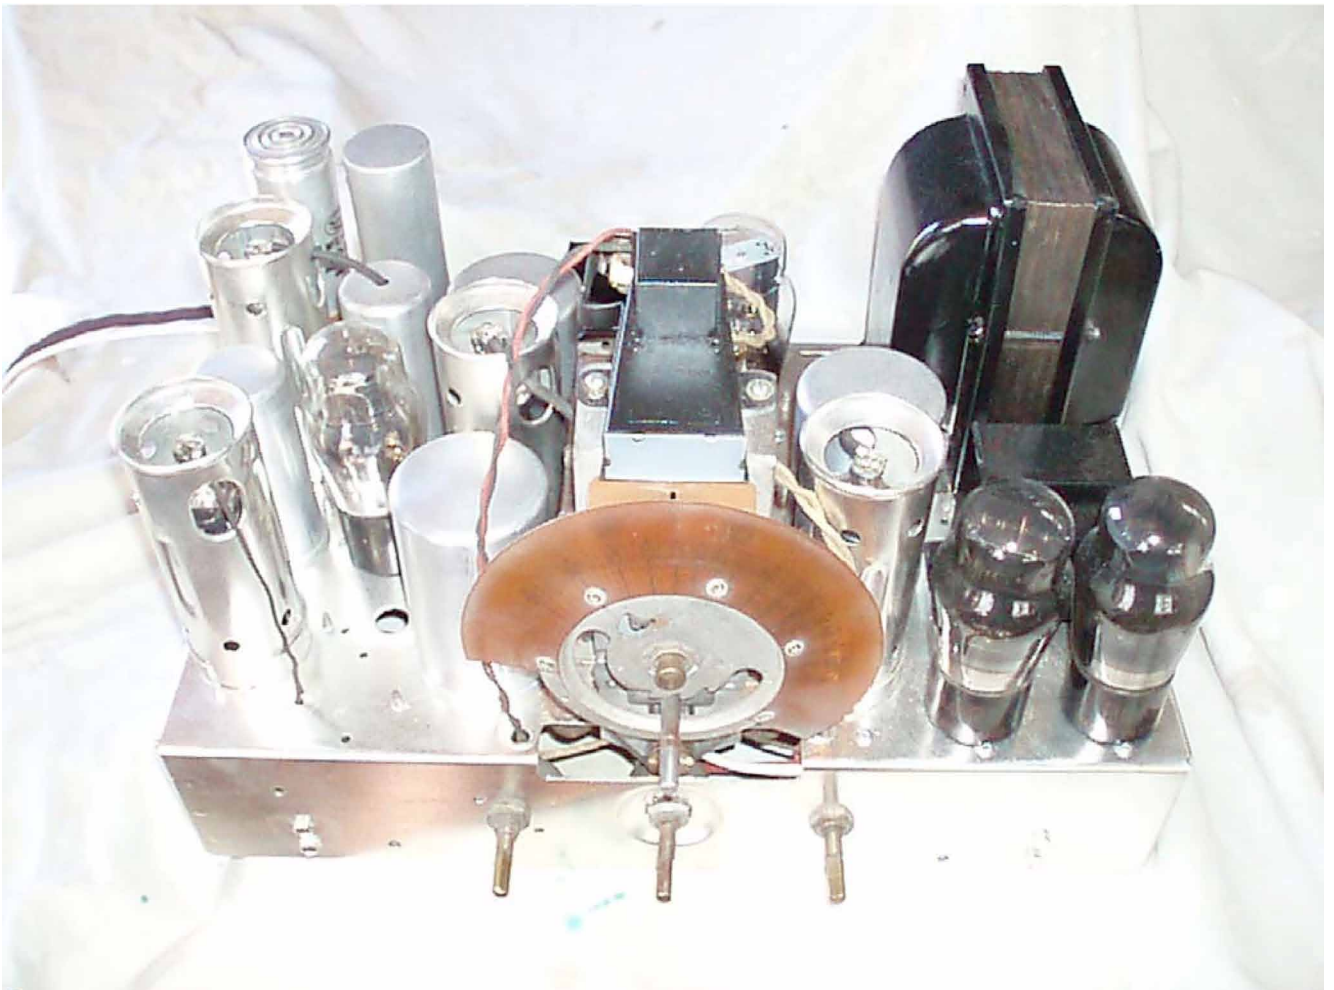
Completed chassis

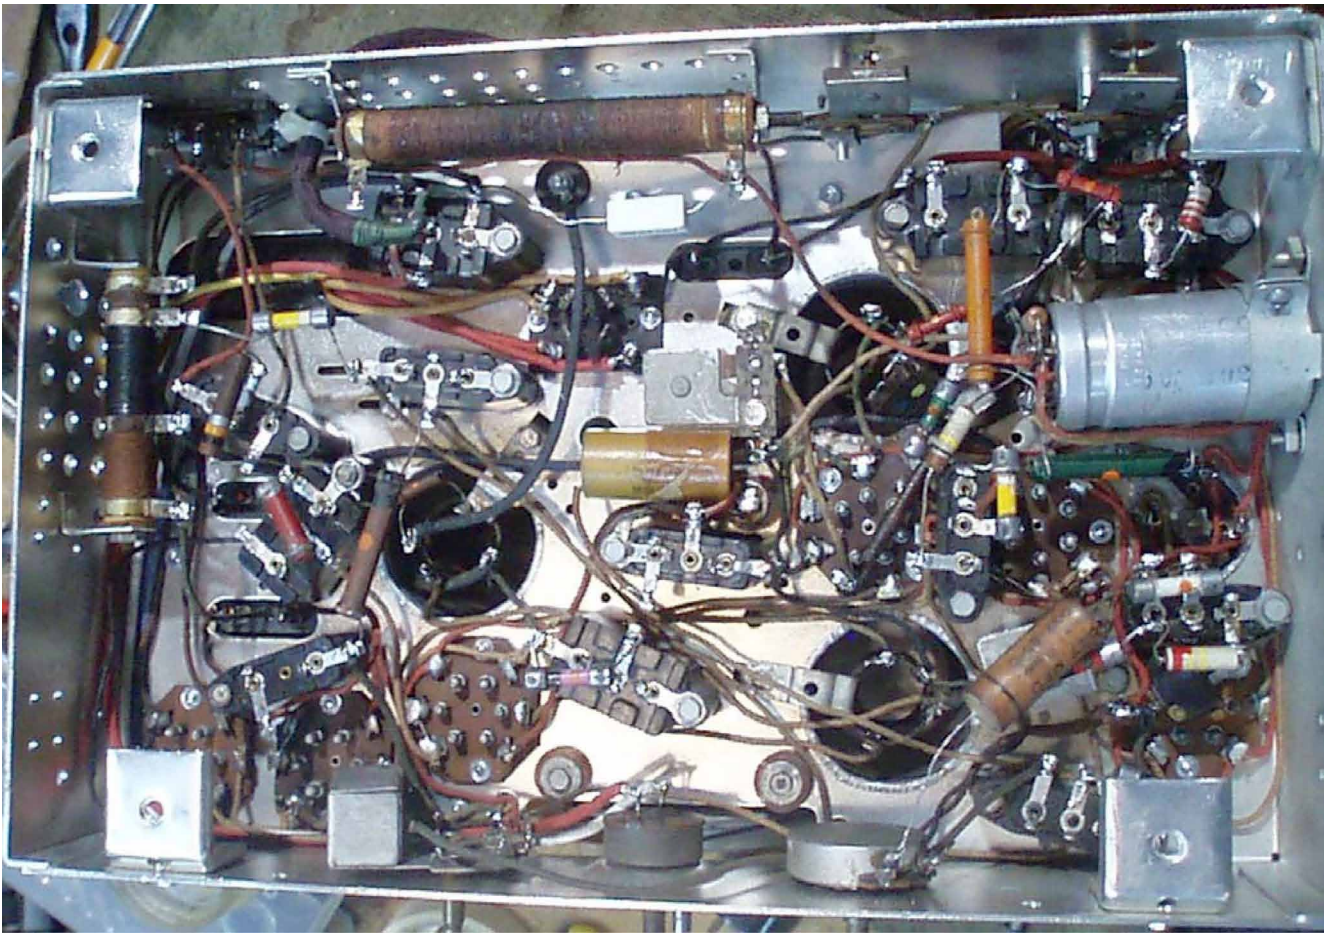
Completed chassis underside

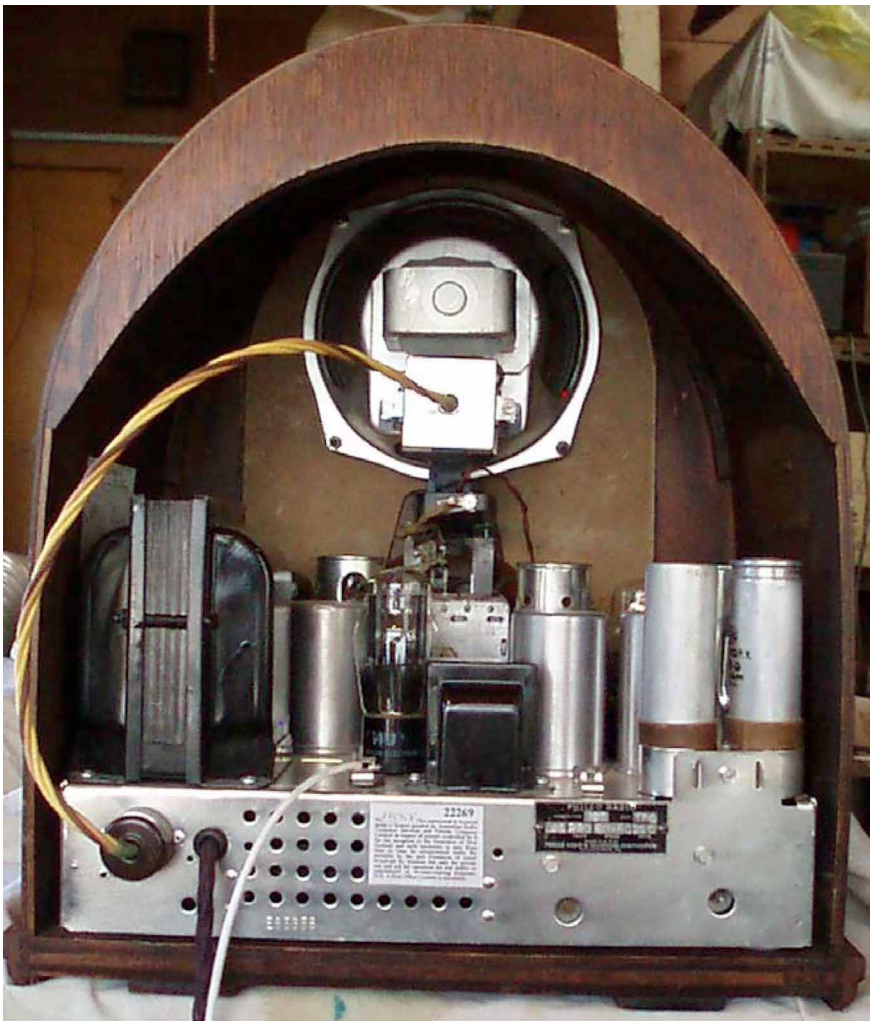
Completed rear view

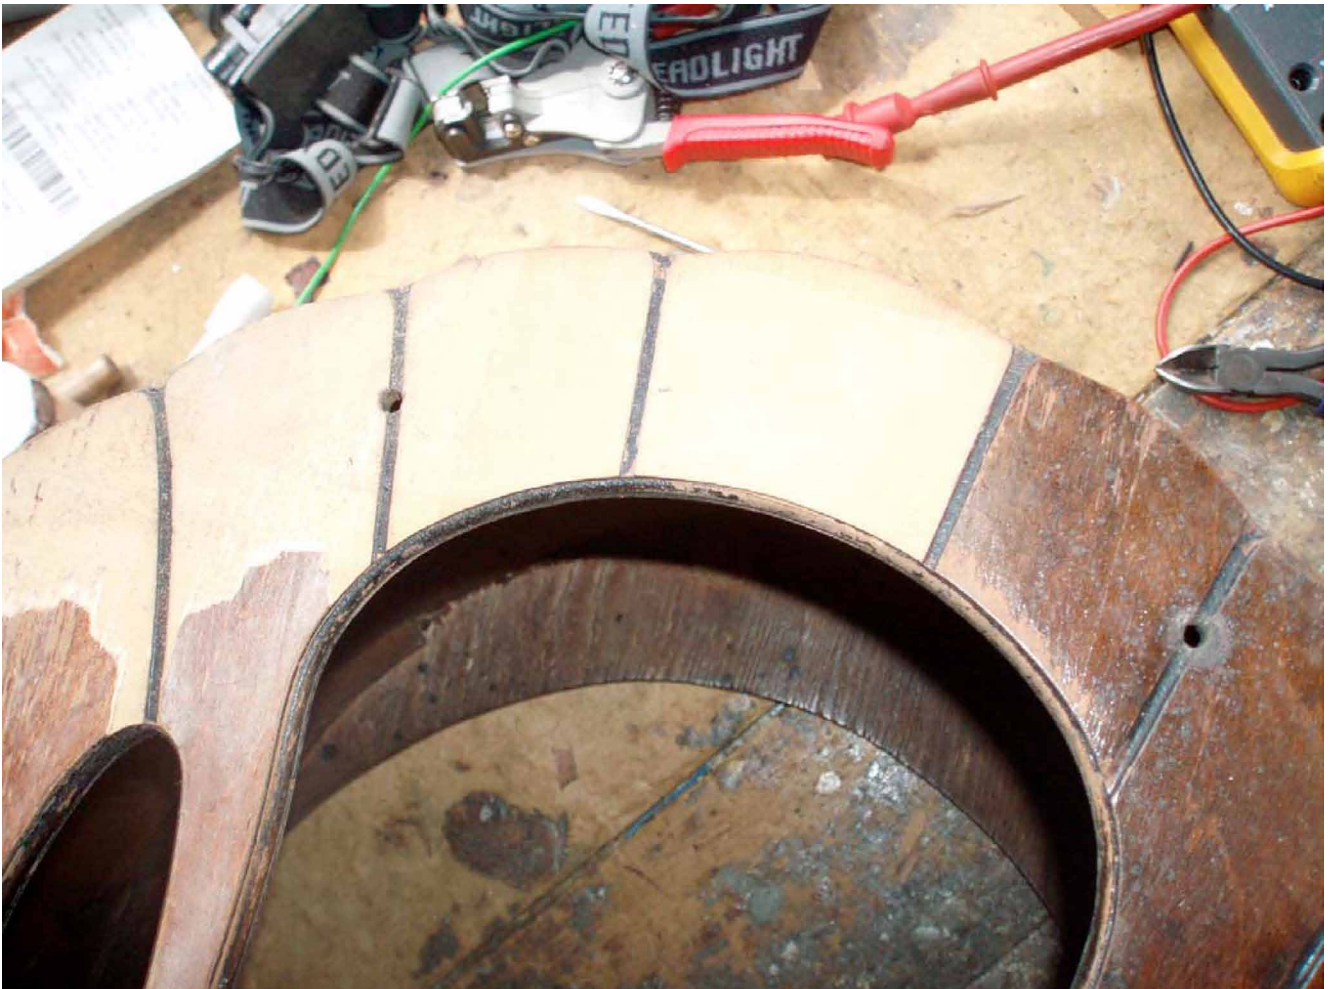
Cabinet repair in progress

The centre piece of veneer around the dial escutcheon was of good quality and it was in good order, but it was very apparent early on that the only way to repair the larger part of the front was to replace the veneer. Before removing the old veneer a rubbing of the lined pattern was taken so that it could be reproduced in the new veneer. Also the removal of the two pieces of thick, high quality veneer, one to each side, and the moulding around the bottom was needed. It was a painstaking job to remove these pieces as, in contrast to the rest of the gluing on the cabinet, they were stuck fast. However patience prevailed and in time I was rewarded. The rest of the front veneer came off very easily. The curved top of the case fits, and is glued into, a slot routed into the back of the front, but over time, the back two layers of ply had fallen off and there was only one small piece remaining. It was a tricky job to set up the router to remake the missing pieces so that they fitted snugly around the case. Once again patience prevailed and the reward was granted. During this time, at the end of each session the painstaking job of forcing glue into the delaminated ply and cramping each little piece with small G cramps continued. There were numerous places where the glue between the ply laminates had failed and the case had become quite unstable.

However this came right slowly and the cabinet became rigid again. I had a local joinery firm copy the moulding for the bottom and this is where a bit of New Zealand crept in as the new moulding is made of Rimu. Replacement veneer for the front is American cherry and was sourced locally. Gluing the new veneer on was definitely the easier part of this section of the job. Cutting it around the fretwork was slow, tedious work and routing the pattern back, using a 2mm router bit and specially made router guides, was quite scary. One slip and it was all over. However, when completed, the cabinet started to look a lot better. It was time to clean the remaining varnish off the rest of the cabinet. I used a very sharp chisel drawn backwards, as a scraper. This is very effective and, provided it is carefully done, does not harm the wood in any way. I agree that liquid stripper is necessary for some hard to reach places but I avoid it if at all possible. This was followed by a thorough sanding with finer and finer grit paper.

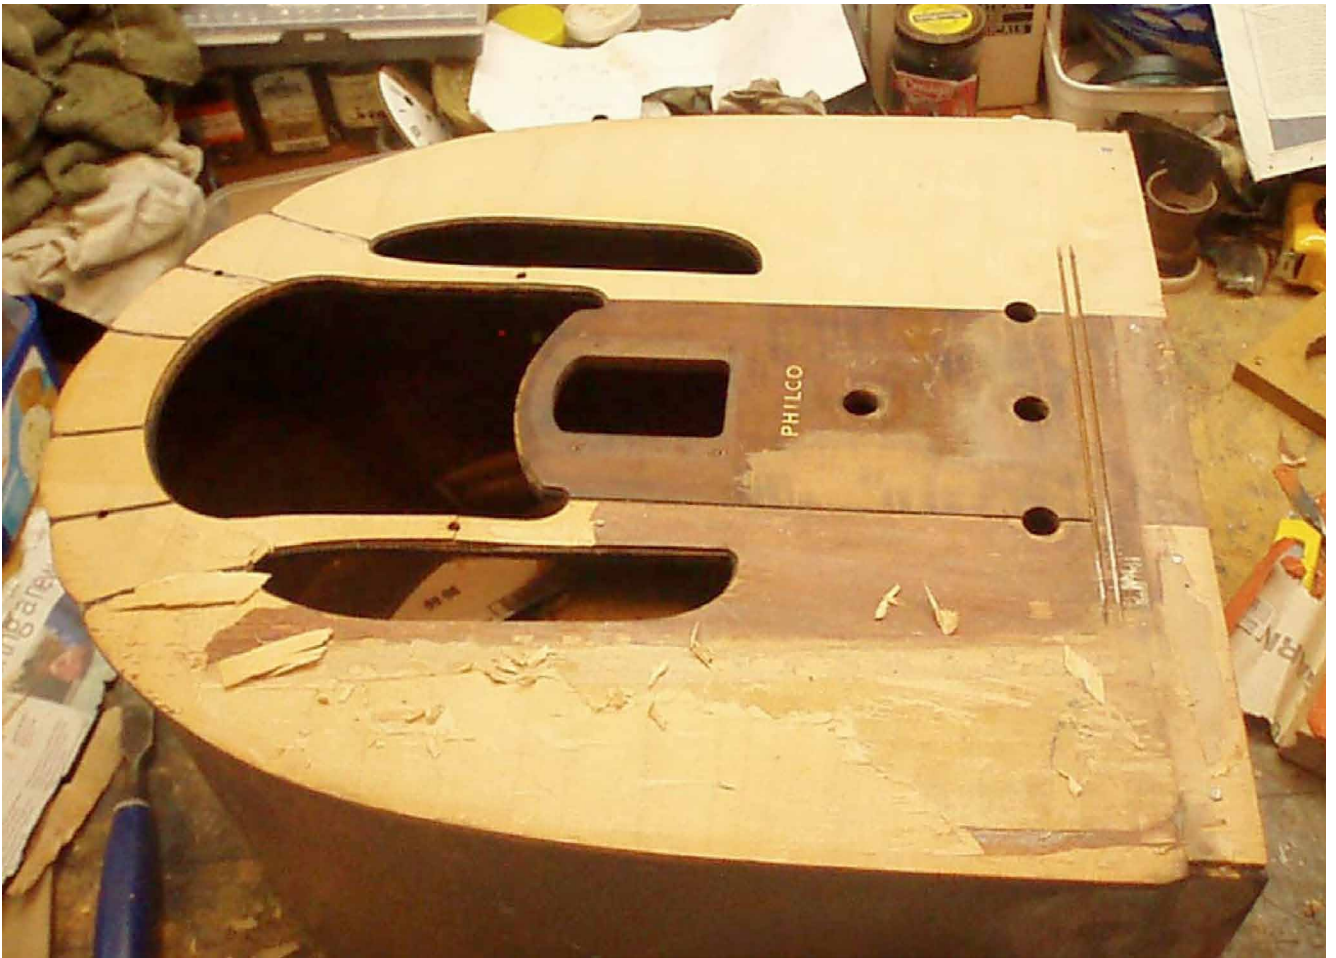
Cabinet repair in progress

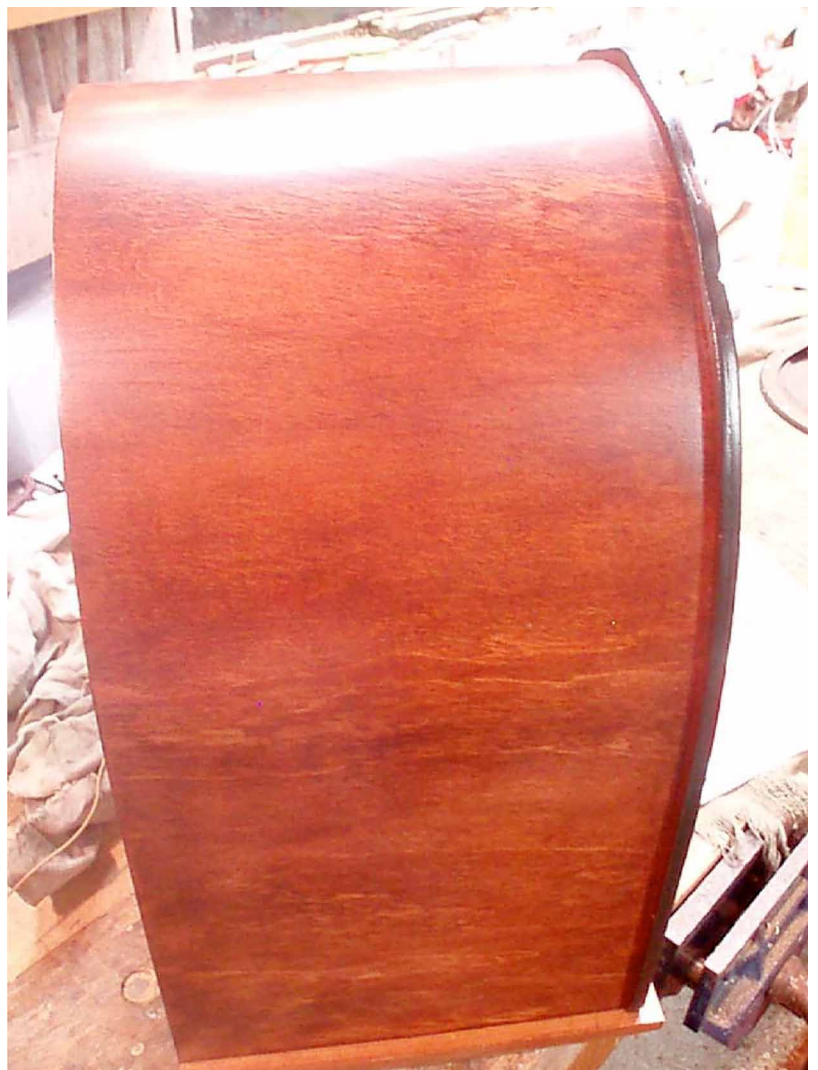
Cabinet recoloured

That job complete, I stained the new veneer and moulding with a water based, rub-on stain. The rest of the cabinet still had some colour so I lightly stained it with a diluted stain until everything matched. The timber of the two pieces that had been removed from the front and the central part of the front are of dark, beautifully grained timber which did not need any staining. It was time now to fit the new moulding and refit the two pieces of veneer to the front. The cabinet was now complete and certainly looked a lot better than when I had received it! As I am not very proficient with a spray gun, I finished the whole cabinet using satin polyurethane thinned 50% with turps, put on with a brush. There is a total of eight coats with a sand using 00 wet & dry, dry, between each coat. The shine slowly builds and the finish is smooth and rich. After the second polyurethane coat and with a fine artist's brush, I painted all the necessary edges and lines with black paint. The remaining coats of polyurethane brought the paint to the same finish as the rest of the cabinet. Finally a replacement transfer was floated onto the cabinet.

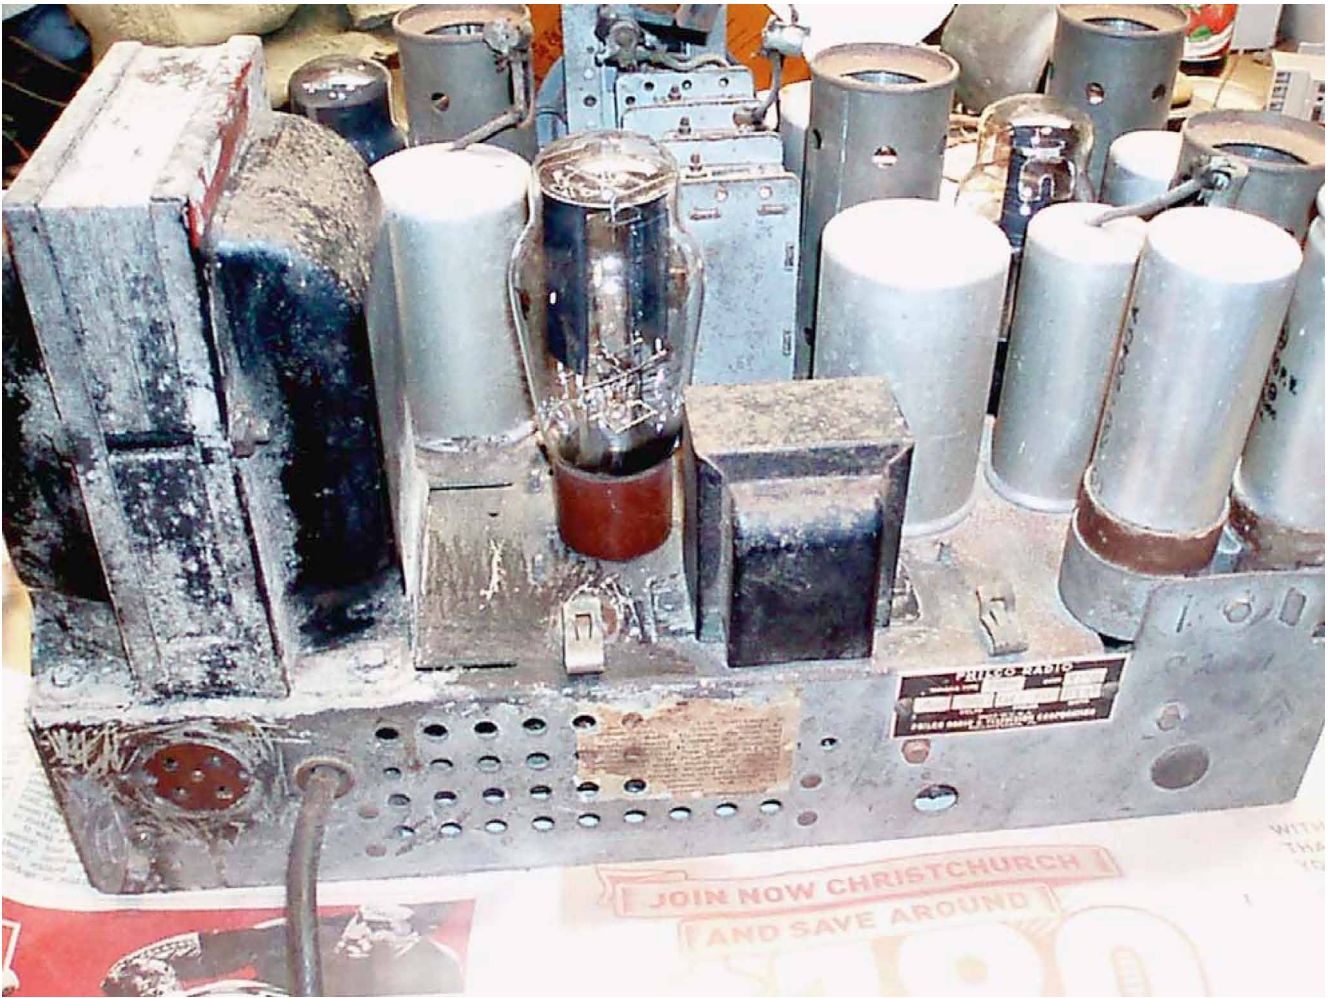
Chassis 'as received'
