RCA Gloria

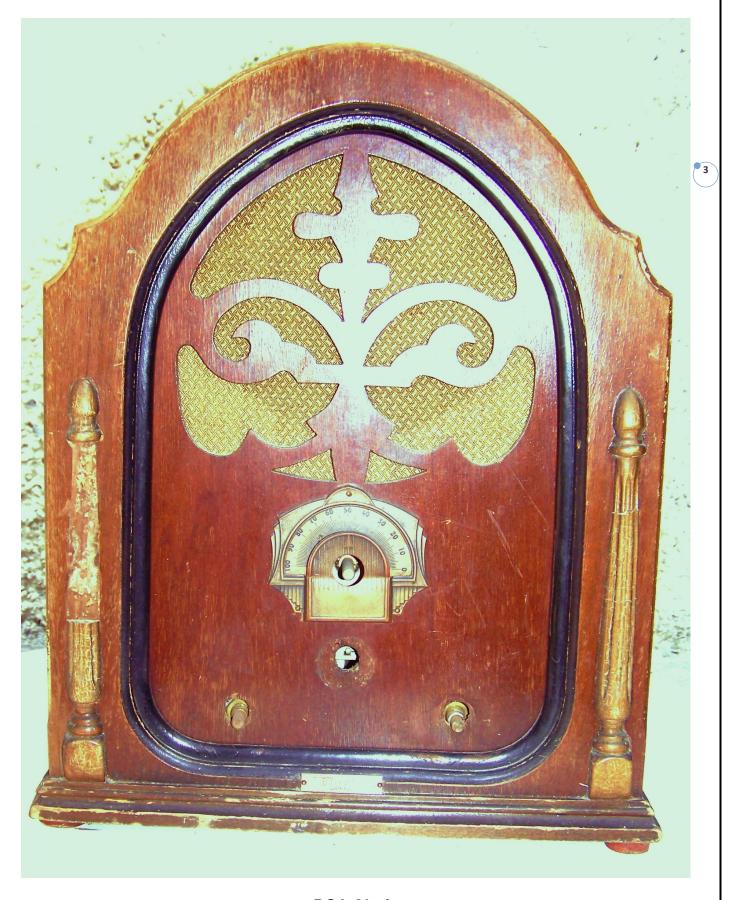
This is a typical American designed Radio in very bad condition. (Fig. 1) The surface of the chassis was scratched, part of the decoration broken off, the loudspeaker decentralized and the fabric dirty. The metal parts were very rusty. (Fig. 2)

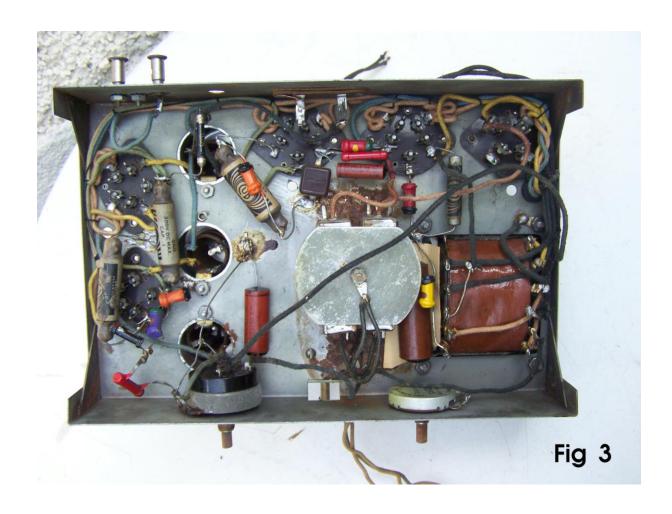
The wires on the bottom of the chassis were in a chaotic muddle. (Fig. 3) Most of the condensers were defect and the resisters had a tolerance of up to 50%. One of the electrolyte condenser $8~\mu F$ was short circuit and both potentiometers were defected.

All the condensers were replaced, also the resisters with the same type (colour code). Below the HF spool, the body of the spools was glued together with the HF core. Like that the equipment could be set at 600 kc. Additionally the point of resonance was moved to 525 kc to be able to get the radio station Beromünster at 531 kc. This was not possible before. With the trimmers on the tuning condenser the maximum of 1200 kc was equalized.

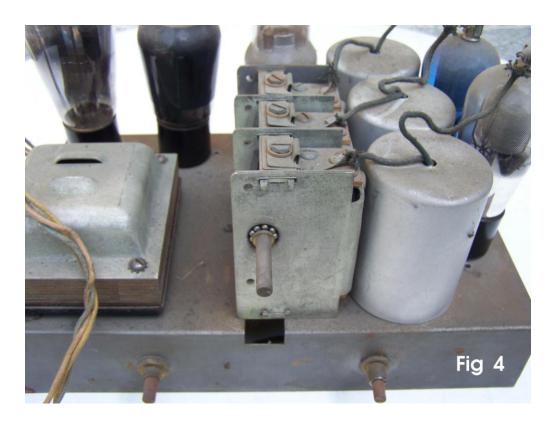
The drive part for the tuning condenser is missing, otherwise it was in order. The gap of the plates is set properly. (Fig. 4)

On the tuning condenser a new drive was fitted. A cord on the plastic disc gets its movement from the driving axle. Next to it a power light indicator was put on. (Fig. 9)

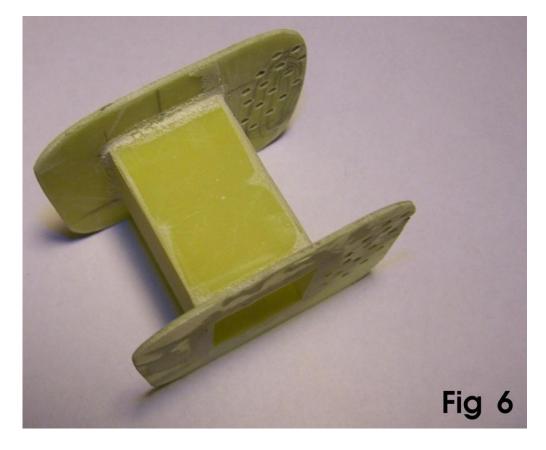
The anode winding on the mains transformer varies a lot, for the 100 volts new winding are required. The special thin insulated paper to be able to do it in layers is missing. Therefore a new transformer body had to be produced (Fig. 6) which was very time consuming. It was necessary to calculate a new specification which gave the following dates:

Mains 230 V	1070 windings	0.32 mm
2 x Anode 330 V	2 x 1700 windings	0.14 mm
Heating 80, 5 V	26 windings	0.7 mm
Heating 2.5 V	13 windings	1.4 mm
