NZVRS Entry in SQCRA International Restoration Competition.

Restoration of a Philco Model 89E Code 121 Cathedral Radio

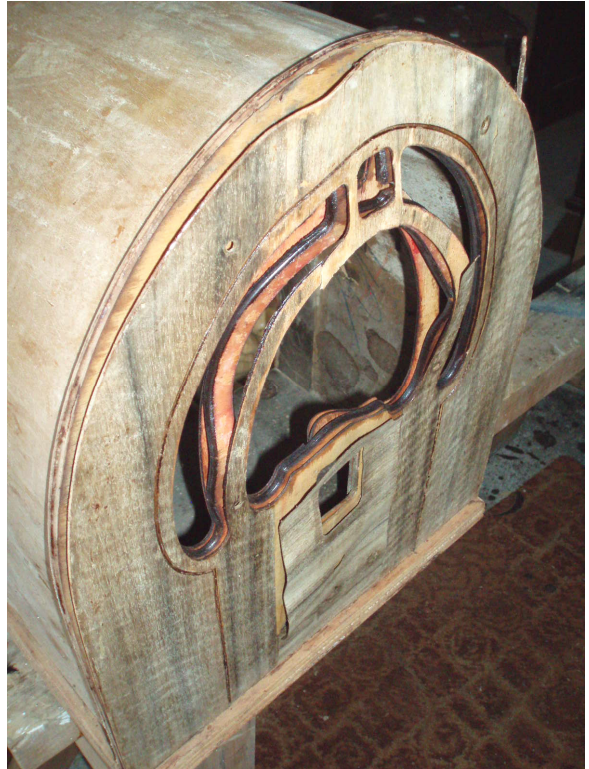
Everything screamed at me “don’t do it, it’s too far gone”. However not one for shying away from a challenge, I did do it. The cabinet had been extremely badly affected by water which caused most of the front to de-laminate and distort extensively. The rest of the cabinet was also in a very sorry state with bottom moulding badly mutilated.

The chassis and speaker were badly rusted, one valve shield was missing but everything else appeared to be intact & reasonably original. Who knew what else awaited me?

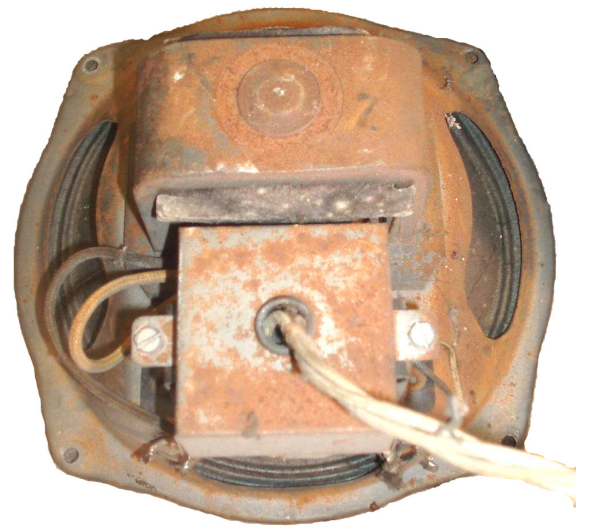
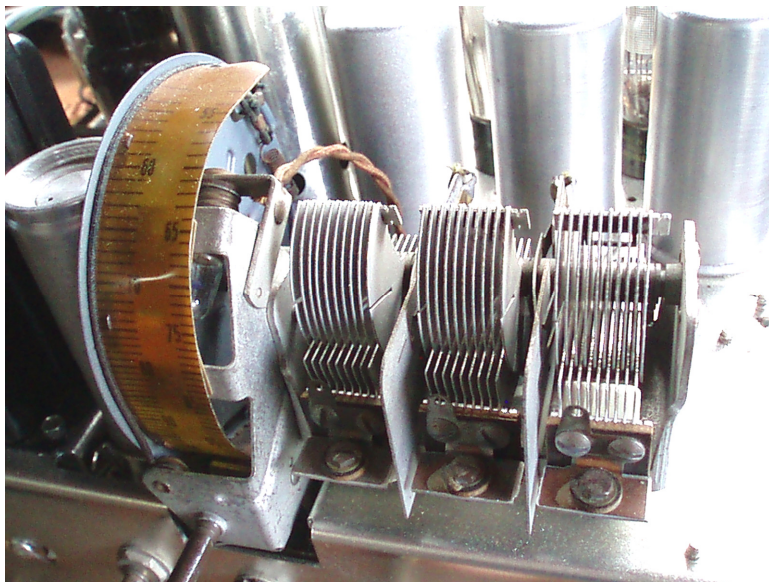
paper capacitors used to replace the originals were leaky & differed wildly from their stated values. Fortunately, all coils, the speaker electromagnet coil and all of the transformers tested satisfactorily for

continuity & insulation resistance. Once the chassis, speaker frame, valve shields and other hardware were sent for re-plating, clean-up of the individual parts occupied some considerable time. All block and electrolytic capacitors had to be emptied and repacked. The power transformer leads were still in good condition so all that was required was to clean and repaint the covers. The three coils for aerial, mixer & oscillator and the two IF coils, were cleaned, taken to work and left in the oven for a week at 60°C. Following this all soldered connections were redone and the coils dipped in paraffin wax to seal them. This was one of Ryder's recommended fixes for the oscillator problem. One of our Christchurch Vintage Radio Group members has a low pressure grit blaster which is ideal for cleaning up tuning condensers and this was put to good use here with excellent results.

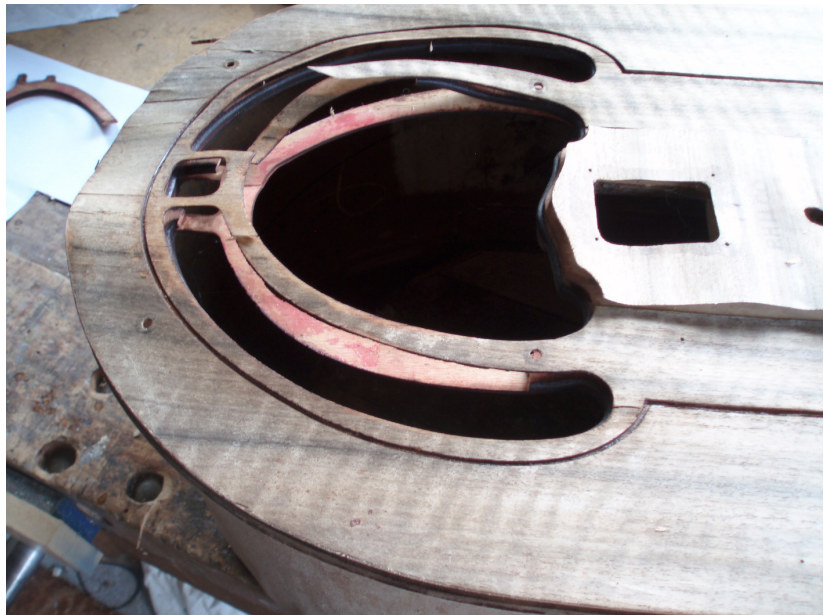
The cabinet, as I said at the beginning, had been very badly affected by water. The front veneer had almost completely delaminated and the underlying layers were also delaminated and, by far the most difficult to fix, had warped and twisted extensively. The only way forward was to almost completely dismantle the front into its multitude of broken and twisted parts. After the cabinet was taken apart, I made the decision to completely replace the main body with new, New Zealand native Rimu plywood but the front needed to be restored. Two of the main tools in this part of the job were steam and clamps, not to mention much time and patience. Each little piece of twisted timber was steamed, clamped between two plates and left to cool and dry. Slowly but surely, the front came together but the original walnut veneer was beyond re-use. I was able to source some excellent quality replacement, walnut veneer from a NZ company, and so the most difficult part came to surprisingly successful conclusion.

Routing the decorative grooves was a nail-biting experience! Bending the plywood into the curved shape for the body was helped considerably by steaming it several times as the cords tying it were progressively tightened.
