3^{ème} Concours CHCR de restauration radio

ELITE-RADIO" Model: 191

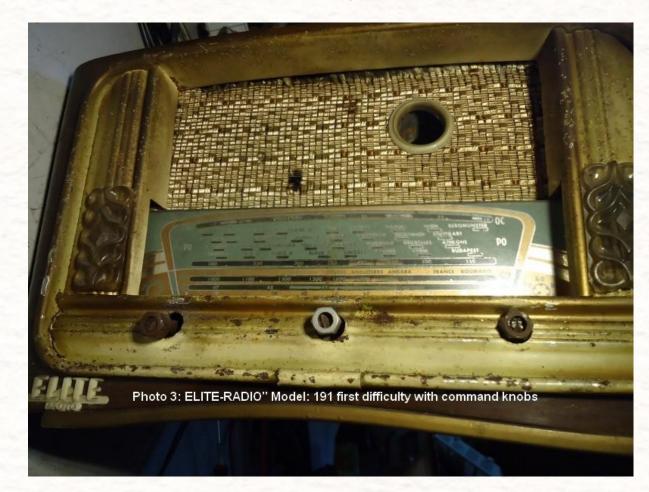
• The first difficulty was the condition of the three setscrews on the command knobs which were rusted with broken heads. (Photo 3)

• Using an electric drill being careful not to damage the knobs and a small extracting tool of my own design, after a few hours of effort, I eventually extracted them without damage. It will be necessary to drill and tap them again, in order to put back in the set screws (without head) with a diameter of 3mm. The stripping of the strongly corroded frame being imperative, (Photo 4)

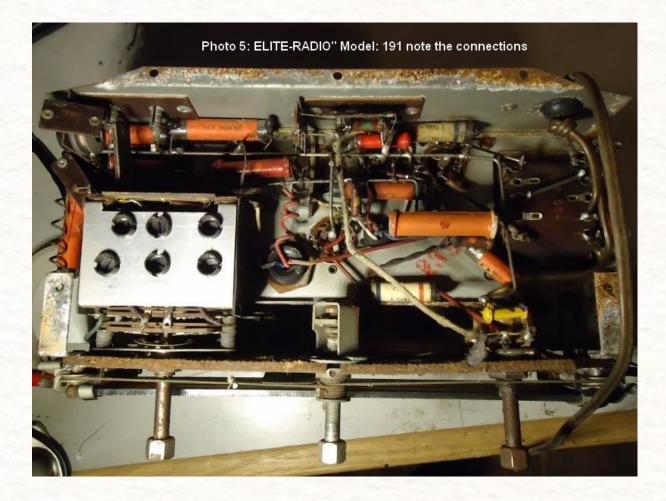
• I proceeded to the removal of every component, taking care to note the connections, (Photo 5) and taking numerous photos; which allowed me to establish a schematic which could not be found on the web.

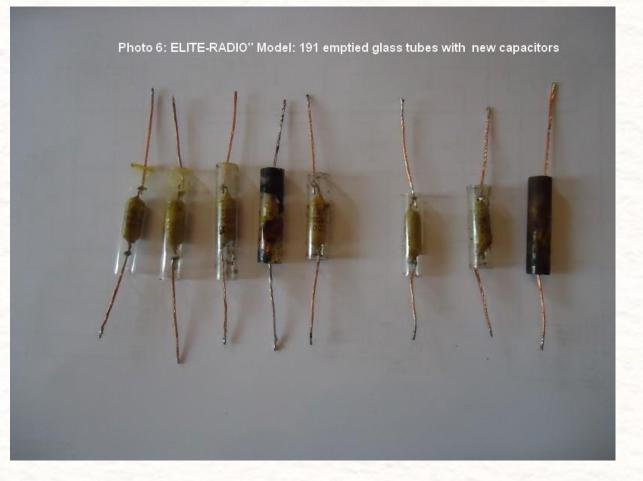
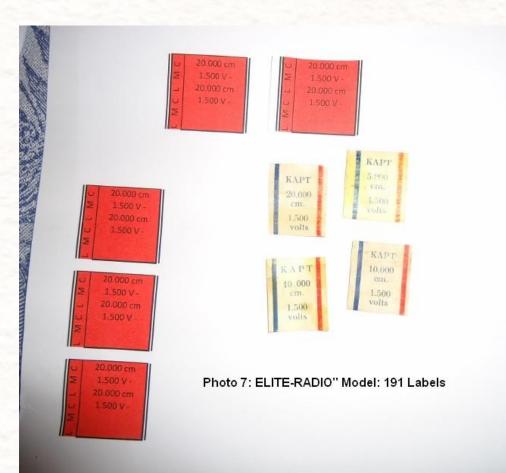
• All the <u>paper capacitors</u> values were out of tolerance, I emptied glass tubes and inserted into them new capacitors; then I stuck labels, realized from an Excel file, identical to the originals. (Photos 6, 7)

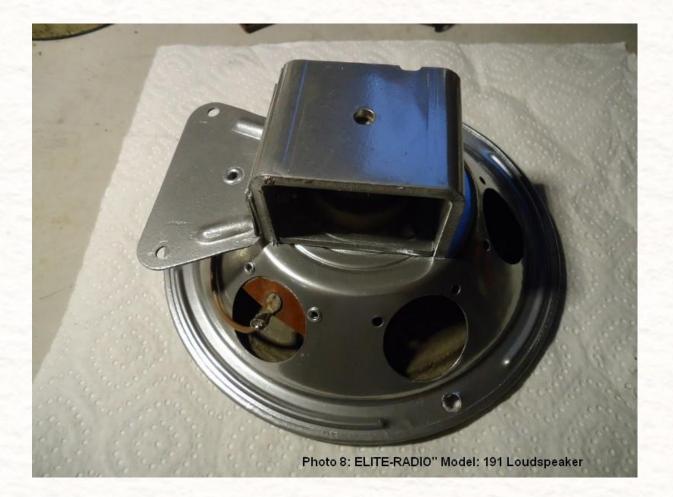
- <u>Loudspeaker</u>: its membrane having disappeared under the teeth of a rodent, and not having time to fetch a hypothetical spare membrane, I got back a same size loudspeaker with an intact membrane, slightly corroded, on which I put on the transformer support after modification. Repainted, the set now looks fine! (Photo 8)
- <u>Tubes</u>: all have been tested on a tube checker. Except the ECH81 which was a little border line (it will be necessary to change it for the final tests) they are still good for the service.

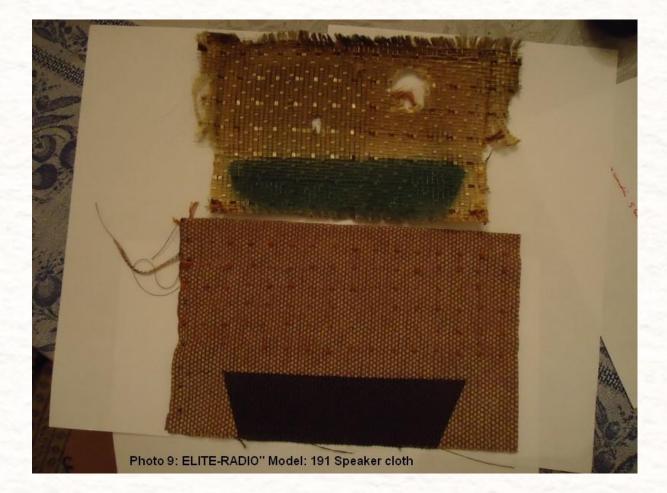
<u>Speaker cloth</u> (in front of the receiver) was moth-eaten or nibbled by the same tiny creature which ate the loudspeaker membrane. Therefore it was necessary to find a replacement. I found some in a special furniture fabric. I fixed it in place on the hardboard of the façade by sticking it, after putting in black paint to the background which will allow good contrast with the needle (Photo 9).

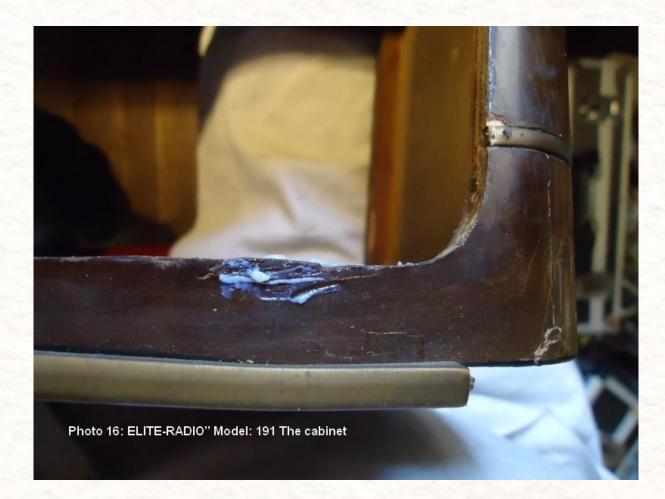
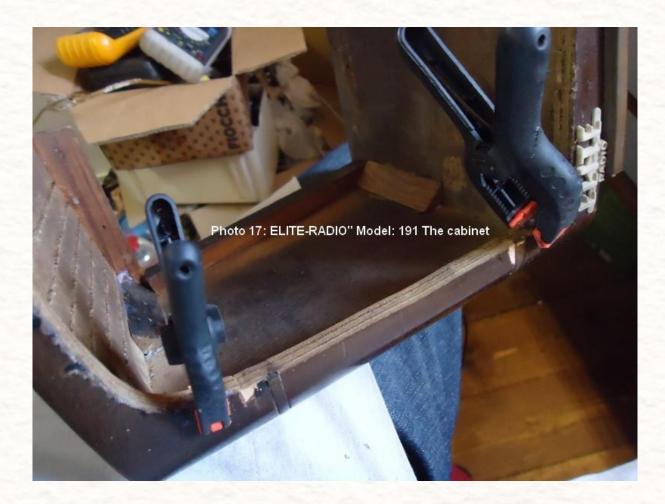
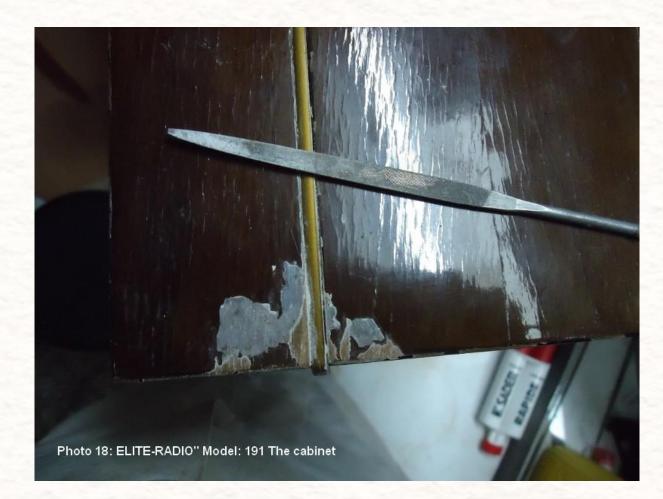
<u>The cabinet</u> making underwent a severe cleaning with a "regenerative" product, internal bracing were made and set up (Photos 16, 17, 18)

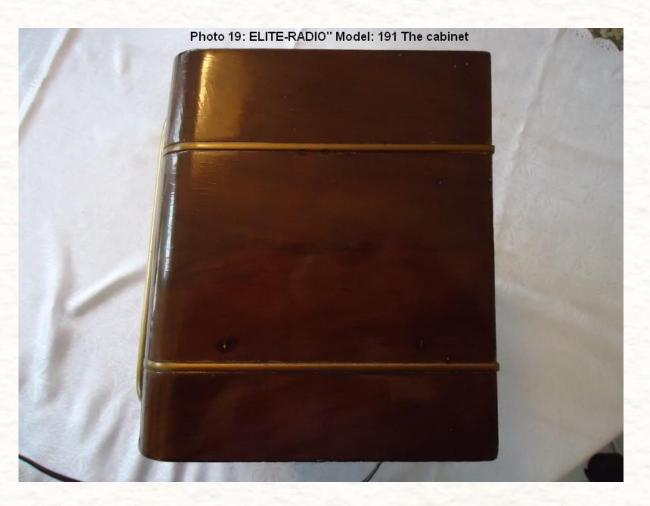
• and retouches to the varnish completed the set which presents a beautiful patina (Photo 19).

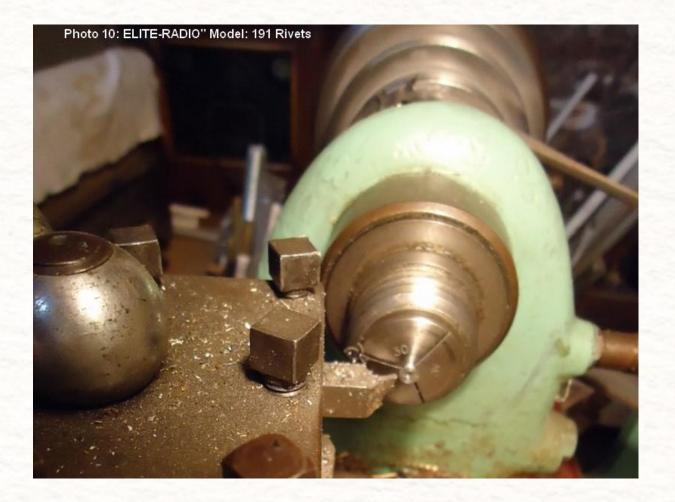
<u>Rivets</u>: all connectors and lamp sockets were fixed to the frame with rivets. To remove them I had to destroy the rivets using a drill. Unfortunately I didn't possess any similar rivet. In order to keep the same aspect, I modified, using a lathe, some screws 3 mm in diameter with cylindrical head, to give them the aspect of a head of rivet (Photo 10).

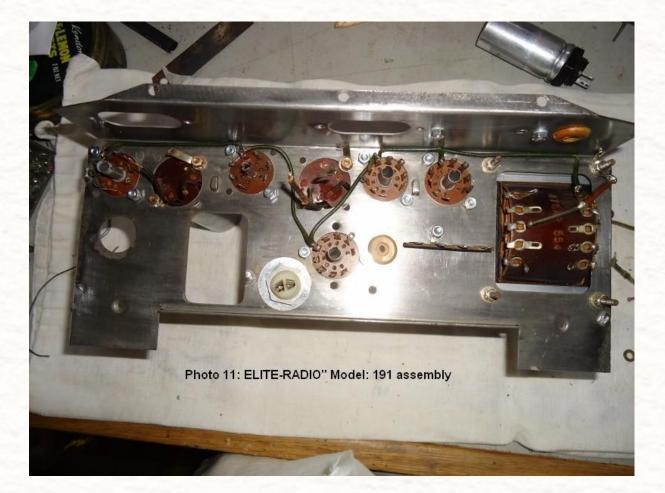
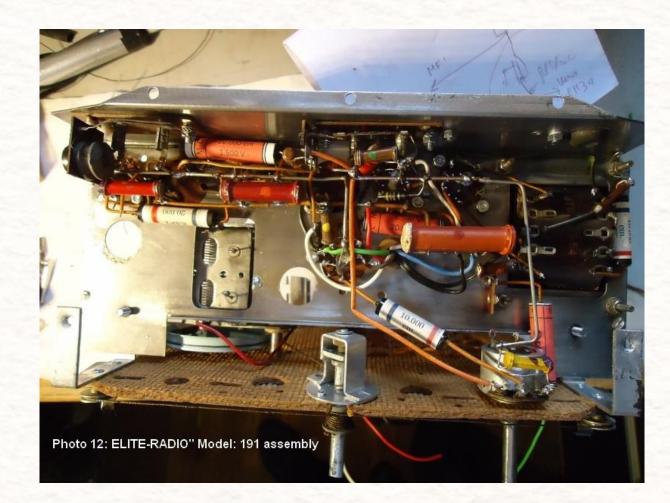
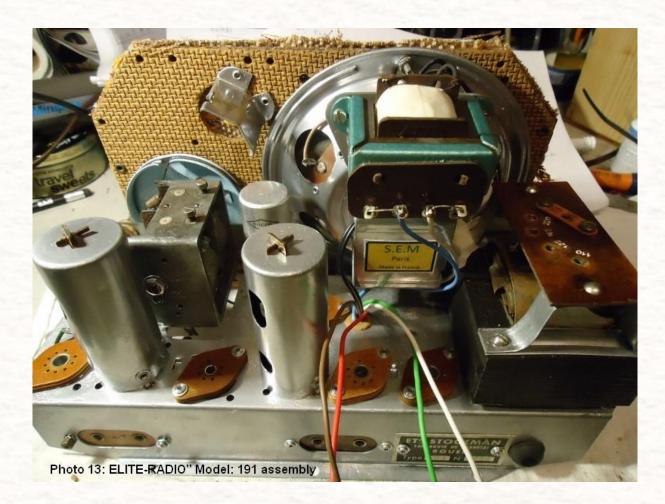
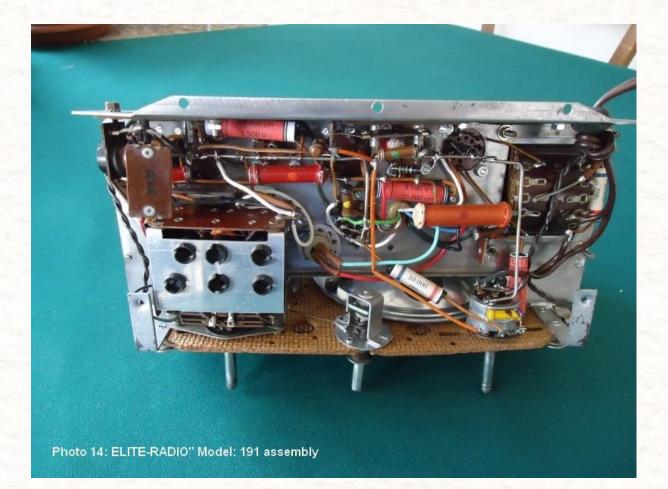
- The first operation was to install new tube sockets identical to the former which were in very poor condition.
- Then I reinstalled the IF transformers, the power supply transformer; now, I could proceed with the first welds by setting up the filament heating circuit (Photos 11, 12, 13, 14).
