# ASSOCIATION RADIO CLUB DU BASSIN D'ARCACHON F5KAY

## RESTORATION OF A LAFAYETTE FRANCE RECEIVER

**Type T536A Series AS N°2143  
Contest 2012-2013**

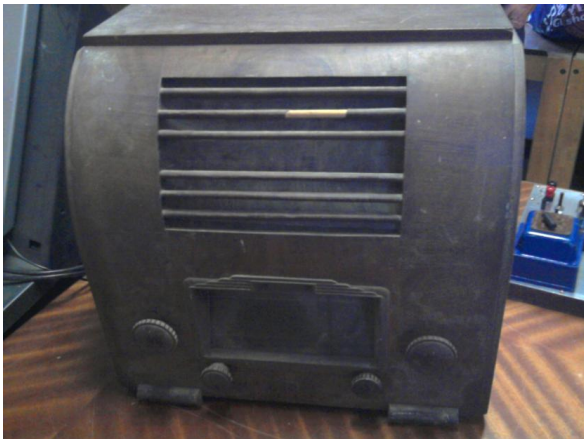
Face appearance at start

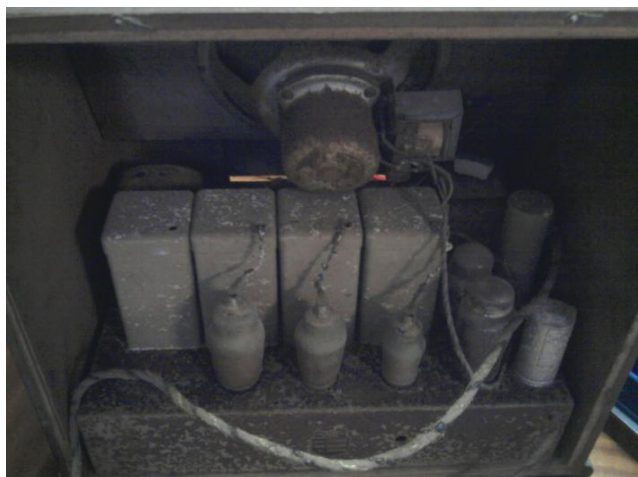
Backview

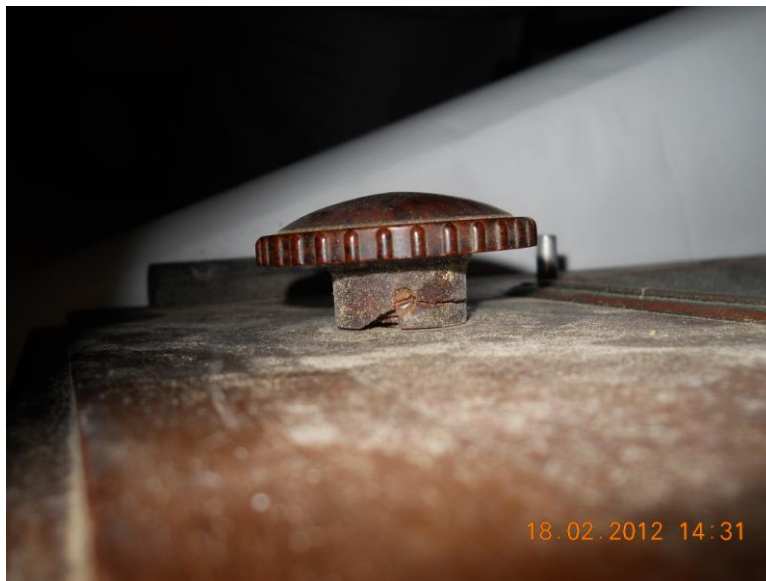
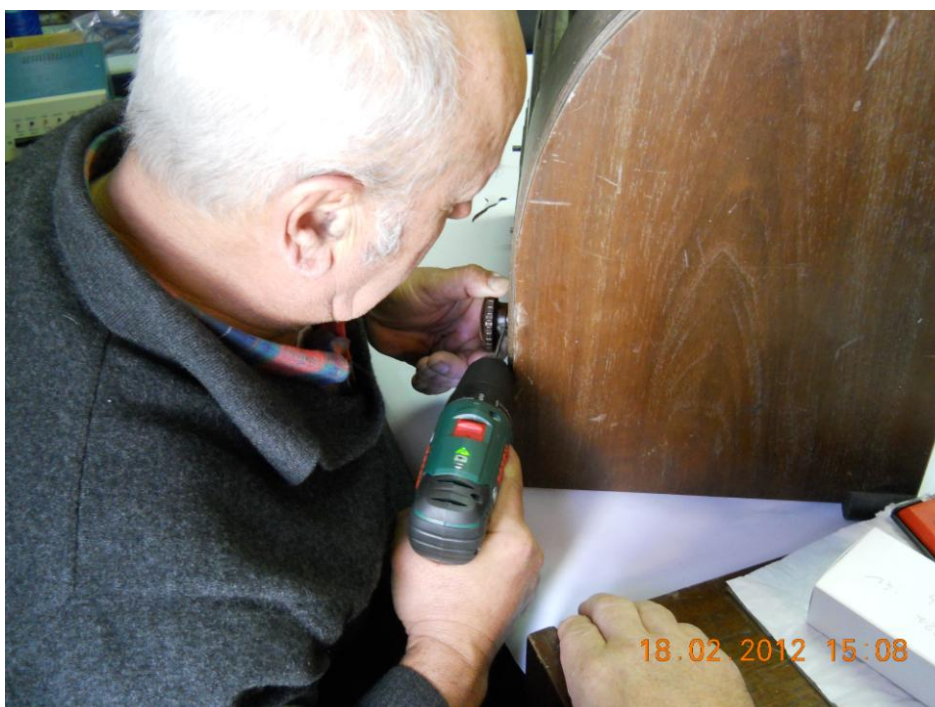
Initial dismantling involved removing the knobs which did not cause problems except for one which was broken.

We had to use a more radical approach to removing it, the drill.

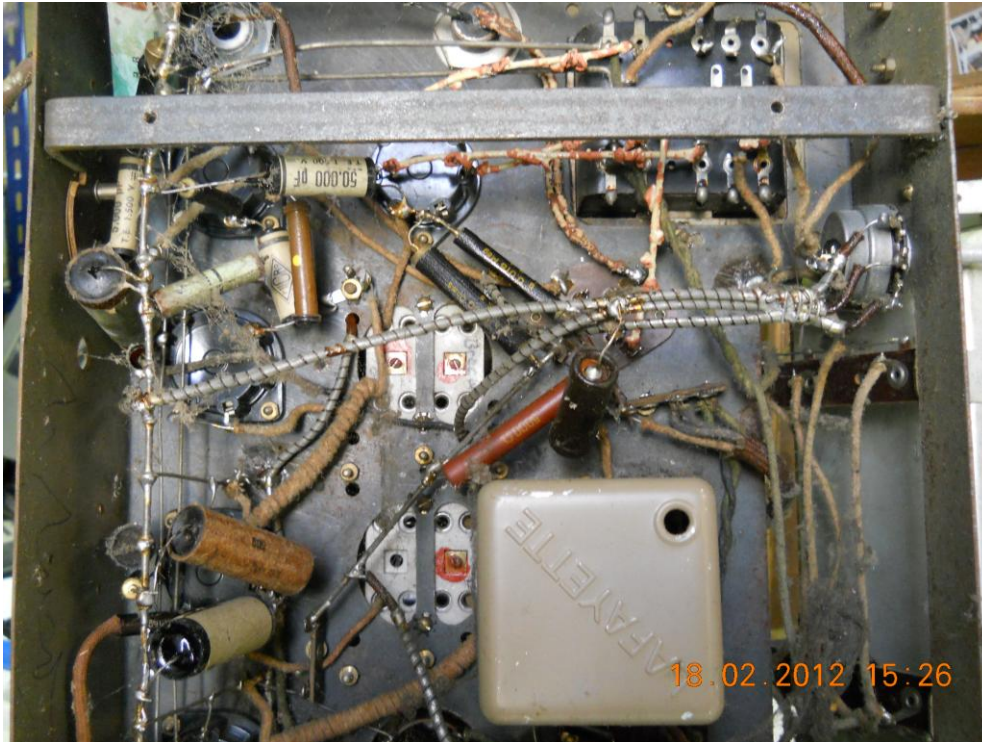
Under the chassis: Note overheated wires on the right, spider web in the middle left and the mid wires shielded by a metal band.

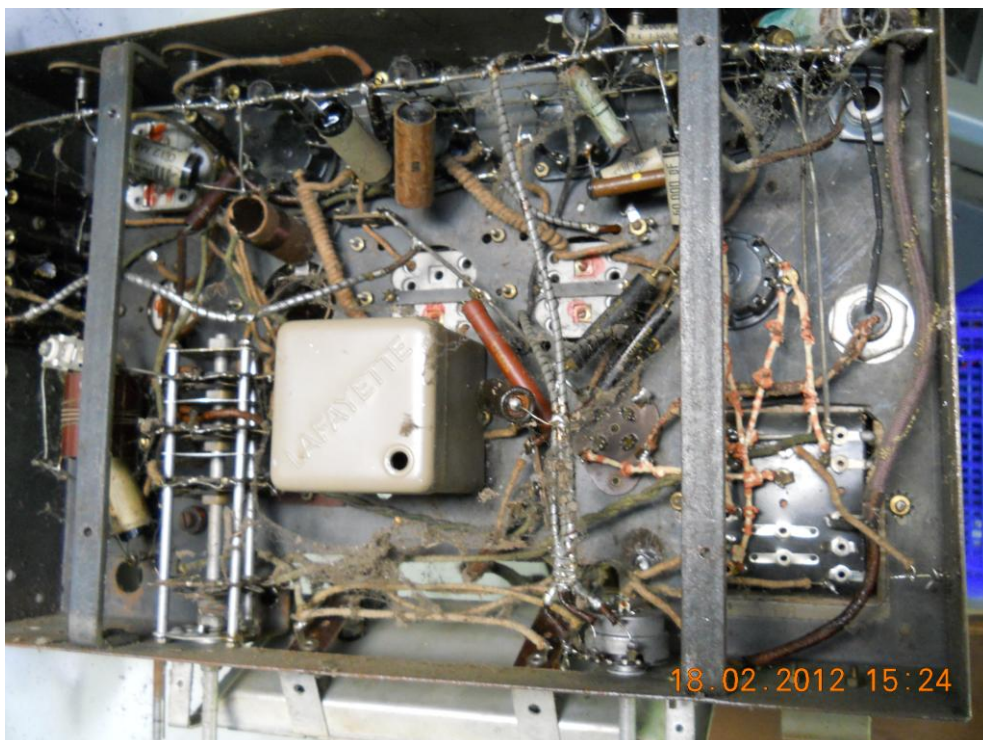
Complete view of underside

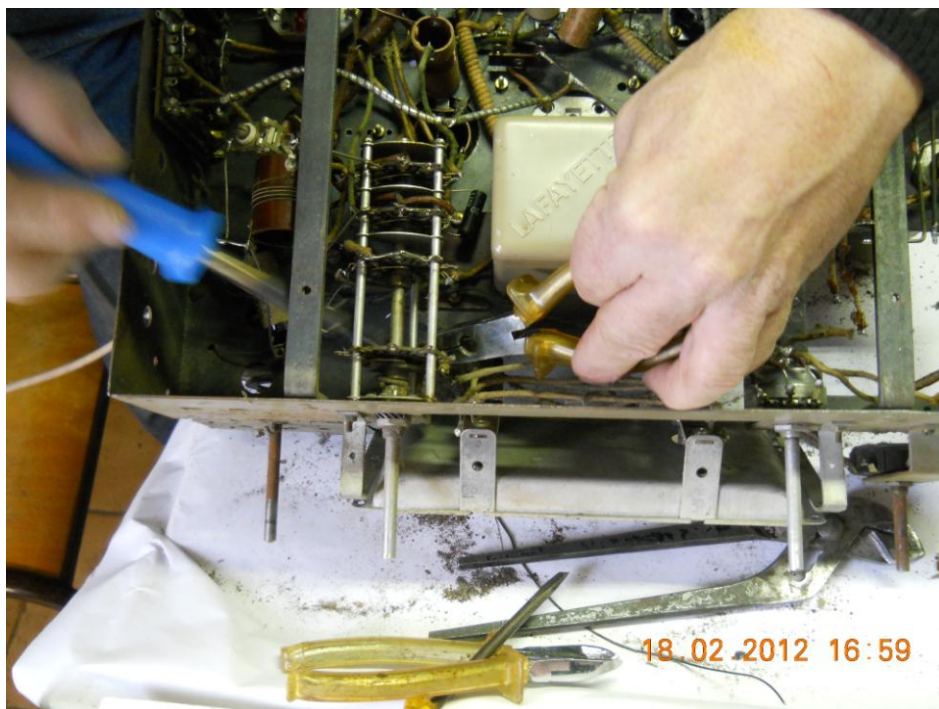
Pilot lamp wires must be unsoldered

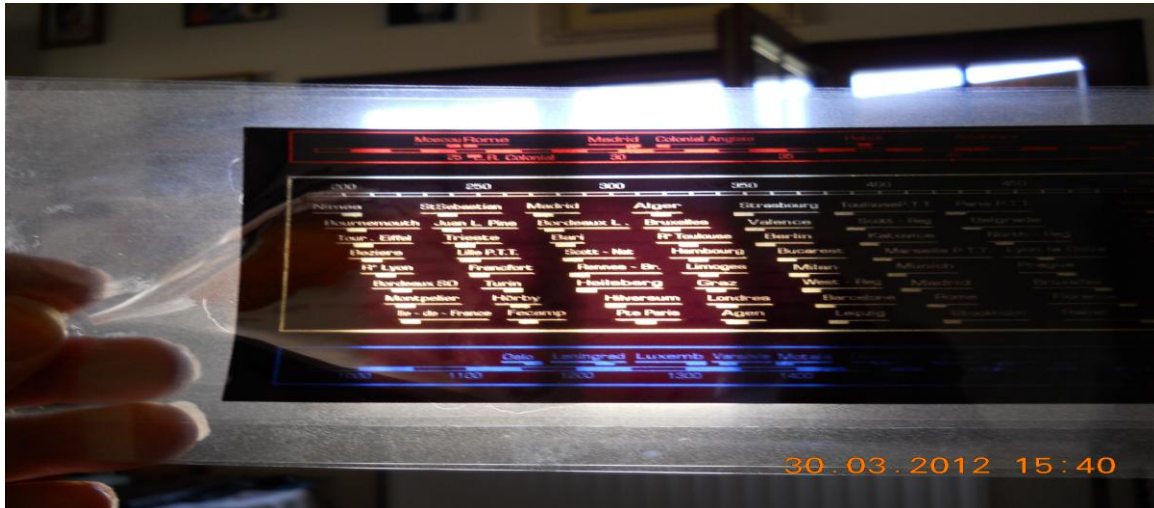
After a trial or two (see below) on a transparent sheet printed on an inkjet let too much of the bulb light through and was not sufficiently opaque.

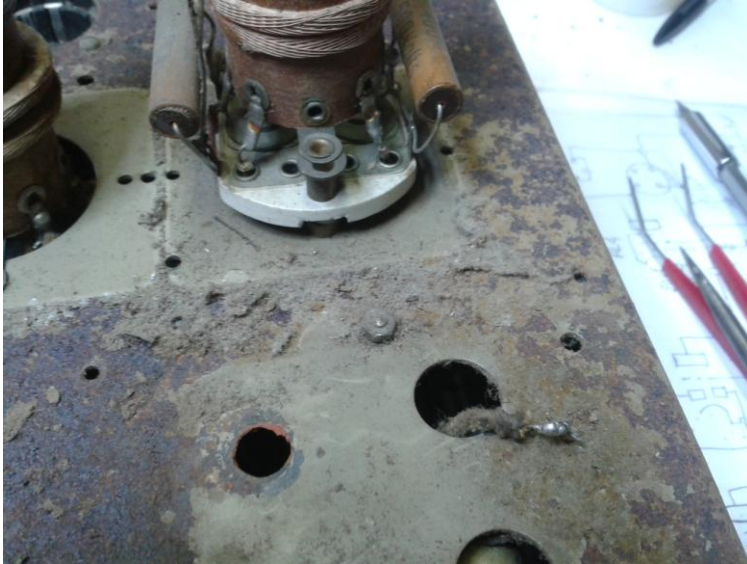
Obvious deep rust, result of a trip in the trash can.

We stripped it with a sander and painted it with a color obtained from a chip left on the chassis.
