Restoration of a Canadian General Electric Model GE-66 – SPARC Museum, Coquitlam, BC

SPARC Radio Museum, Coquitlam, BC, 2013

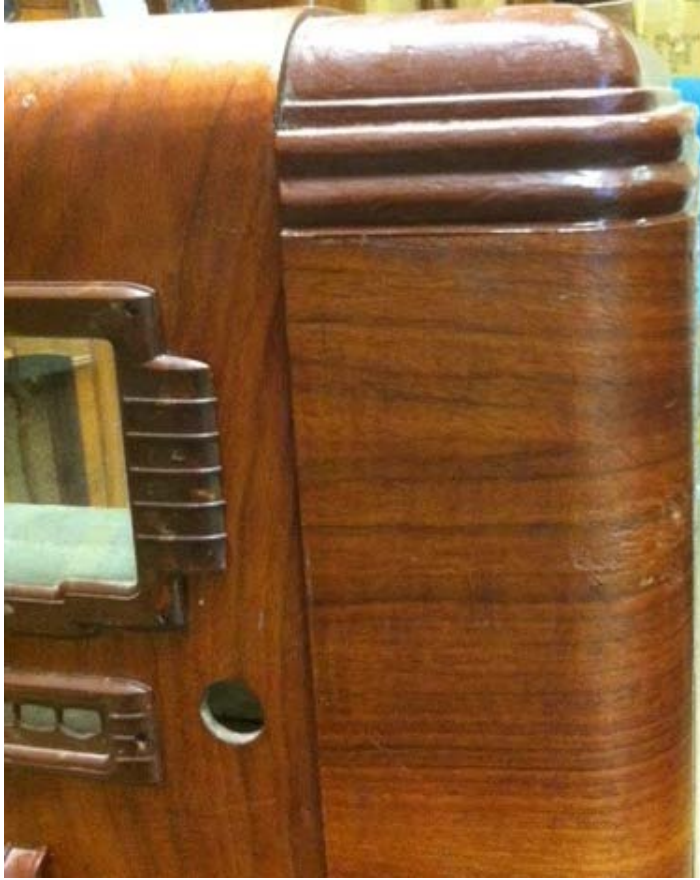
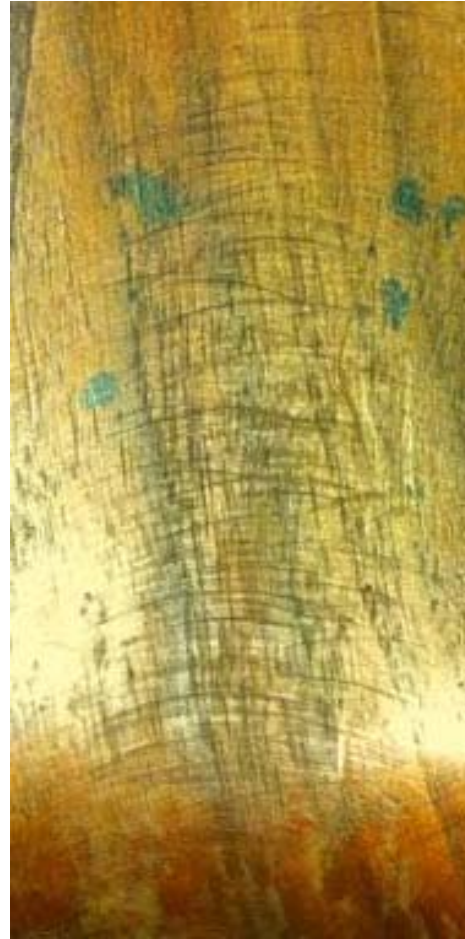
This set was suffering from many of the above afflictions: the cabinet had been sanded down with a circular disc sander, leaving the tell-tale deep score marks and a few patches where the veneer was worn right through (photos above and below). This had then been given the brushed-on Varathane treatment, with the shoulders having a gloss brown paint applied to effect some form of contrast. The chassis had certainly been ‘worked on’ by the son (but, of course, did not work) - tubes were missing, and so were all of the knobs and push-buttons... This set was going to take some time and considerable effort to restore...

Restoring the cabinet was a ‘labour of love’ for the SPARC restoration folks. First, the rather liberally-applied Varathane and brown paint (photo, right) were scraped off (not an easy task!), revealing the crudely circular-sanded veneer beneath. Several patches where the veneer had been removed entirely were evident and some parts of the veneer were lifting off the plywood beneath, or had chipped-off. The upper surface of the cabinet had water damage that had penetrated to depth, leaving dark patches through the entire veneer thickness.

Following stripping, a random orbital sander was used to remove the circular sander’s score marks. This operation had to be undertaken with extreme care such that the veneer was not removed – a very fine-line as many of the score marks were very deep. Hand-sanding was then undertaken to remove the last vestiges of the score marks. Several small pieces of veneer were then replaced with

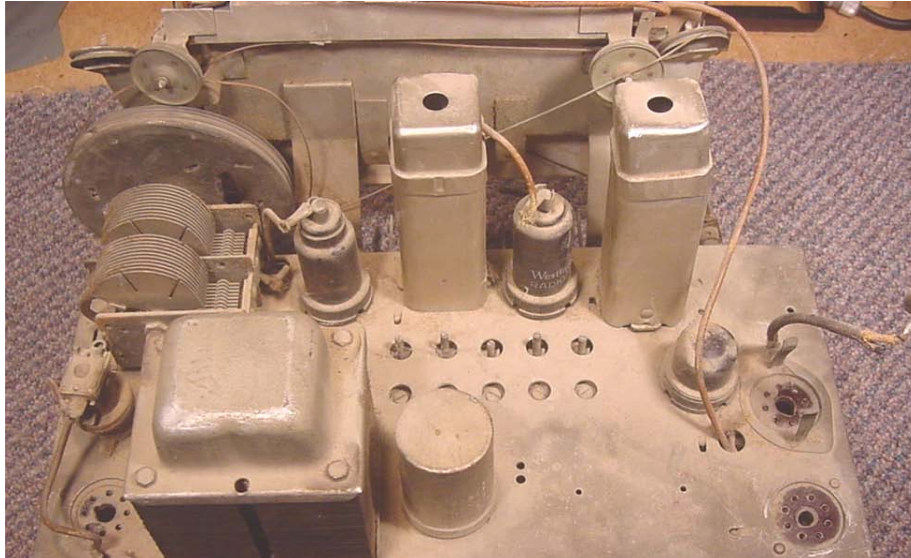
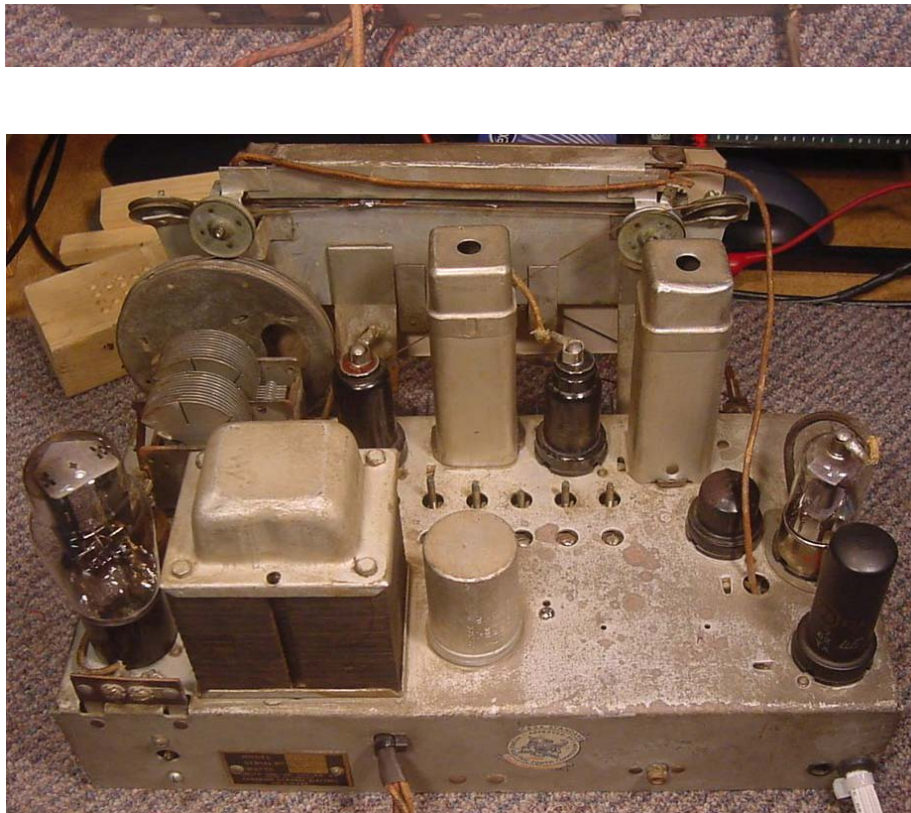
Above: chassis as-received. Below: chassis after clean-up and repairs

The usual culprits of a dead chassis were replaced: all electrolytics and paper capacitors (and previous service replacements thereof), dial bulbs, and three tubes. All resistors were checked and those not found to be within tolerance were replaced. The

mechanical components of the push-button assembly was cleaned with WD40 and then lubricated with lithium grease (applied sparingly). The electrical contacts were cleaned with Deoxit, as was the volume and tone control pots. An in-line fuse was fitted to the power transformer primary to offer some protecting in the event of a major fault condition developing

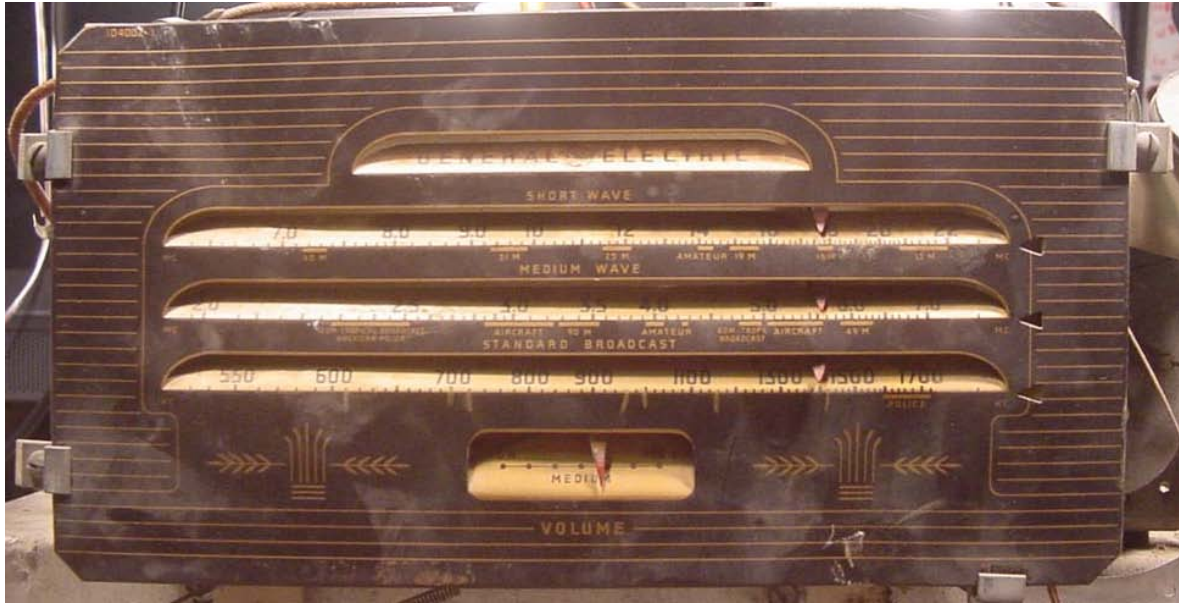
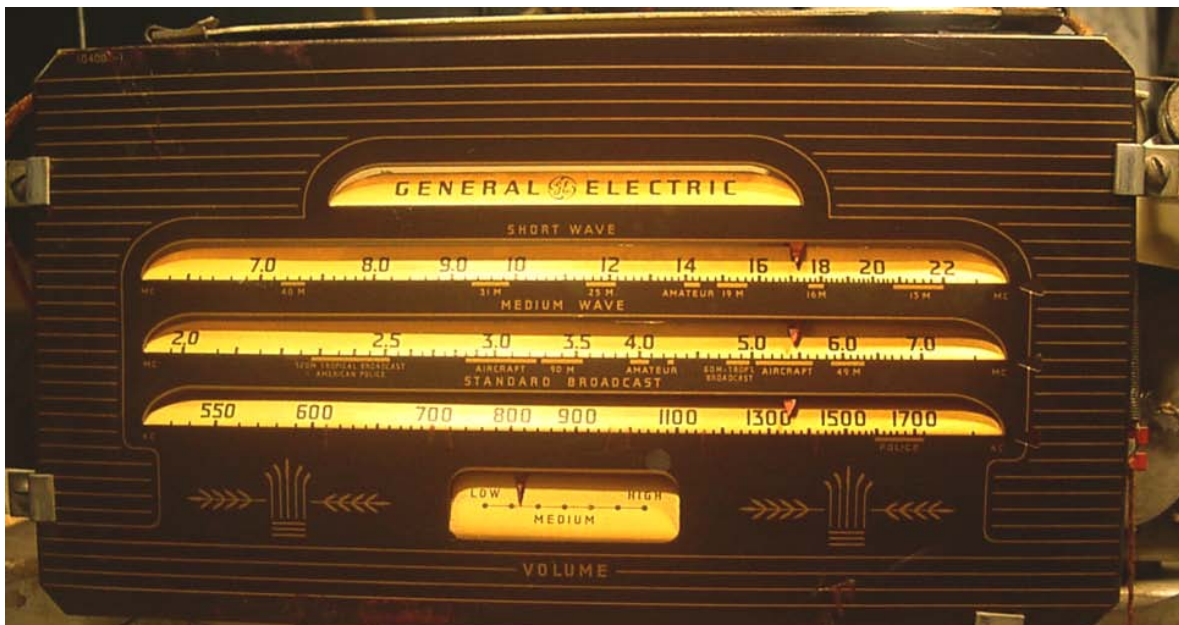
Above: scale plate as received – looking very ‘worse for wear’. Below: After much ‘tender loving care’ – almost as good as new...

in the future. The speaker was then re-wired and the scale plate straightened, cleaned, and scratches touched-up, to complete the job (photos, below).

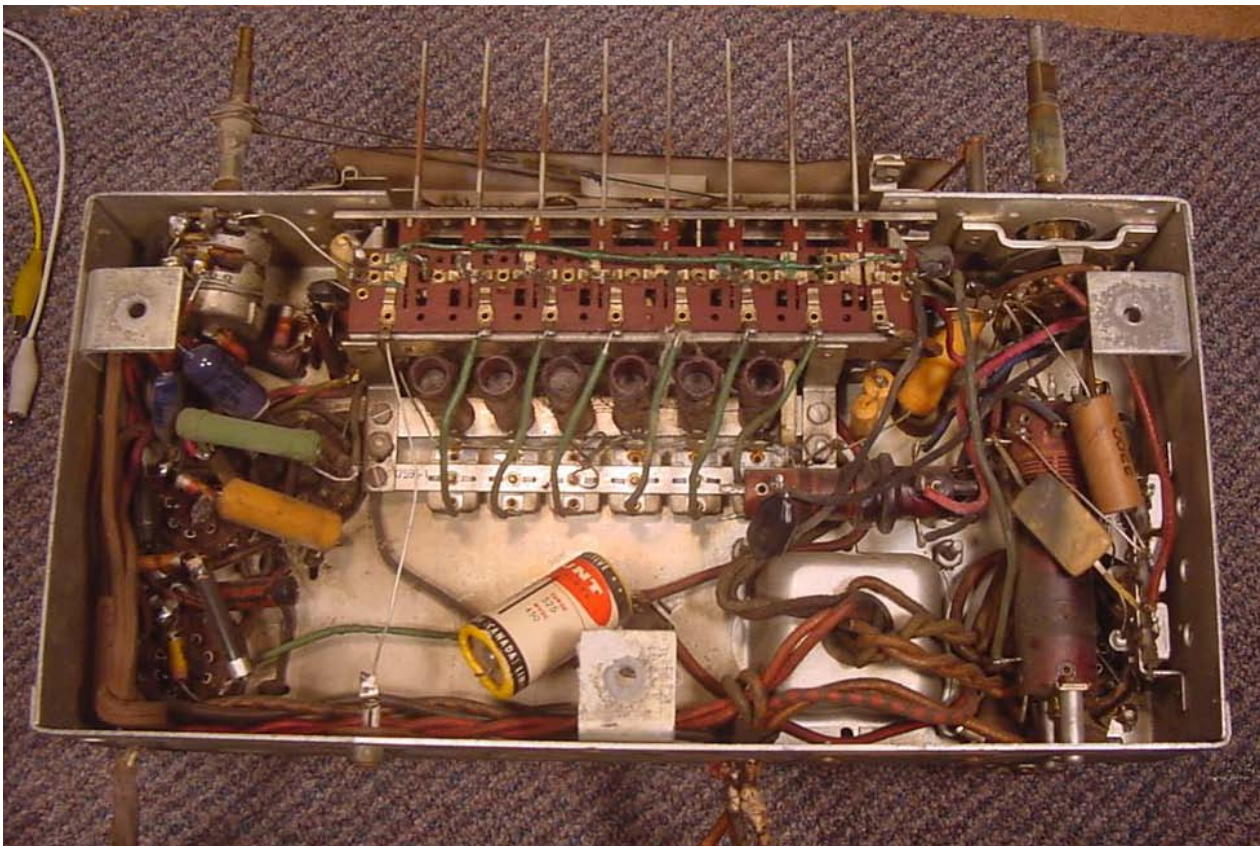
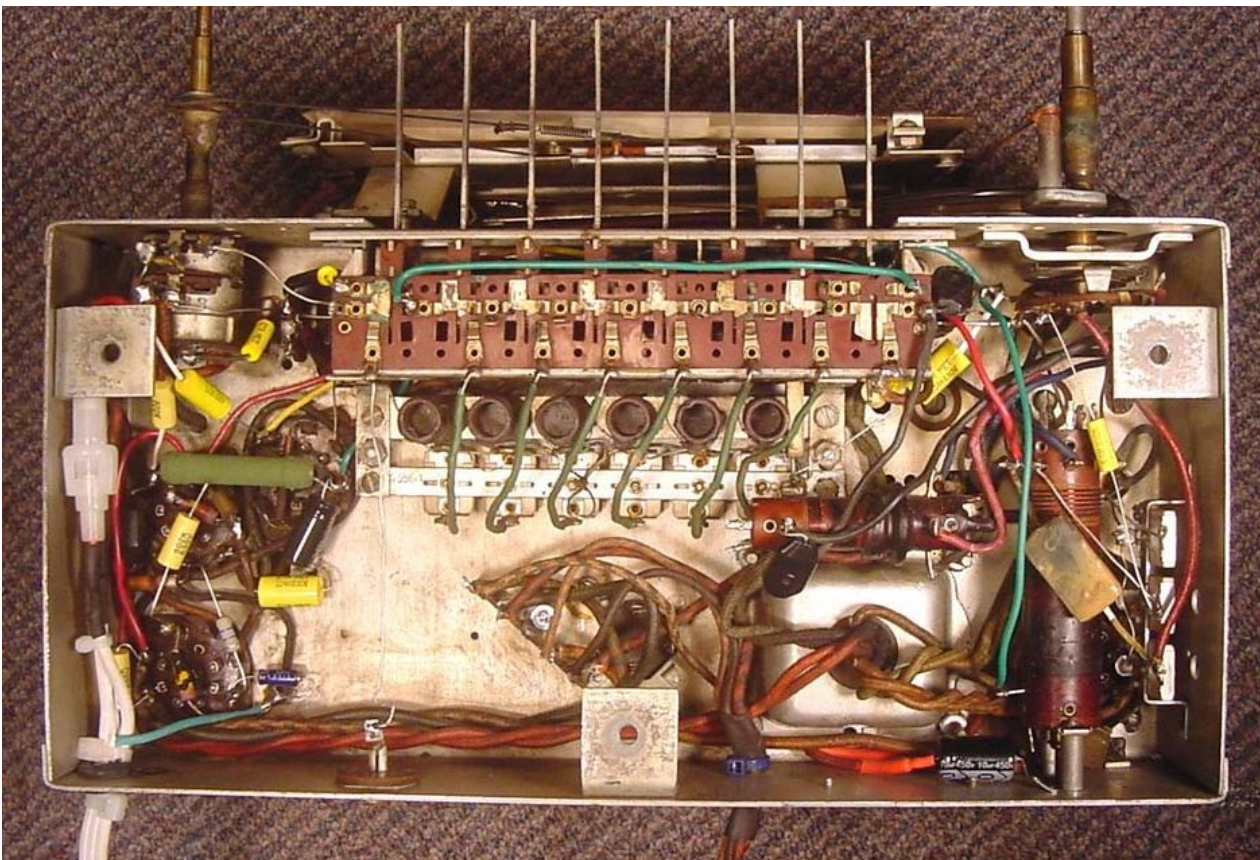
Above: under-chassis view as received – note some replacement parts. Below: following re-capping, part re-wiring and replacing some resistors

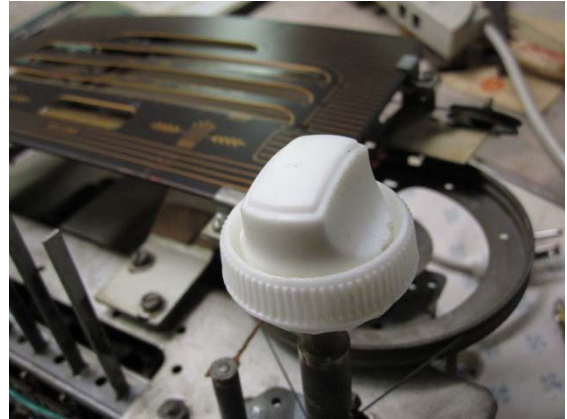
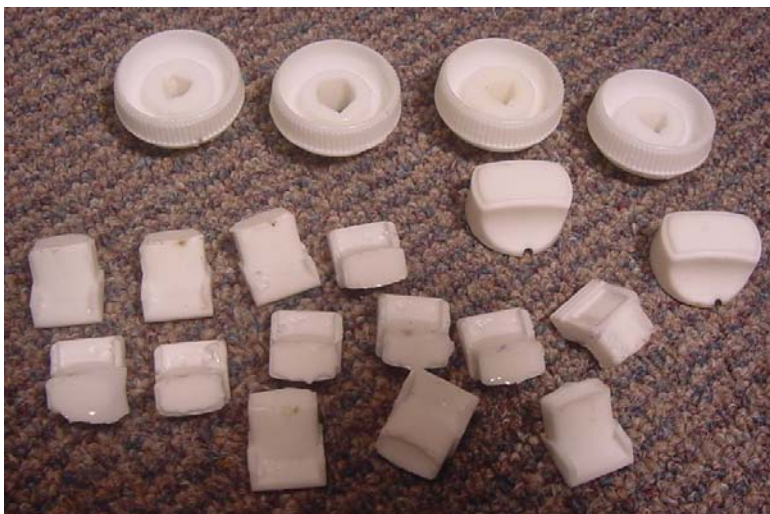
On receipt at SPARC, the radio had no knobs or push-buttons fitted. An extensive search through the SPARC stock failed to come up with anything suitable (the knobs are a unique, concentric design, and the push-buttons must fit through shaped holes

in the escutcheon plate). However, the SPARC museum display has this model of set on display and this allowed a set of knobs and push-buttons to be replicated. The process is described in the article at <http://www3.telus.net/radiomuseum/> (under 'Restorations – 'Knobs!'). Essentially, this involves making moulds from the original knobs and then casting new knobs out of a special resin, milling holes/slots as needed in the casting and then painting (photos above). Following spray-painting, the end-result in this case were a complete set of knobs and push-buttons very close in appearance to the originals – photo, right.

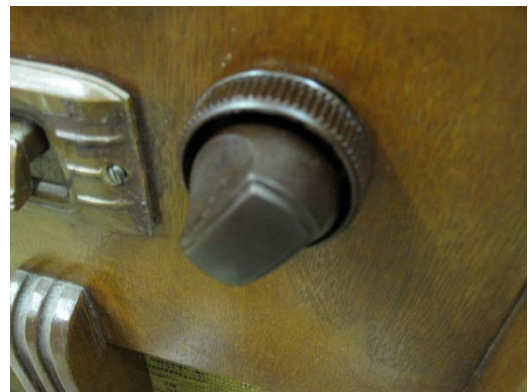
Once the cabinet had been re-finished, the chassis was re-installed. The plastic escutcheons around the pre-set push-buttons and the dial were cleaned using Novus #2 and then #1 – thankfully these were not too warped (as they are prone to do) – photo, bottom of page 6.

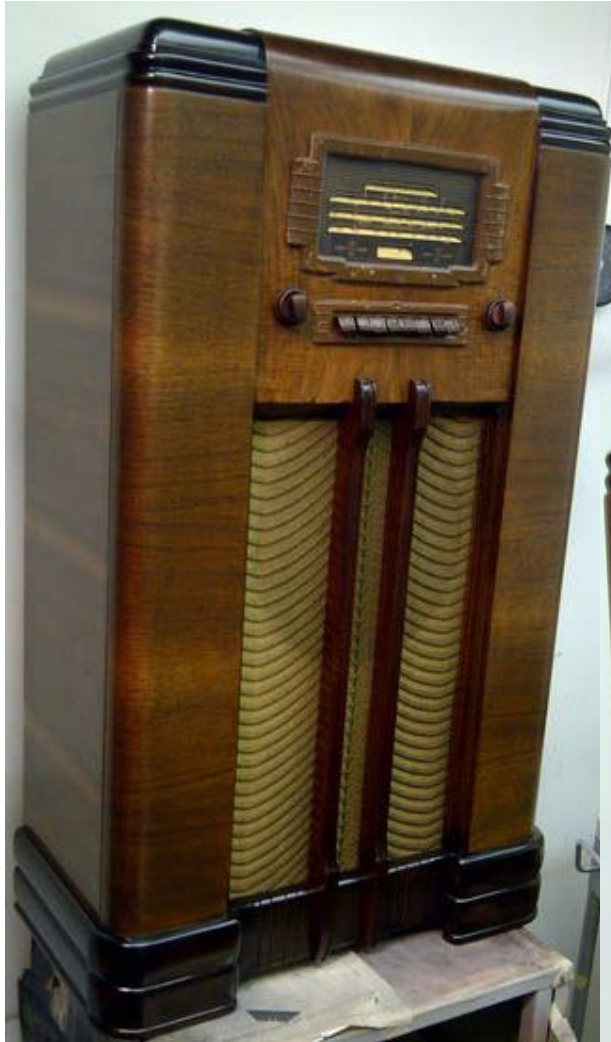
The original speaker cloth had been replaced sometime in the past with a coarse fabric that did not look ‘the part’ at all, and the baffle board was missing entirely. A suitable baffle board/cloth assembly was located in the SPARC ‘boneyard’ and fitted to the re-finished cabinet. The end-result was remarkable – it looked as if it really belonged in the set.

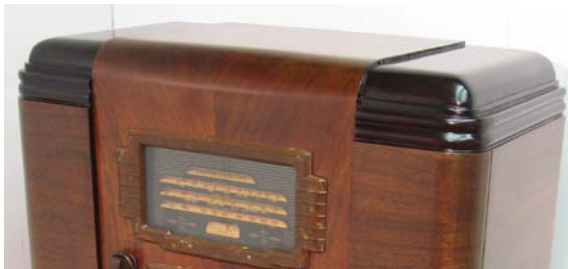
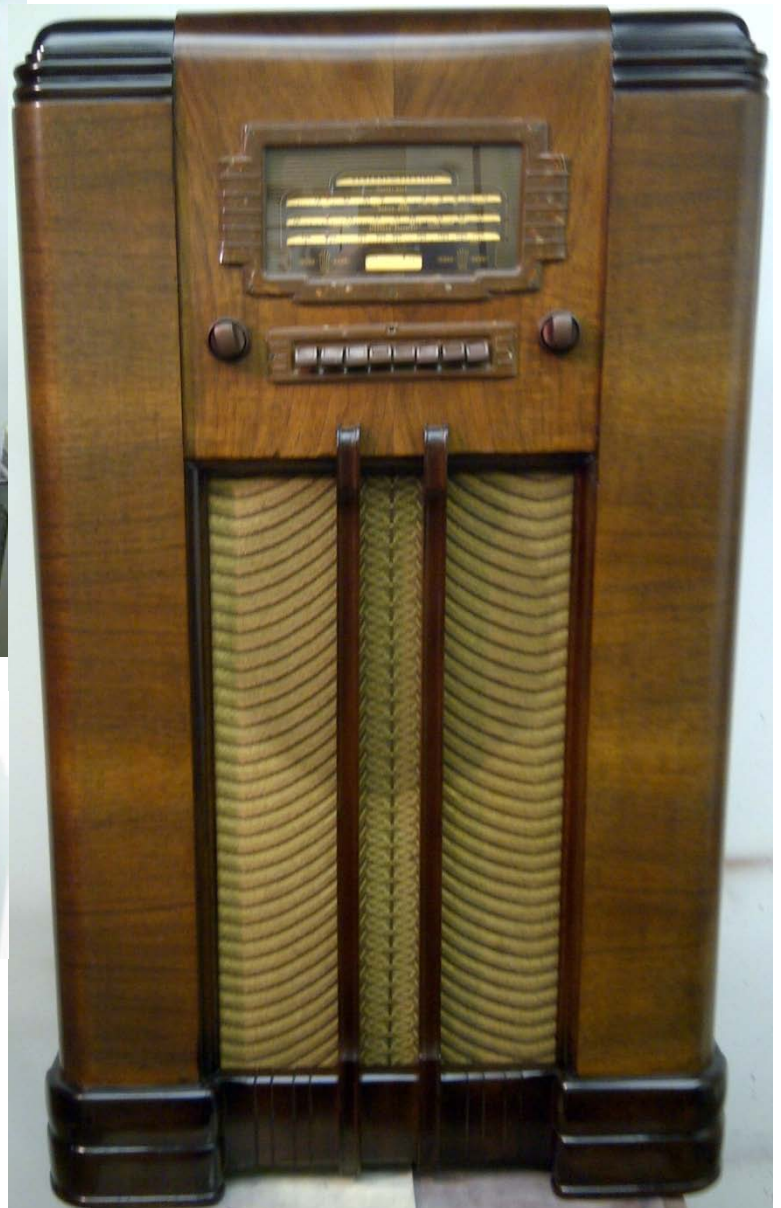
Above and right: completed CGE Model GE-66 standing in the SPARC spray-booth awaiting collection by its proud owner – another Canadian-manufactured radio restored to working order, its looks preserved and once again giving stalwart service.
