Restoration of Heacock Radio Phone R12

Summary of O.M. Heacock, who built and sold radios around 1920

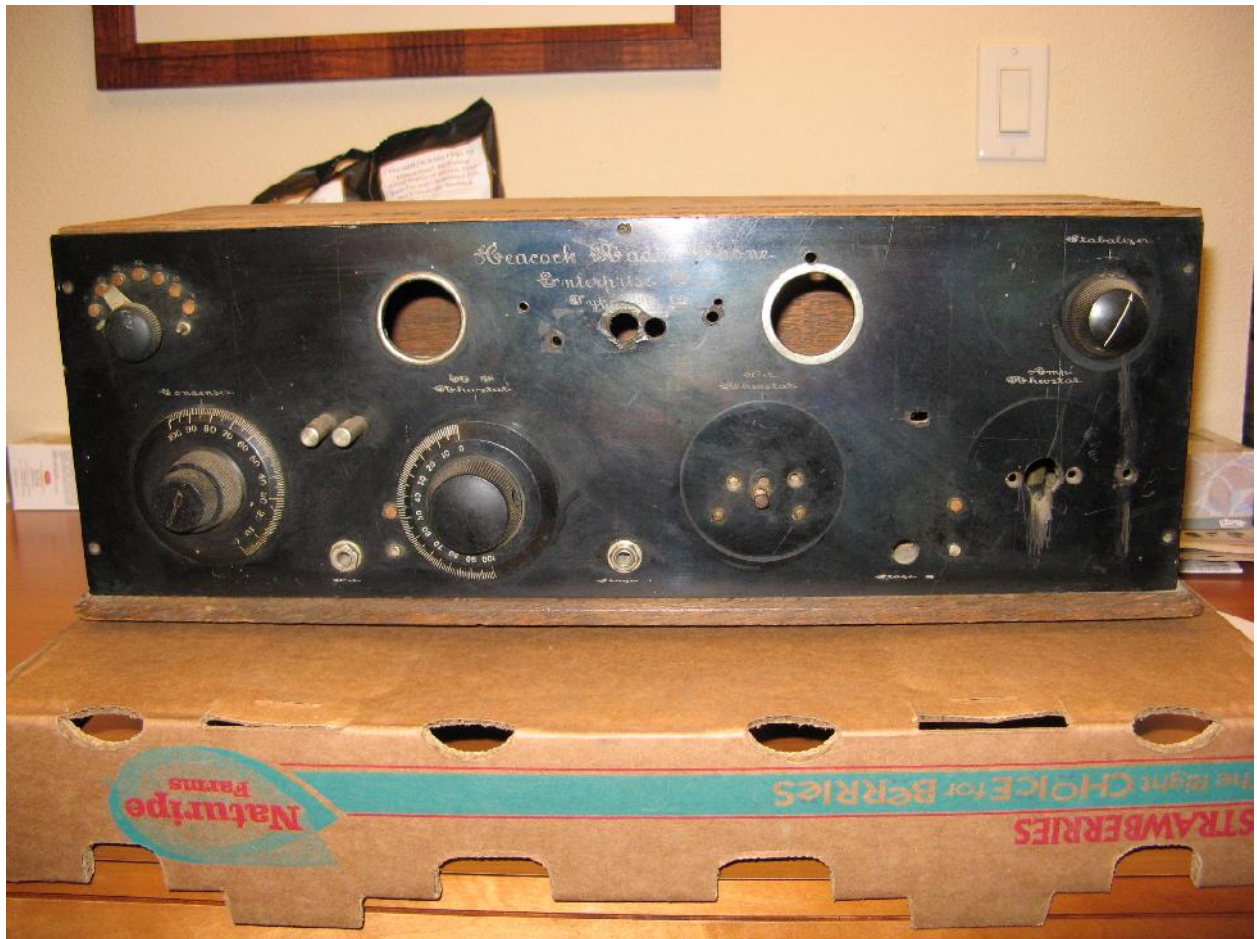
Figure 3. Picture of basket case example found in Portland, OR basement.

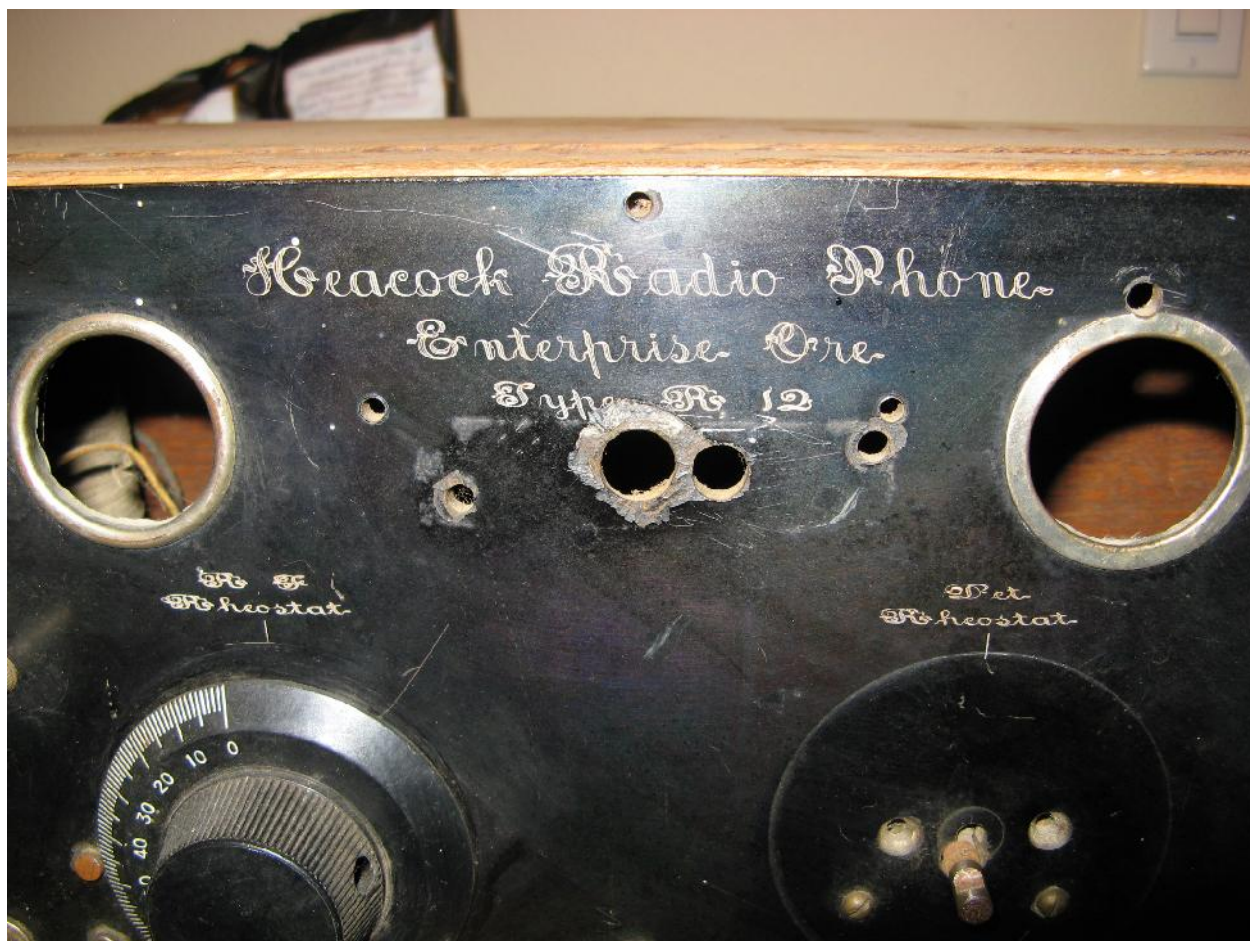
Figure 4. Picture showing damaged panel, extra holes, missing dials

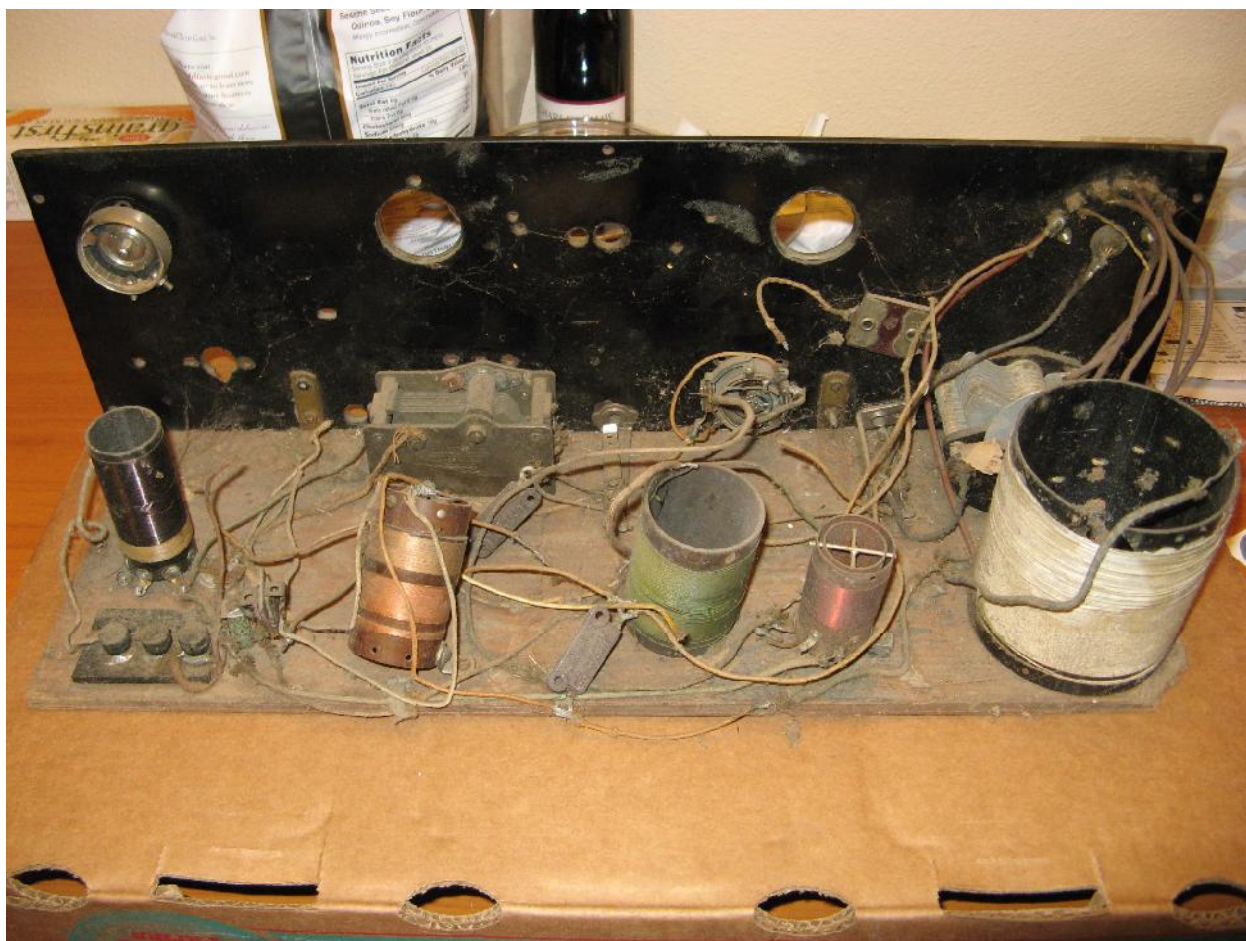
Figure 5. Inside of case showing non-original parts. Probably an “ improved” radio using much later parts but with original tuning capacitor & coil with added coils and capacitor.

The modifications were all stripped out and discarded (stored). The chassis board was removed, cleaned, sanded and laquered. This board was original plywood type used in all of Heacock’s radios. The 2 chassis to panel “ L ” brackets were polished and reused (badly rusted). It was possible to see the original tube and transformer layout from holes. A set of matching tube sockets were selected, CH type. Audio transformers by Acme matched the chassis holes, and this was type used in most Heacock sets. An Acme rf tranformer fit the panel holes as in other Heacock sets.

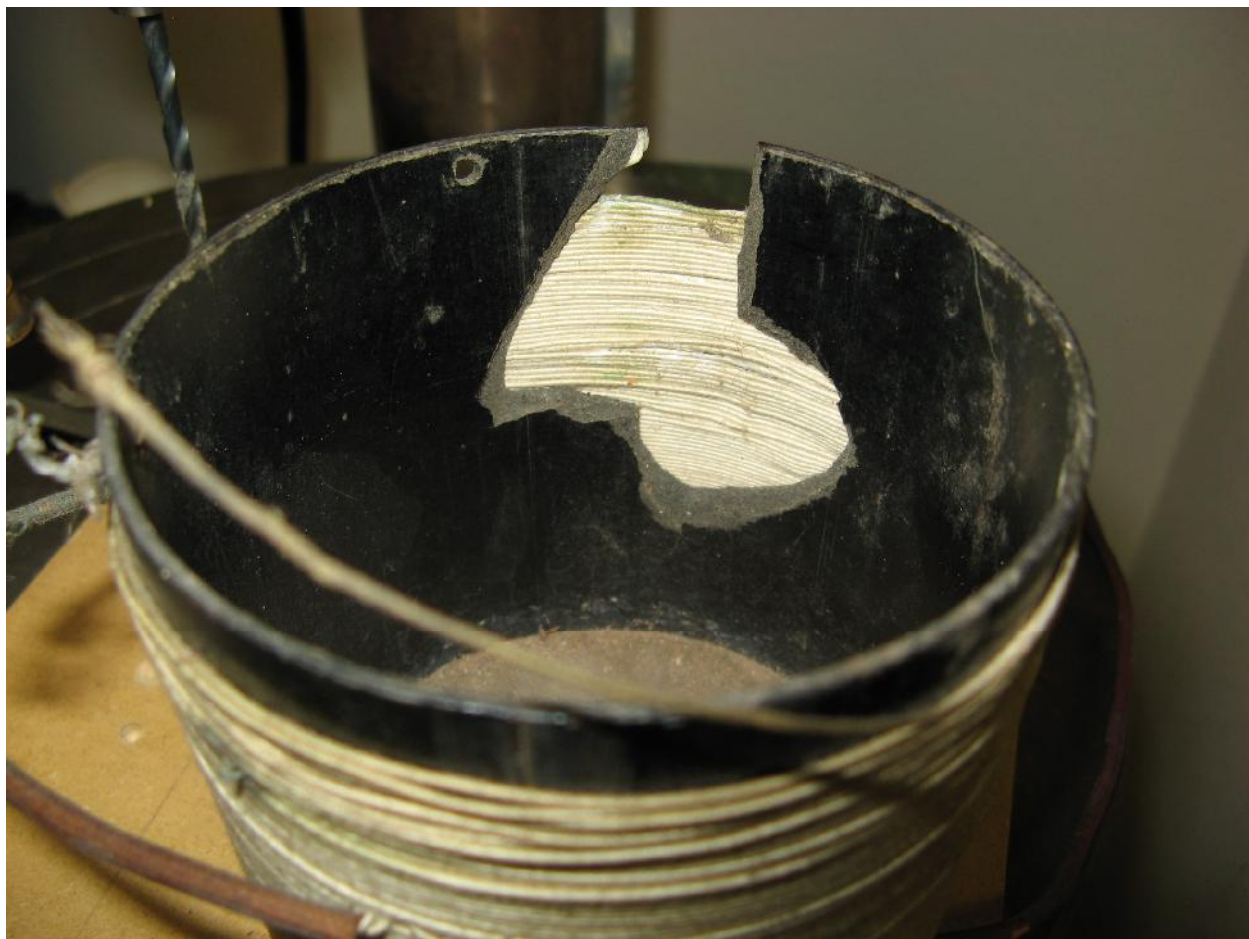
The main tuning coil was badly damaged, though probably workable. I decided to replace it since I found some common black plastic pipe that was the right size and I had the right double cotton covered wire.

Figure 6. Picture of damaged original coil, approx. 100 turns #24 dcc wire with 8 taps.

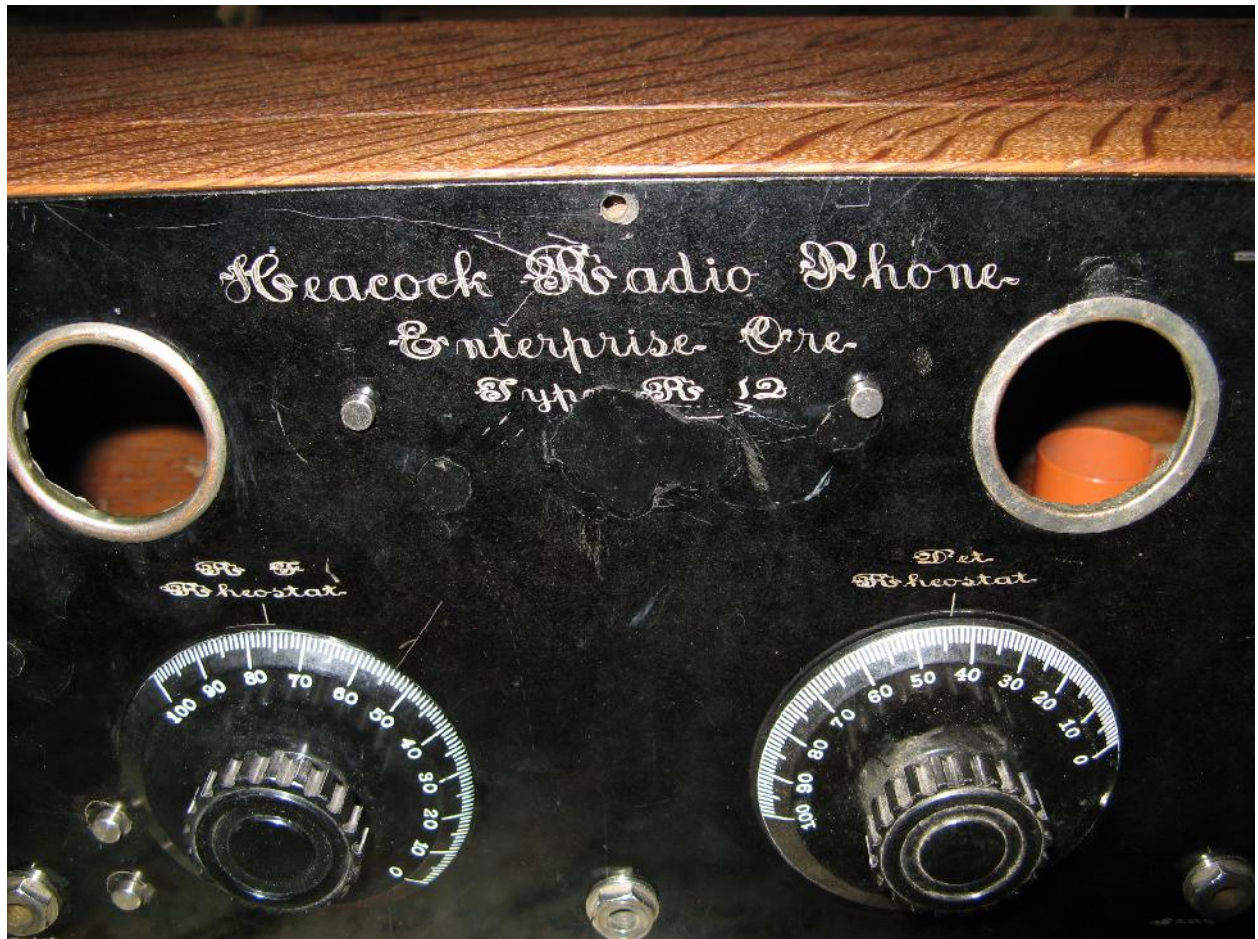
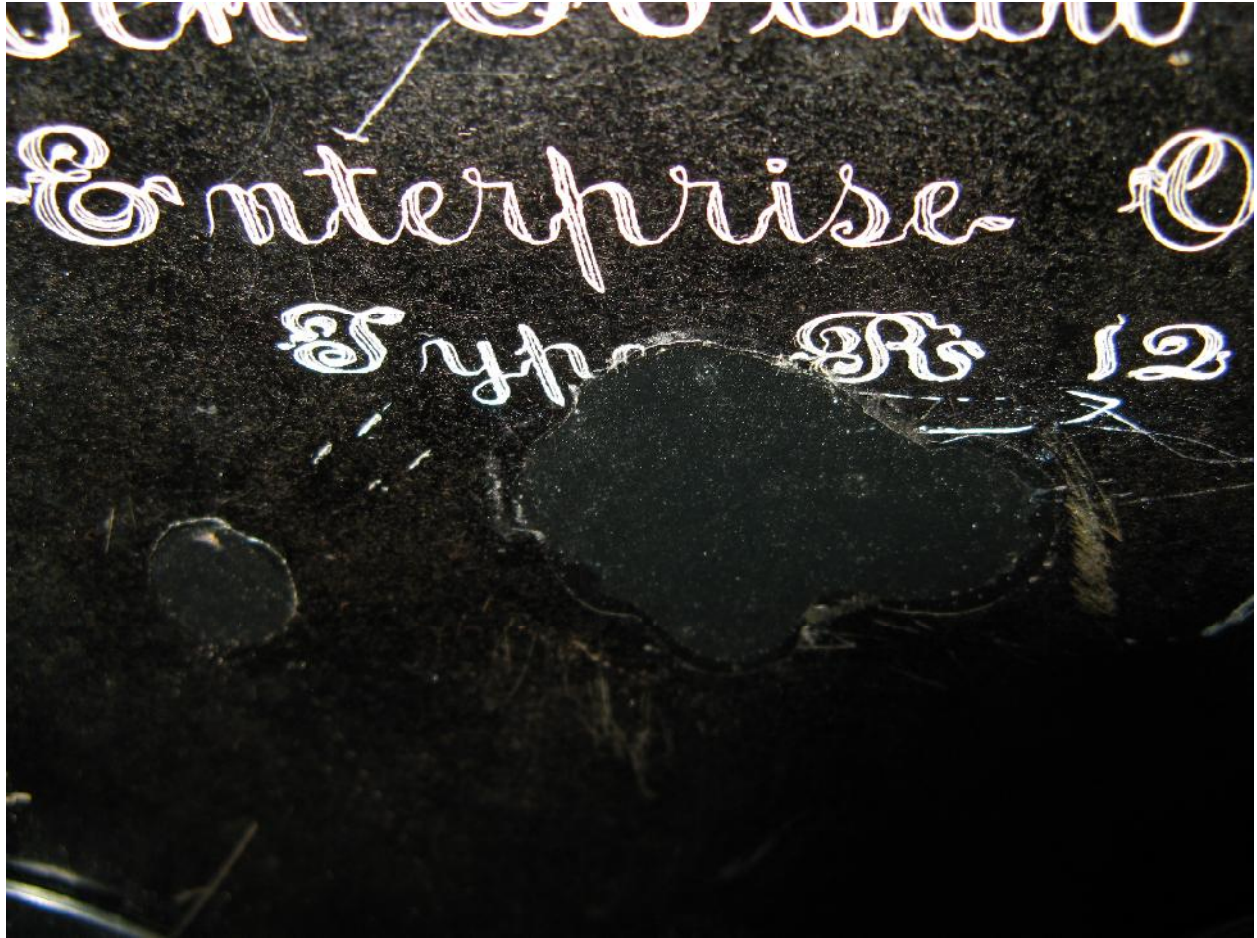
Figure 11a.

Figure 11 b. Repair of Front Panel - Picture of Filled holes

I used epoxy mixed with black paint powder. Carbon black also works. Put just enough powder in to get deep black but not so much that sheen is lost when it hardens. The hardened epoxy will replicate the surface that it is cast against. I used silicone rubber sheet which has a shiny side. Epoxy will not adhere to it. I used a back up block of high density particle board to make it flat and clamped it in place during casting. You can use the silicone rubber on both sides of the filled hole but then you may have to remove extra that "squirts" out under the silicone.

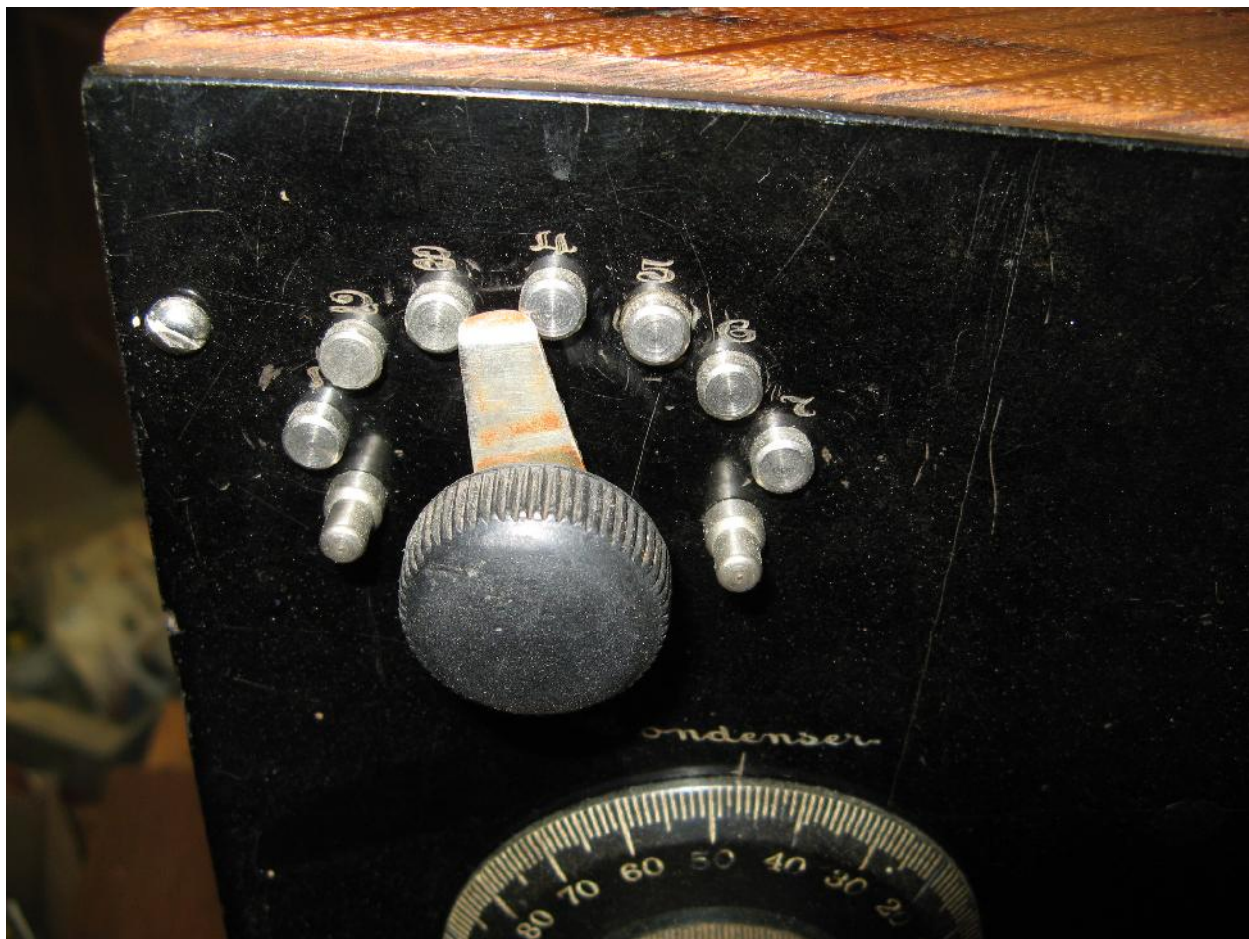
Figure 13. Picture of tap switch.

I replaced all the tap contacts and small screws as the originals were beat up. The original has metal tabs on each coil tap lead and I used the same scheme.

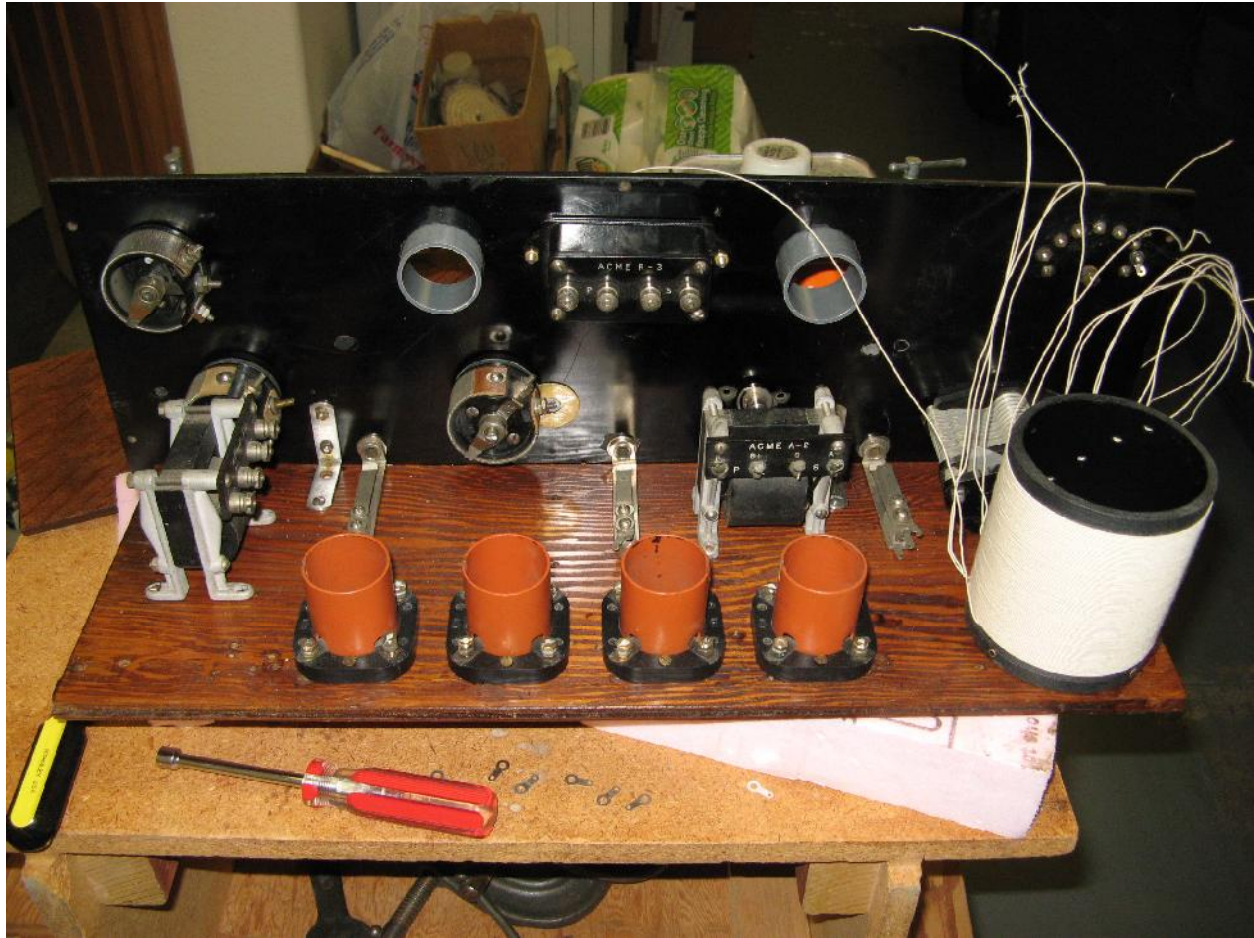
Figure 14. Partially completed parts installation.

The phone jacks were all replaced but only the final speaker jack was wired into the circuit. I left wiring of the jacks from the detector and the 1st audio as a future task for someone. I rarely if ever have used these jacks on radios that I've restored even when they were functional.

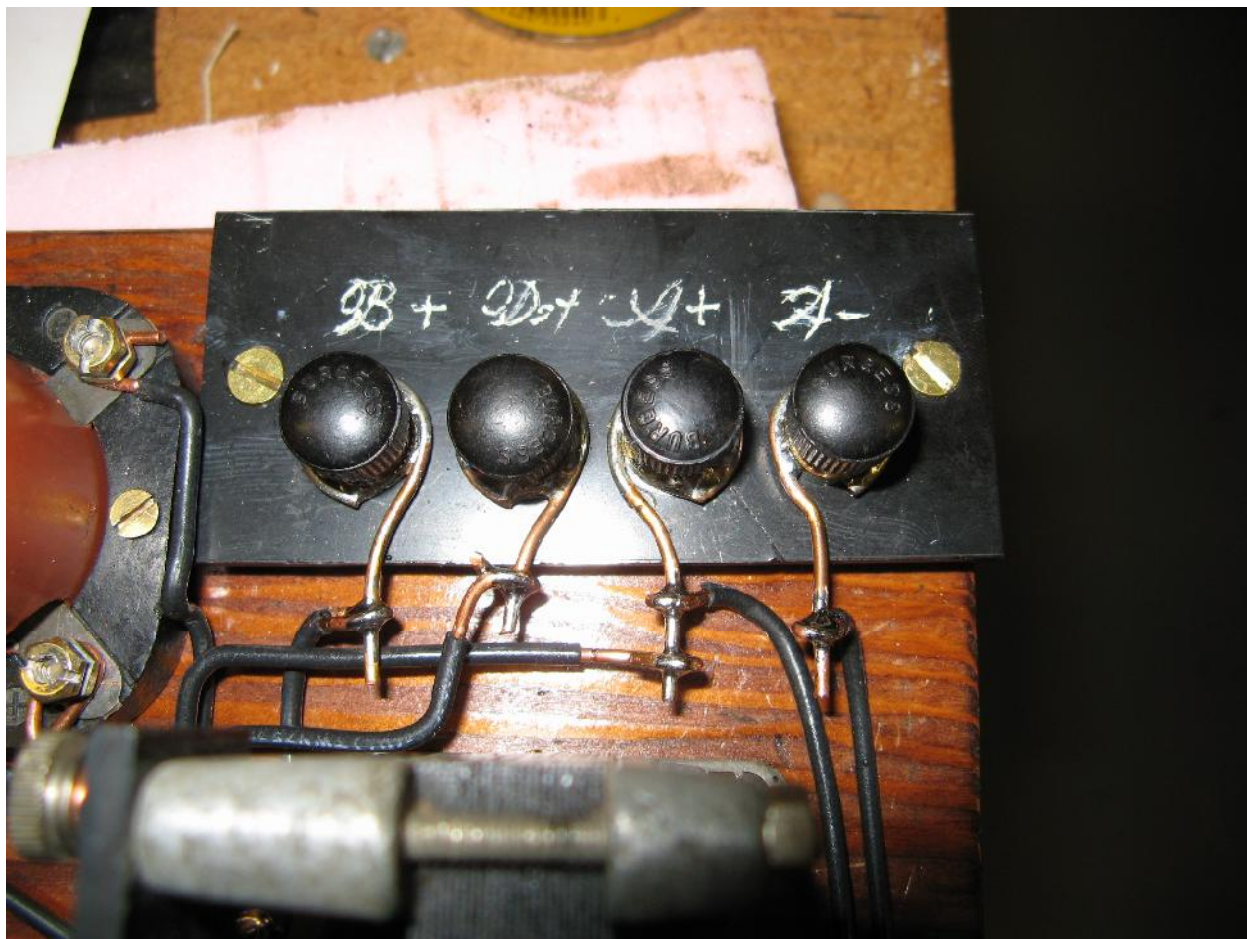
Figure 14. Hand engraved power terminal.

The power terminal strip in the original radio used fancy old English font like the front panel and I mimicked this by engraving by hand with a small pencil engraver from Harbor Freight, price about \$8. I printed the desired lettering with the computer word processor and taped it to the bakelite strip as a guide for the tool and engraved through the paper.. This worked pretty well considering it was my second try after a practice attempt on a scrap piece. I may get up enough nerve to try tweaking the front panel at some date but left that chore undone for now.

Heacock had the unusual habit of soldering the leads from the set directly to the terminals ABOVE the bakelite, see in Picture, on the power terminal strip. I duplicated this detail and had to make one of the connectors to match the other three, as these were a little different style than most in my junk box.

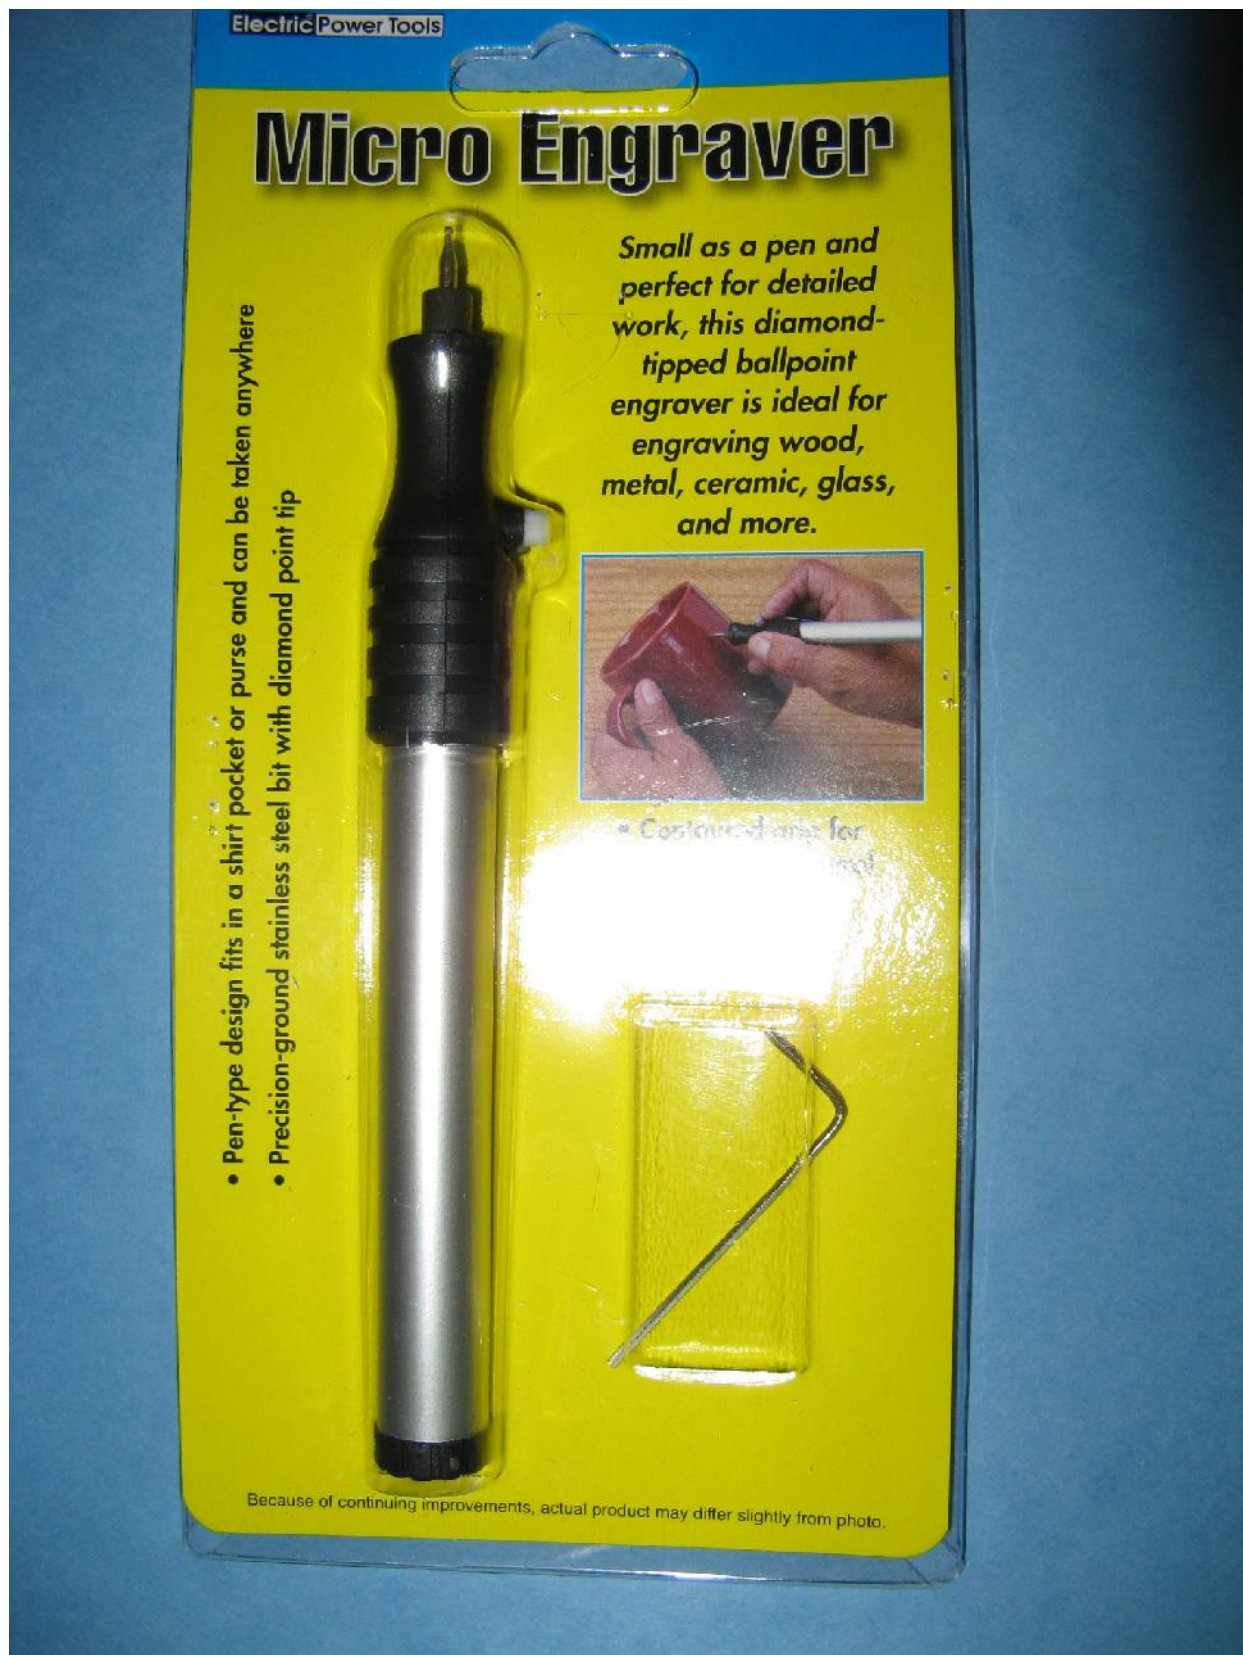
Figure 15. Harbor Freight engraving tool. Uses two AA cells and has diamond cutter.

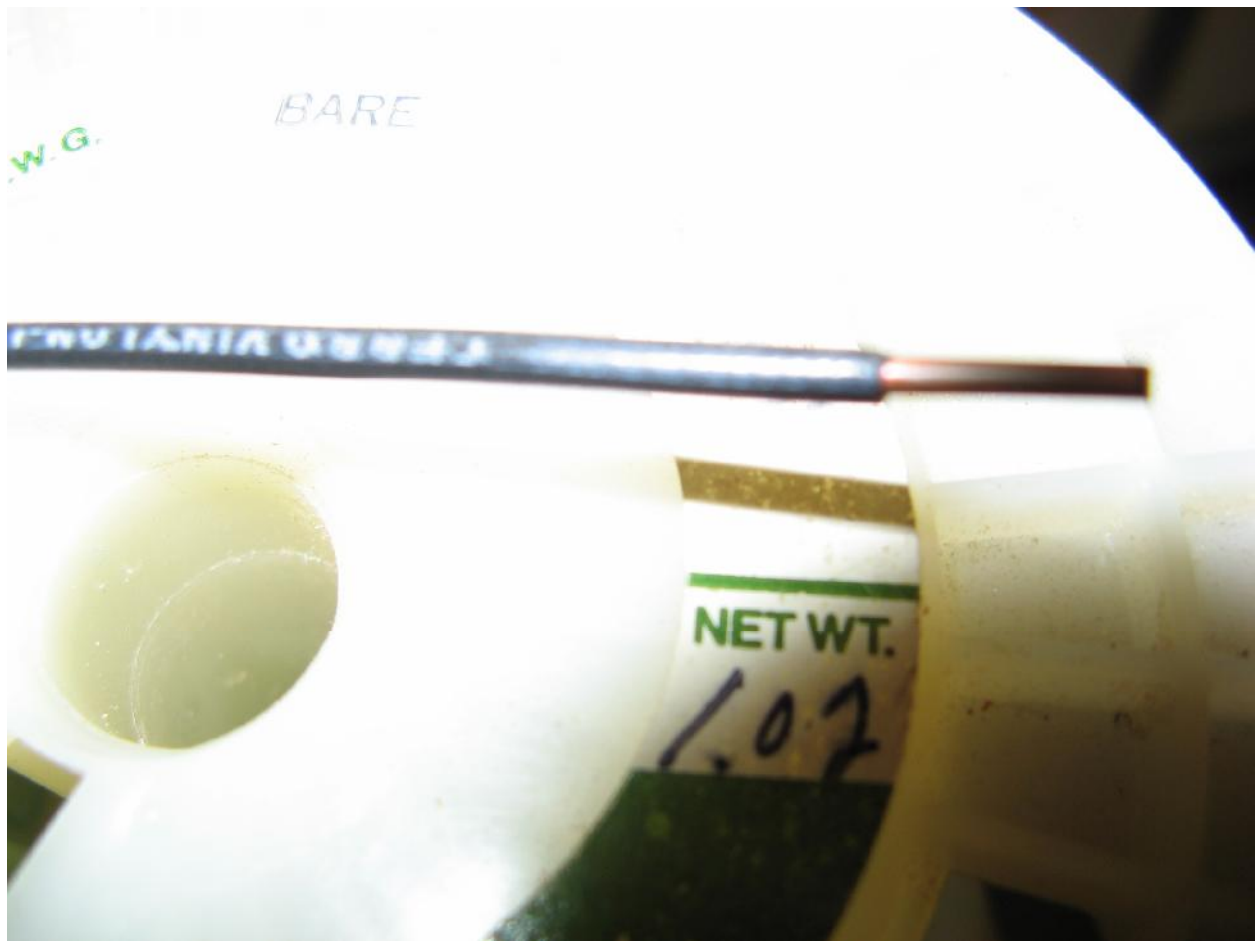
Figure 15. Wire for circuits.

Heacock used 14 ga wire with black covering, probably a rubber product. Common 14 ga wire from Home Depot is a good substitute, but it looks better to get rid of the outer thin transparent covering, by scraping with a pocket knife until thinned and then stripping that covering away. The lettering on the wire can easily be swabbed away with a little acetone and the wire looks nearly identical to Heacock's. His wire was not tinned.

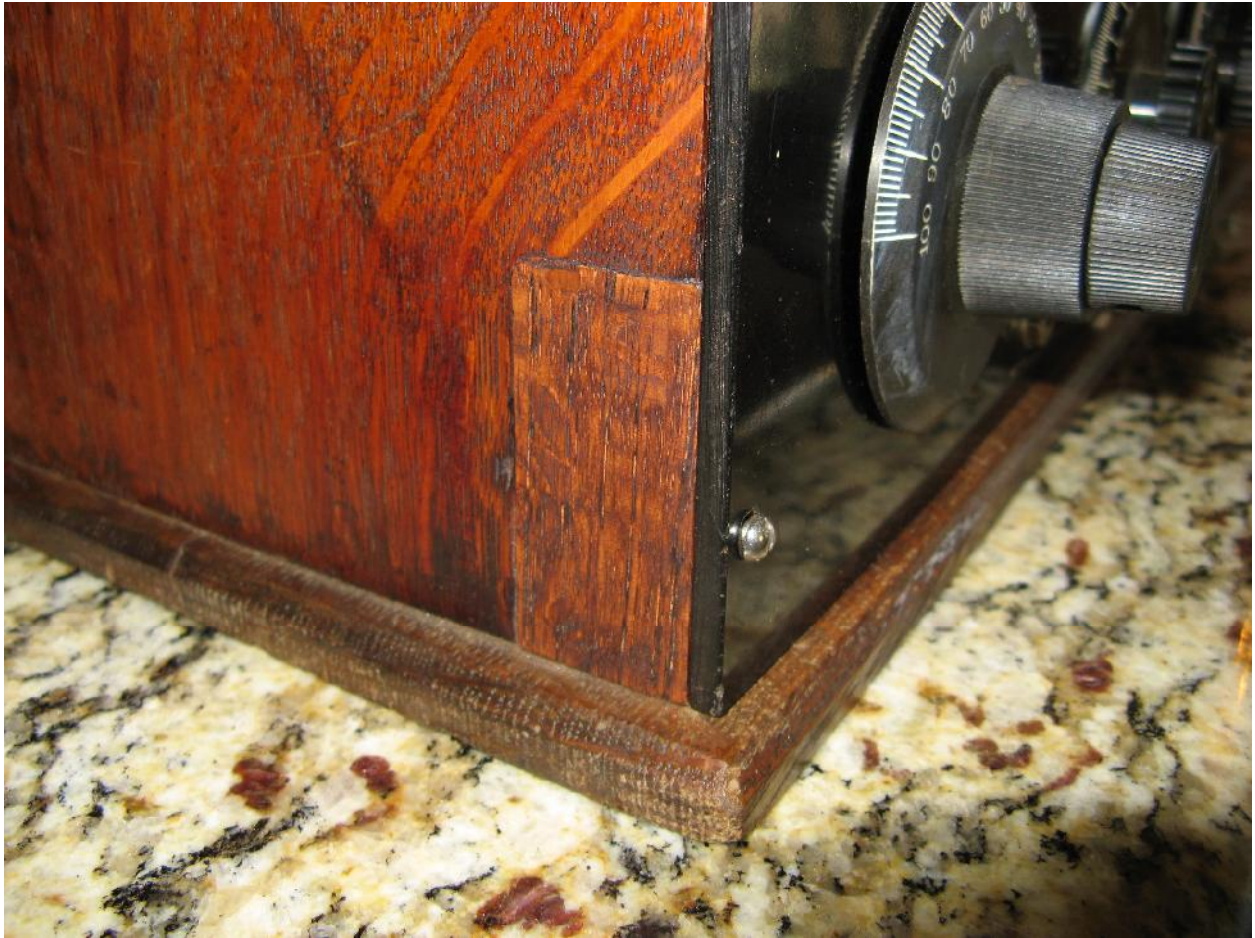
Figure 16. Pictures of cabinet repair.

Near the front left at bottom, the side panel was damaged and a 1 x 2 inch piece of wood needed repair. I fooled around quite a bit trying to cut oak at various angles to get something to match the decorative grain of the quarter-sawn cabinet. The result was less than I hoped for probably because my oak didn't have a much of right kind of grain. This could be redone if I discover some better wood. I routed out the damaged wood with a small trim router and replaced it with a thin slice that fit the cavity.

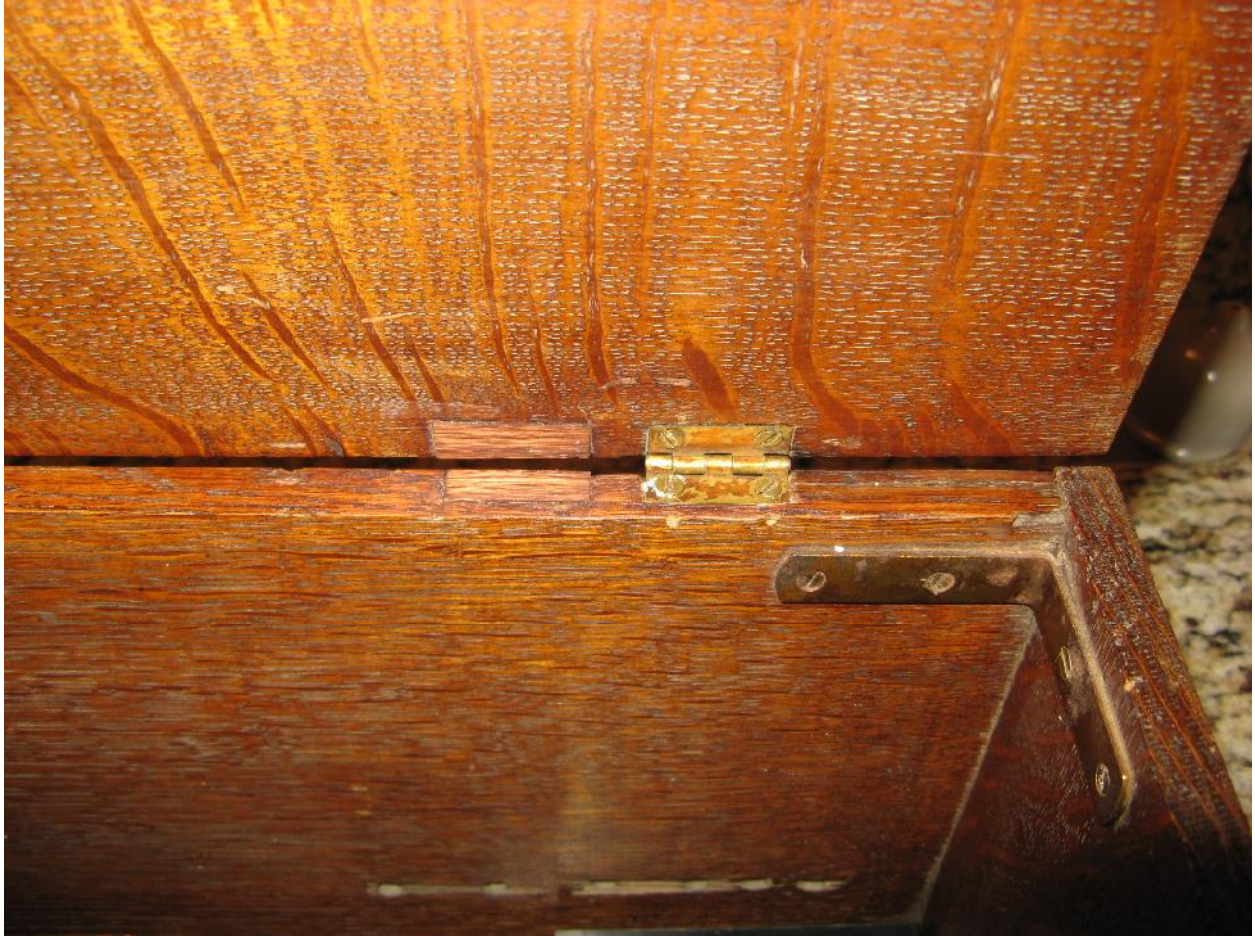
Figure 17. Repair to hinge area of cabinet

The hinge area had some areas that were used for non-original hinges. This was repaired and the hinges were put in the original cut-outs.

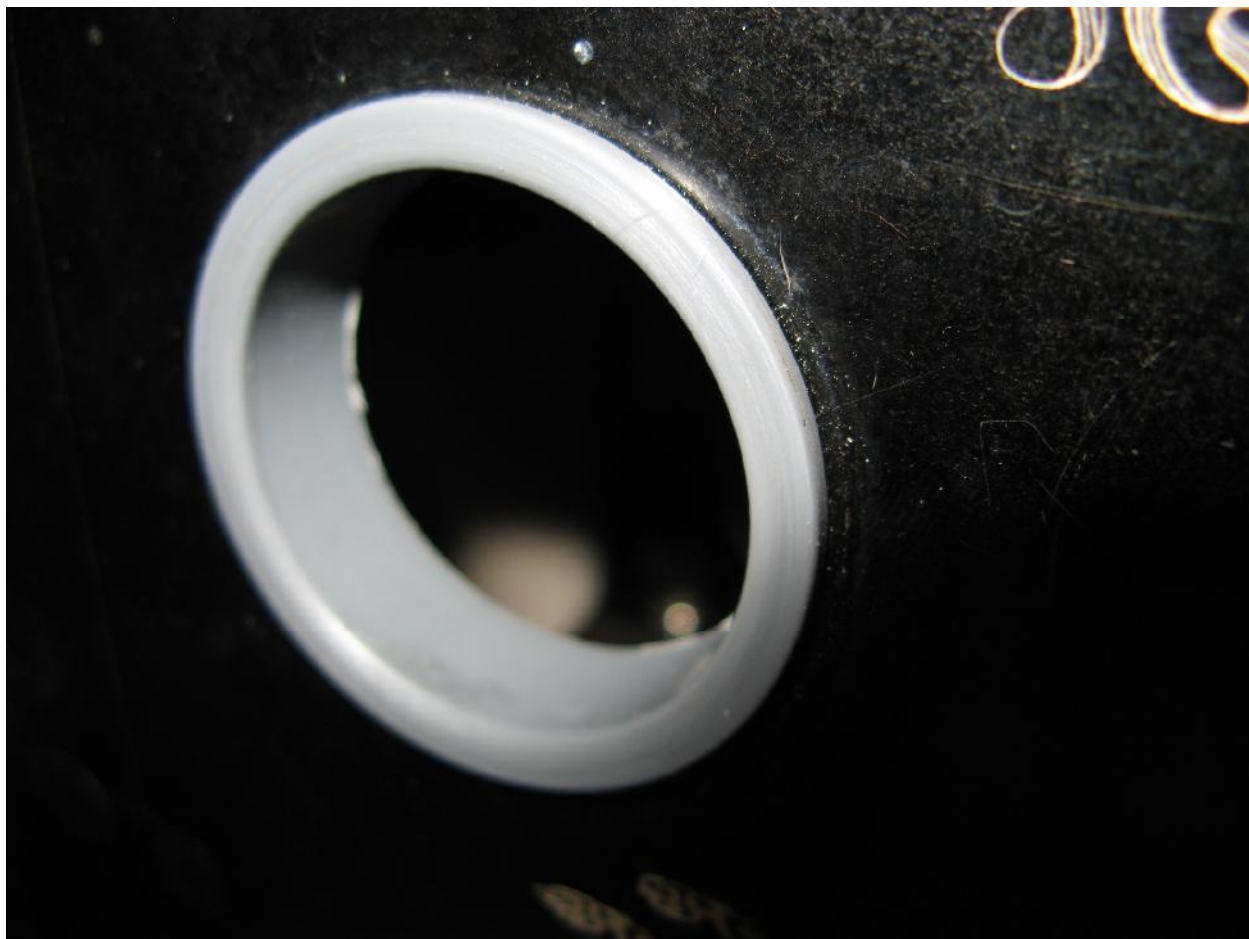
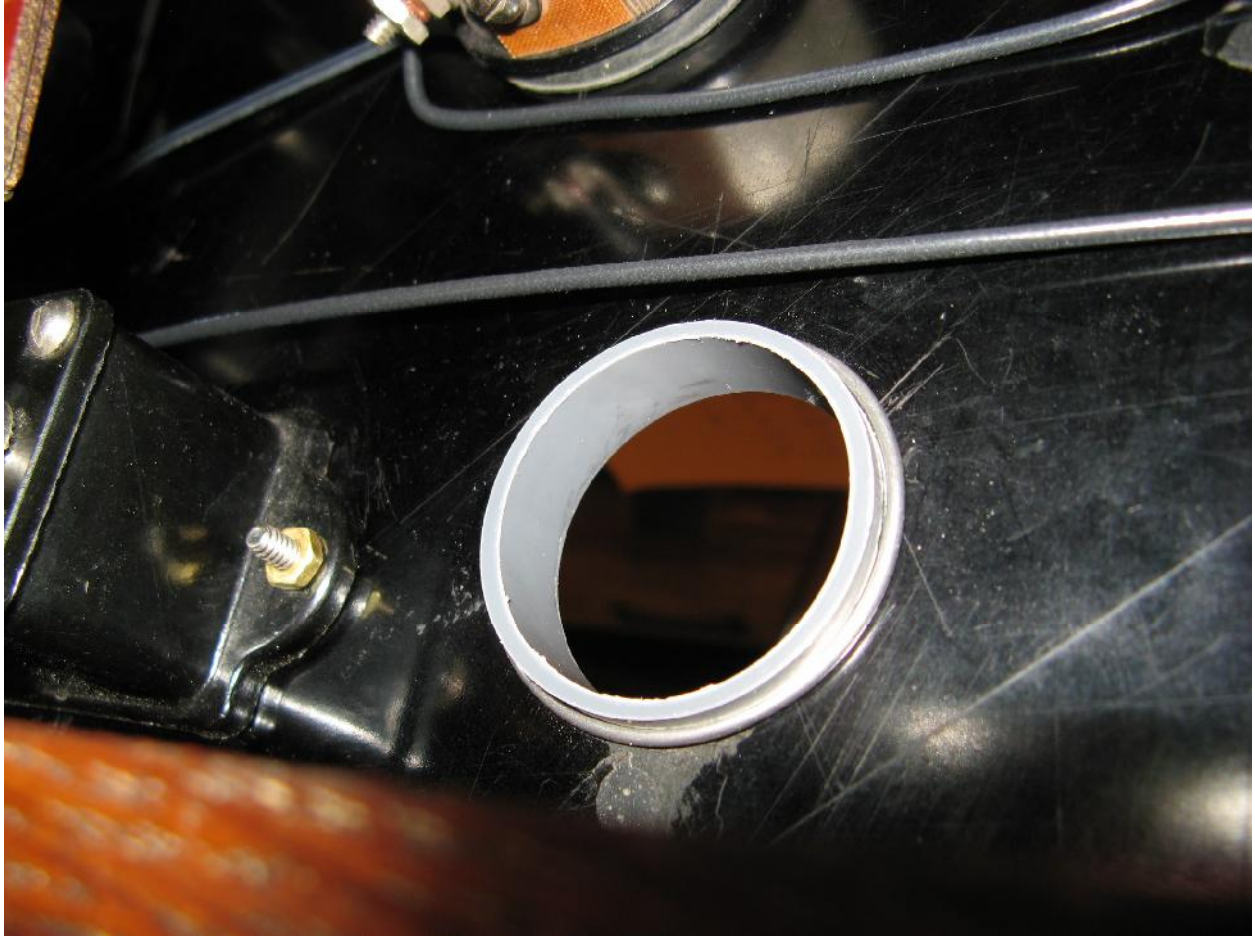
Figure 18. Substitute tube-view hole liner.

Figure 19. Back View of tube-view liner with stainless wire retainer.

The two large hole rings that line the tube-view holes on the panel were damaged. One was beyond repair so I made two matching liners out of plastic pipe. These were held in place by a ring of spring stainless steel wire. These appear ok and could be replaced easily with the original type rings with screens if found. I have smaller ones but none of this large size. Advertising with the Seattle club didn't turn up any.

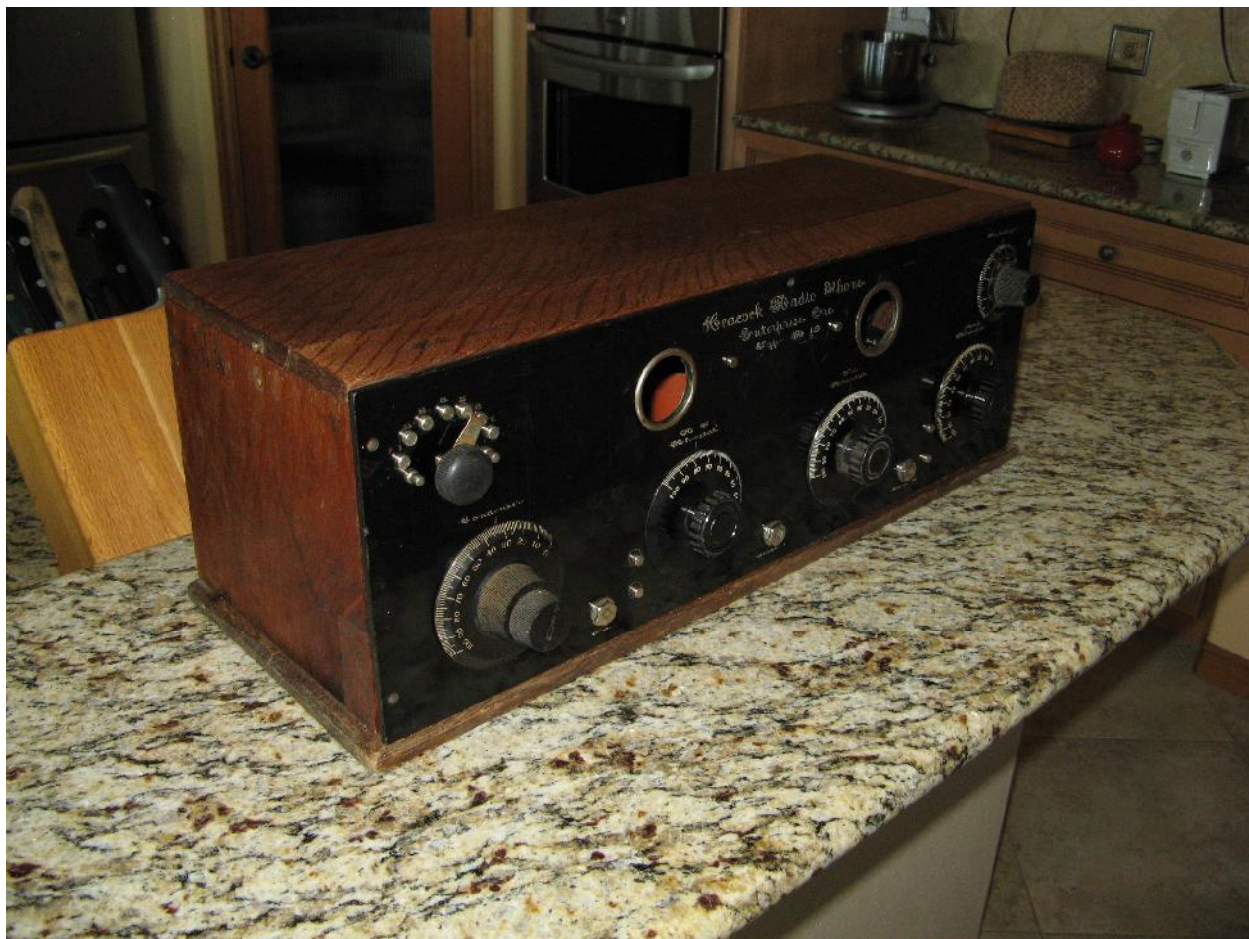
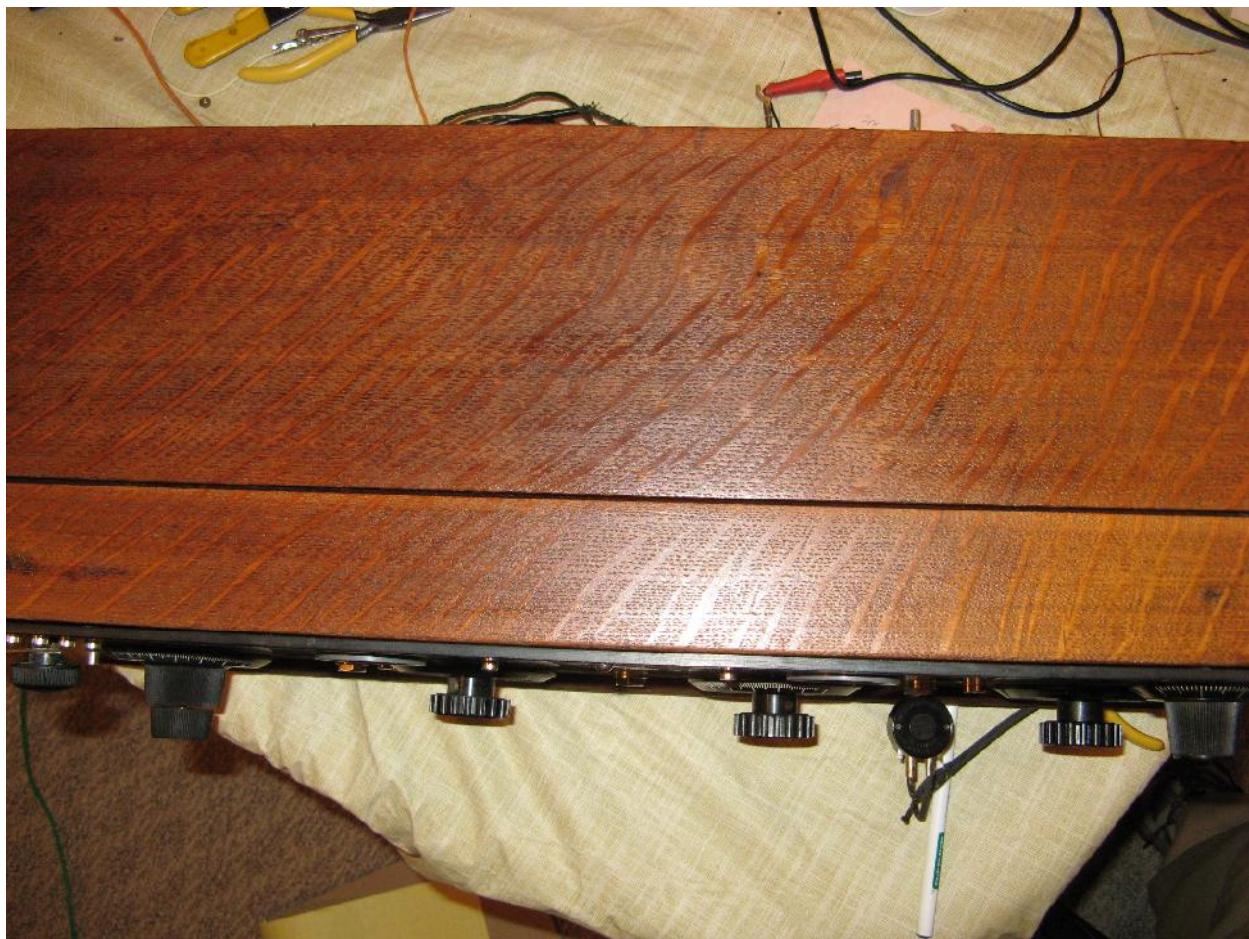
Figure 20. Finished cabinet, front view.

Figure 21. Finished Cabinet, top view.

The as-found cabinet was fairly nice looking except for the damaged areas and the hinges which had been remounted because the original screw holes in the hinge inlet had pulled out. I drilled the old holes out and plugged the holes with small dowel. I also filled the non-original inlets with oak. The hinges were easily remounted using the original screws. The finish on the set was dirty so I cleaned this with a soapy rag and also with turpentine. I restored the luster to the set using Birchwood Casey Tru Oil gunstock refinisher. This is, I believe, is basically linseed oil with driers added so it will set up in a few hours and can be re-applied as needed. The product is similar to “Linspeed ” also a gunstock finish. I was quite happy with how this restored an old look to the cabinet and took away the dried, weathered look that the cabinet had. The cabinet, typical of Heacock radios, has brass “ L” brackets at upper corners inside to hold it together.
