Restoration of Heacock Radio Phone R12

Summary of O.M. Heacock, who built and sold radios around 1920

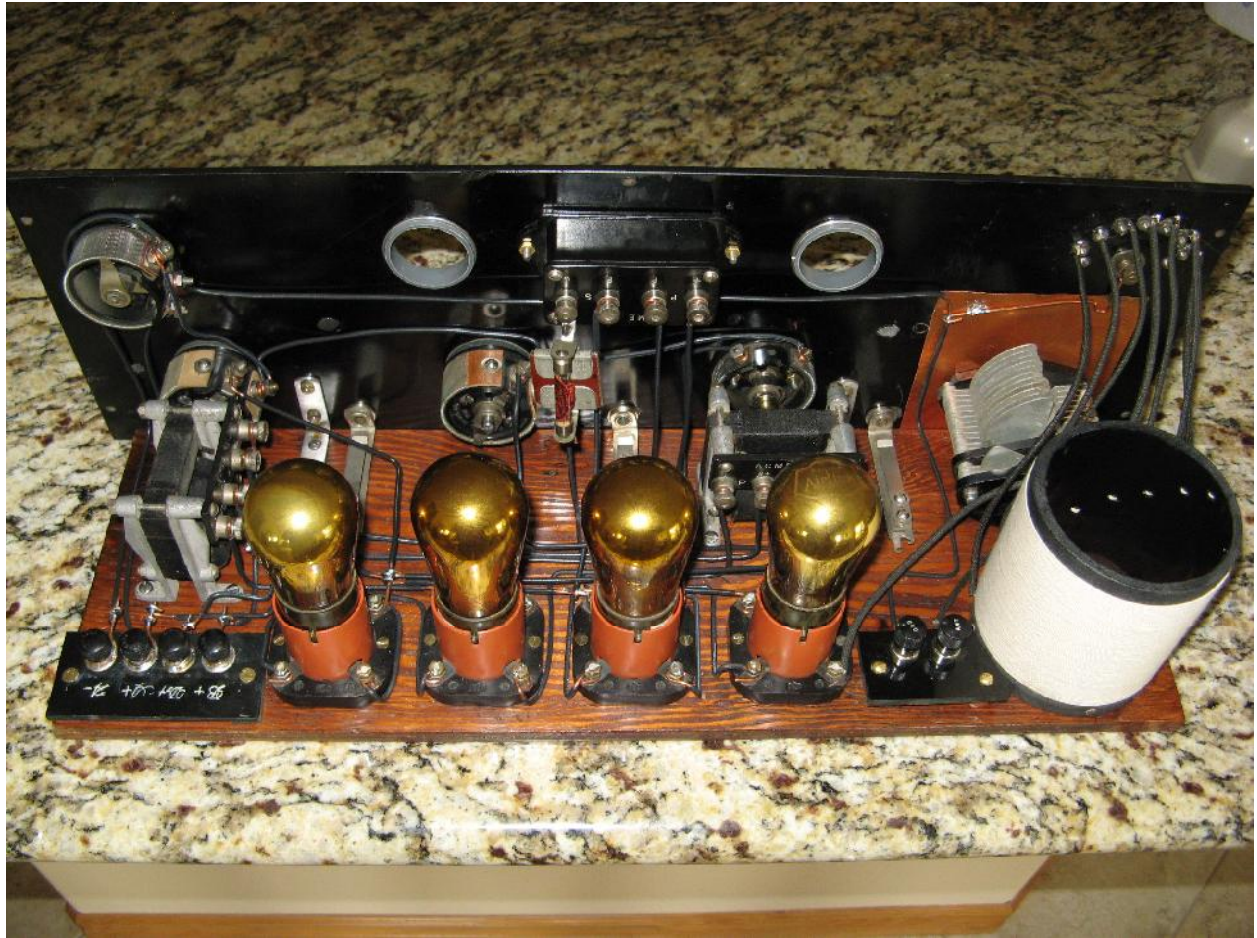
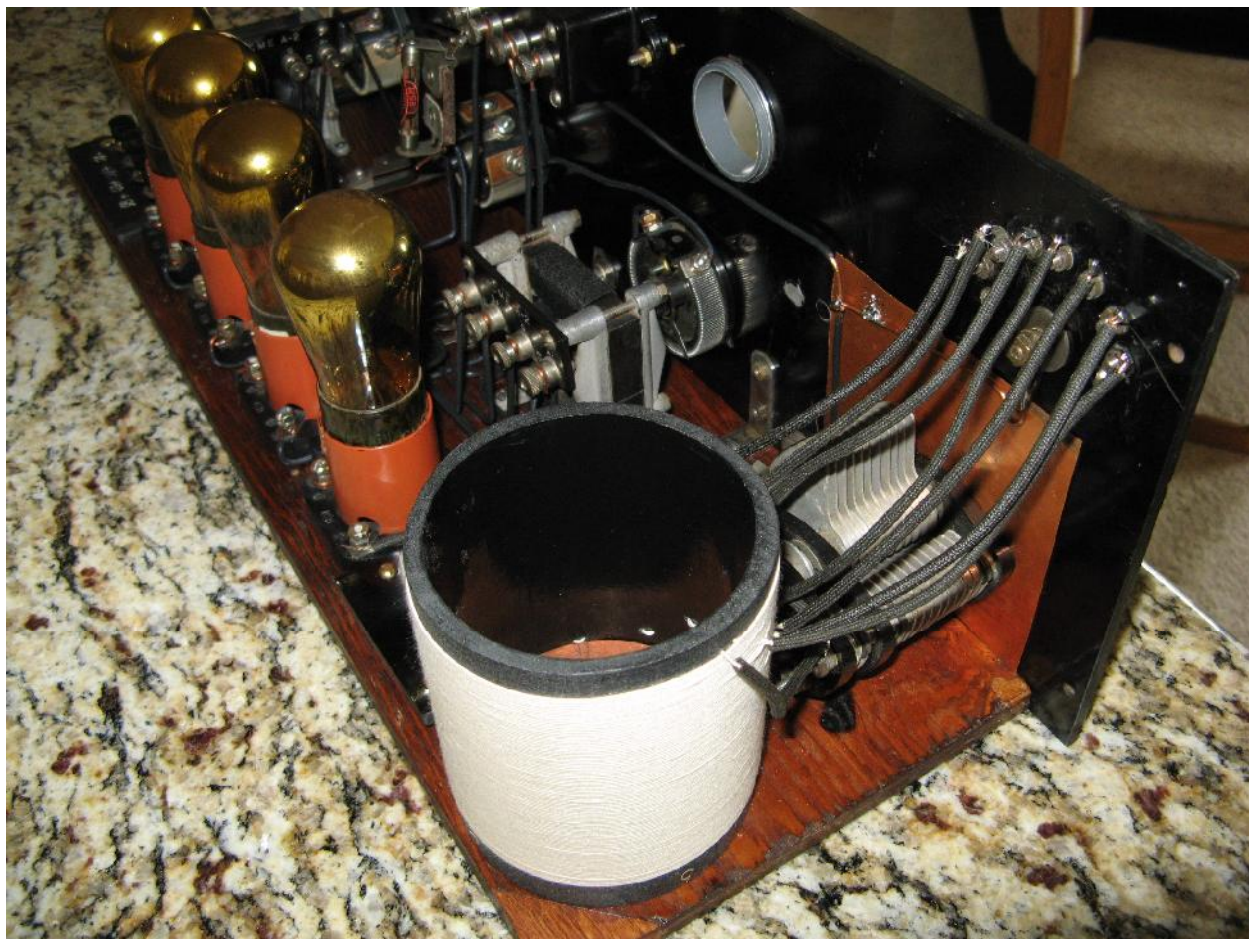
Figure 22. Restored Heacock Radio Phone, inside back view.

Figure 23. Restored Heacock Radio Phone, inside side view.

The finished radio, interior rear view, without cabinet. I replaced the copper ground shield in front of the tuning capacitor that was missing and was used by Heacock in his sets.

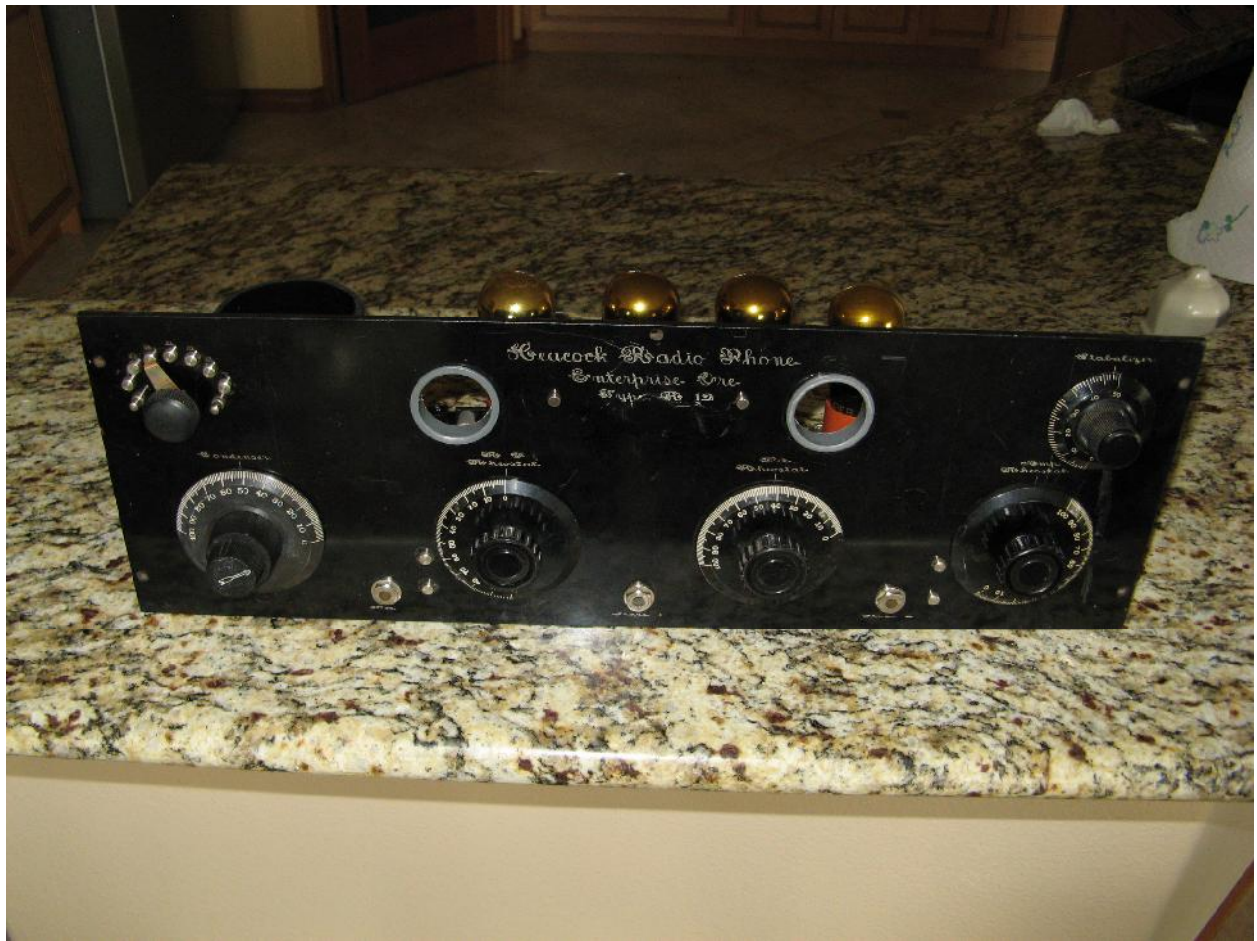
Figure 24. The finished radio, panel front view, no cabinet.

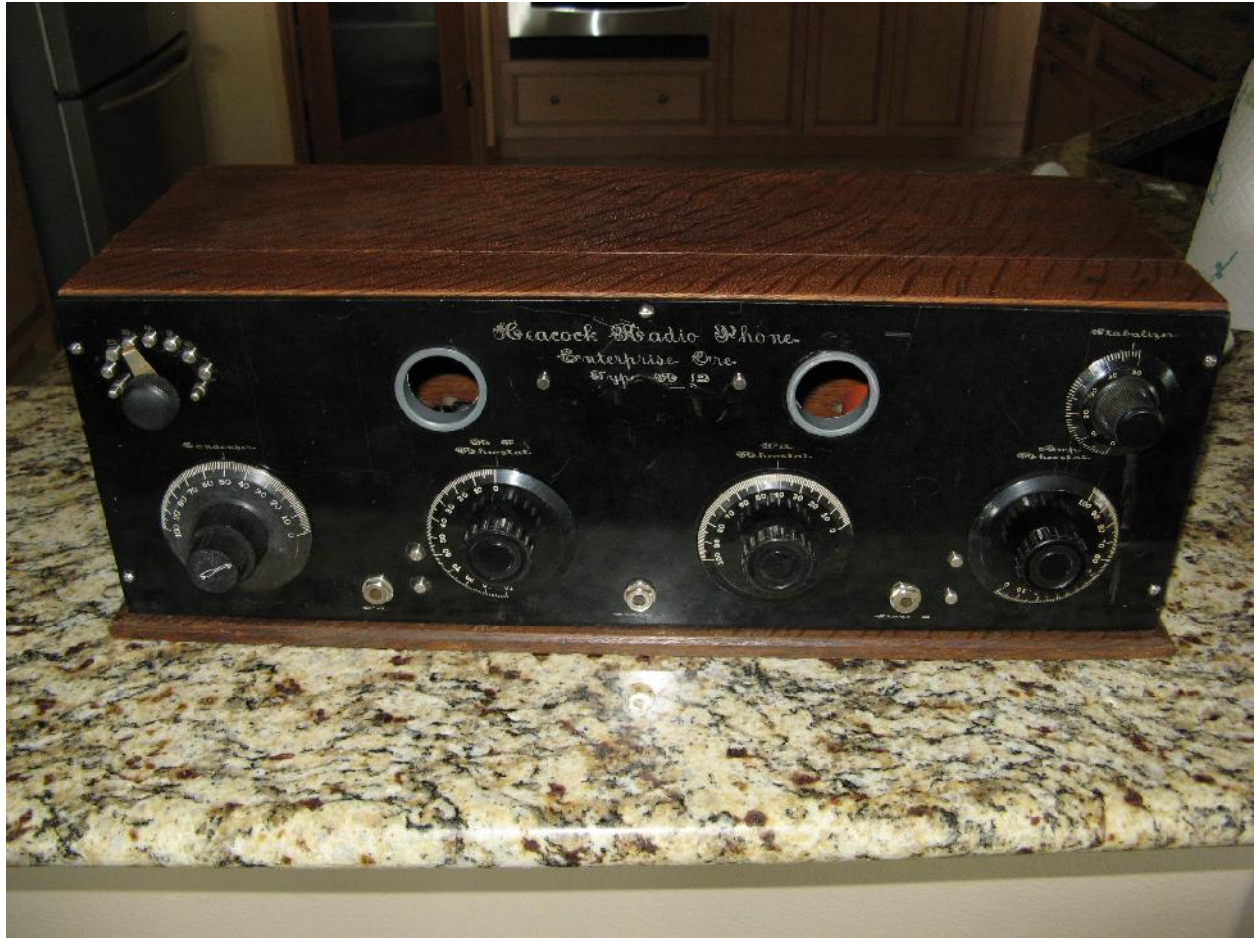
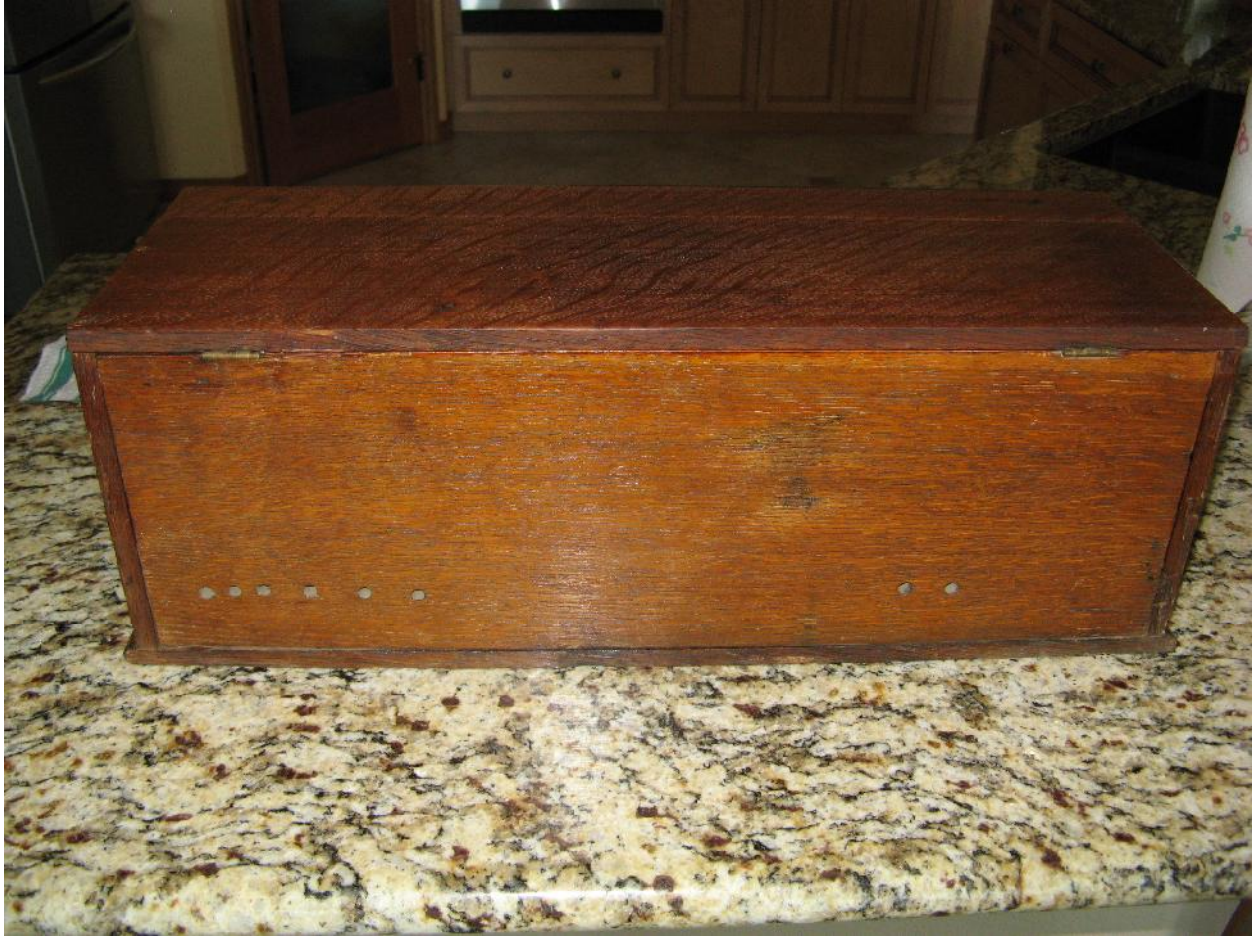
Figure 25. The finished radio, in cabinet, front view.

Figure 25. The finished radio , in cabinet rear view.

The set tunes typical of single stage variable tuning followed by broad rf transformer , not always able to tune just one station

It will tune from 600 to about 1400 Khz

Tuning is dependent on antenna type because of series connection of capacitance and inductance. I believe it works best with a long wire type antenna particularly for frequencies below 800 khz.
