Restauration of the Colonial Globe radio (by David Agresti)

1. Repairing the Bakelite and redrawing the continents

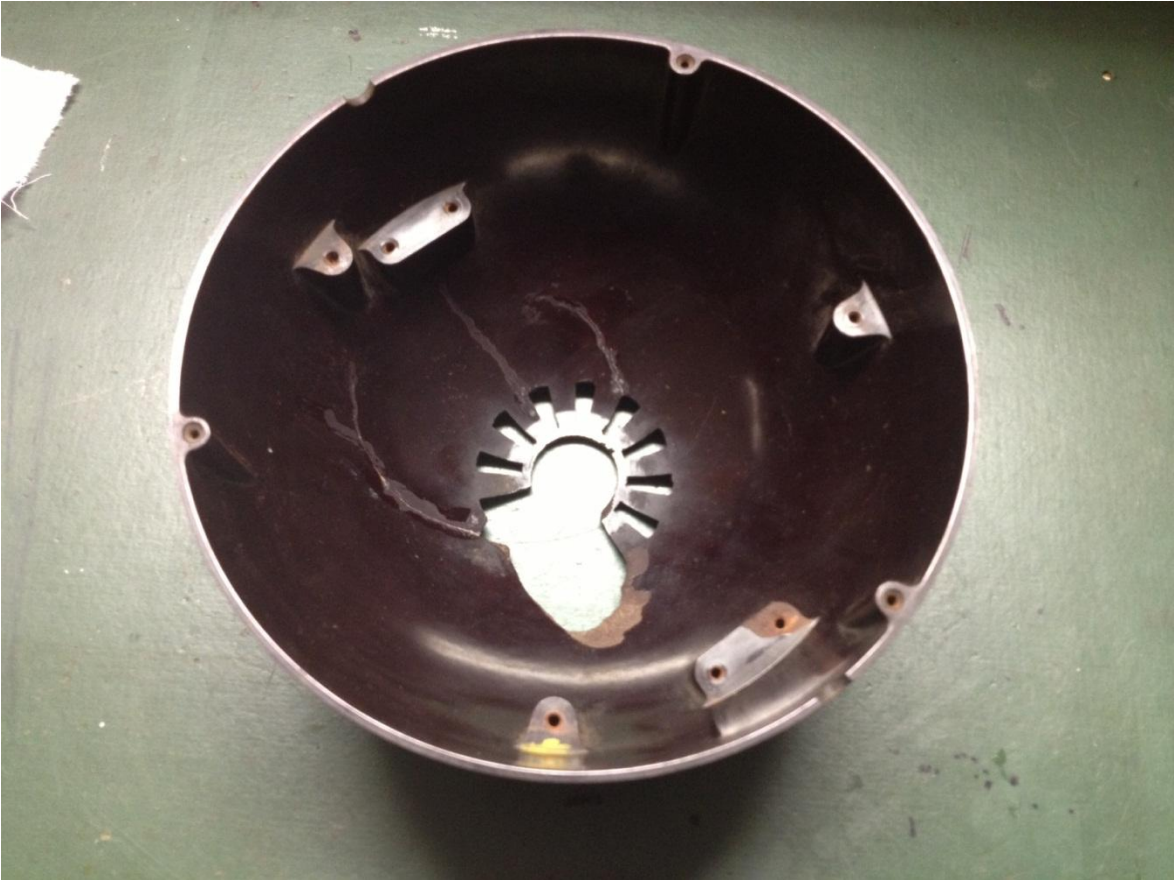
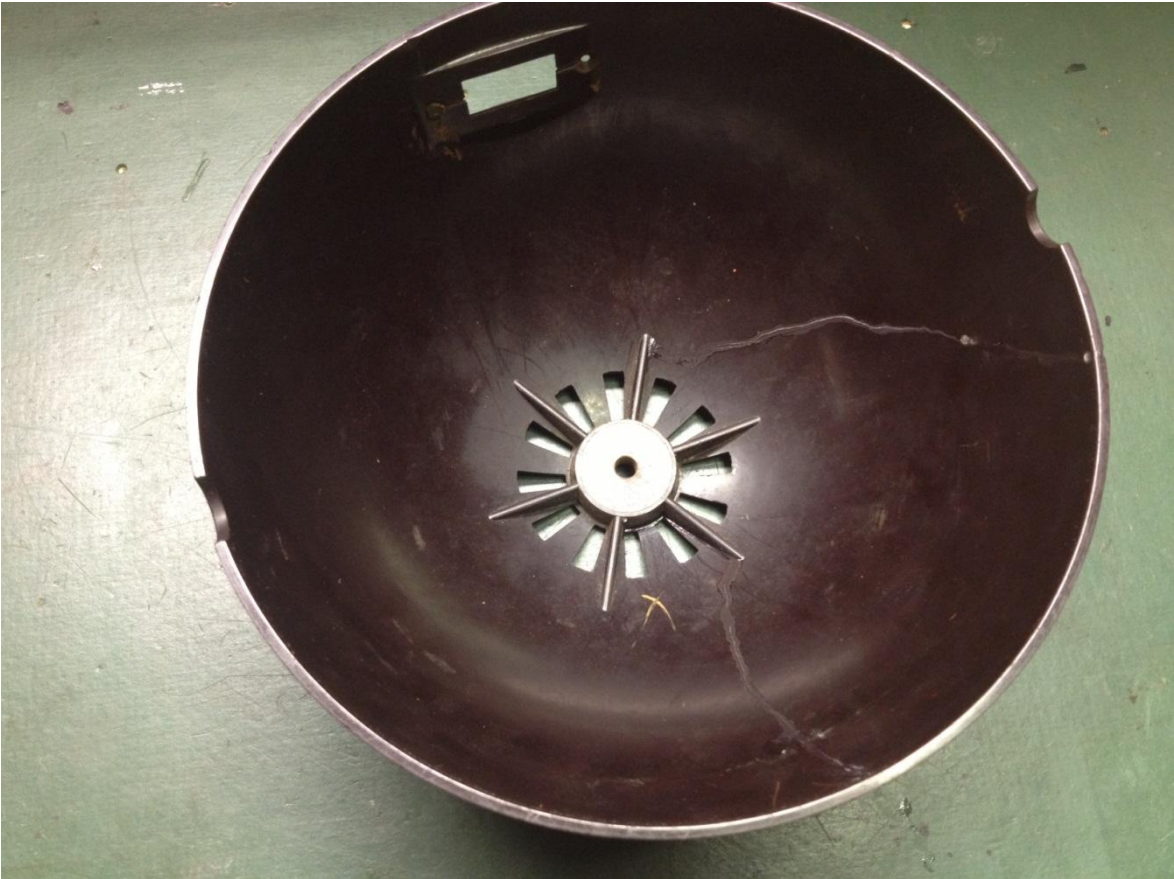
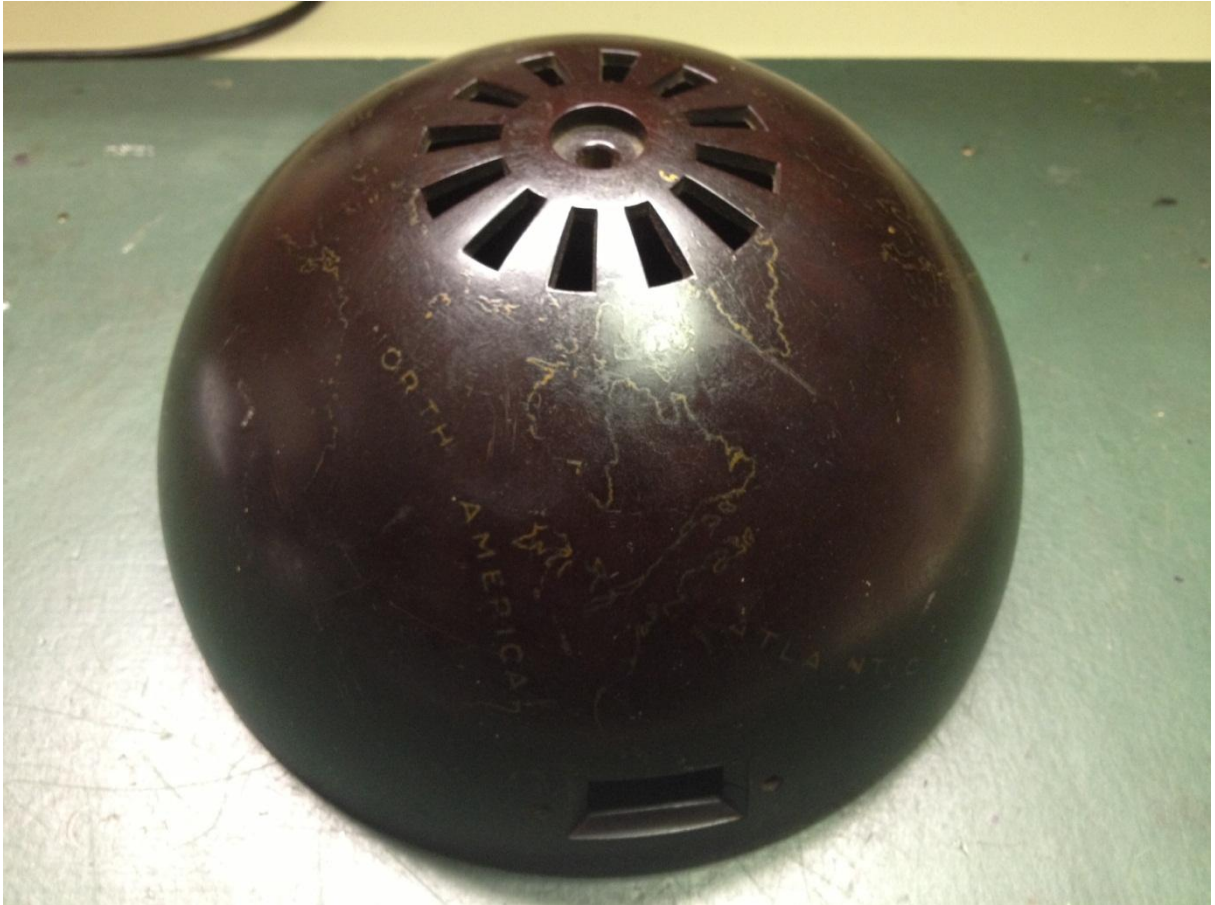
- A big hole in the Bakelite on the lower half of the globe
- Some cracks in the Bakelite in the upper half of the globe
- The continents and names in gold color ware very vague and missing
- Missing speaker clothes
- Missing tuning and volume knob
- Missing equator ring
- Missing copper top on globe
- Missing valves and bad valves
- Missing components like resistors, capacitors, mains cord, top cap connections
- Leaky Electronic capacitors
- Mechanically broken and interrupted coils
- Rusty chassis
- Perished wiring in the neck
- THE WHOLE ELECTRONICS PART IN THE FOOT was missing, so I mean :
- Speaker, speaker holder, Valve fitting, output transformer, connection plate
- And last but not least, the metal bottom cover was also missing

Here below you will find some pictures of the disaster :

To fill the cracks and the hole, I looked for a piece of Bakelite of a donor radio, which had the same color. Then I start to file it till I had enough Bakelite powder to fill the gaps. Next I used clay and put it in the intact piece of the globe to create a mold. After the clay was dried out I fitted it in the missing part and filled it up with Bakelite powder. To create the 'artificial' Bakelite I put special superglue from Starbond on the powder to harden it out. This process of powder and glue was repeated until the substance was piling over a bit. After drying out, It was time to sand it and then polish. Then it was time to redraw the continents and for that I bought a gold pen. Works pretty fine.

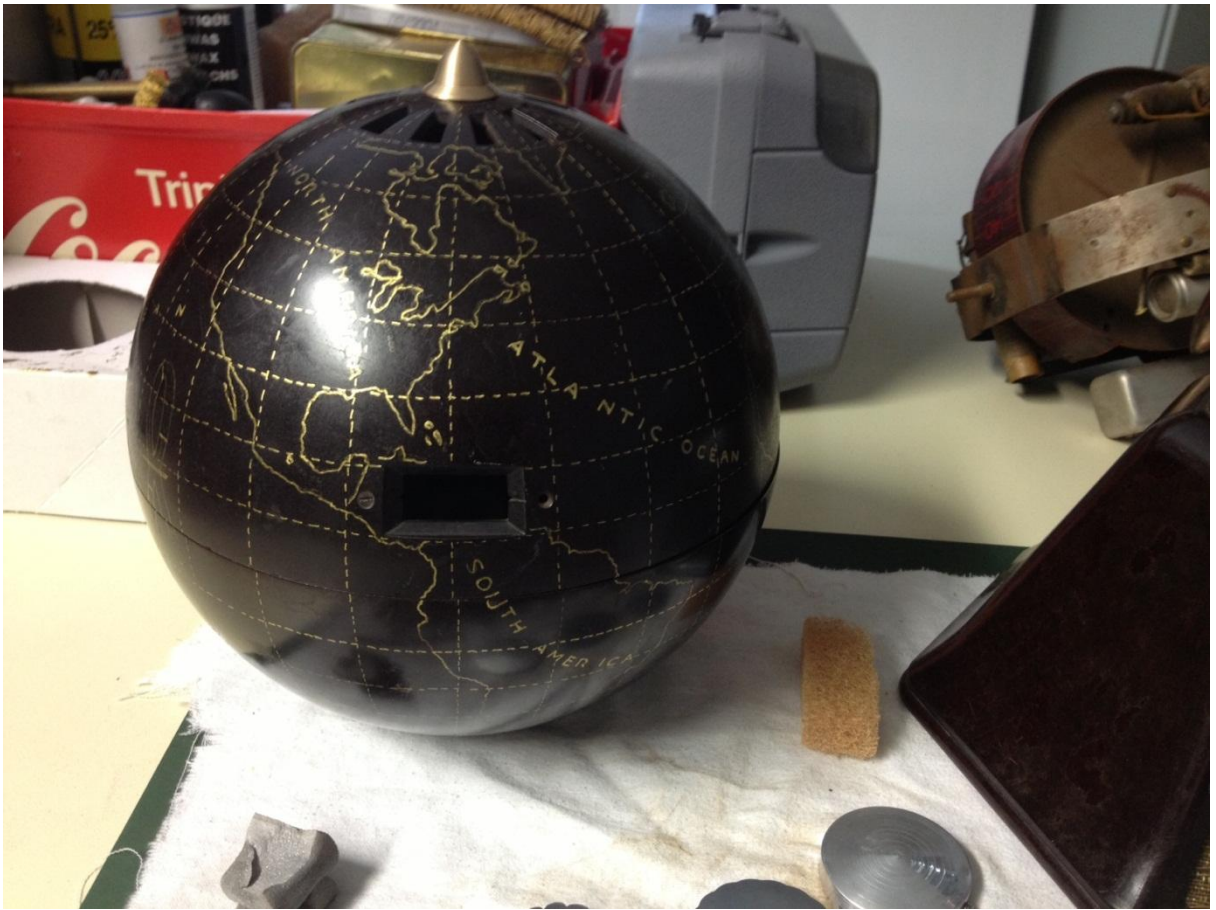
The result was superb !

Time to do the other half of the globe now.

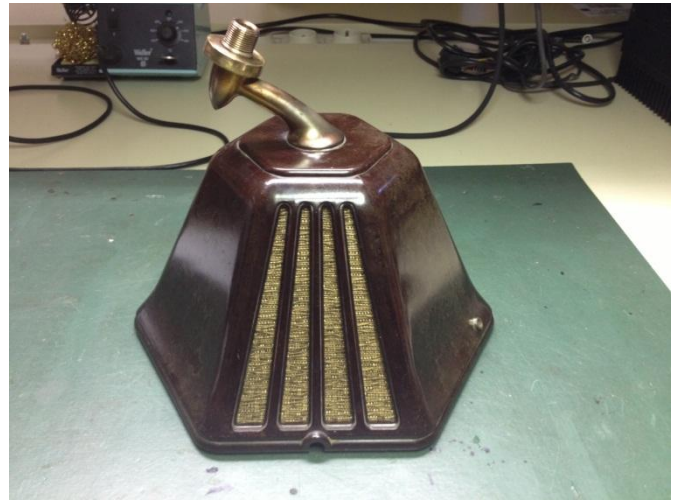
2. Replacing the missing clothes on the speaker compartment

There is not much to tell about. First finding something that matches the original in my stash of spares. Cutting the right size and glue.

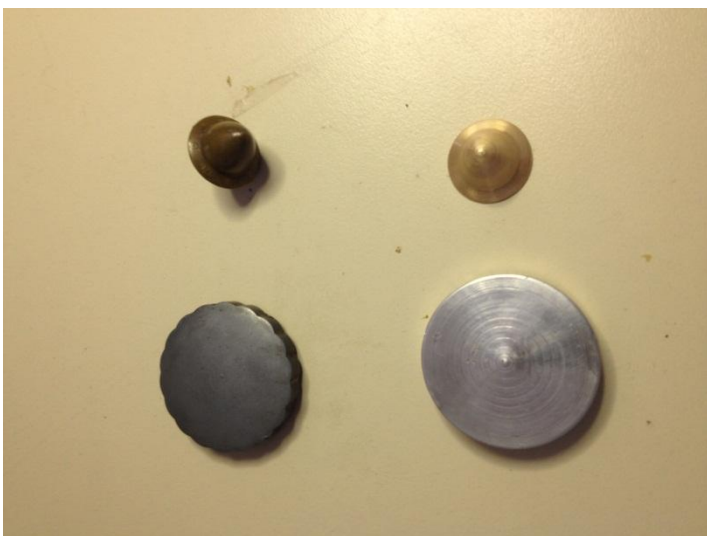
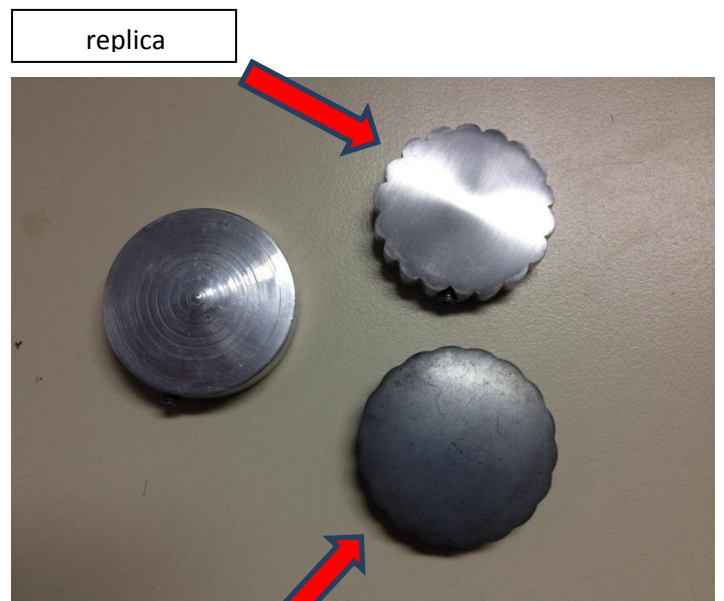
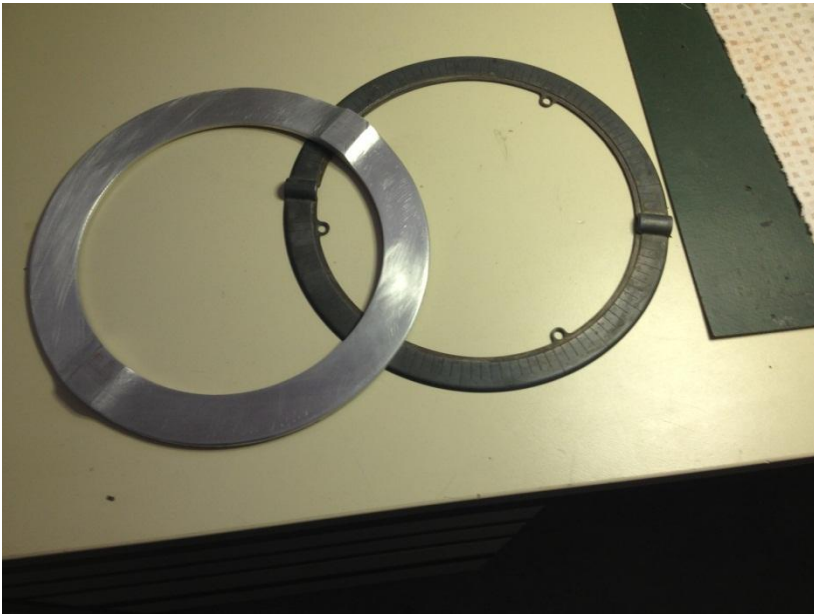
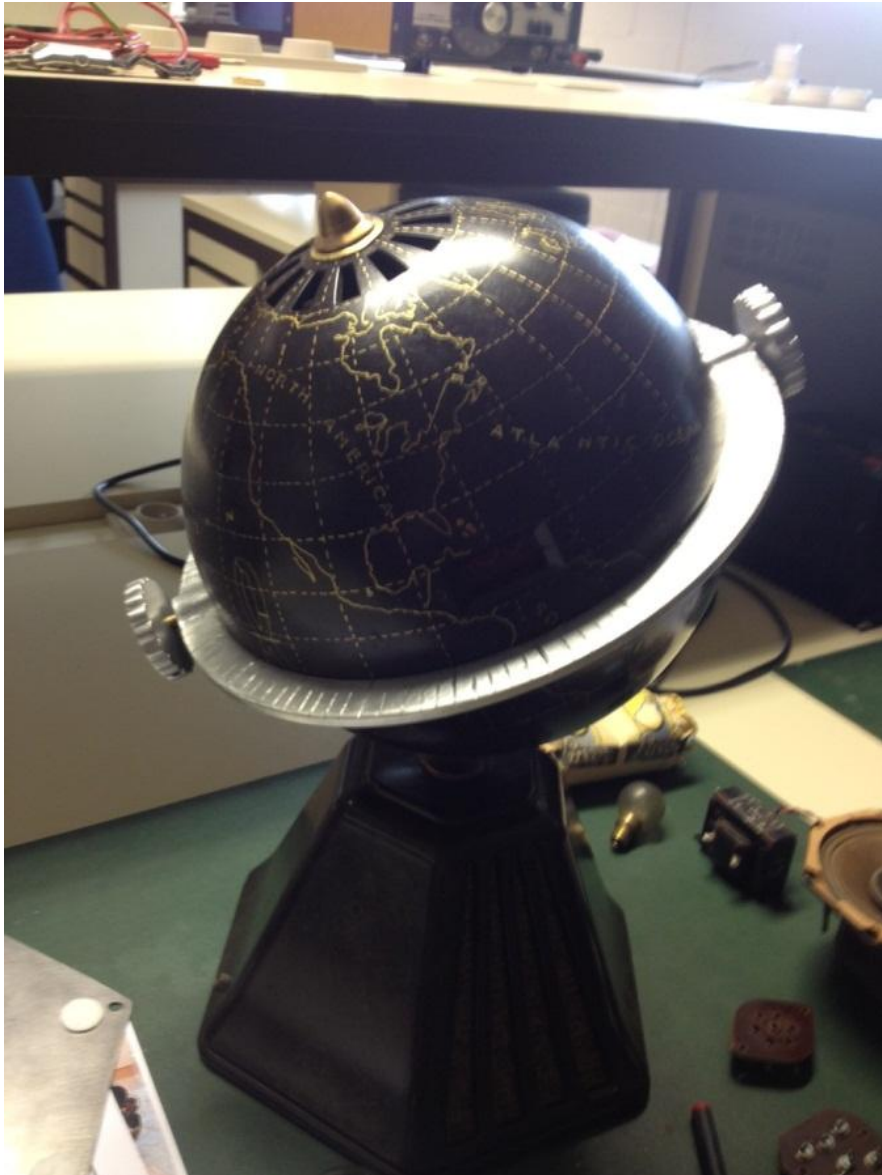
Original model

3. Making the equator, knobs and top

As I told a little earlier, I had some help here from Luc to create the equator and knobs. He has a turning bench where we could make it in the right form and size. But then the fine work started to get it in the right shape with the same curves as the original. So I did this with a file and I can assure you that it took a long time and it caused many blisters.

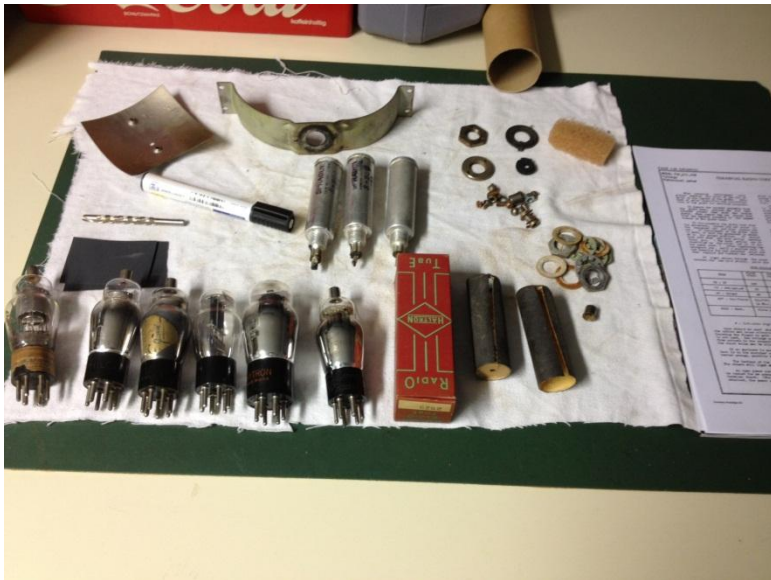
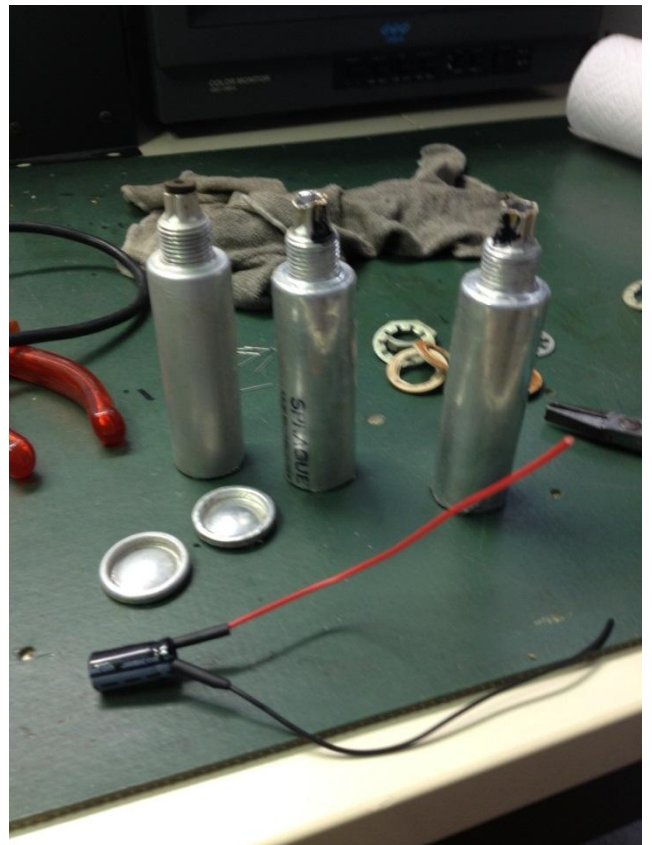
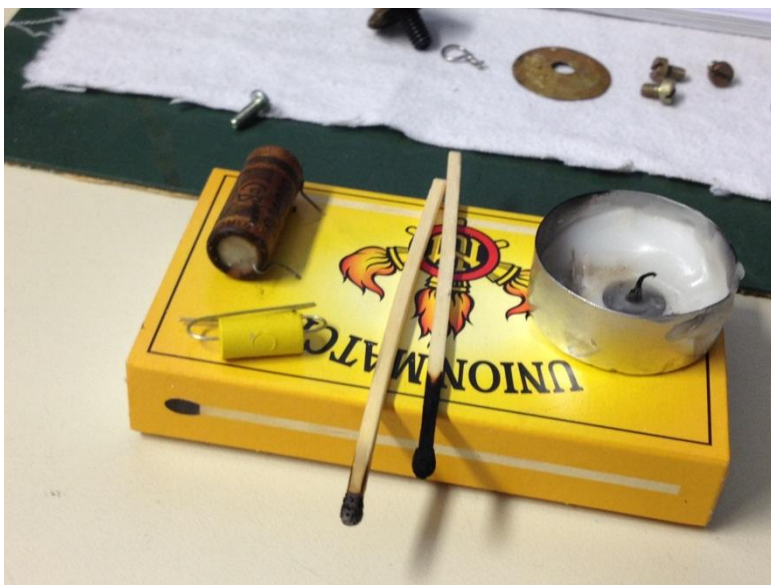
I quickly discovered that it was needed to replace a big part of the capacitors because their leakage was too high. I did some tests with my Heatkit IT-28, which love by the way. But I wanted to do it in the right way and keep the housing of the capacitors and change the internals.

I also tested the remaining Tubes if they had shorts and if the emission was ok. Luckily I have some spares and could replace the missing and defective ones.

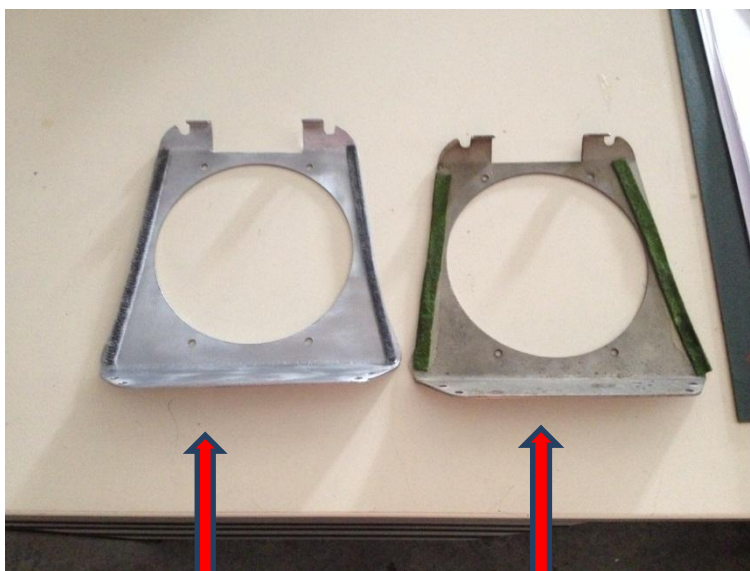
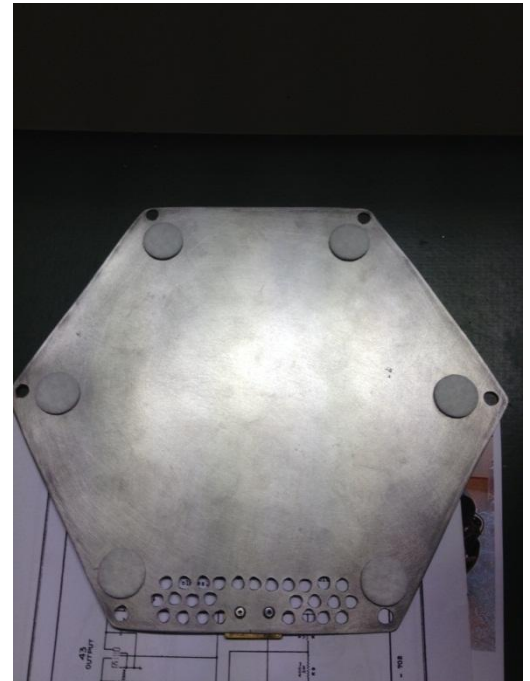
In the end I was happy with the result :

First of all I started making in metal sheet the speaker fitting and the bracket. That was not so hard because I had the globe of my friend a model. Although it was easy, it implied a lot of work to make it exactly in the right size. Else it would not fit properly.

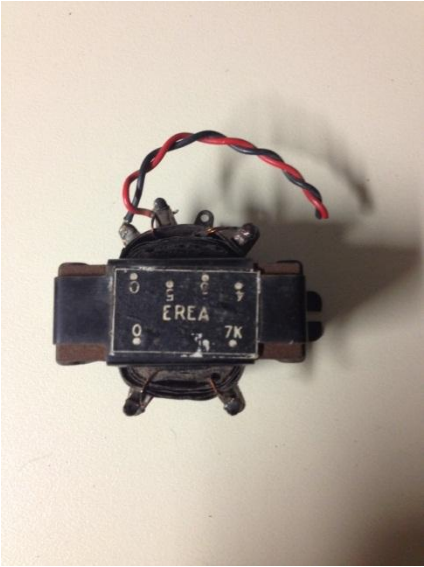
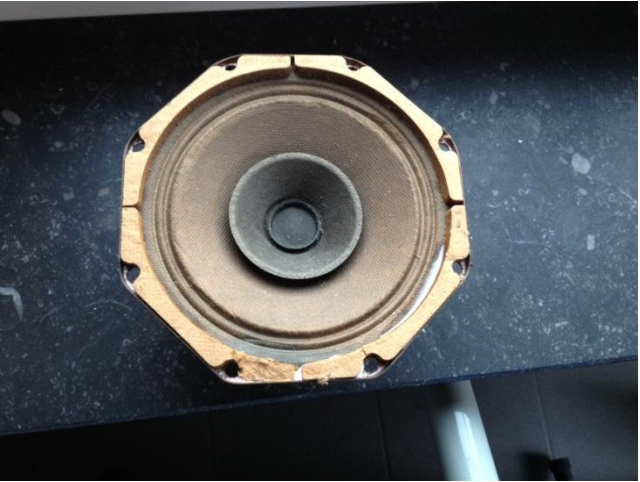
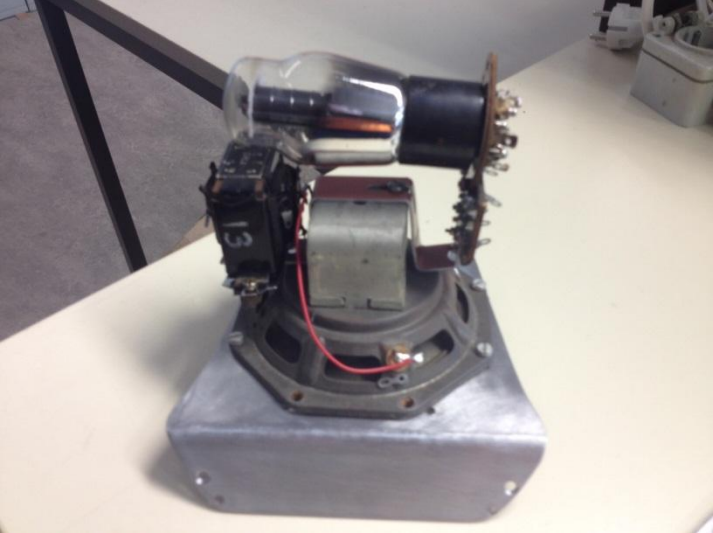
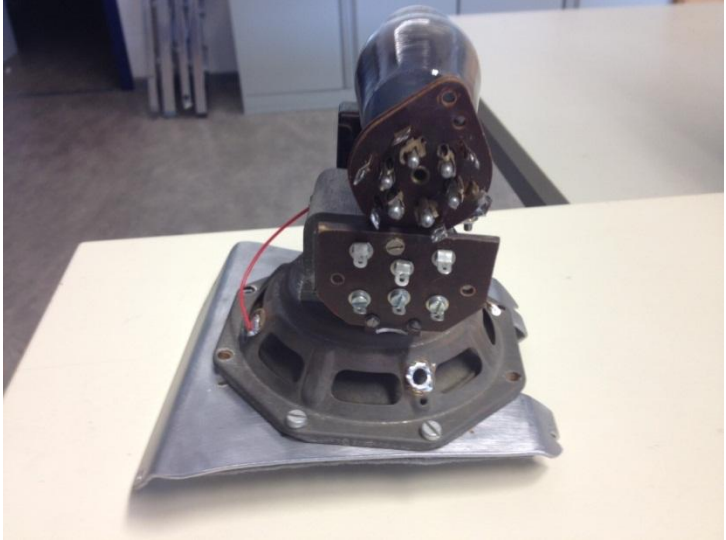
Everything seems to fit.

Ok let's get everything assembled and fitted in and hooked up...

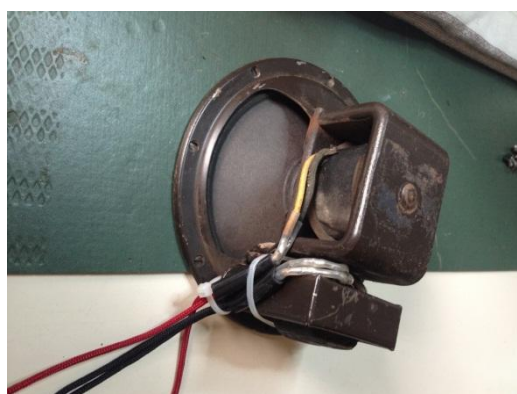
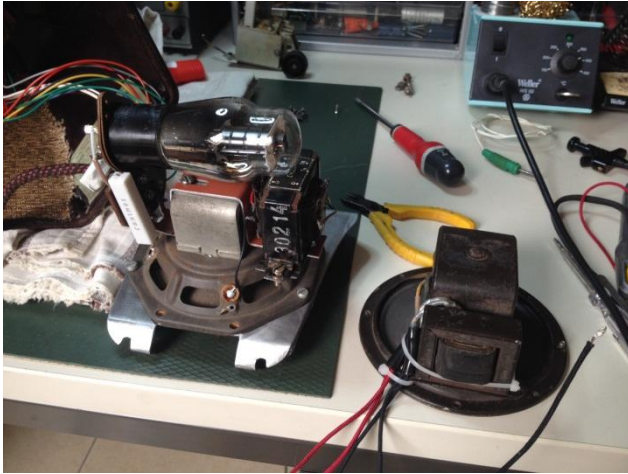
Because of the location (nearly a cage of Faraday) and a lot of TL-lights, we could only receive one station and we also detected a quite high hum. This hum was caused due to the fact I had to use a replacement speaker which did not really meet the specifications. Luckily, I found a suitable replacement that day of a small Emerson radio. This was nearly like the original speaker and had the electrical energized magnetic field.

So when I arrived home, I immediately started to built-in the speaker. It fitted really well and when I turned on the radio the difference was huge. At home I also did not have the reception problem that I had at the remote location, so receiving different radio stations was no problem anymore.

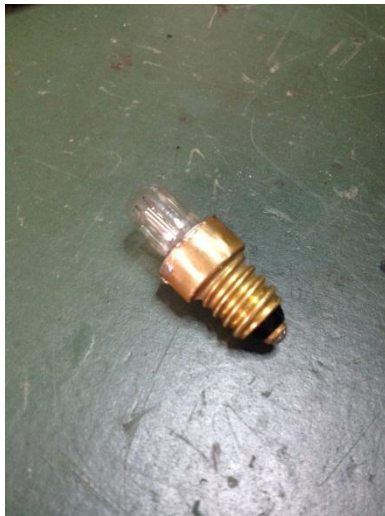
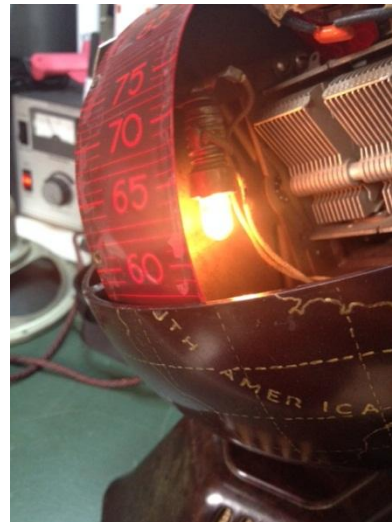
Last but not least, the dial lamp. I did not succeed to source a dial lamp with the appropriate fitting and the 110-130 voltage (Belgium 220V). So I re-used the fitting of the defective lamp and fitted another one on into that. Works fine and gives the right amount of light to illuminate the dial.
