## Erres KY 159

*The restoration of an uncommon radio set*

By Jacques Hermans & Paul Bolt

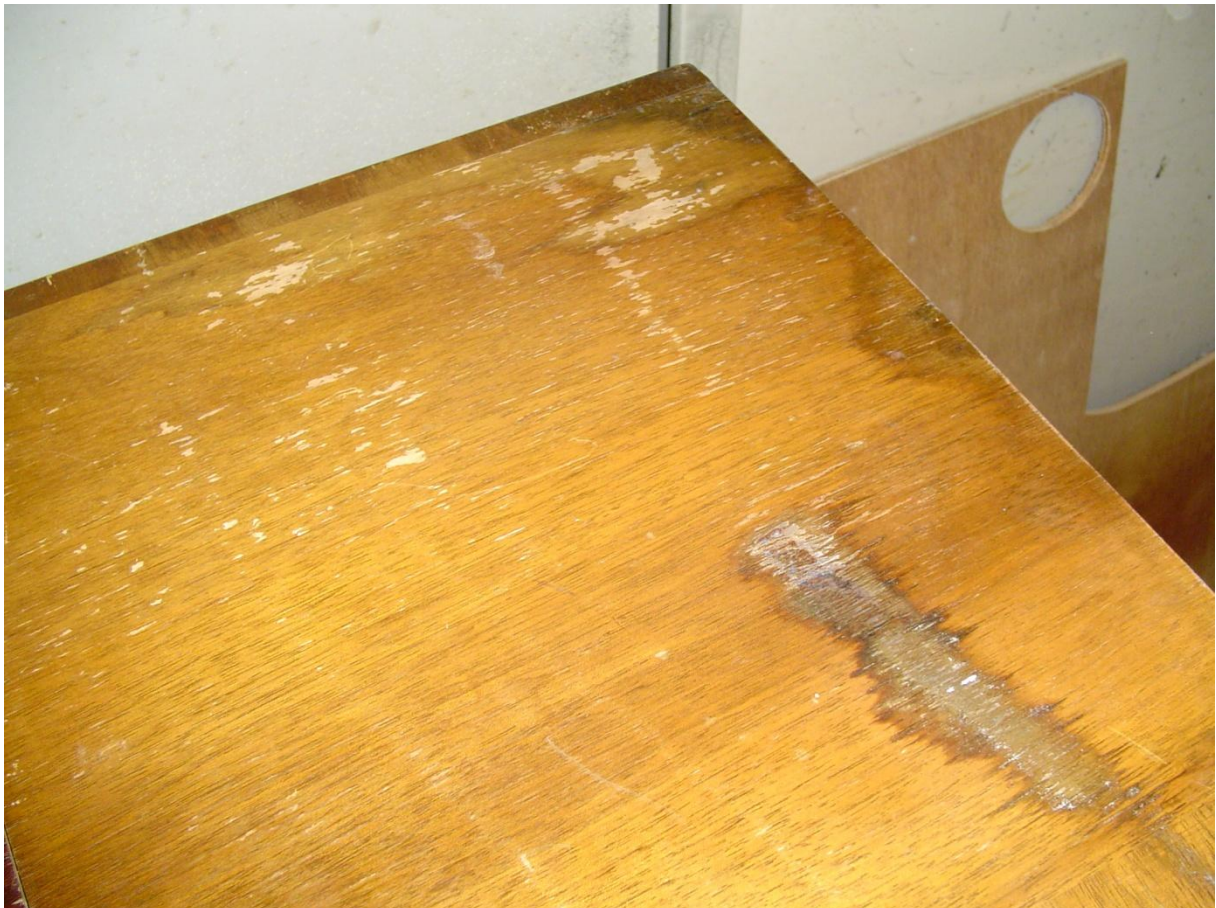
Picture 1.1

The casing looked a lot less flourishing than it looked on the sunny market stand. The damage to and stains on the casing would not give in to basic cleaning and scrubbing. In

some occasions furniture oil can provide a great result, which would make stripping, coloring and varnishing not necessary. Unfortunately this was not the case (picture 1.1).

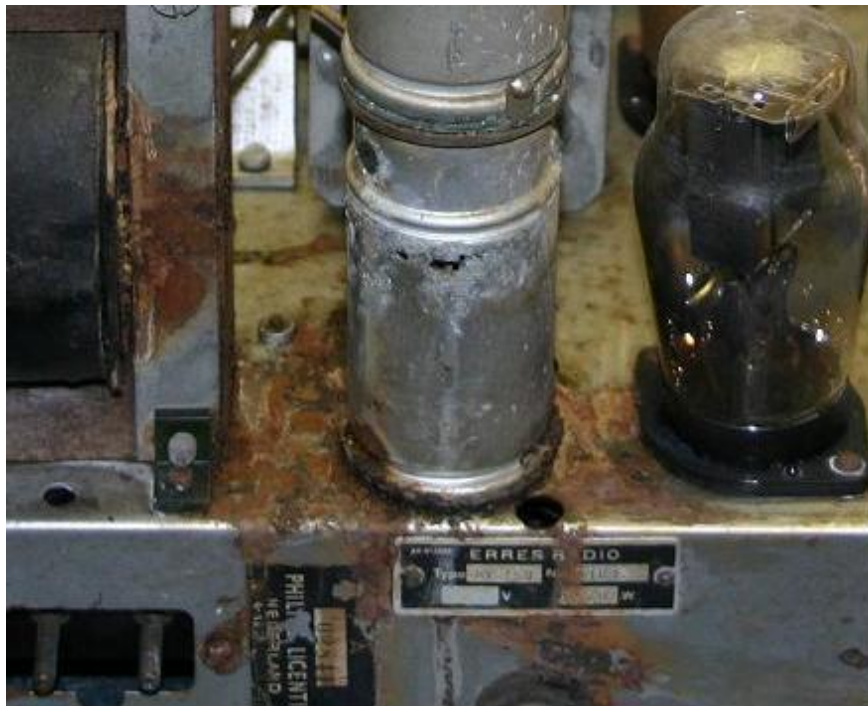
Picture 1.2

A quick look at the interior did not make my heart skip a beat either. The double electrolytic capacitors were filled with holes and heavily damaged by the boron acid. The chassis had the same complications (picture 1.2).

The third electrolytic capacitor had disappeared, the speaker cloth was ripped and the small celluloid glass in front of the station scale had become so opaque that the scale was unreadable. After thoroughly examining the device, many of the tar capacitors appeared have burst or worse. In other words: the ideal candidate for destruction. On the other hand, radio sets in this condition are hard to demolish any further and most adaptations turn out to be an improvement.

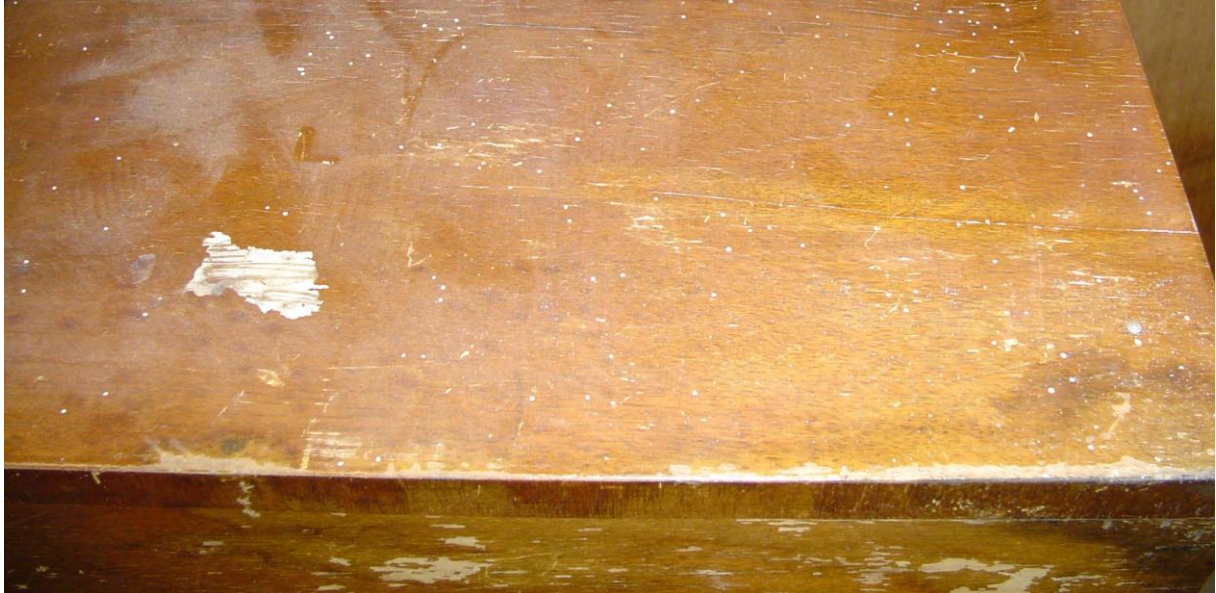
Picture 4.1

With a case that has little to no damage, furniture oil is a great product to get good results. Light scratches and stains become near invisible when treated with this oil. Our casing wasn't just damaged (deep scratches and bald spots), it also appeared to have rested on one of its sides for a long period. One of the sides had a nasty damp stain (picture 1.1). Furthermore, small pieces of veneer were missing (picture 4.1 and 4.2).

In order to make the casing presentable once more, we were forced to strip the casing, remove the damp stain and refill the veneer where possible. This made the work order very clear.

After taking off the casing, it had to be stripped first. The copper ornaments have been taken off together with the speaker shelf and cloth. This was followed by a treatment with stripper, and the old paint layer was removed. We then proceeded properly cleansing and drying both the inside and outside of the casing. Drying the casing afterwards is done to minimize the amount of liquid seeping into the wood, which could potentially disband the veneer or curve the wood.

Removing the damp stain proved to be a difficult task. At first, we tried removing the stain by slight sanding the surface. It is however, important to stop this in time due to veneer's thin body. The stain had apparently seeped into wood to great extent, for sanding did not provide much improvement. The treatment continued with an oxalic acid based cleaner, which provided acceptable results after a few treatments.

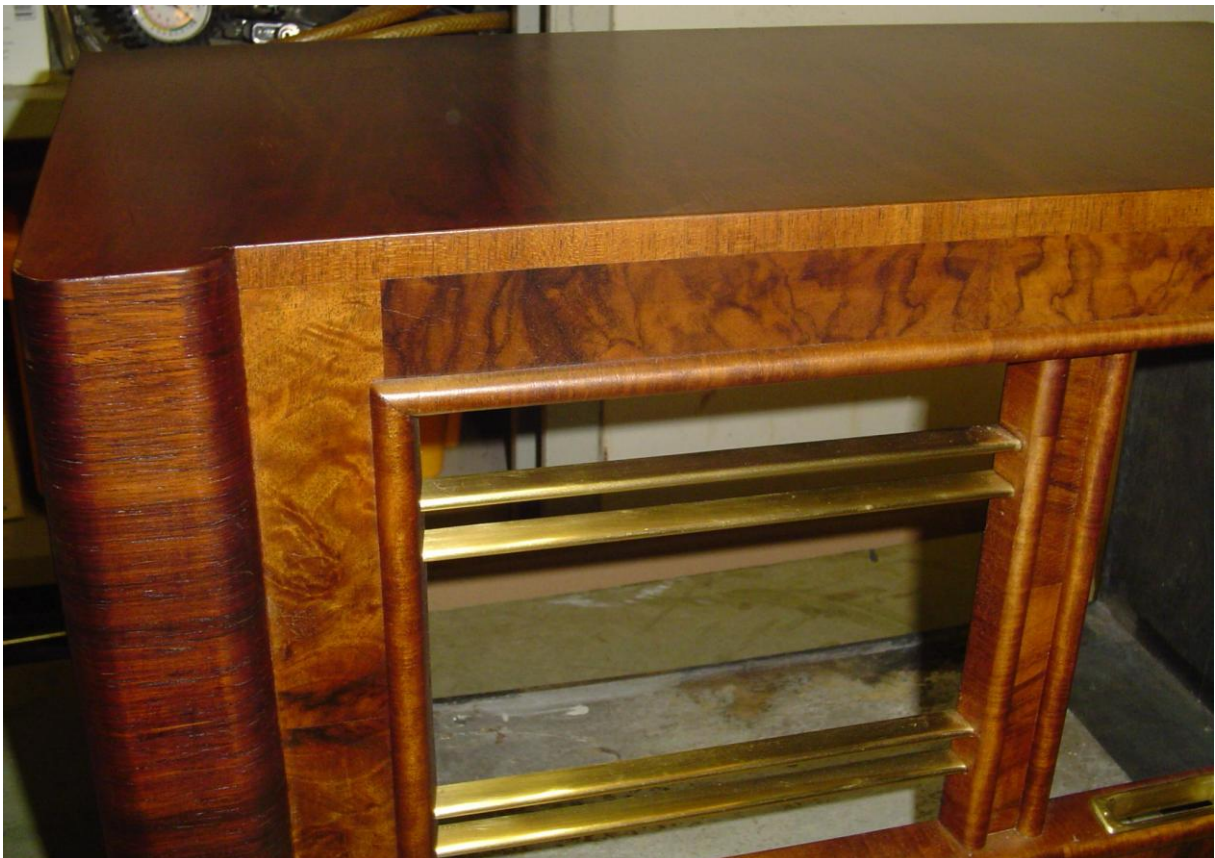
Picture 4.3

Now the casing has to be varnished. The original varnish is often unavailable, but nowadays a wide range of transparent varnishes are available. We used poly-urethane for our casing; the old varnish did not look like high gloss but rather something between high and satin gloss (picture 4.3).

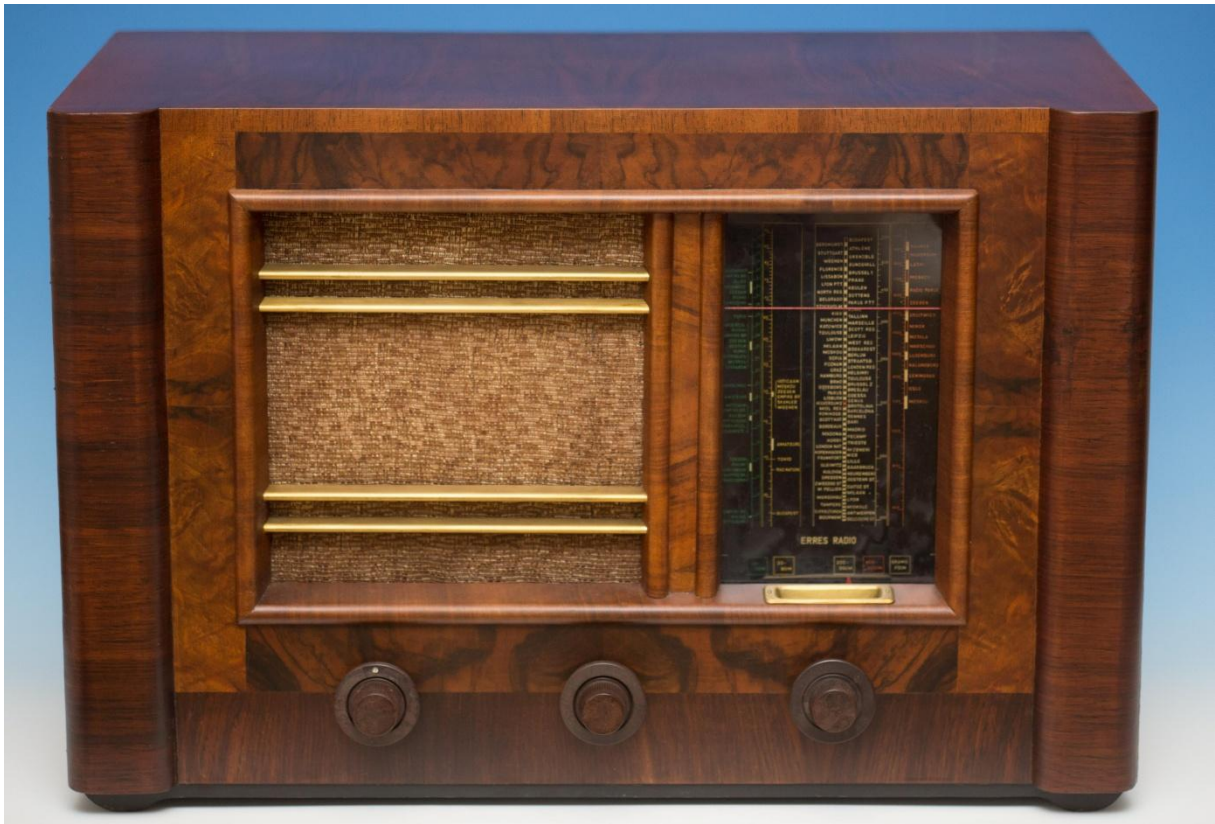
Picture 4.5

The end result (picture 4.5).

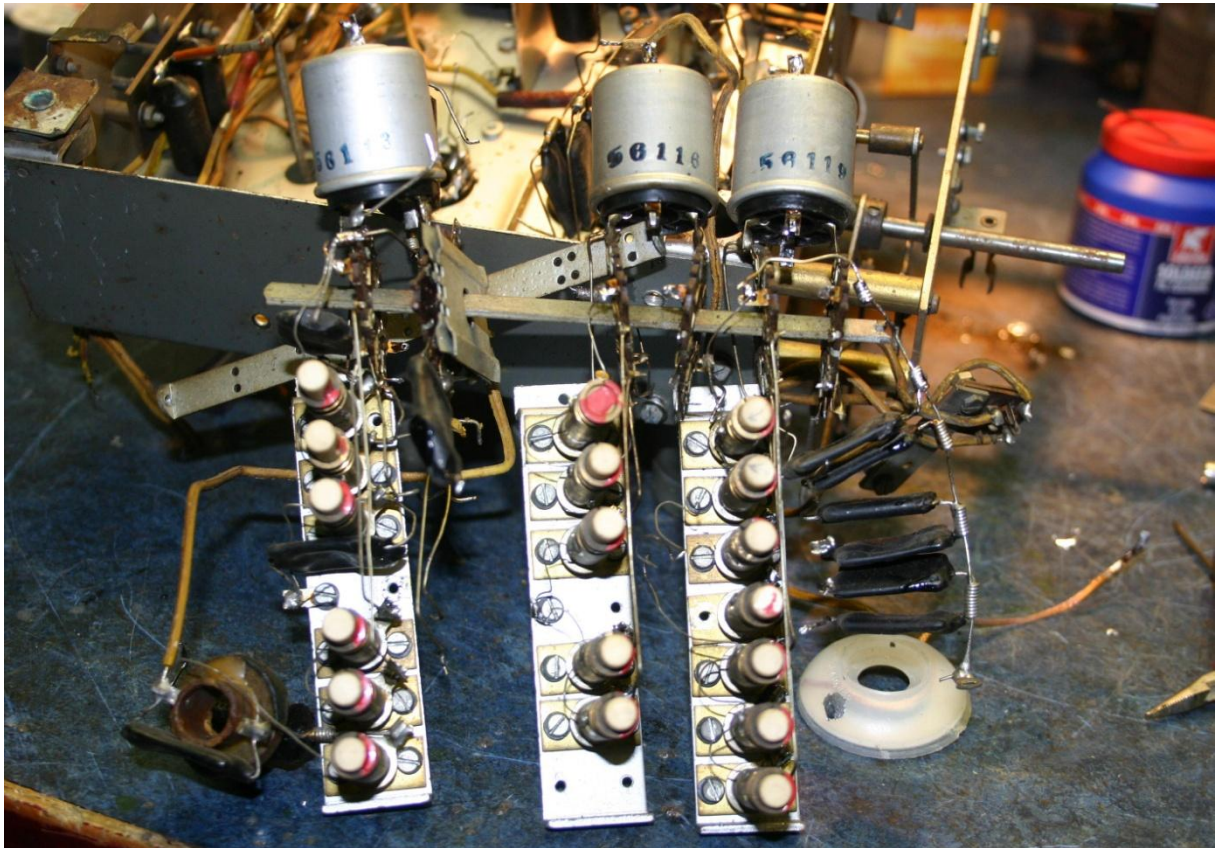
Picture 5.2

Removing the tuning scale was simple, the position of the capacitor disc and the cables were well documented. Subsequently, we demolished as much as possible from the bottom, but with policy of course. The capacitors, trimmers and coils for the short wave (picture 5.2) were easily accessible and we could reasonably leave it together.

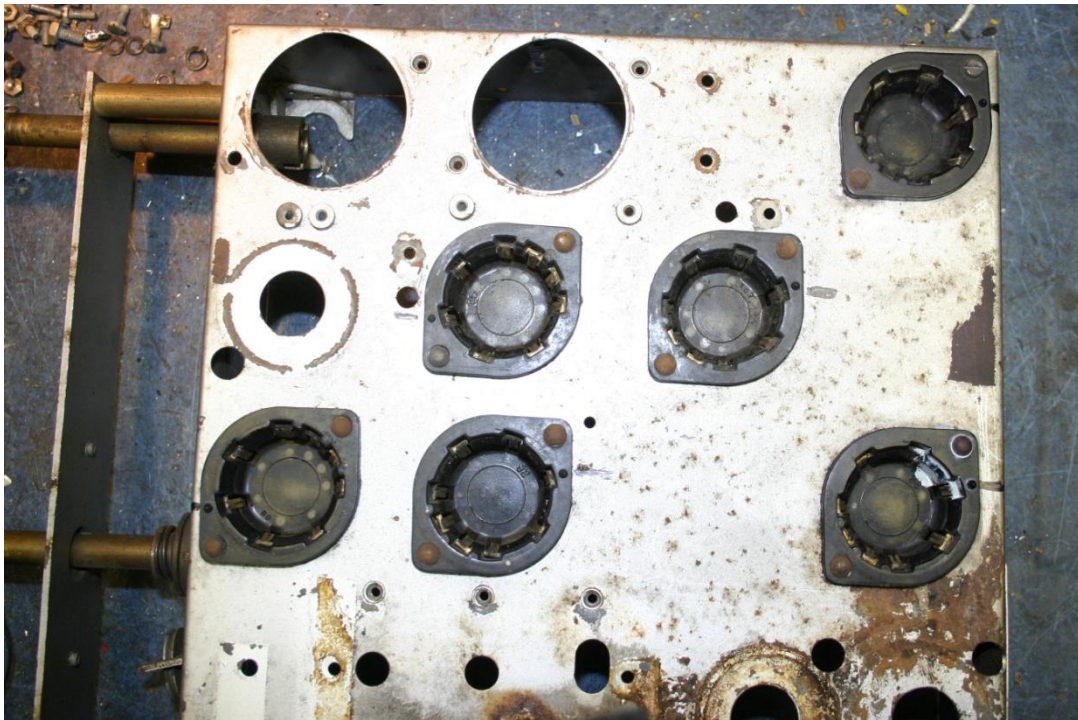
Picture 5.3

This enabled the removal of the other waveband coils. As the device started to become more and more barren at the bottom, we could also remove the necessary parts from the top. The transformer and capacitor were removed followed by the intermediate frequency transformers. Finally the valve feet were removed (picture 5.3).

In many of her pre-war devices Erres did not plate the chassis, but simply treated it with a silver paint. Pictures 5.3 and 6.1 clearly show that the paint has come off on multiple spots. The boron acid damaged the paint even further.

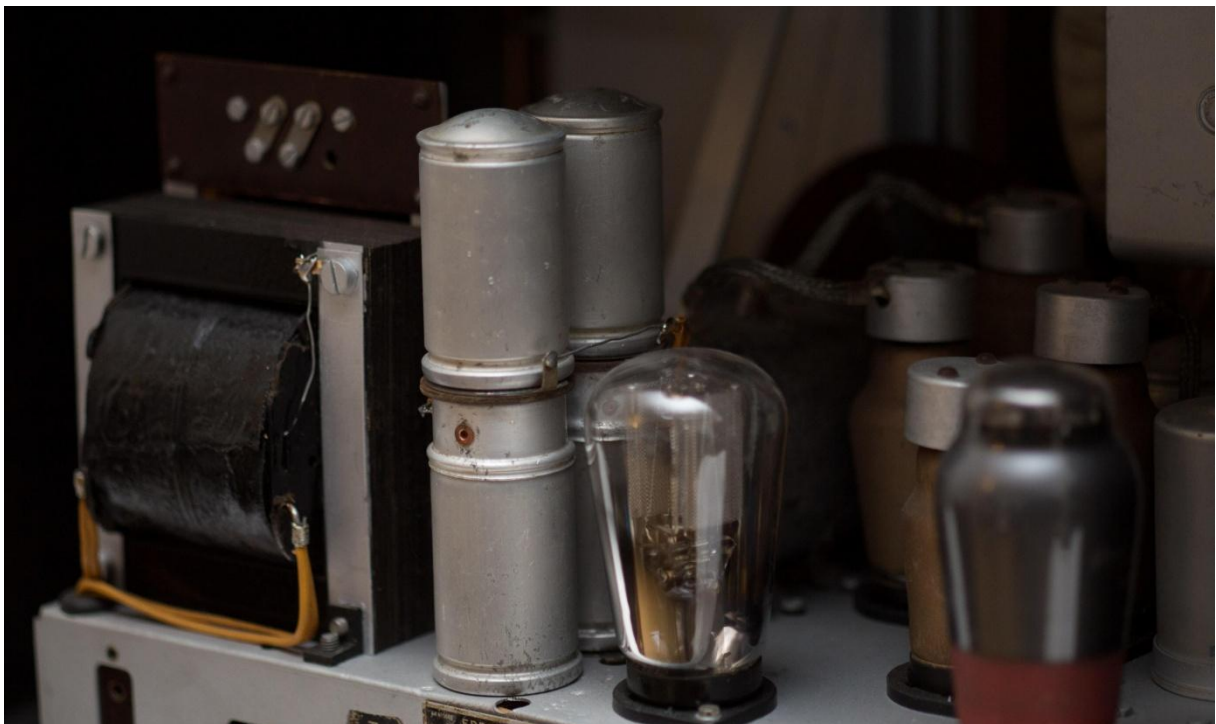
Picture 7.1

The radio set has a number of electrolytic capacitors; the most striking capacitors have to be the two stacked capacitors (picture 7.1).

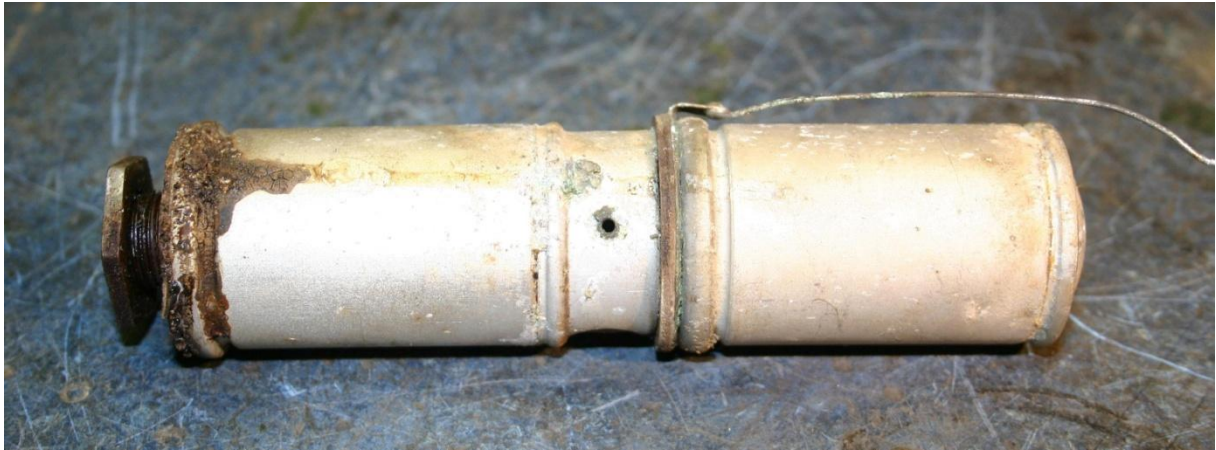
Picture 7.2

These wet electrolytic capacitors don't last a lifetime and have the nasty habit to start leaking boron acid after a certain period. Boron acid is a rather aggressive substance that can cause serious harm to metal parts that lack protection. In this case, not just the chassis was damaged but the electrolytic capacitors also showed damage from this acid (picture 1.2 and 7.2).

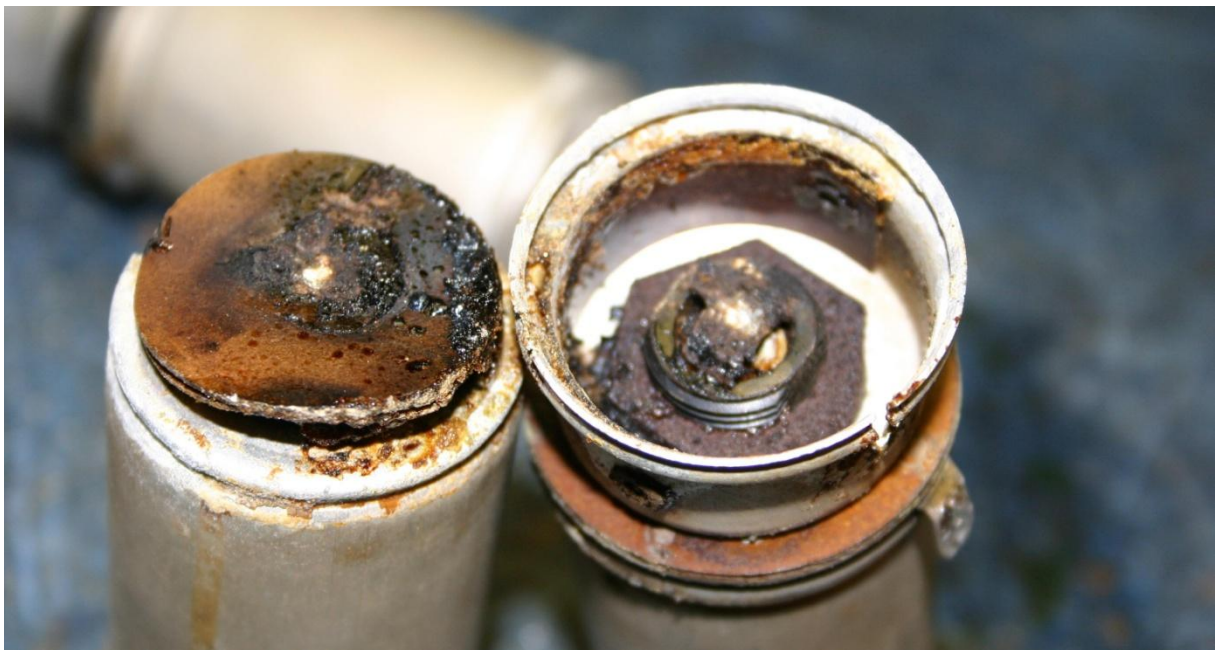
Picture 7.3

Separating the electrolytic capacitors without damaging the small parts between them turned out to be quite the hassle (picture 7.3).

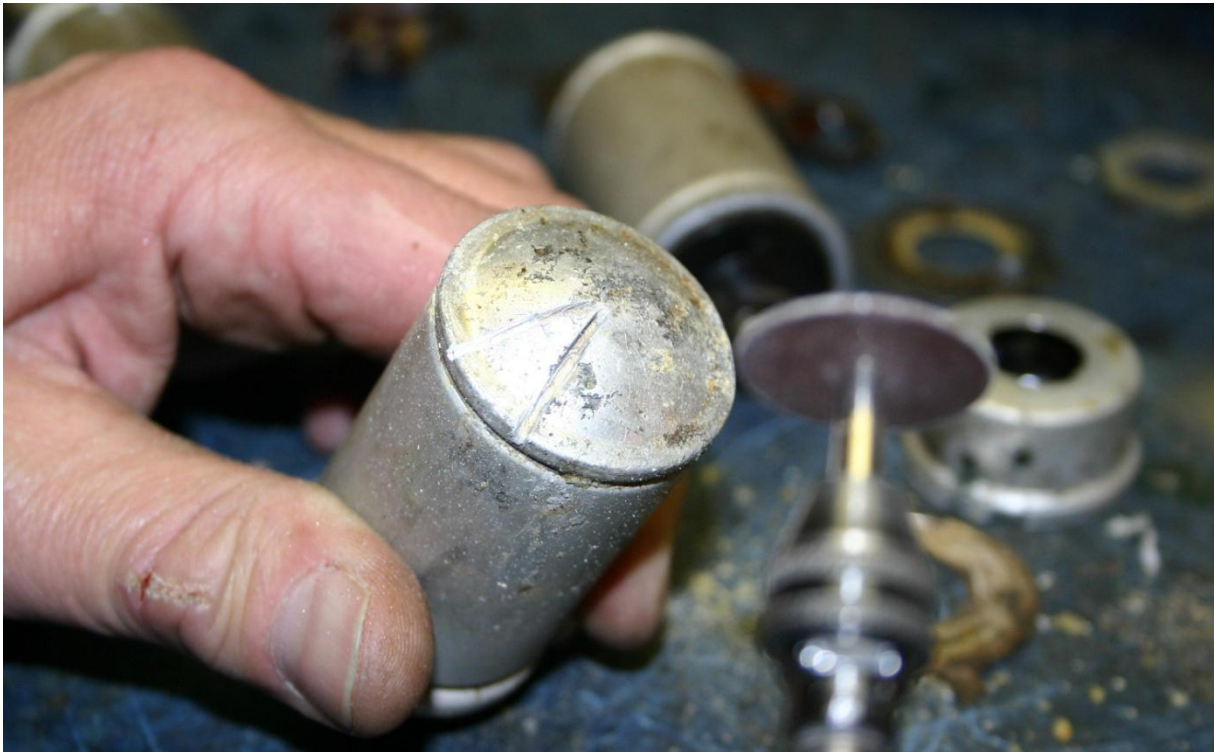
Picture 7.4

We eventually managed to separate the lot without causing visual damage. We did not particularly like what we saw. Both capacitors were damaged to an extent where both of them had to be replaced. One of them was in the bottom position. The replacement had to be "decapitated" first and then emptied in order to place a new capacitor. Removing the hood is best done by using a little grinder to make two incisions (picture 7.4) and bending the aluminium away.

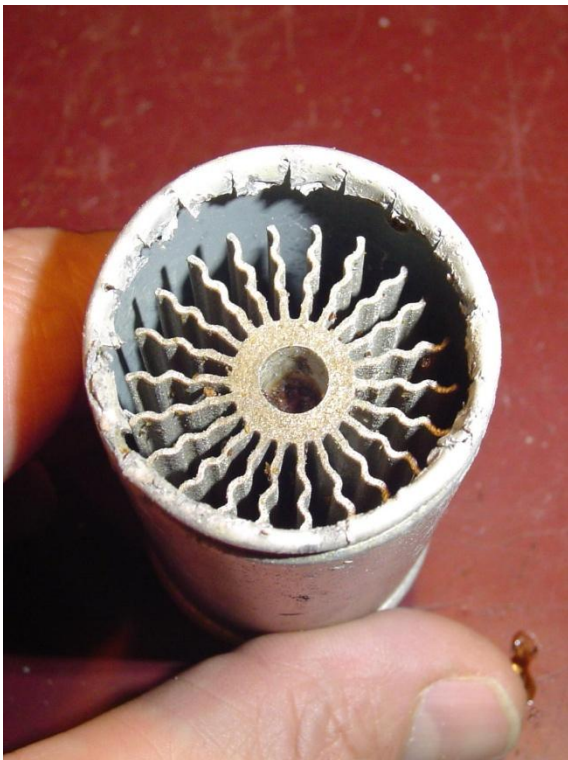
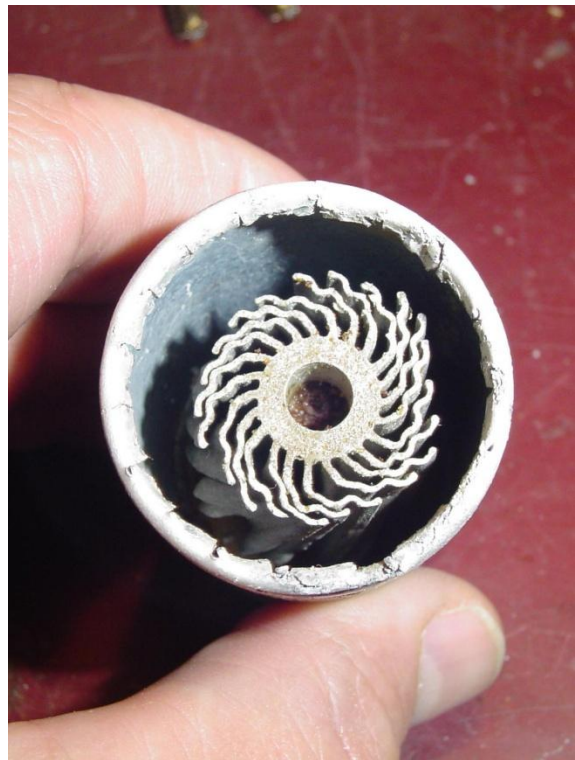
The hood contains wood-pulp to absorb leaking boron acid. This means that the electrolytic capacitor is sealed from the top from the space beneath the hood and that a hole had to be made above the electrolytic capacitor. Then the old content must be removed before a new capacitor can be placed. The star-shaped element first had to be bent before it could be removed (picture 7.5 and 7.6).

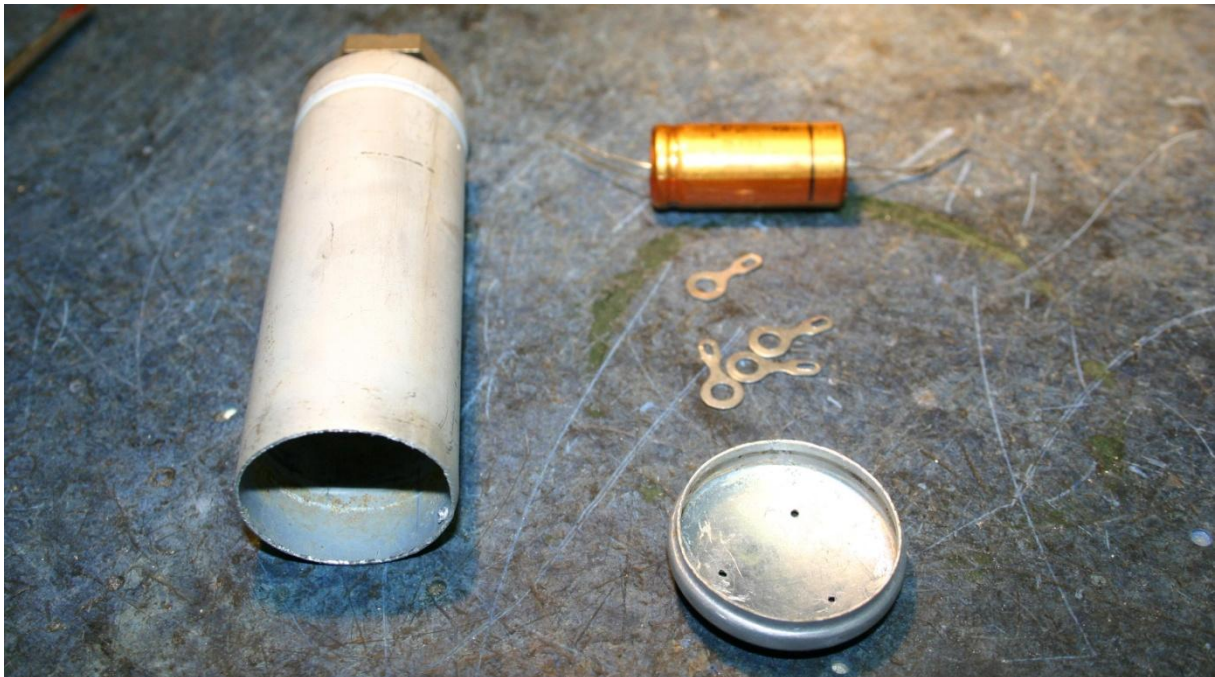
7.8

There are roughly two methods that can be used to replace the content of an electrolytic capacitor. The capacitor can be opened from either top or bottom. Nonetheless, in this case we chose to open it from the top, sawing through the capacitor right under the hood (picture 7.8).

Additionally the inner edge (the sawn-off part) is removed from the hood and, after placing the new capacitor, the hood is glued back on the capacitor. One advantage is that

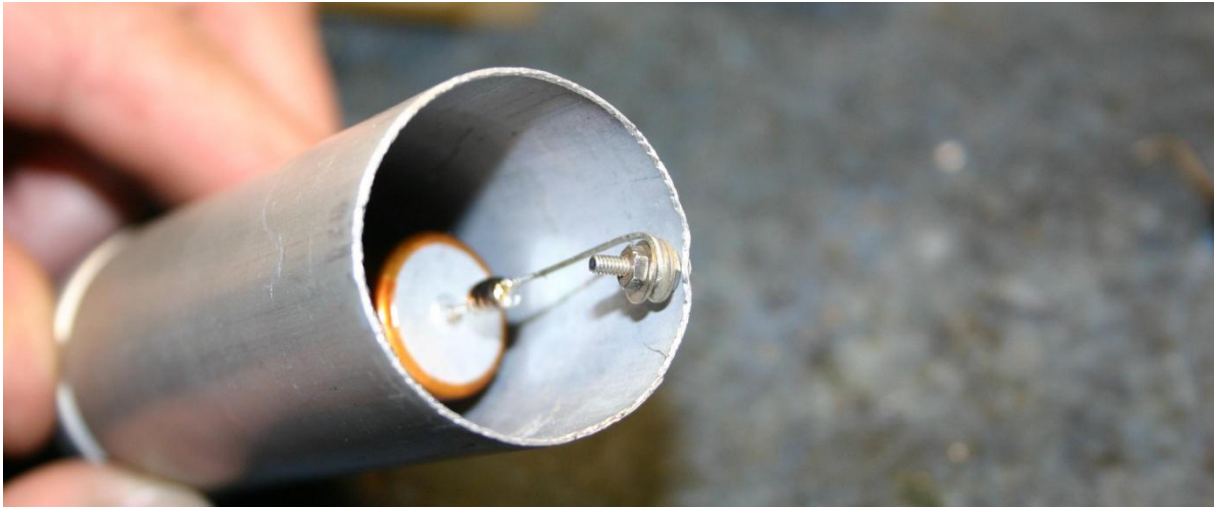
Picture 7.9

the mass of the new capacitor can be attached to the casing by a screw and nut (picture 7.9), so that there will always be a good connection.

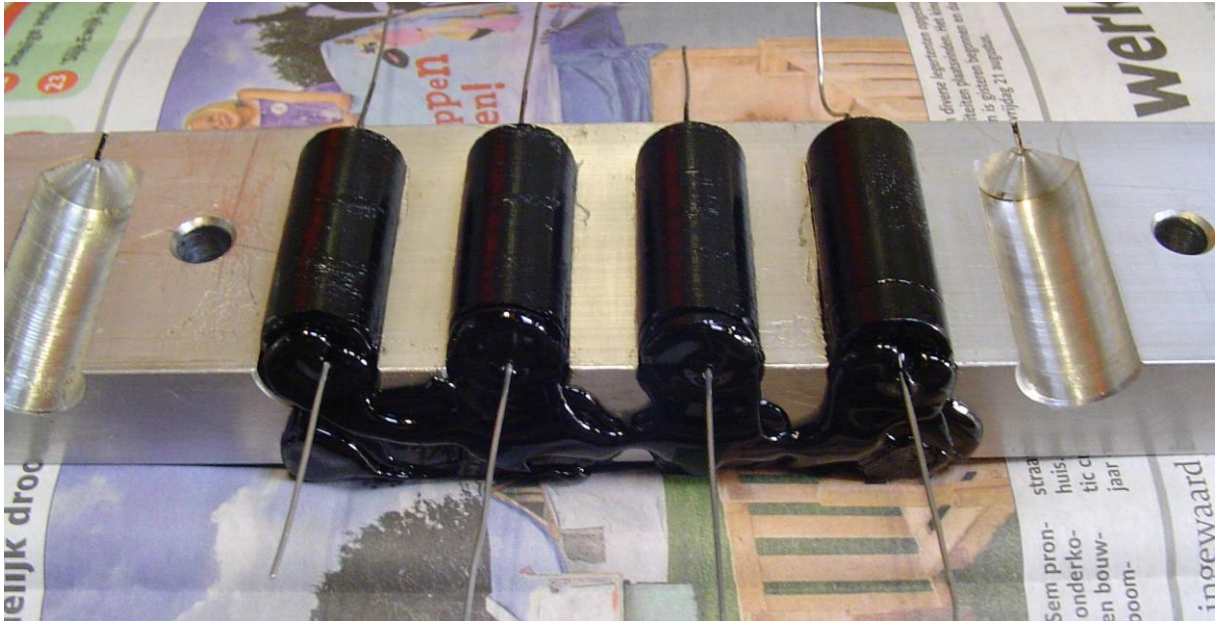
Picture 8.3

After cooling off, the two halves will be taken apart and the castings can be taken from the mould (picture 8.3).

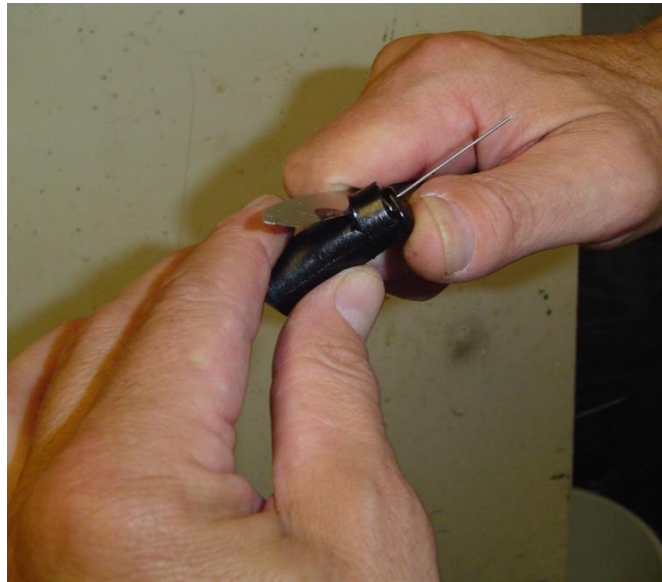
The bottom of the new tar capacitor already has the right shape, but has yet to receive the top. First the unnecessary part of bitumen is cut off, as much in the right cone shape as possible (pictures 8.4 and 8.5).

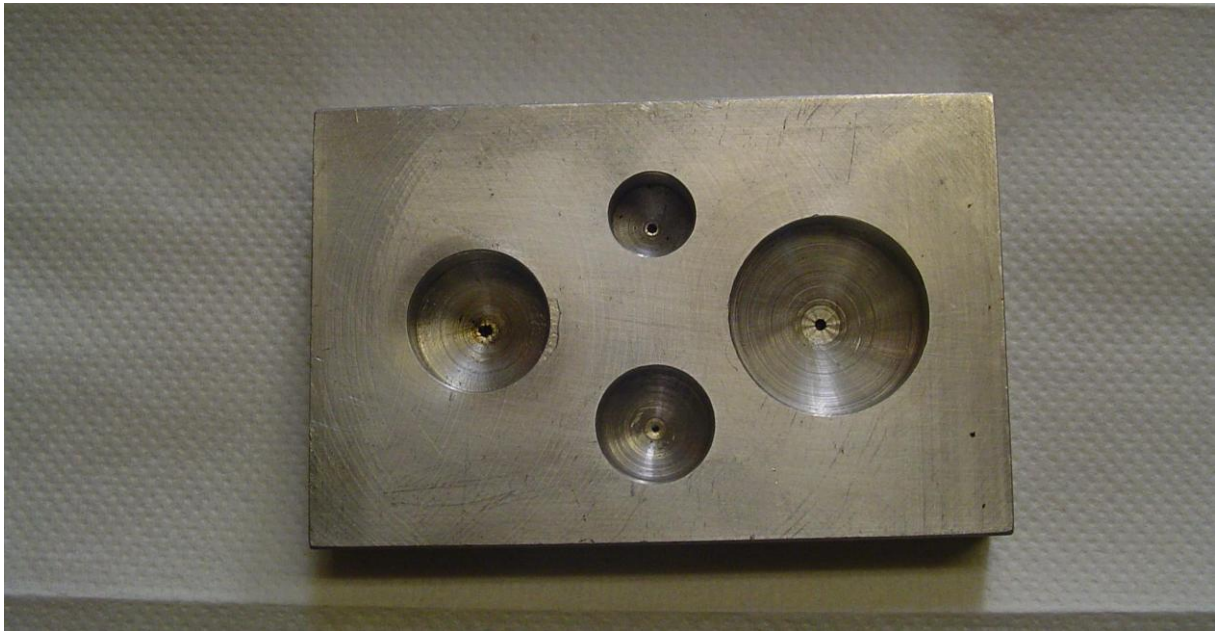
Picture 8.6

Then the end will be reheated and with a special mould (picture 8.6).

The top of the tar capacitor will be turned in the right shape. After this, most of the time an edge remains that needs to be removed. Because the bitumen is still soft the edge can be easily removed by powerfully rolling the capacitor between two slices of wood. Bitumen has the characteristic of being sticky for a long time, especially when it's warmer. To solve that problem they are sprayed with clear lacquer, preferably satin or matt, as gloss doesn't give a nice effect (picture 8.7).

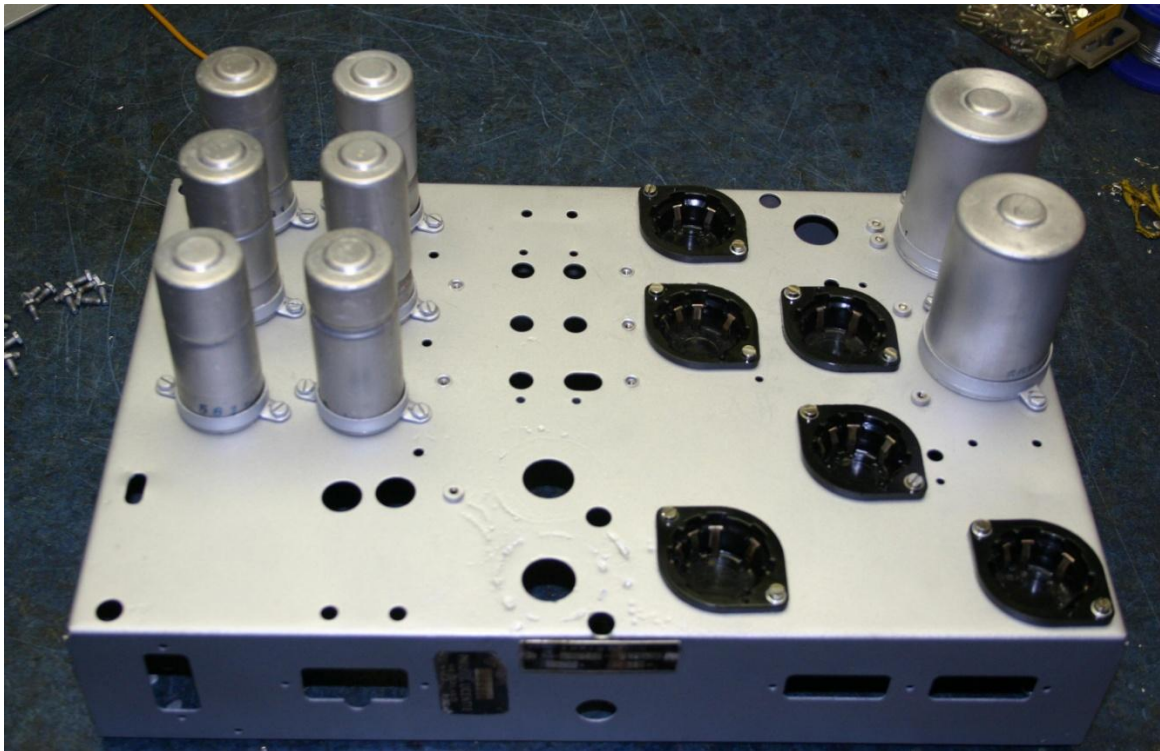
Picture 9.2

First we replaced the coils, together with the valve holders and the entrances (picture 9.2).

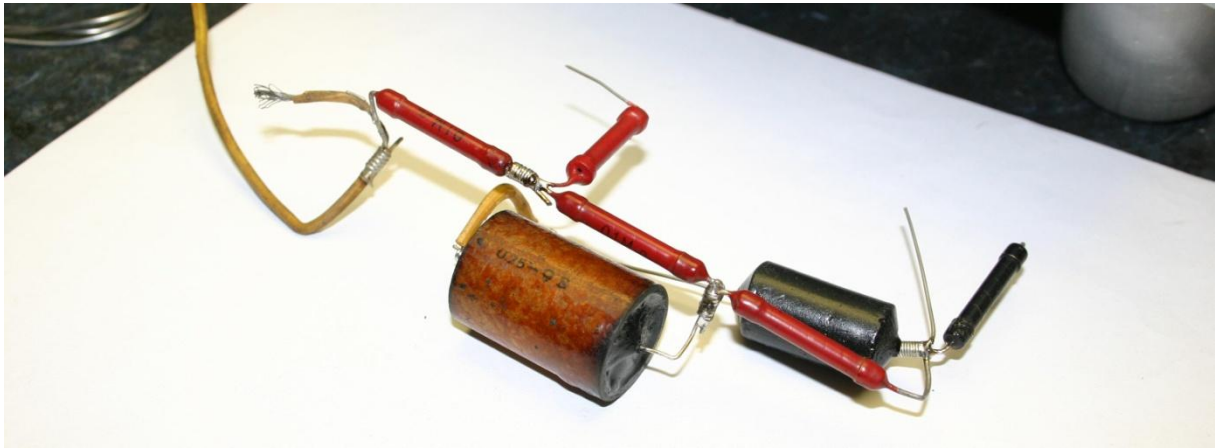
Picture 9.3

Then the first connections were made. Where possible we left the connection wires attached to the parts and we also left the parts itself attached as much as possible. This seemed to be quite handy during the build-up, because we could be assured that the set of parts was placed back correctly (picture 9.3).

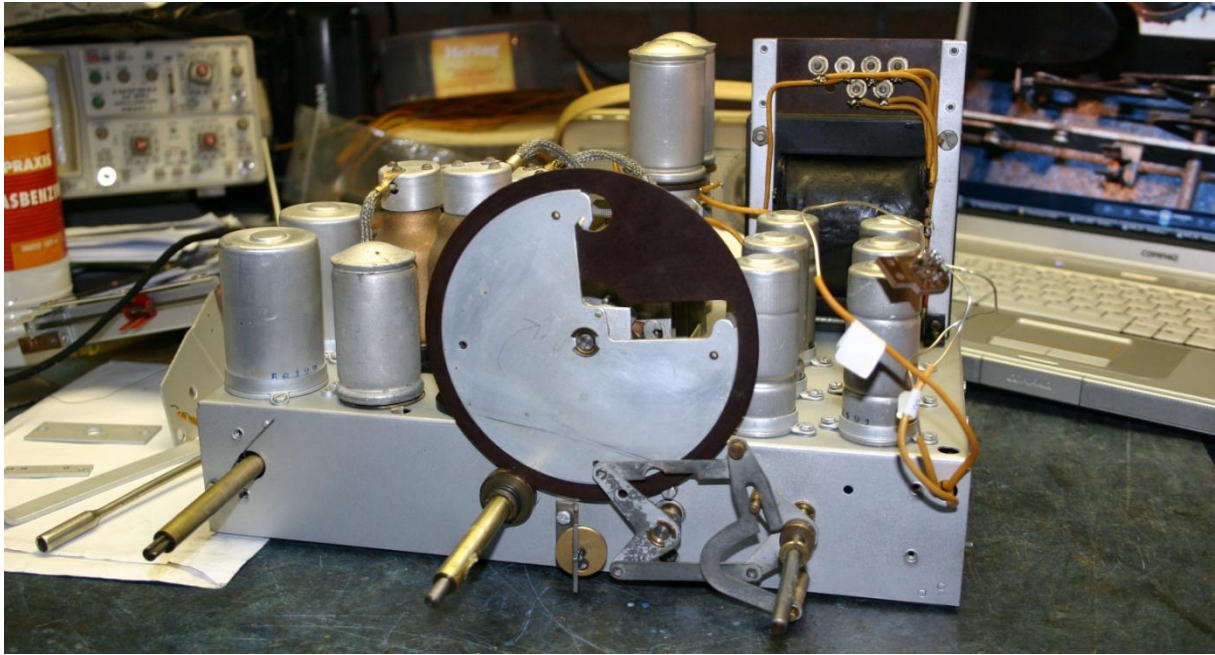
Picture 9.7

Before the channel scale of the chassis was removed we carefully drew down the run of the scale strings, as well as the turntable with respect to the tuning capacitor (picture 9.7).

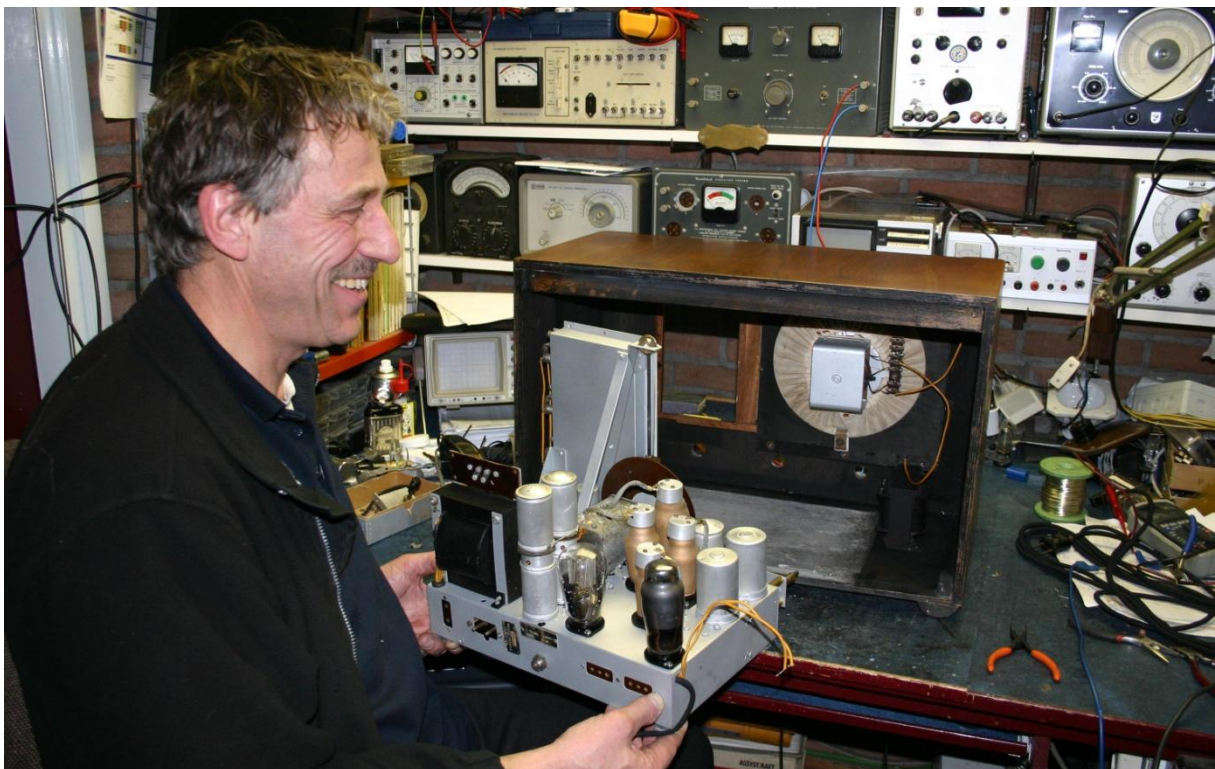
Picture 10.2 (Paul Bolt)

The third problem involved the inability to turn the volume to zero. Even in the lowest position the windows were shaking. A quick measurement with the volume potentiometer revealed that even in the lowest position, the resistance was still 16 k $\Omega$ . We decided to take out the potentiometer and replace it with a new resistor disk. On the lowest position, the resistance remained high; it was still at 12 k $\Omega$ . There was nothing we could do mechanically, but the small carbon resistor disk solved the problem after slightly twisting it, so a solid 100  $\Omega$  of resistance remained. After the potentiometer was reset the volume turned out to be perfectly tuneable from high to low. On the 30<sup>th</sup> of December 2009 the chassis was put back into the casing and the restoration was completed (picture 10.2).
