## Restoration of a Silvertone Model 4766 – SPARC Radio Museum, Coquitlam BC, 2013/2014 – Gerry O'Hara

### Introduction

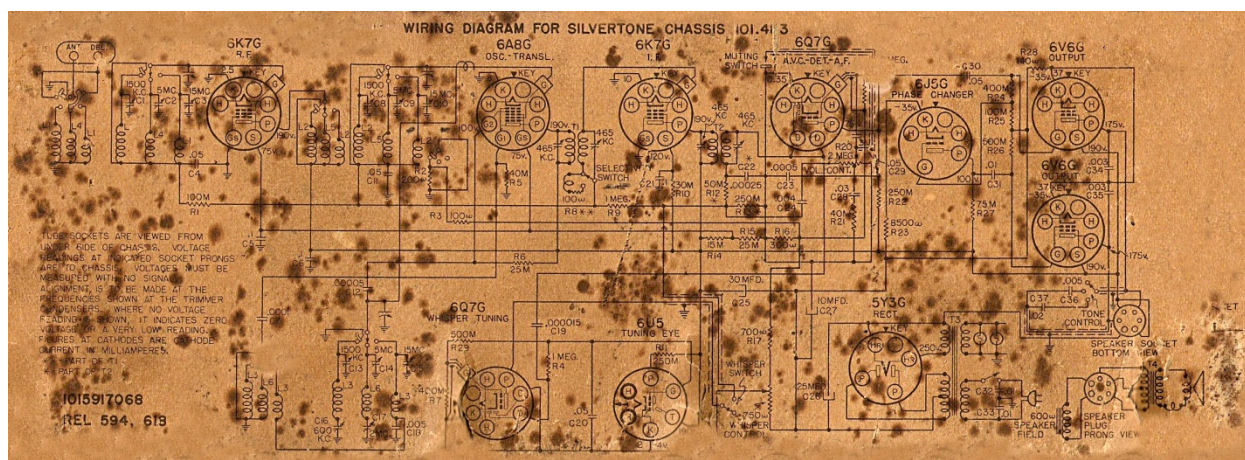
The chassis is quite compact for a ten tube design (chassis label with schematic above), although under the chassis is still quite accessible. The tuned circuits are well-screened and access for alignment is through a metal cover plate with a label attached identifying which trimmer is which. The RF, IF and AF tubes are arranged logically around the coilpack, with the power supply components off to one side. Power supply filtering is by two large above-chassis mounted 500 volt

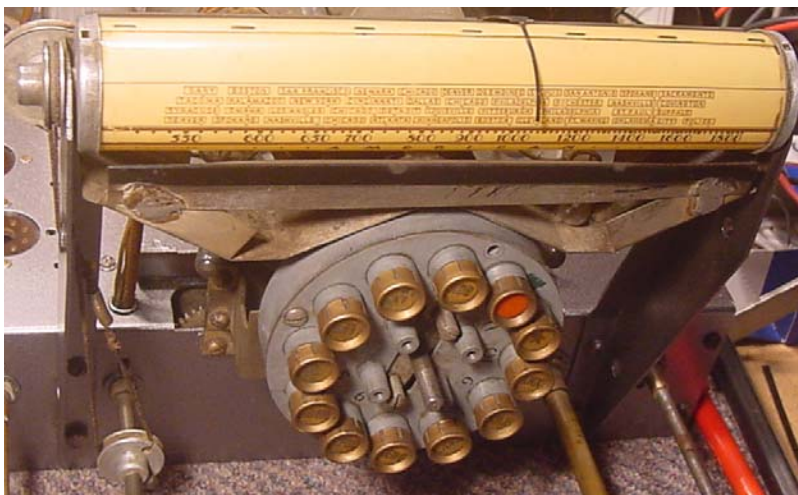
The tuning mechanism is fairly complex, having separate dial cords for the wavechange switch and pointer, together with a ‘telephone dial’ form of station pre-set (‘Automatic Tuning Dial’) – photo above. The instructions for setting-up, operating and servicing the latter take a full three pages in the available literature, complete with 23 diagrams! – and we thought Video Cassette Recorder (VCR) instruction of the 1970’s and 1980’s were complicated... (thank Heaven for PVRs, Netflix and YouTube...).

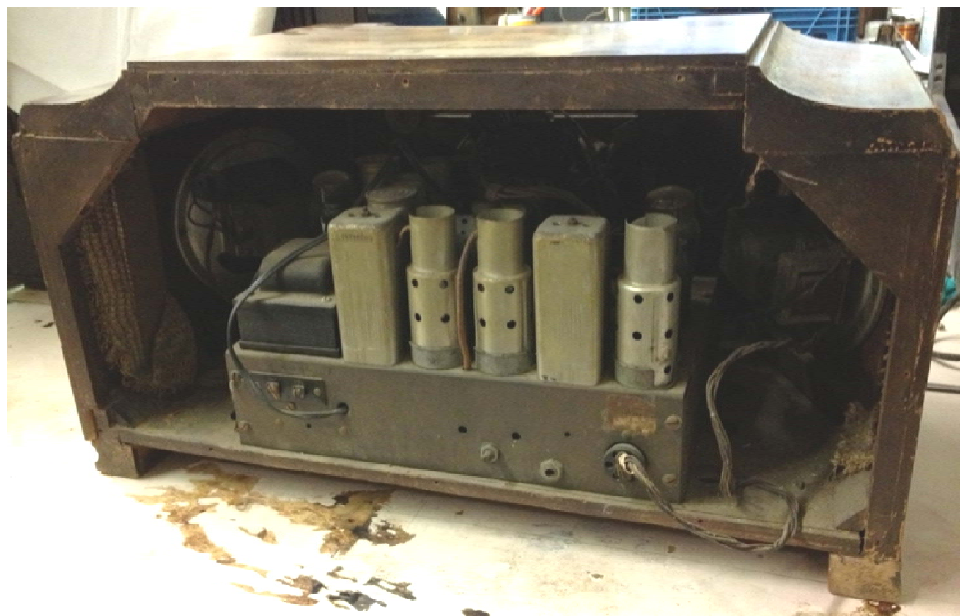
The as-found condition of the set would not really do the above 'flannel' justice – in short, it was a wreck: the seams were literally falling apart, most of the speaker aperture ribs were broken, speaker cloth ripped and the finish in a very poor condition.

The plastic tuning dial

escutcheon was warped and broken into several pieces. The rear plywood cover was missing, and inside was filthy, the chassis rusted and the dial cord wrapped around everything it should

not be (due to a missing pulley – luckily recovered from under the chassis. On the positive side, all tubes were present, as were the tube shields and few, if any, repairs had ever been done over the years as all under-chassis components looked original (photo, right).

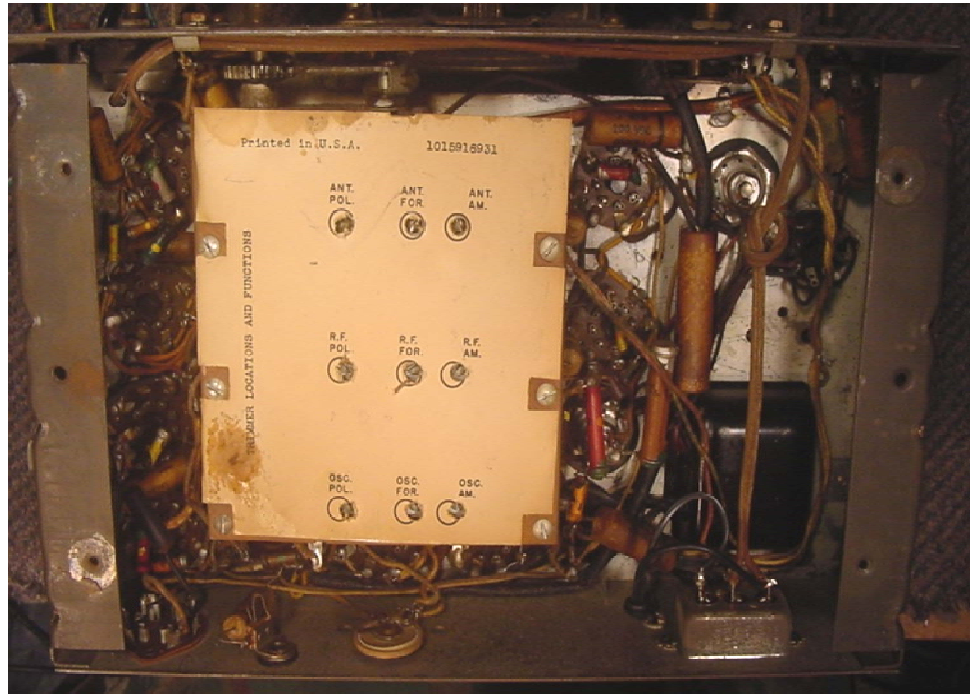
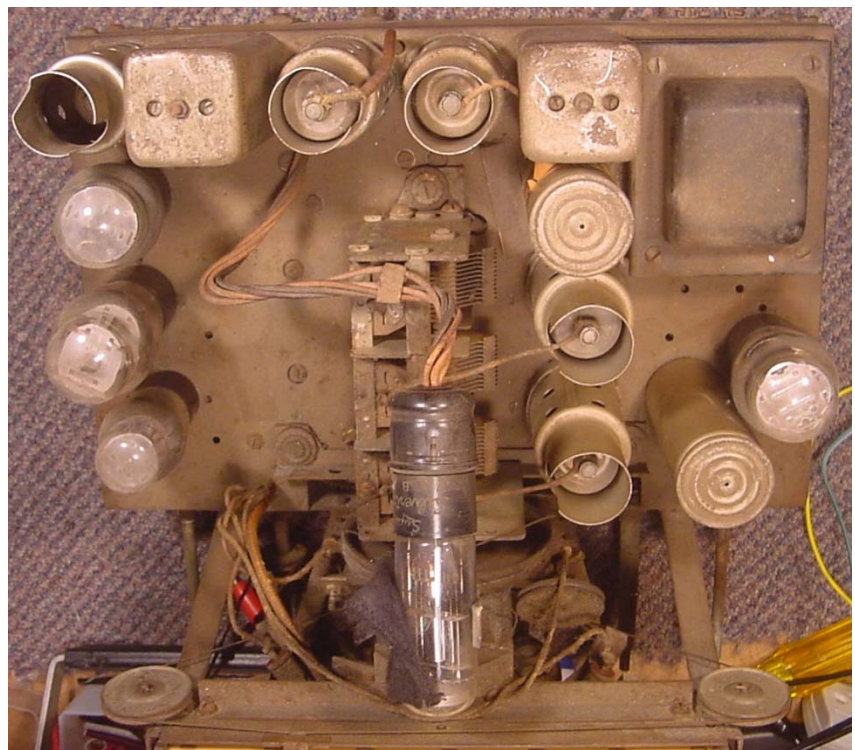
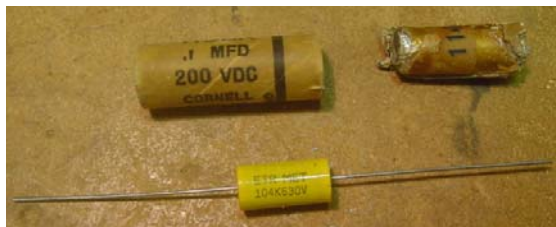
transformation to something close to its original appearance. The tuning gang was carefully cleaned, re-lubricated and new rubber mounts installed (combination of tap washers and grommets). All paper capacitors were removed one at a time, the cases cleaned and re-stuffed

with modern parts (photo, above), as was the single tubular electrolytic located beneath the chassis (large tube at upper right of photo, right). The two large above-chassis mounted can electrolytics were also re-stuffed (photos, page 8) and reproduction labels fitted. The majority of the dogbone-style resistors had drifted significantly out of tolerance, so all were removed and reproductions were made by using a fibre glass fishing rod as a housing with wire-wrap/epoxy built-up ends (larger styles – photo, below, left), or using two-watt metal film resistors with their ends beefed-up with dental super-glue or epoxy before painting in the original colours (photo, below, right). A reproduction label was also made for the coilpack screening lid, and the two labels on the chassis sides were re-made using cleaned-up photos of the same labels on the Museum's Model 4766 as these were discoloured to the point of illegibility.

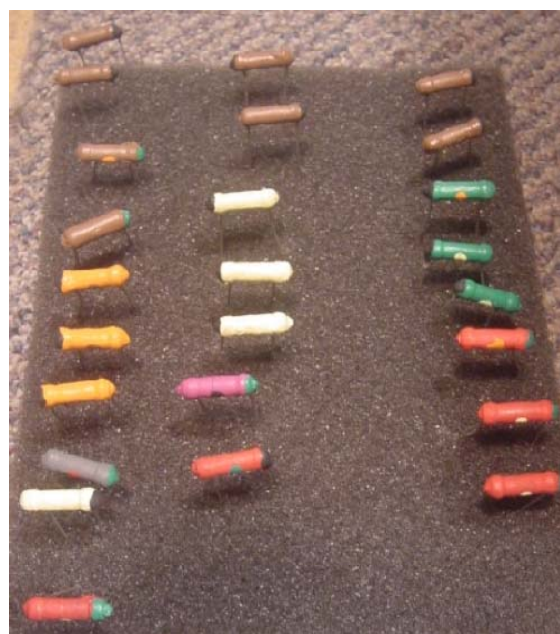
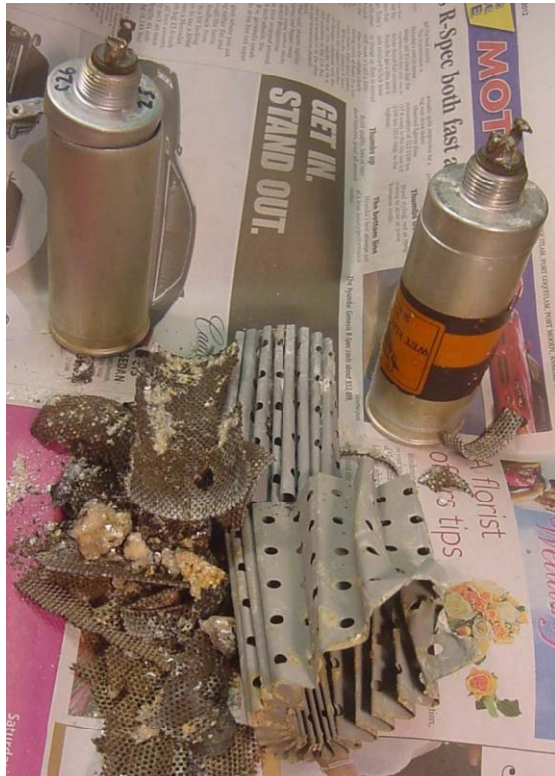
The tubes were cleaned and tested. The 6U5 eye tube was working, but very weak, so was replaced with a NOS tube, along with a 6K7G, the 6A8G and a 6Q7G, the latter found to have a heater to cathode short.

powered-up for testing. The power transformer had previously been tested for continuity, so the rectifier tube (5Y3G) was installed (all other tubes removed) and the line voltage wound up on a Variac, monitoring the HT voltage line. All was found to be well, so the remaining tubes were installed and the set powered-up again on full line voltage. The two short wave bands came up immediately, but the 'American' (Standard Broadcast) band was dead. Checks revealed that the local oscillator was not working on this band. I suspected the wavechange switch, but after copious careful contact cleaning with Q-Tips and Deoxit and more checks, the fault was traced to an

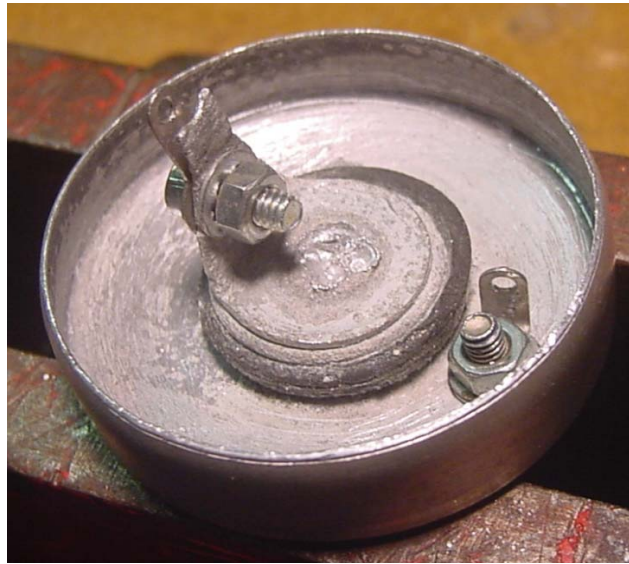
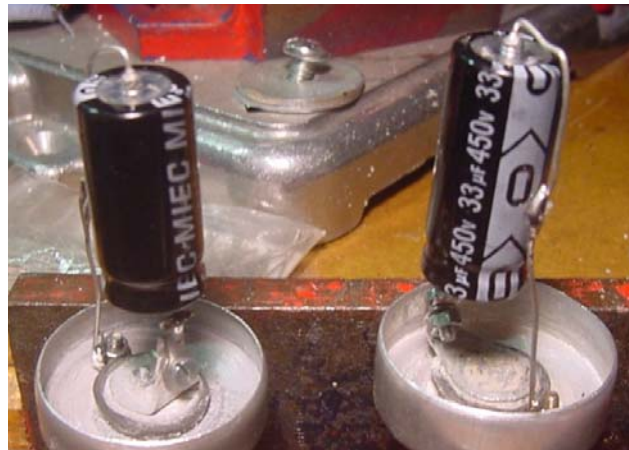
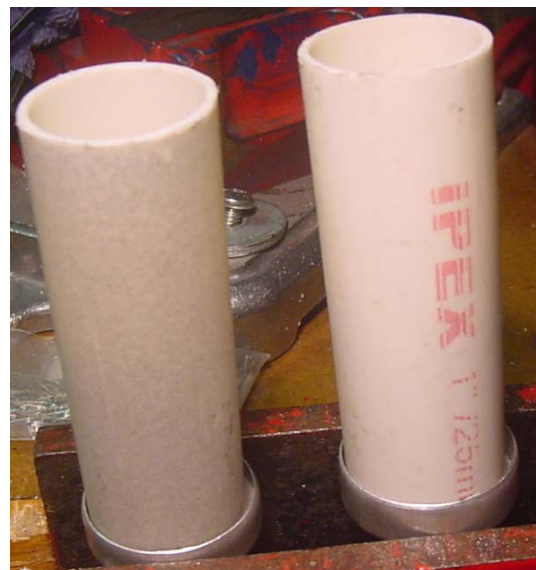
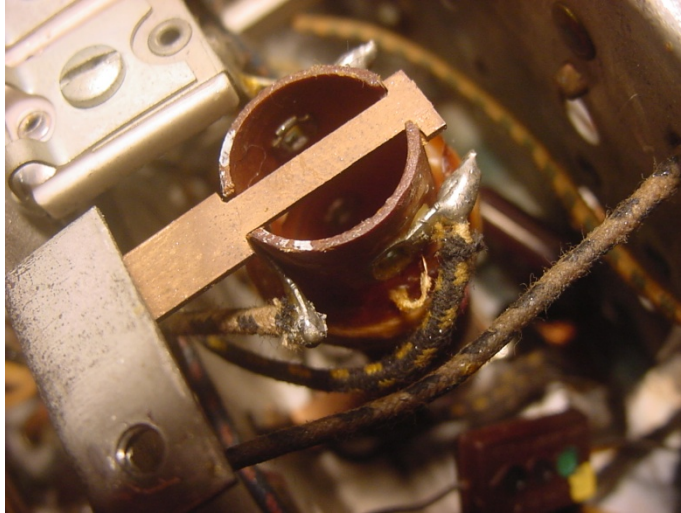
open-circuit local oscillator feedback coil (photos, left). This had to be removed from the set for repair – luckily the feedback coil secondary winding is not tuned, and tapping into the coil to a point where continuity was found worked like a charm – up came the ‘American’ band. By this time the reproduction dog-bone resistors were available and installed. The set was then re-aligned and found to be working very well across its entire tuning range, with very good sensitivity, though with some scratchiness in operating the controls.

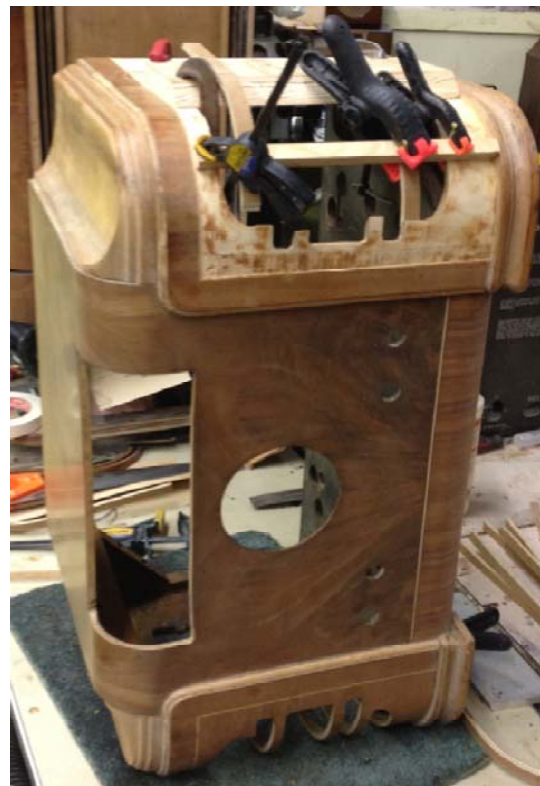
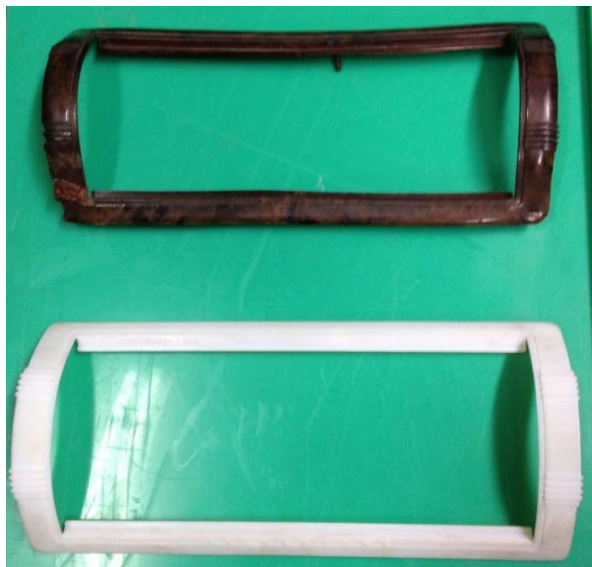
The plastic escutcheon on the Museum’s Model 4766 was removed and scanned in a 3-D scanner (although also warped and damaged, it was in better

shape than the one on the set being restored). After some (software) manipulation to remove warping and other defects in the scanned image, the escutcheon was reproduced in plastic on a 3-D printer. The printed escutcheon (bottom in photo, left) was then finished using high-build primer,

carefully sanded, and spray painted to reproduce the original escutcheon colouring.

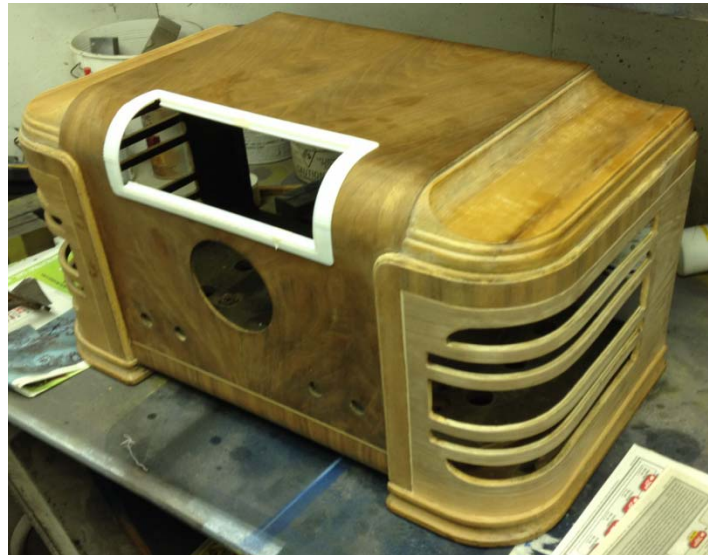
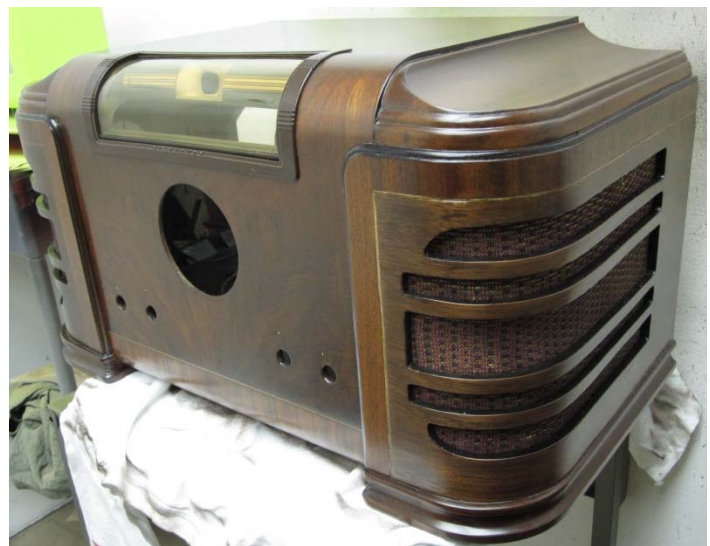
Above: Reproduction rear panel (prototype from the SPARC museum top, reproduction panel below). Below: reproduction panel fitted to the set

This model is fitted with a plywood rear panel with a complex arrangement of cut-outs, as evidenced by the museums example. This was missing from the set being restored, so the rear panel off the museum's set was used as a template to fabricate a replacement, complete with reproduction label.

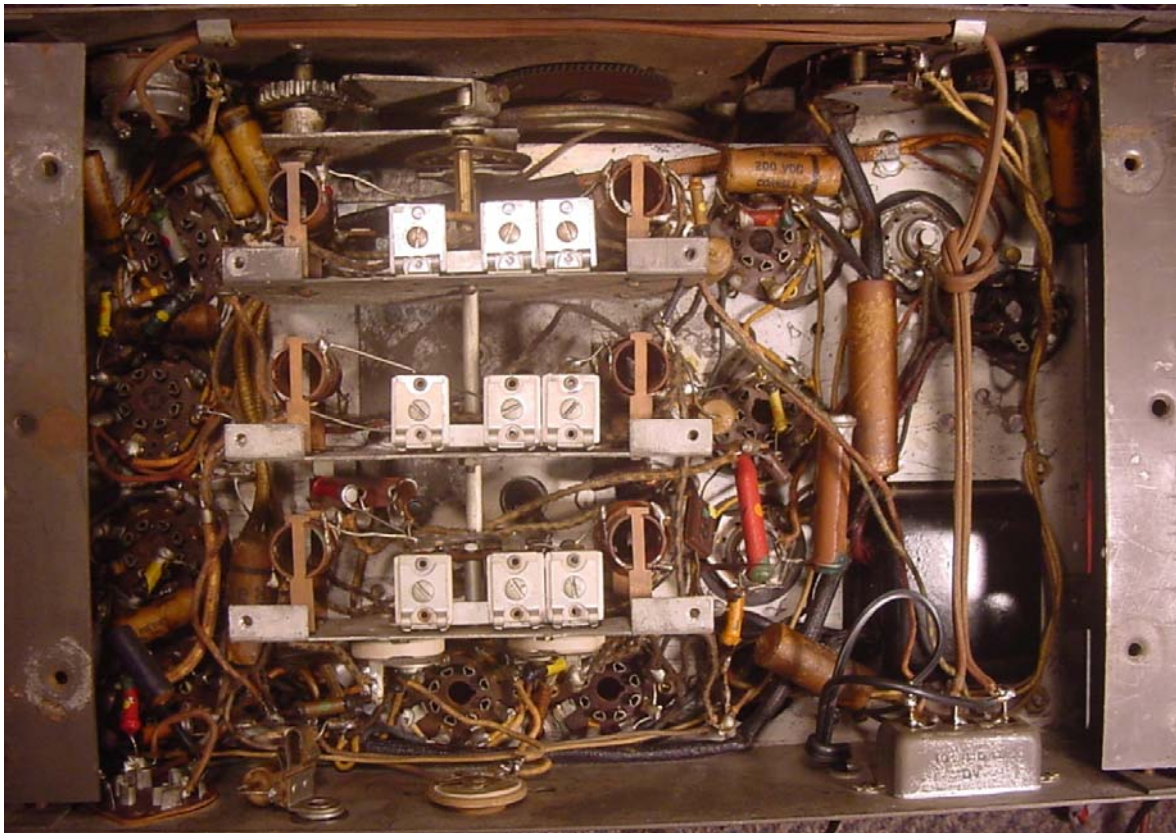
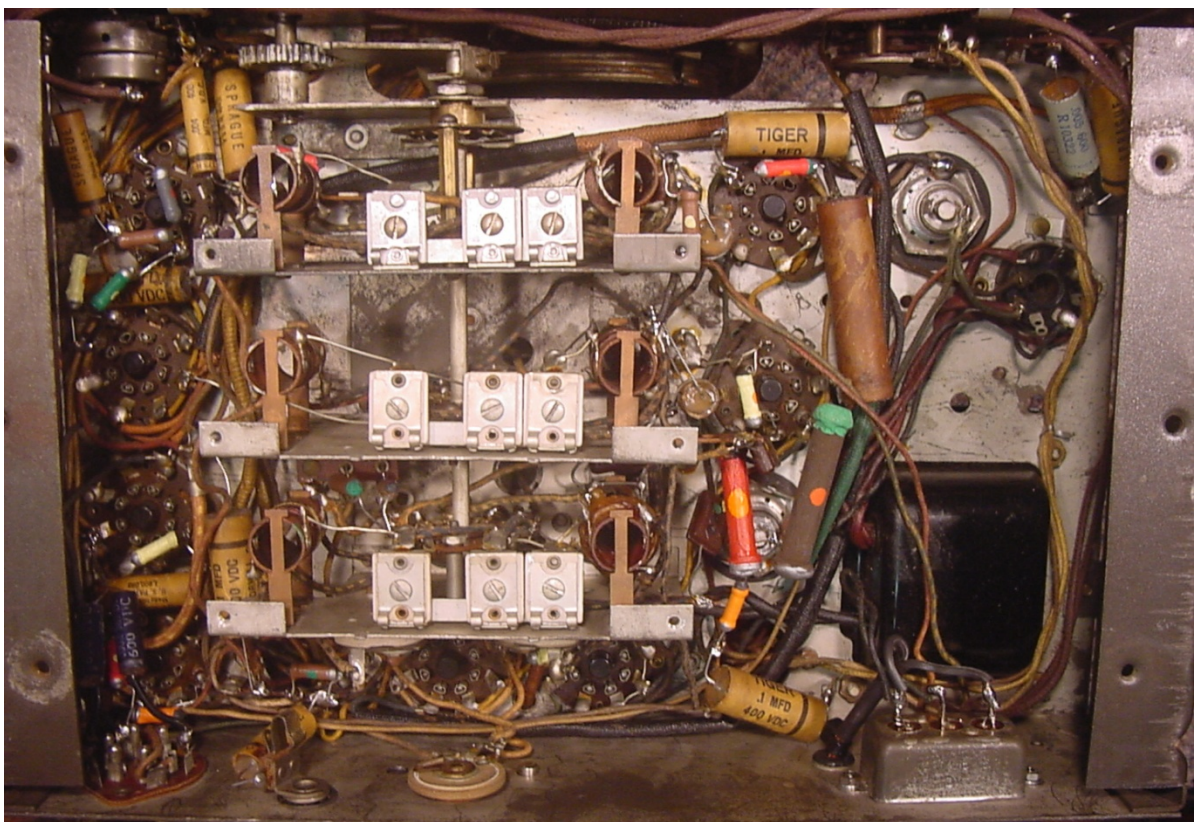
Above: Under chassis before restoration Below: Under chassis after restoration

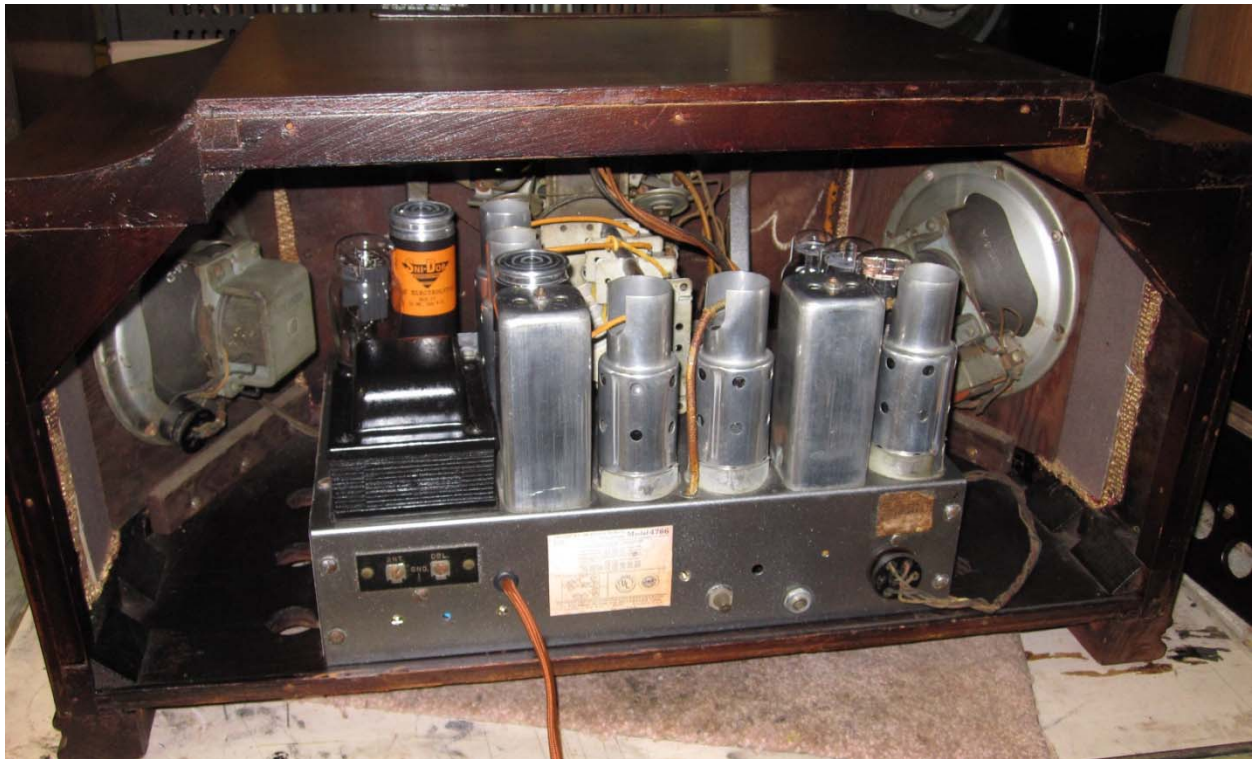
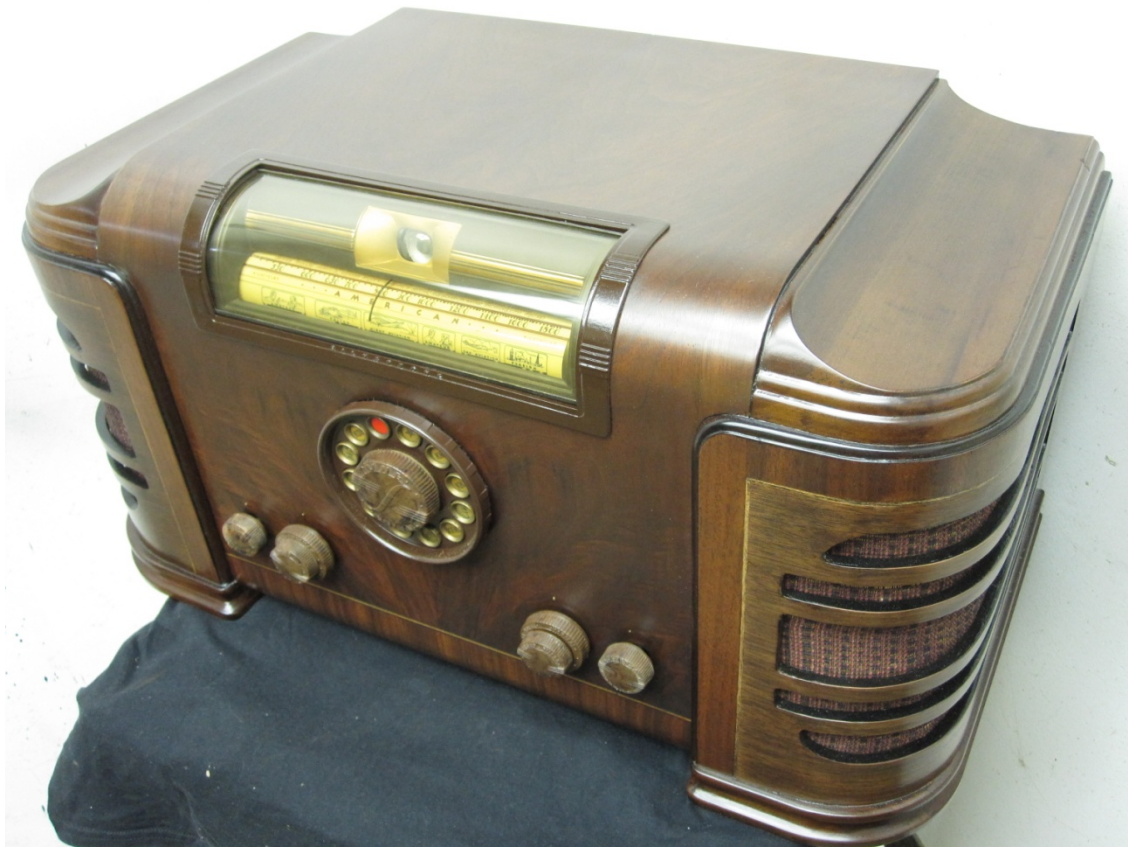
Above: Fitting the restored chassis back into the cabinet Below: Completed restoration

The speakers were cleaned and re-fitted into the cabinet along with the chassis, the knobs re-fitted, eye-tube aligned, rear panel fitted and the completed receiver tested. The sound produced by the two small speakers is remarkably good and the set now looks a 'feels' like a quality piece of 1930's engineering and aesthetics.

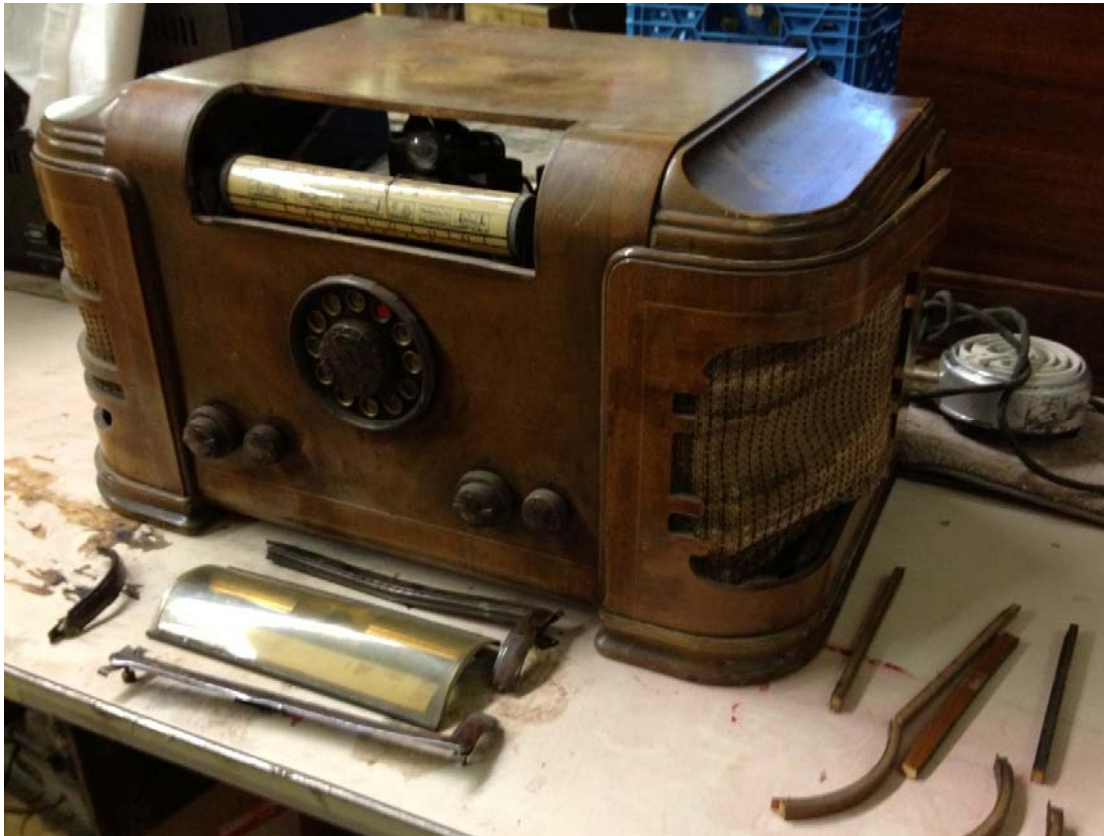
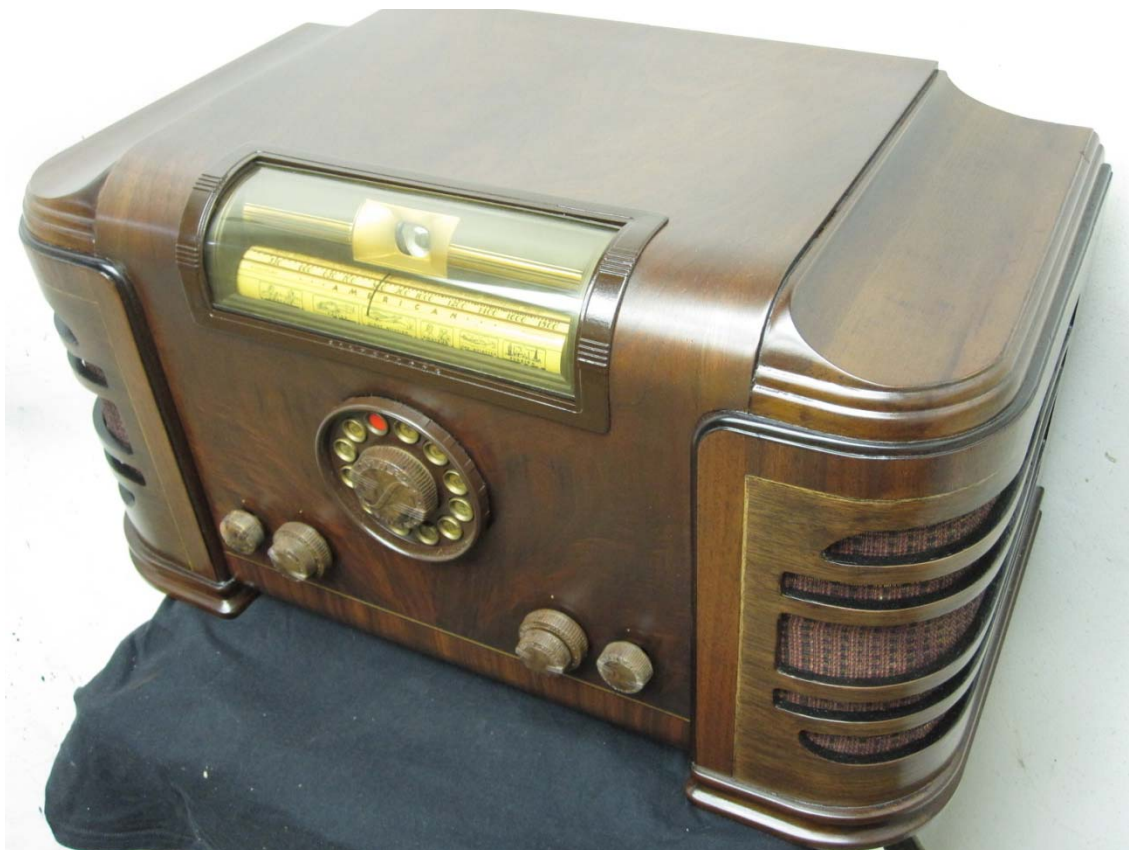
Above: Cabinet before restoration Below: Cabinet after restoration

Following cleaning, the old finish (shellac) was scrapped off the cabinet and the cabinet re-glued together in a number of stages. The broken speaker aperture ribs were reproduced by forming/gluing several thin wood laminates into a plywood using a jig made from one of the ‘good’ ribs. Once fabricated, these were each fitted into the cabinet sides. Following fitting of the ribs, the entire sides were re-veneered and the cut-outs between the ribs made with a sharp knife.

The re-built cabinet was sanded down with 600-grit 'wet and dry' emery paper lubricated with lemon oil, grain-filled, and then finished in tinted lacquers, starting with the darker trim, the remainder of the cabinet being masked-off in stages until the desired contrasting tones were achieved. The entire cabinet was then given several coats of clear semi-gloss lacquer. The knobs were cleaned and polished with Novus #2 and #1 and re-fitted, and new brass locator pins fabricated and installed in the cabinet front above them. Rather than install new speaker cloth, a suitable fabric was recycled from a scrap radio (courtesy of Gerry Taylor) and this was duly installed behind the wooden ribs.
