The restoration of a Zenith's radio, a model Zenette

By Walter Krieg Enz CHCR n°1402

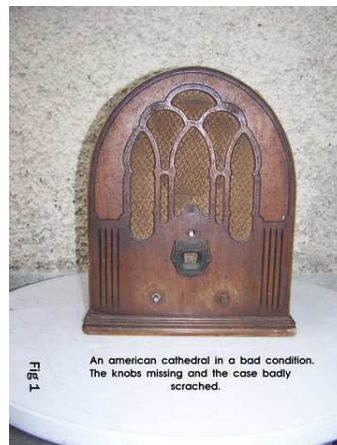
It is an American cathedral used in the 1930's in bad condition. The knobs were missing, the case badly scratched. (picture 1)

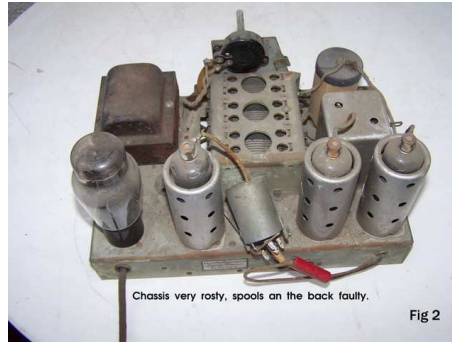
The electronic tubes 57 and 80 were out of order. The chassis was very rusty, the coils located on the back were faulty. I found it peculiar to put the potentiometer above the tuning capacitor (picture 2).

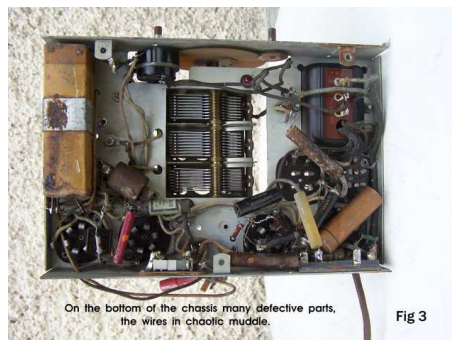
On the bottom of the chassis were many defective parts (picture 3) and the wires were in a chaotic muddle.

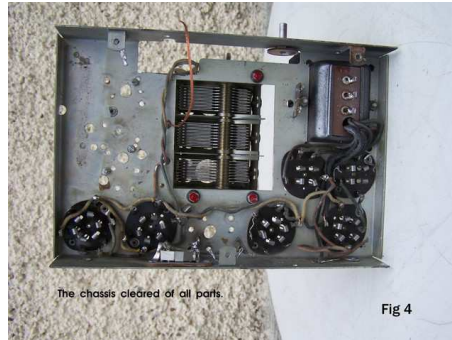
The chassis had to be cleared of all the parts (picture 4) and sprayed with aluminum paint.

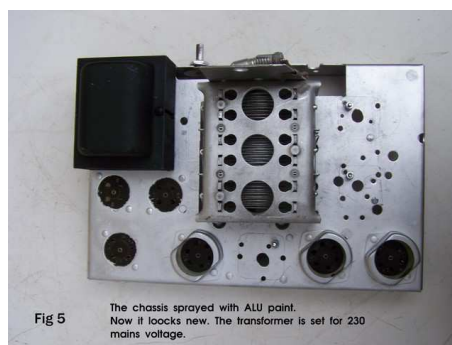
Now it looks beautiful (picture 5). The H.F. coils were partially oxidized and defective.

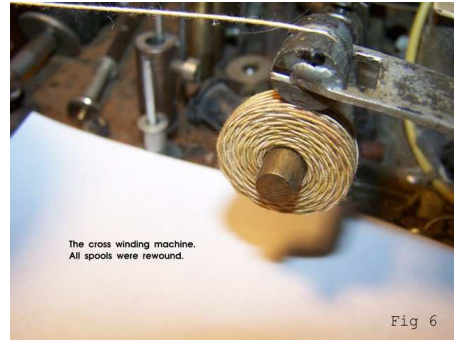
Fig 6

The cross winding machine.
All spools were rewound.

They had to be rewound using a winding machine (picture 6). For safety, all the coils were rewound.

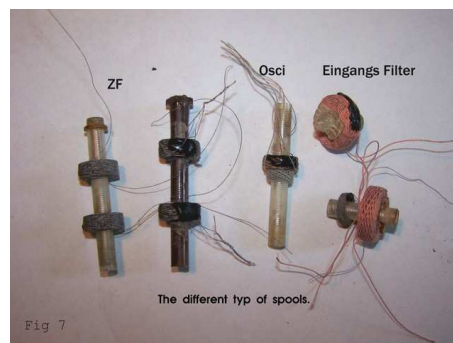
Fig 7

Picture 7 shows the different types of coils. For the sake of simplicity they were wound on the core of the coils, then reassembled with the iron cores.

The different typ of spools.

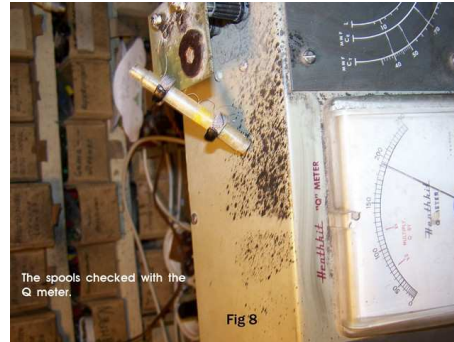
Before assembly, the coils had to be checked with the Q meter. The Q factor has to be a minimum of 170 (picture 8). The Q factor is the rate of alternating current resistance to direct current resistance.

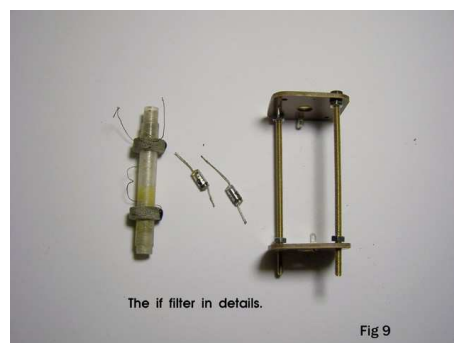
Picture 9 shows the IF filters in details.

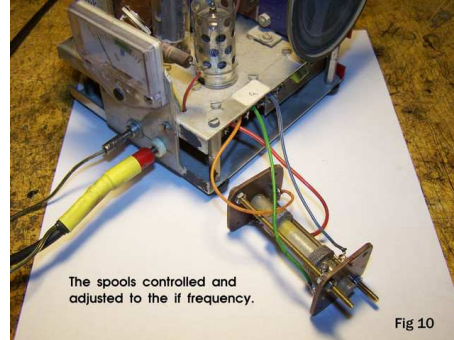
Before assembling the parts on the chassis, the coils had to be verified and adjusted to its respective frequency (picture 10), this way the coils after assembly is assured.

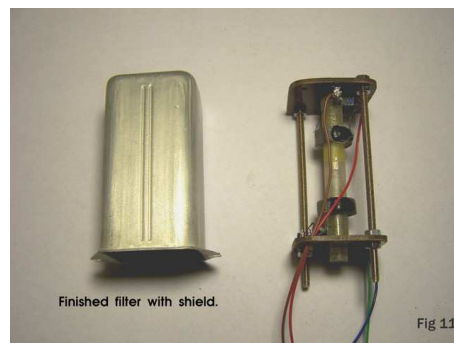
Picture 11 shows a finished filter with shield. The chassis was rewired, all the condensers were replaced as well as the faulty resistors.

Tolerances were off up to 70 %.
Only parts with the American color code were used.
European parts don't belong in this Zenith.

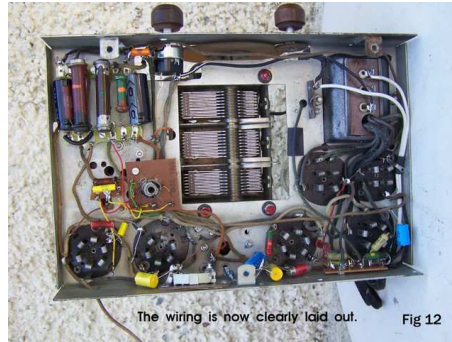
The wiring is now clearly laid out (picture 12). All the contacts to the vacuum tubes are now accessible. It's the same set up but it looks different. This Zenith is a super heterodyne receiver (picture 0) with 5 tubes; 57- mixer tube, 58- IF booster, 57- demodulator, 47- amplifier and an 80 dual-rectifier. To improve the selection a band filter on the antenna is used. With the variable cathode voltage on the IF amplifier the sound volume can be adjusted. The intermediate frequency (IF) is 175 kc.

The wiring is now clearly laid out. Fig 12

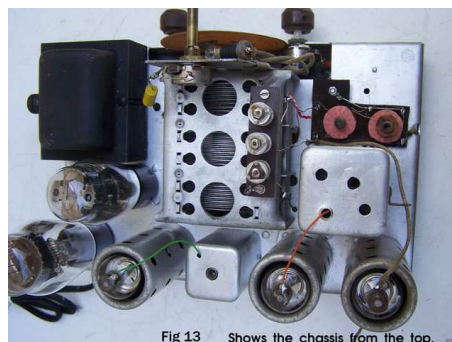
The transformer is set for 230Vac mains voltage. Picture 13 shows the chassis from the top. The red coils are the entrance filter and the tuning capacitor was fitted with new trimmers.

Fig 13 Shows the chassis from the top.

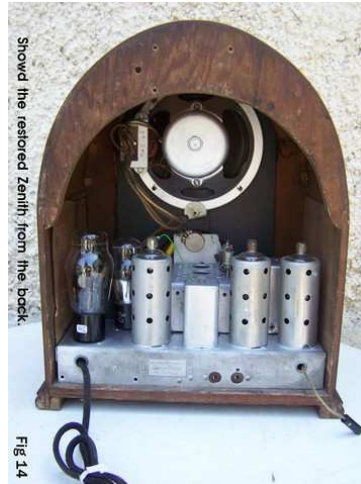
- These trimmers are important to align the frequency to 1200 kc. The IF filter placed on the back of the tuning capacitor is also a reasonable compromise. Through fitting H.F. cores, the entrance filter could be accurately balanced. The sensitivity with balancing IF is increased.
- Measuring the voltage on the tubes all gave precise values. Picture 14 shows the restored Zenith from the back.

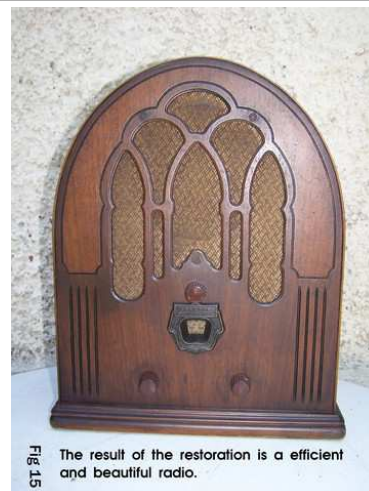
- The result of the restoration is an efficient and beautiful radio. It is a pleasure to listen to the broadcasts, with a sensitivity of 15 μ V. (picture 15)
- All the time spent for the restoration was more than worthwhile.
