FAIRBANKS~ MORSE 1938 RADIO
RESTORATION – Model # 5-C
CALIFORNIA HISTORICAL RADIO SOCIETY
International Radio Restoration Contest Entry

March 15th 2014

Restoration by : Cliff Farwell

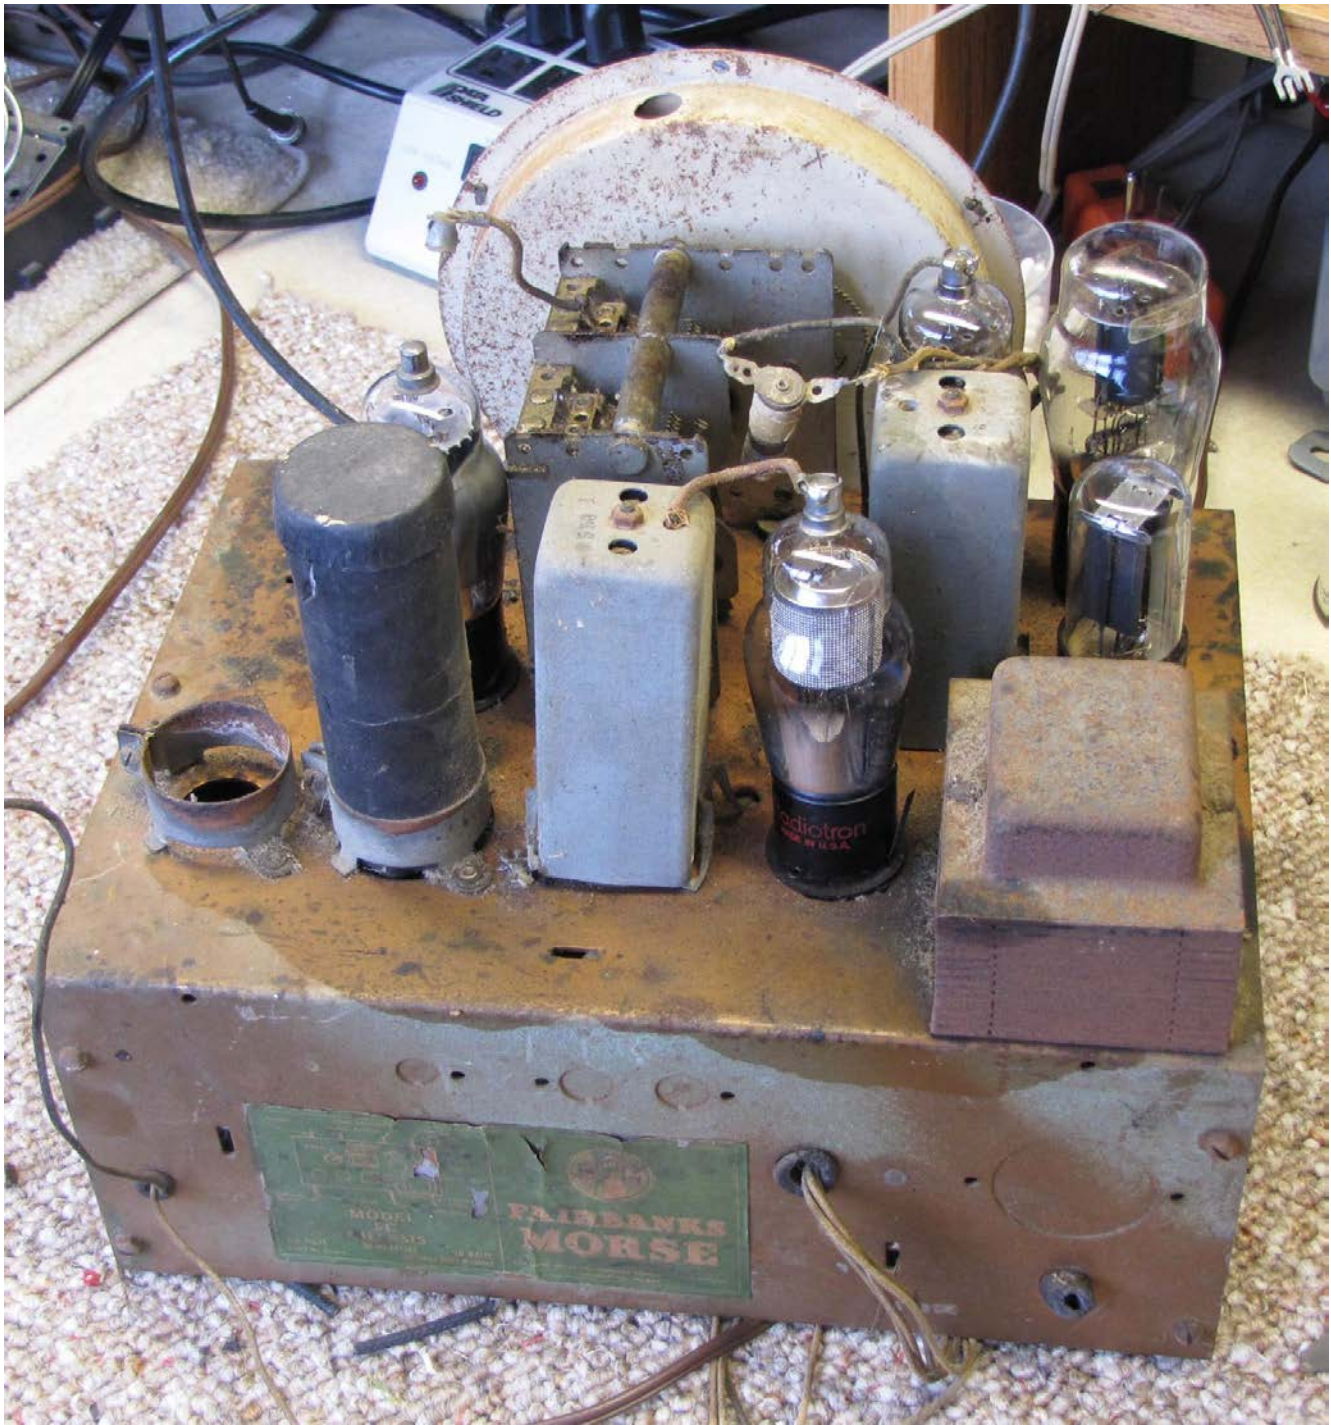
This is what the chassis looked like before restoration, with heavy corrosion.

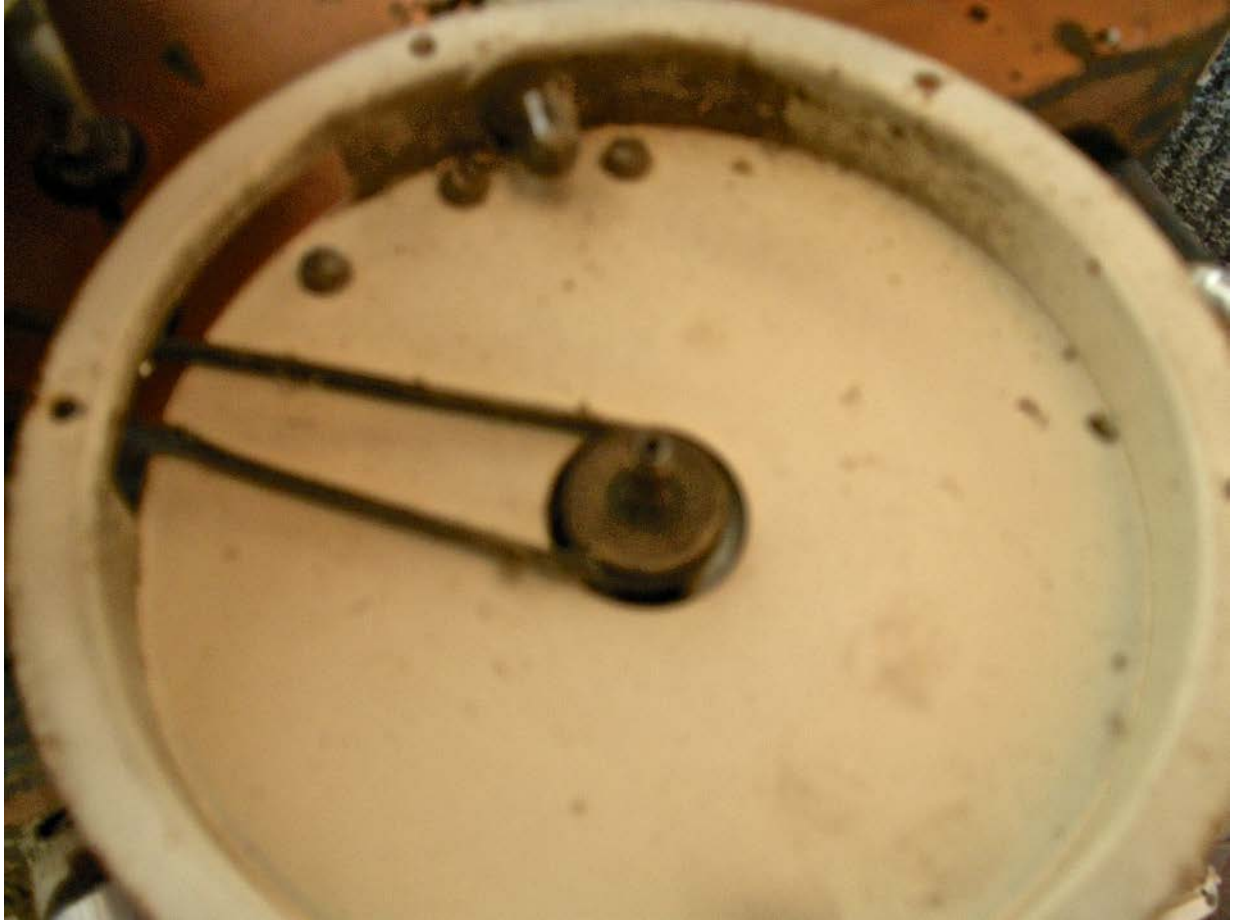
The rusted dial face housing and the old dial belt were removed for repainting and replacement.

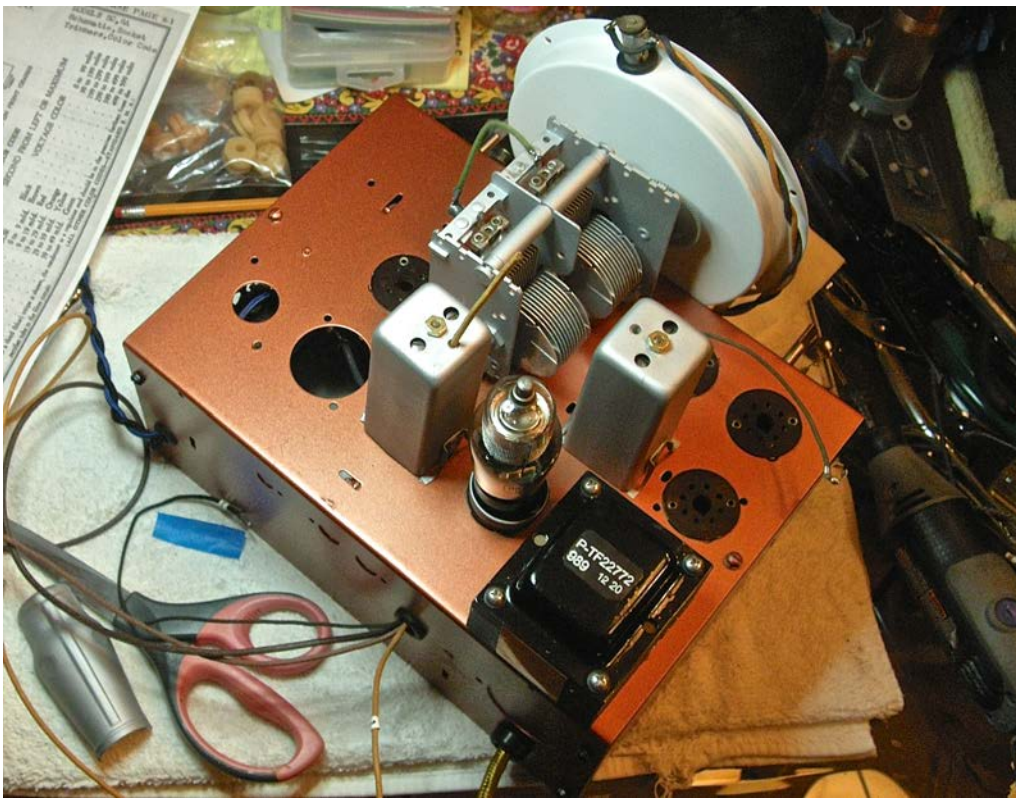
Final step: Speaker gasket added to match original.

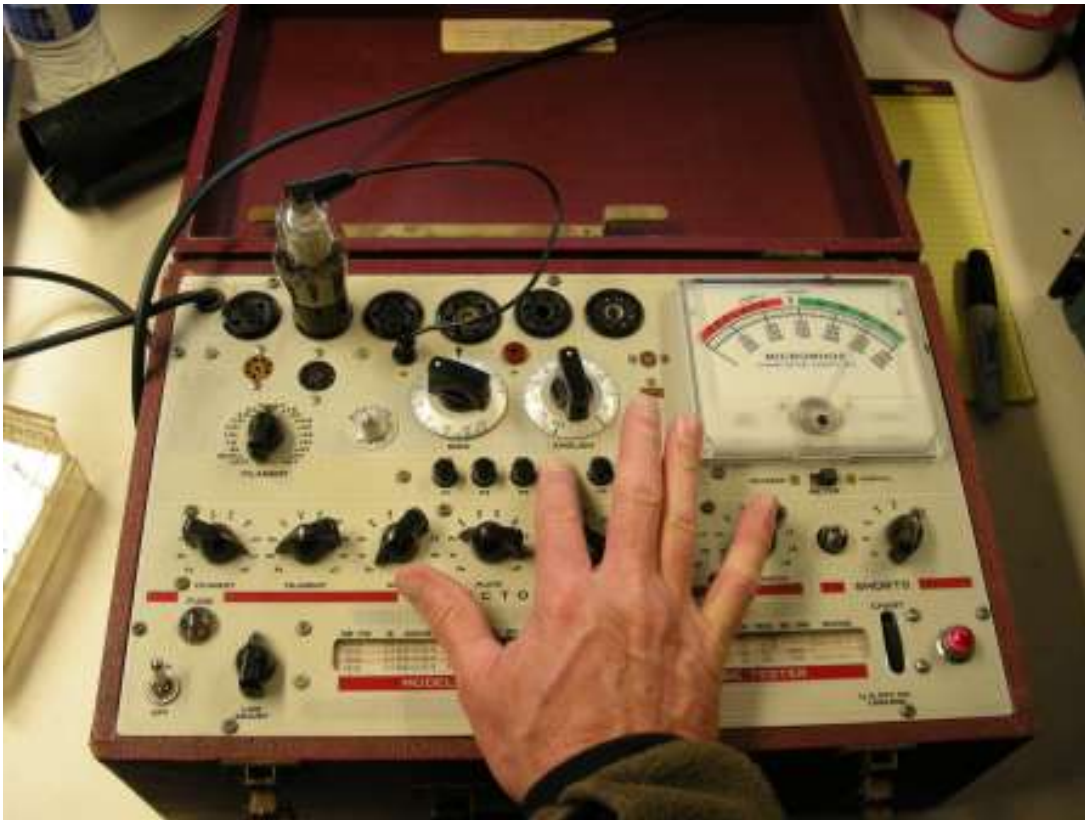
All tubes were tested with a Hickok tube tester. I discovered that several tubes needed to be replaced.

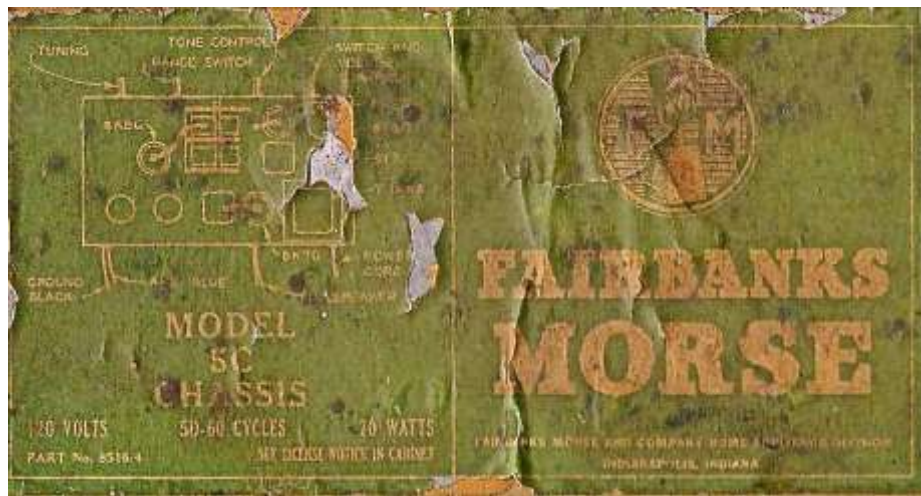
Before

The old damaged dial face was replaced with a new reproduction made by Radio Graphics. The dial lights were rewired and the dial lights were replaced. The face was installed using machine screws and the heads were filed down as per old rivets to give a tight fit to the new dial face cover once the chassis was installed. I had also installed a new belt prior to the dial face being secured.

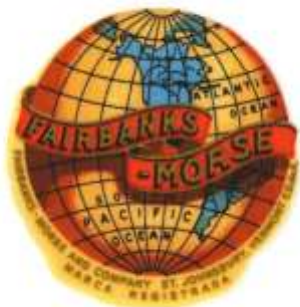
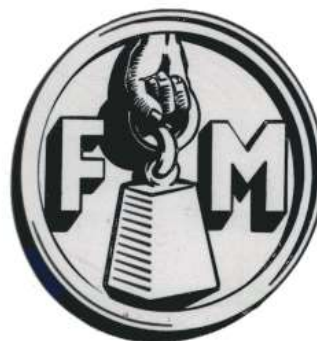
The tube diagram decal for the Fairbanks Morse 5C was removed for the chassis restoration.

The Replicas were made by Graphics Radio

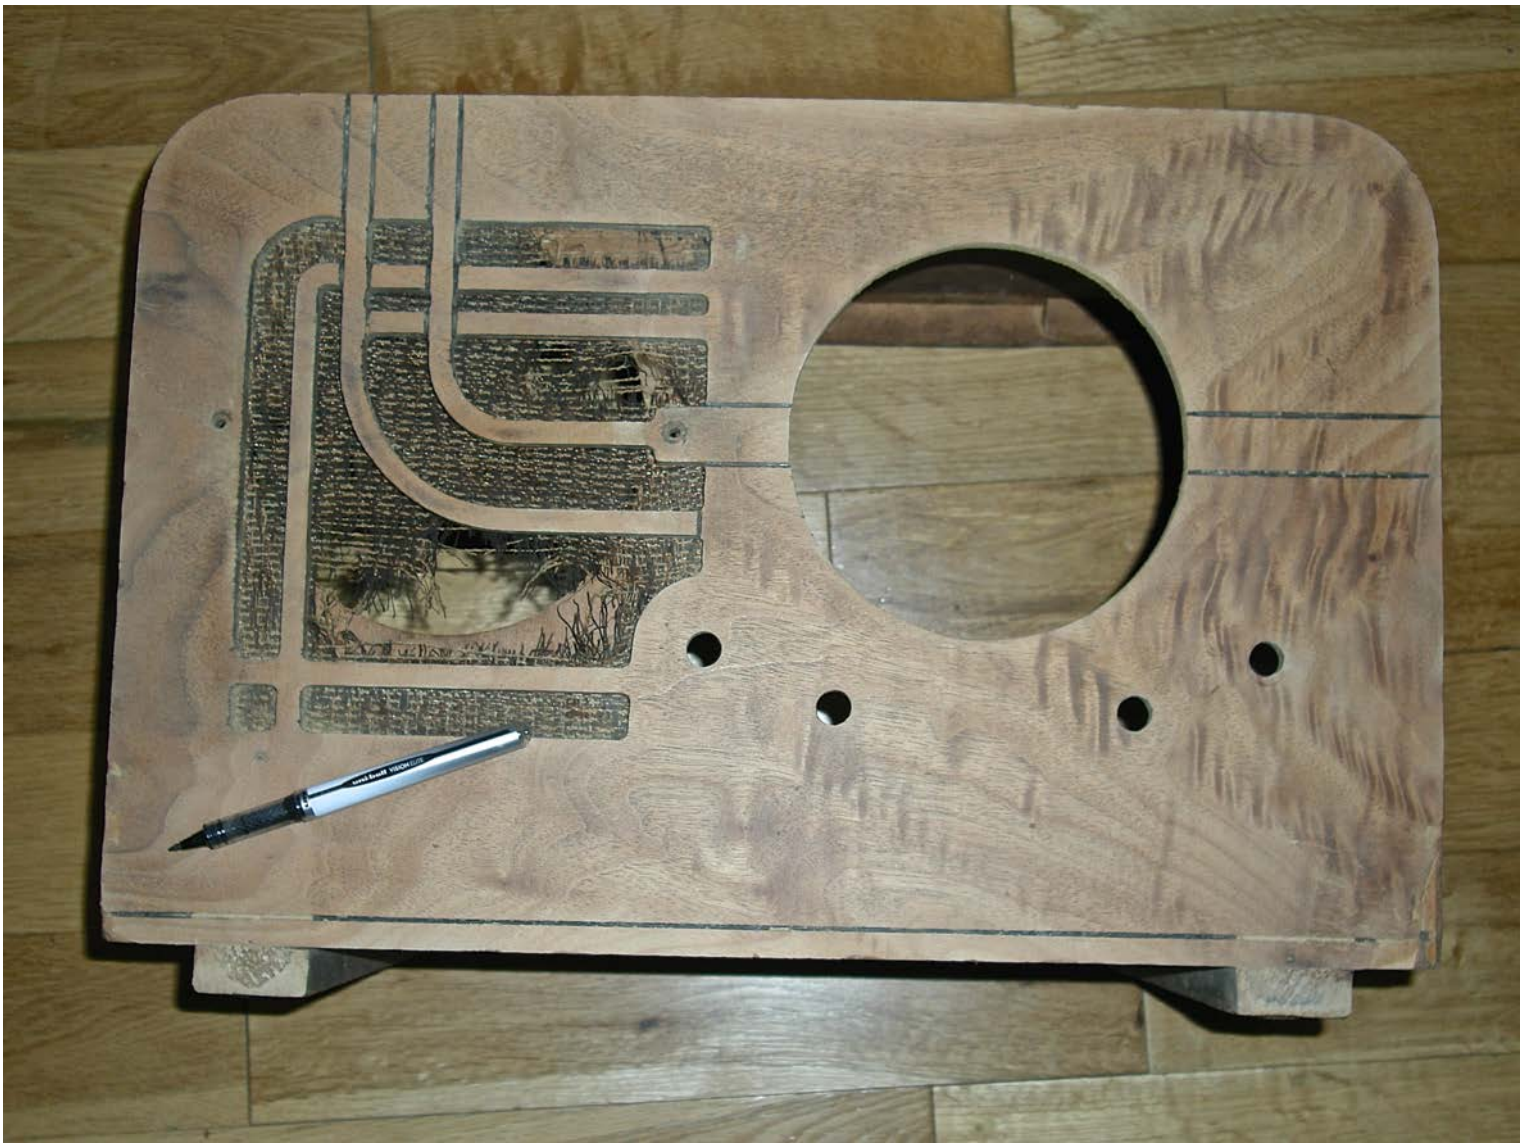
There were several steps to re-facing the body of this radio. The veneers were broken and chipped in many areas. The inside of the unit had a wasp nest, mud and had water damage.

I bleached the cabinet and stripped the inside and outside.

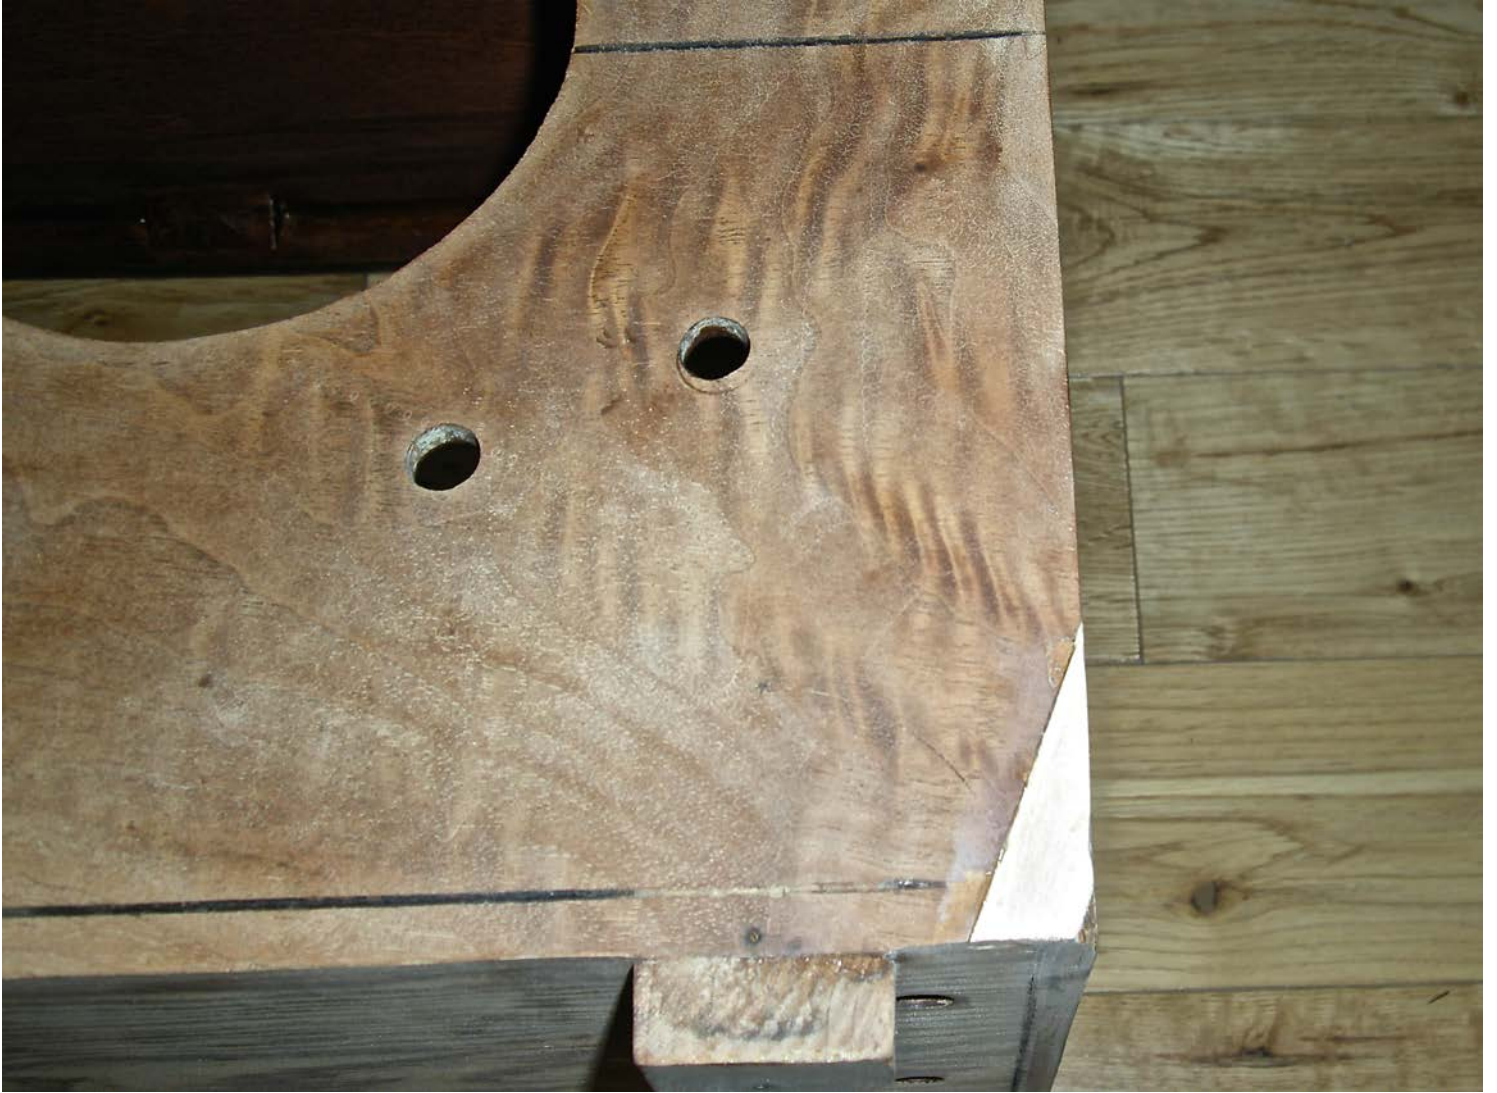
The cabinet needed to be resurfaced with new veneer and the under ply repaired. Both lower and right corners were severely damaged. The photos enclosed will show the process from beginning to end.

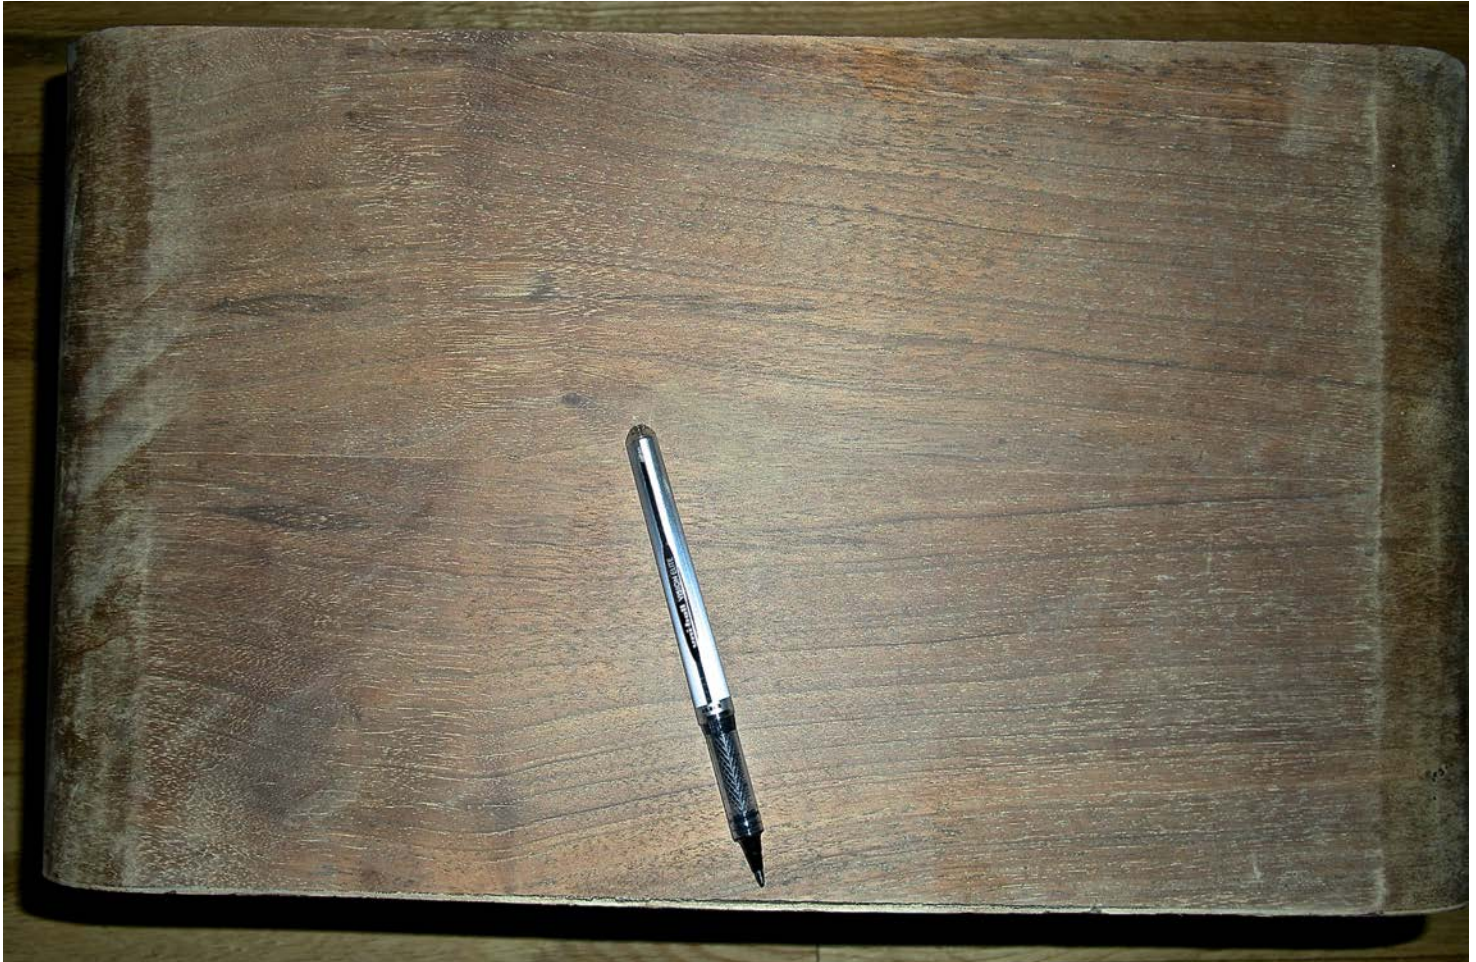
The lower corners were damaged on the face. The side panels required minimal veneer replacement.
The missing pieces were blended in with new veneers.
The front veneer had separated from the cabinet top as shown in the photo.

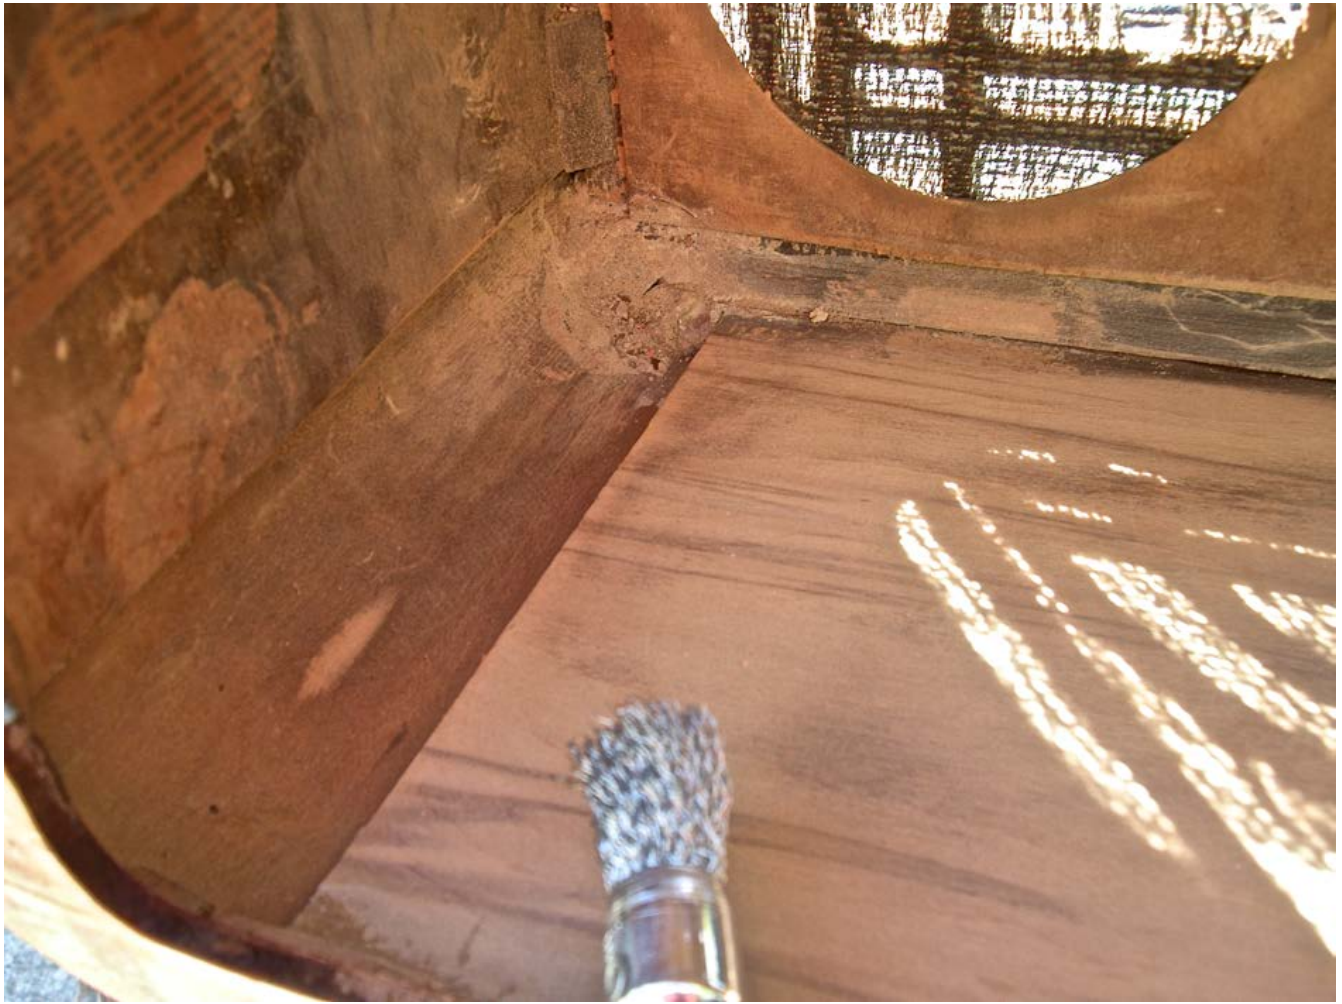
The interior of the cabinet had begun to separate. After the chassis was removed several wasp mud nests were revealed. A round slow speed wire brush was used to remove the wasp nests.

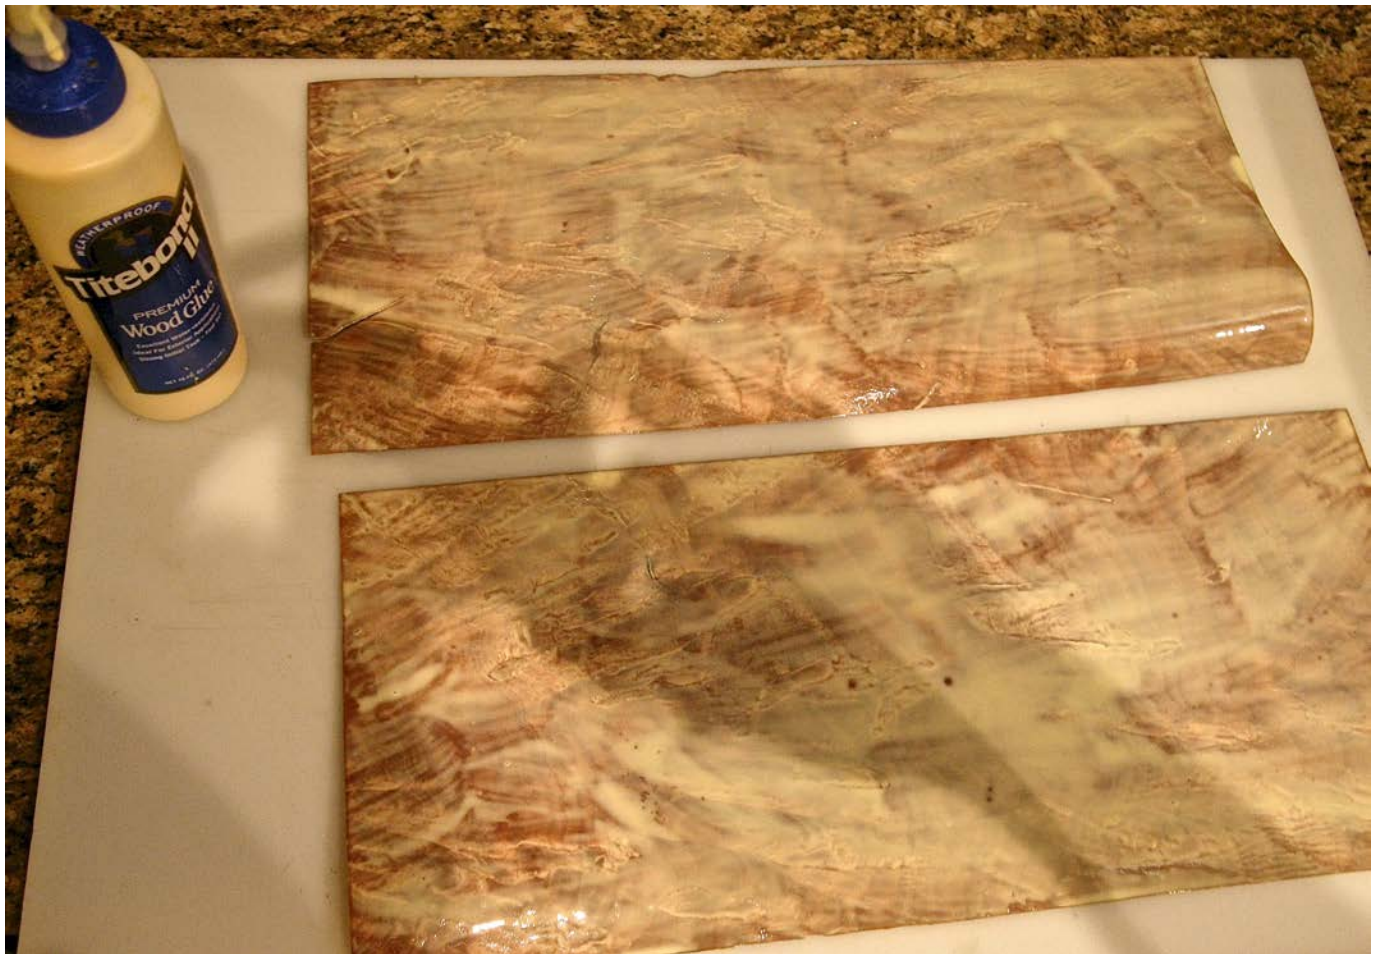
The veneer was so badly damaged that I decided to reface the cabinet. I choose a Fancy face crotch mahogany veneer that matched the original face pattern. After the underlayment and old veneer was repaired, I applied Tie Bond III glue to both cabinet face and veneer and secured with a hot wood iron.

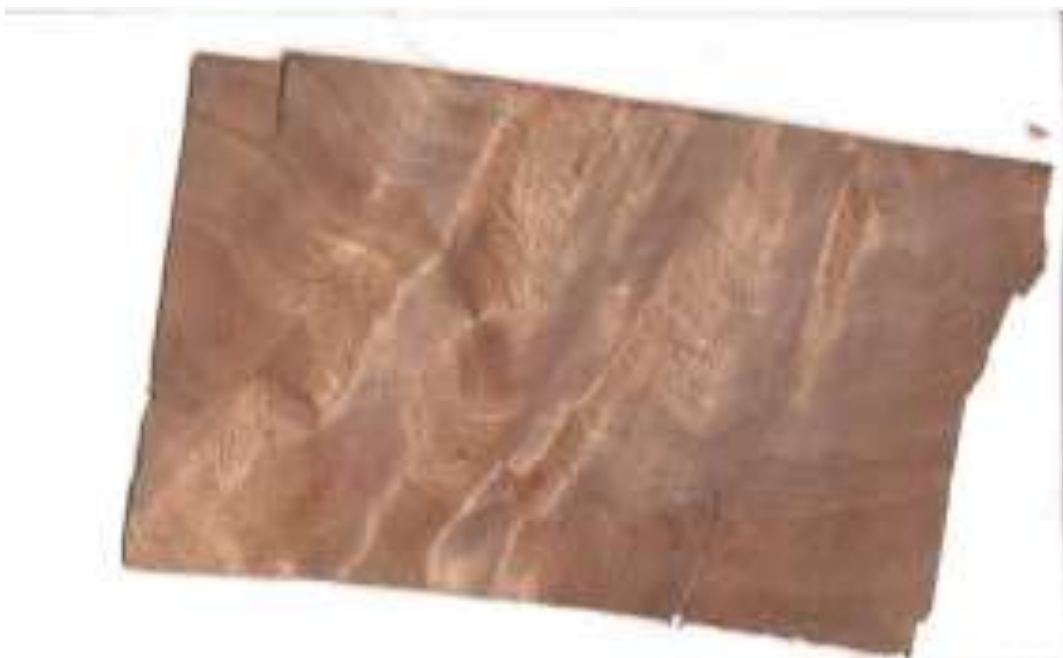
The new veneer I used was from Sauers & Co. processed veneer. This was a Crotch Mahogany book mark matched. I have included an unfinished sample below.

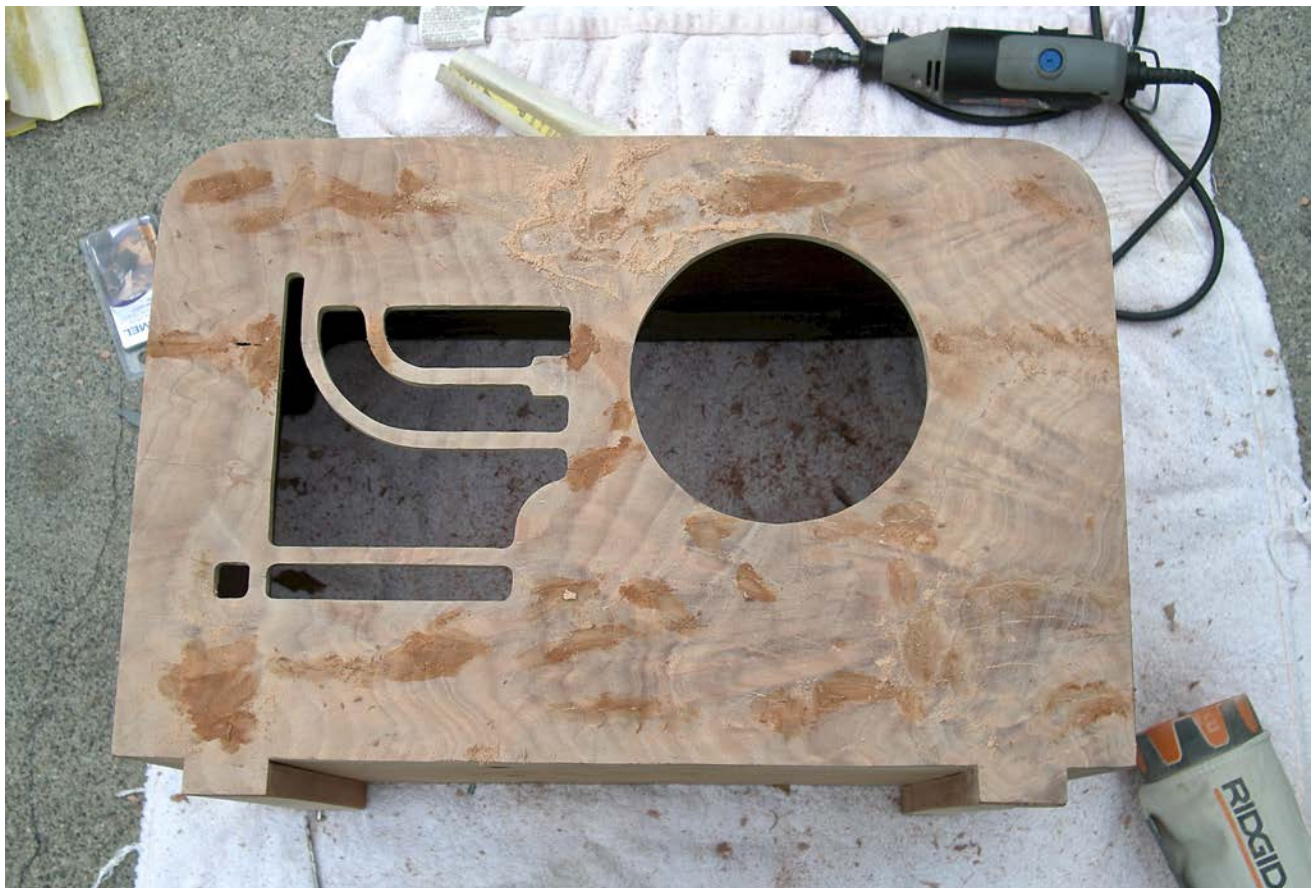
Once the veneer was secured to the face the radio I began the slow and tedious process of cutting the dial face, grill and chassis holes. This was very time consuming. I used a Dremel hand router with cutting and sanding bits.

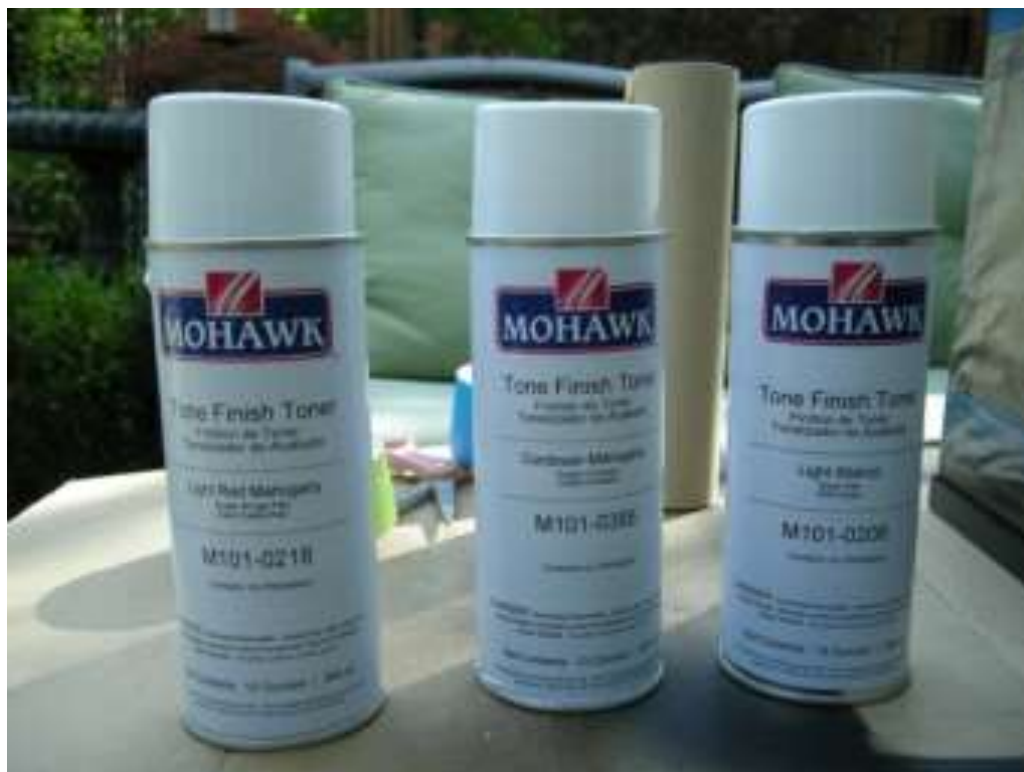
The cabinet was sanded with 320 grit Norton sand paper.

An application of Mohawk grain filler was used to soften the pores of the wood prior to applying the lacquer finish. (Mohawk Lacquer).

Toners were used to blend the cabinet face into the old existing veneer.

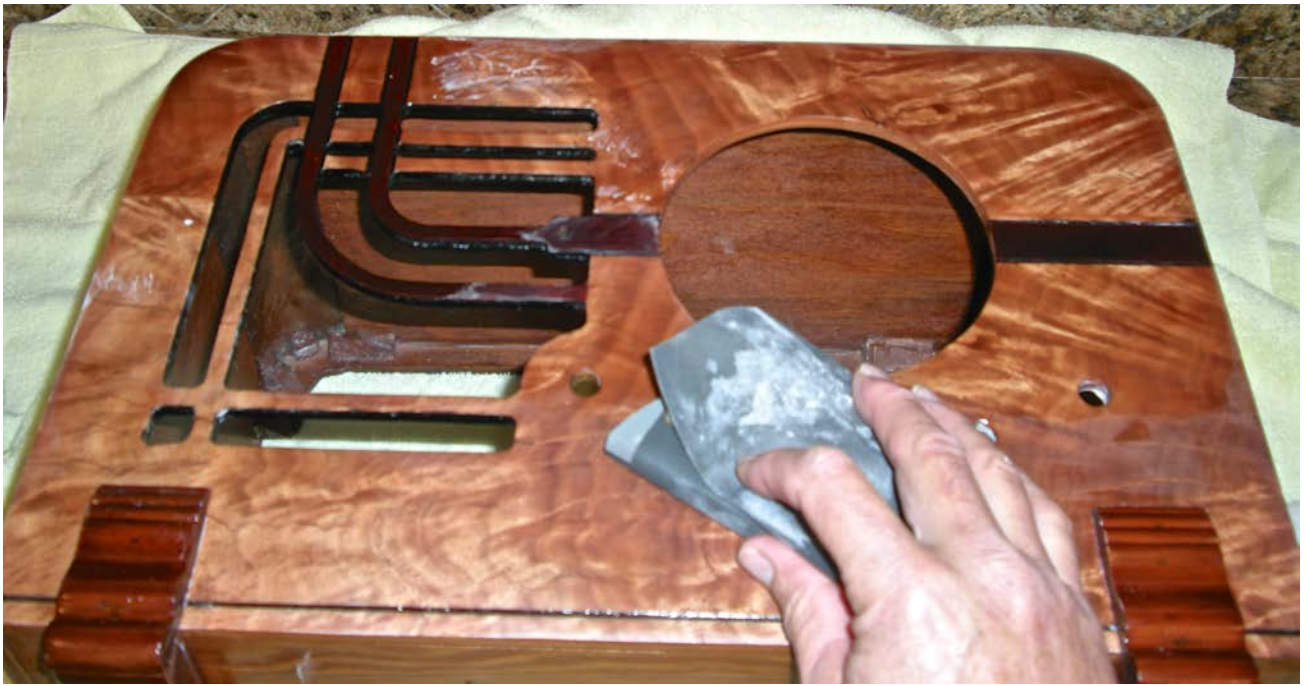
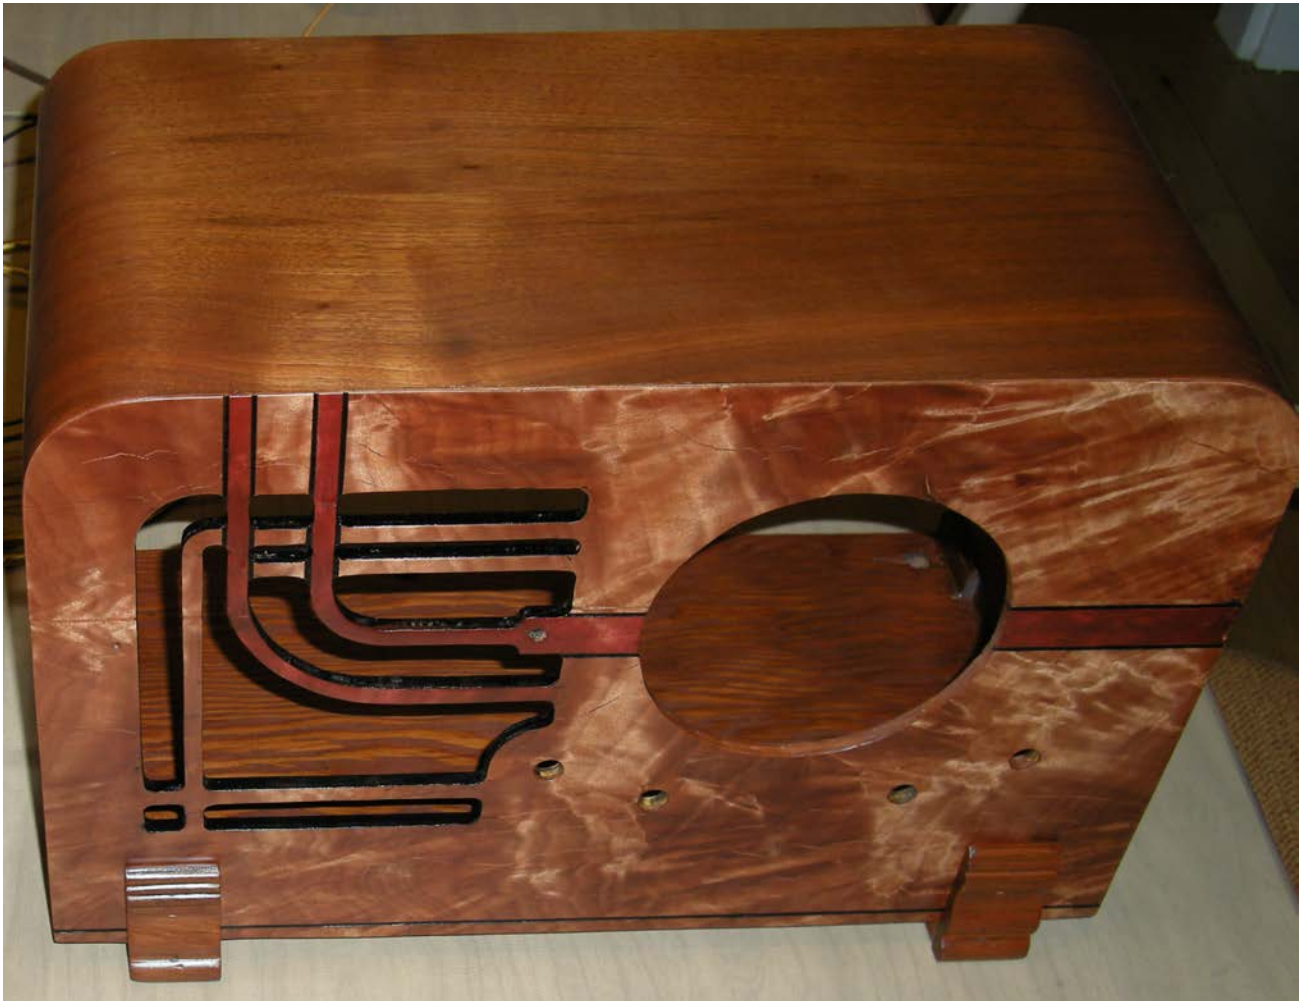
Upon completion of spraying several coats of sanding sealer and satin lacquer, each coat was hand sanded. This took approx. 8 coats.

The final coat was rubbed out with rottenstone compound and light 3-1 oil. I found a chalk board eraser worker well. This helped give it a nice even finish.

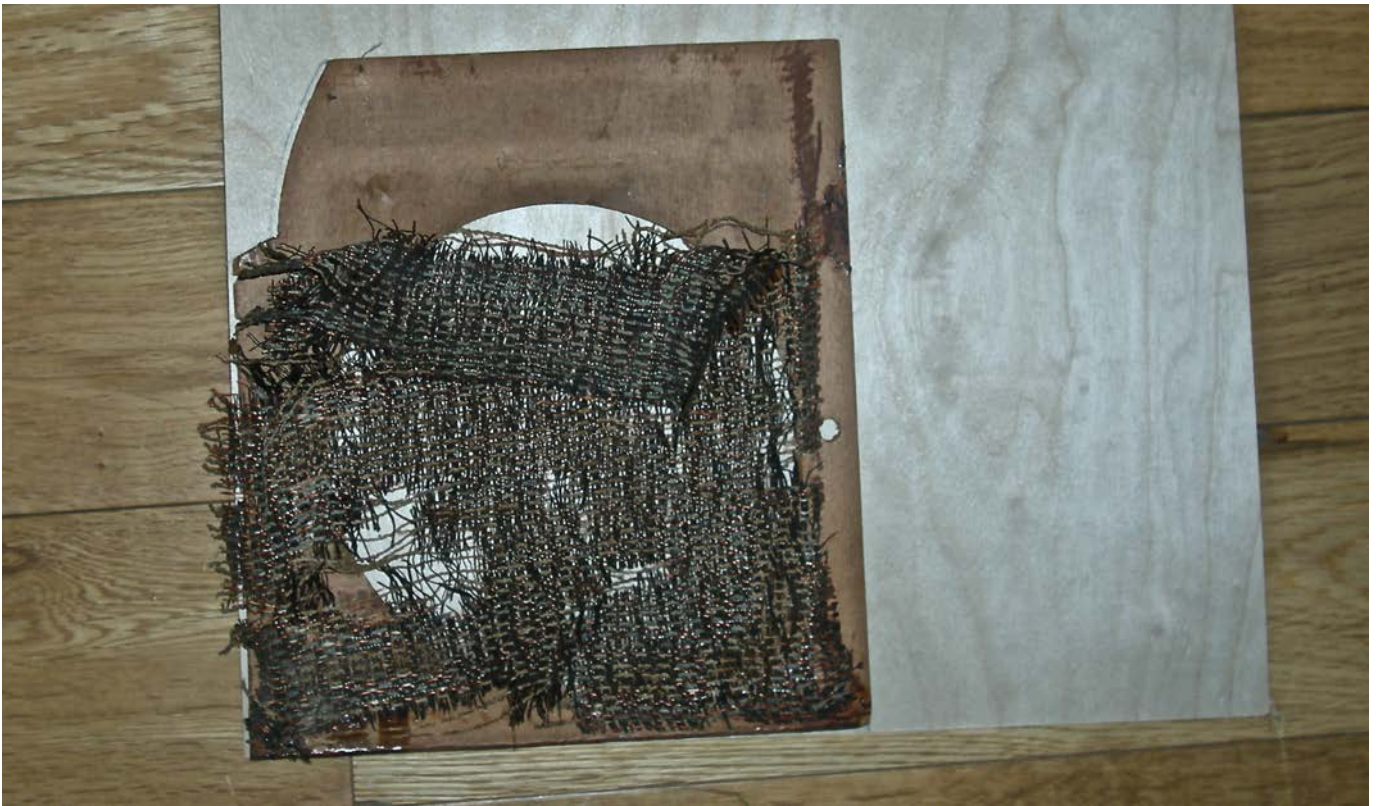
The old grill cloth was totally destroyed.
I constructed a new backer board, using the old one as a pattern and replaced the grill cloth.

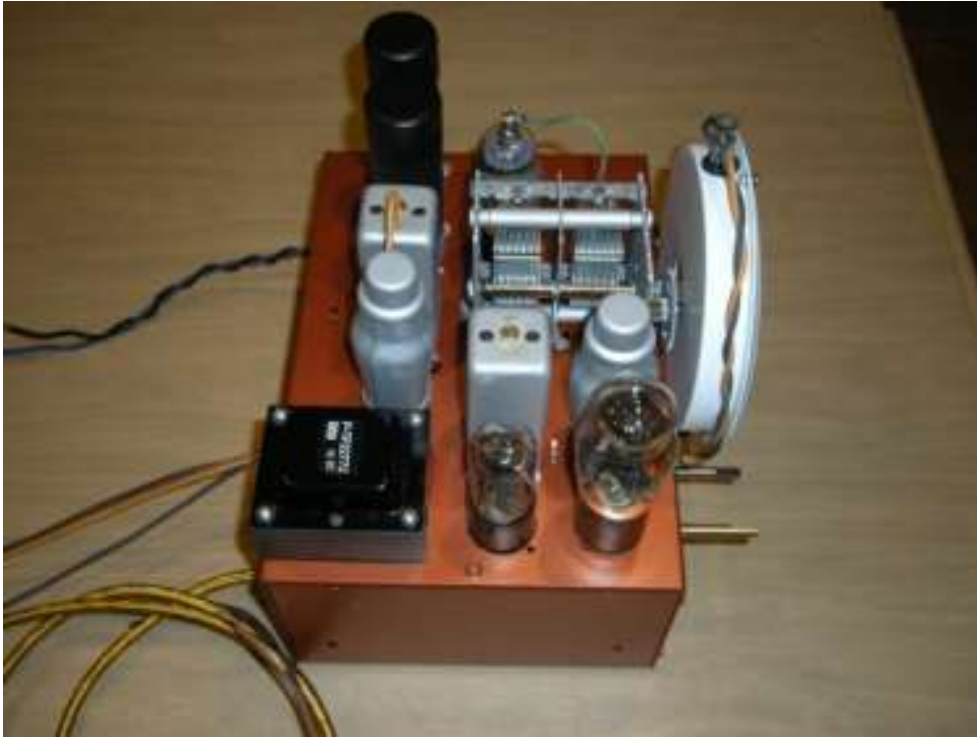
Awaiting the chassis, the cabinet is finished. The speaker grill cloth installed, escutcheon tacked in place with brass nails.

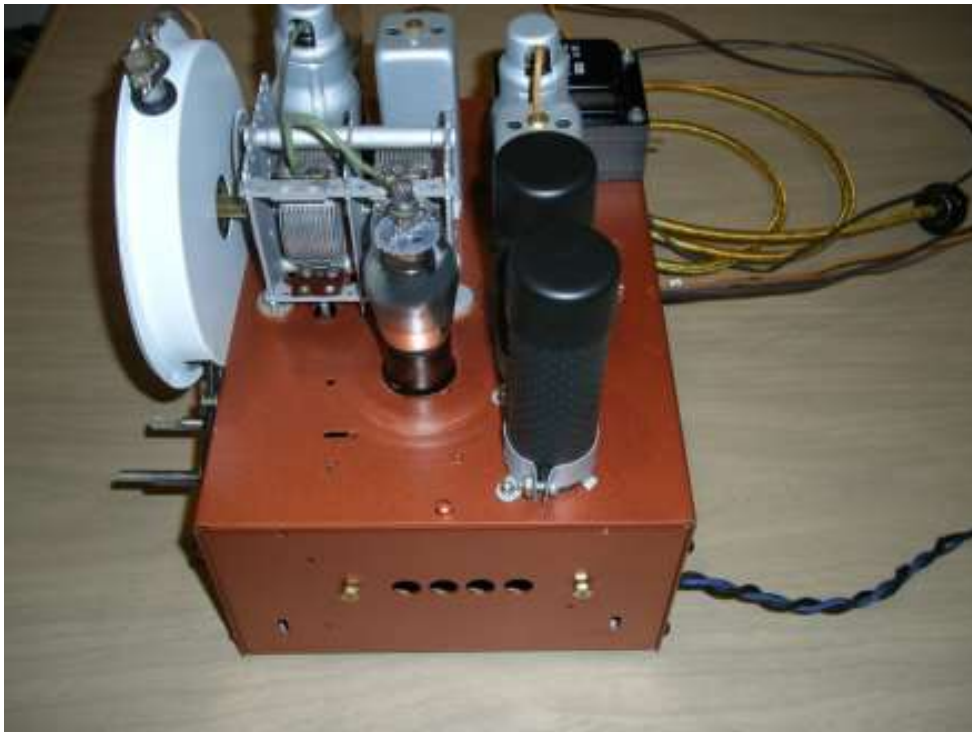
Chassis now completed, speaker re-coned and tested. Cabinet is repaired and refinished.

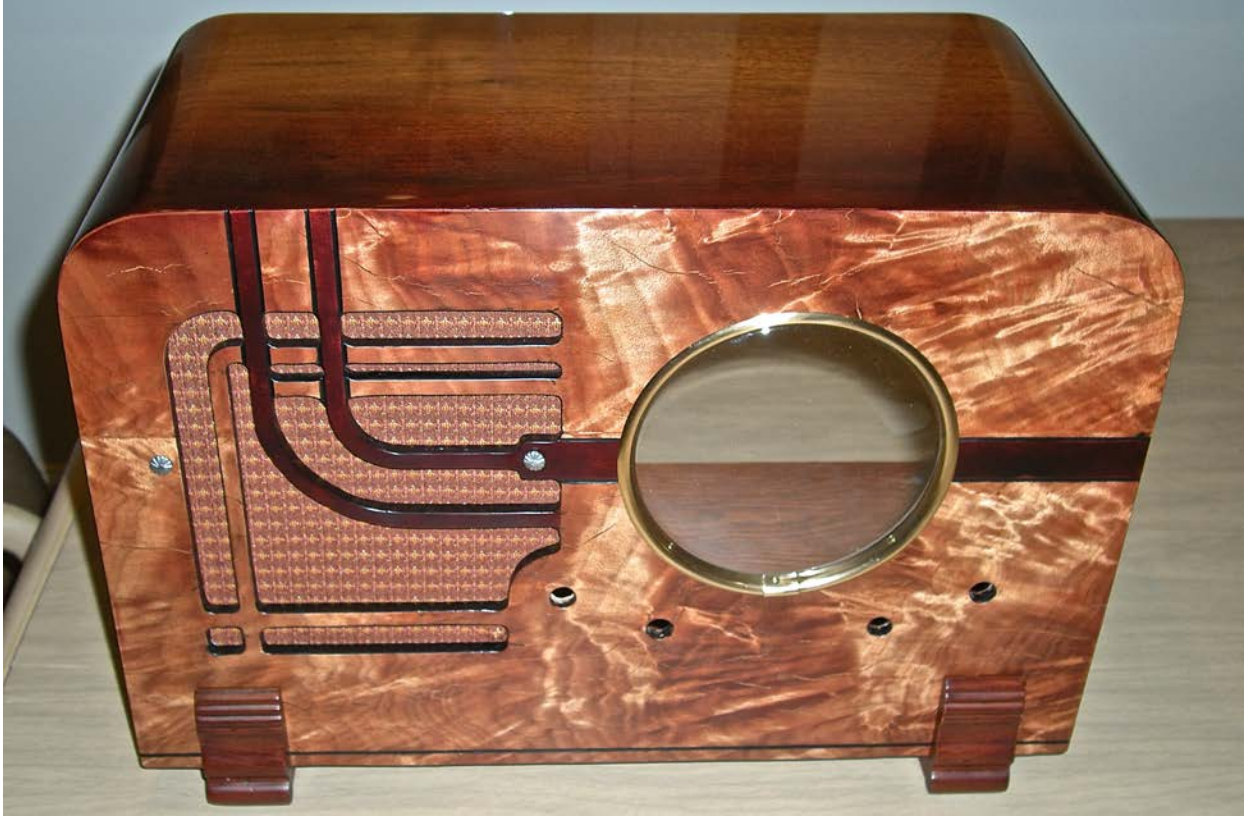
Cabinet ready for chassis installation
