FAIRBANKS~ MORSE 1938 RADIO
RESTORATION – Model # 5-C
CALIFORNIA HISTORICAL RADIO SOCIETY
International Radio Restoration Contest Entry

March 15th 2014

Restoration by : Cliff Farwell

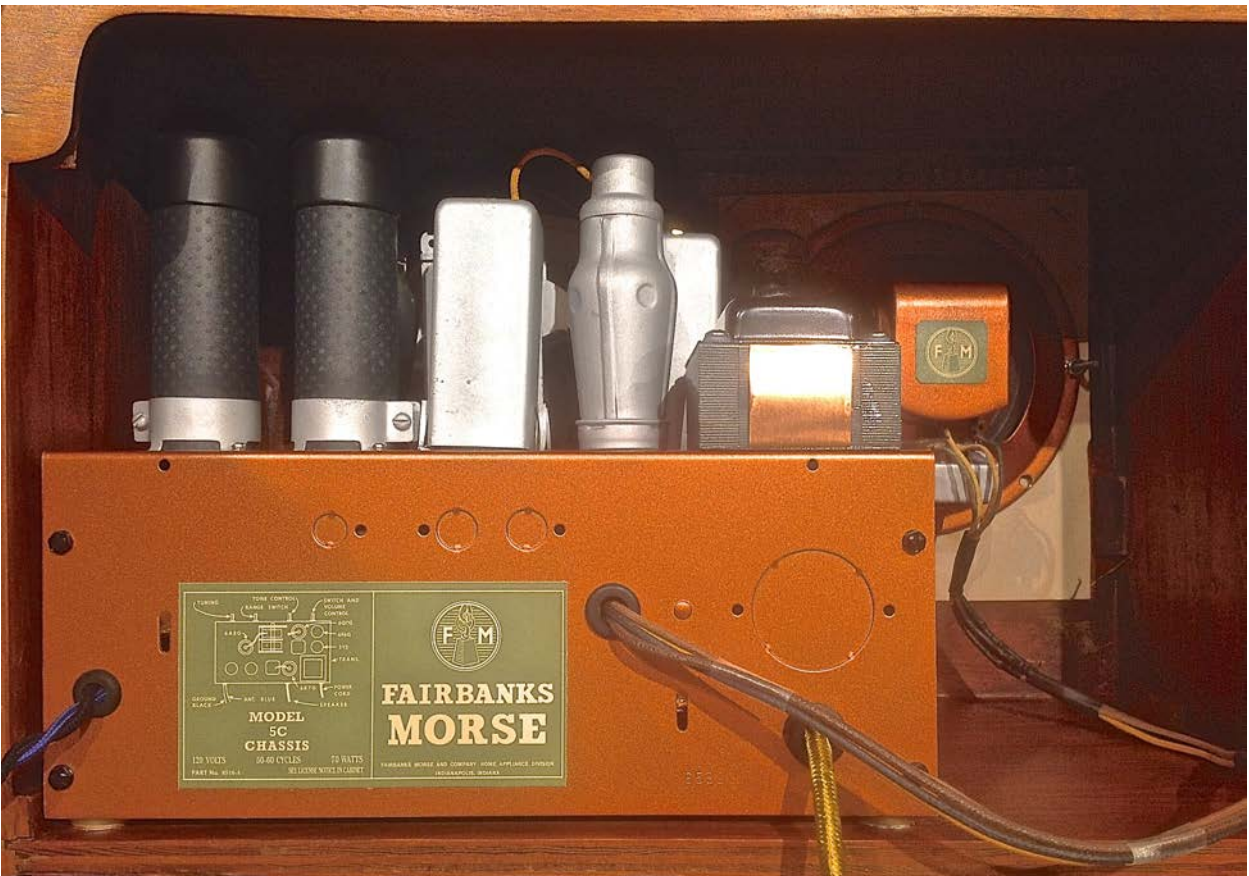
Cabinet complete, speaker is mounted and connected to the chassis circuit. Chassis is mounted with new grommets and bolted to the cabinet using original screw bolts. Decal has been replaced.

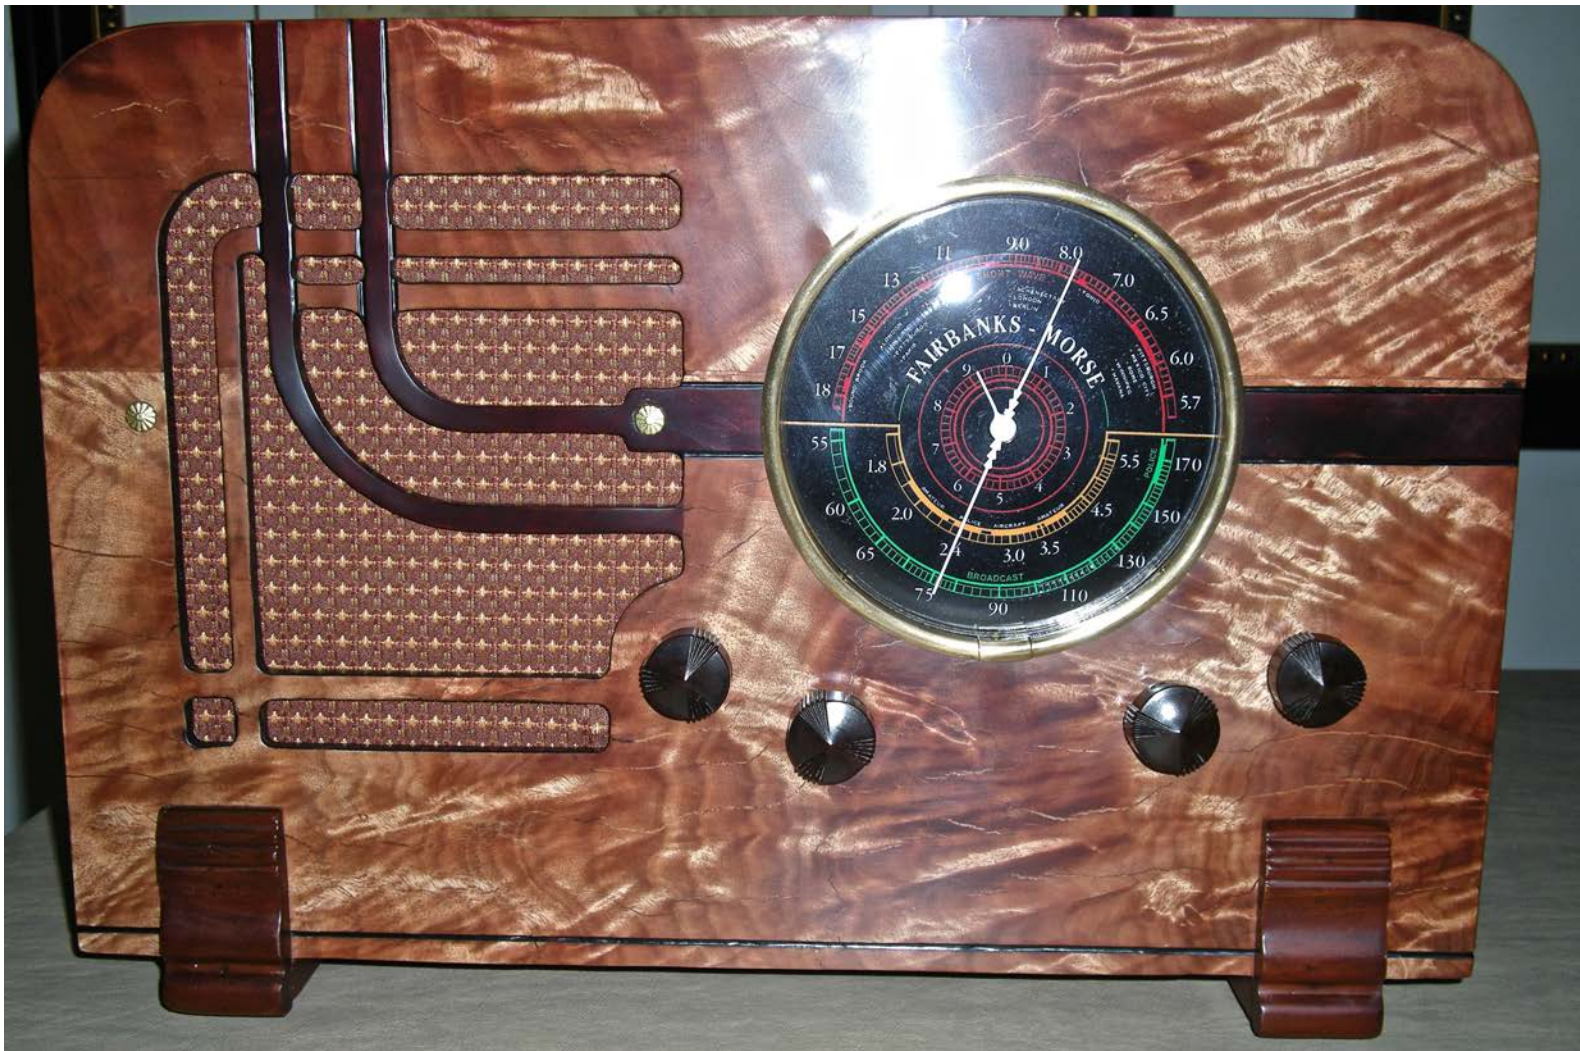
I aligned the radio at KRE (CHRS Headquarters), IFs at 456 KC as per the alignment instructions by the manufacturer. This information was found Via the RIDER publications volume VIII Page 8-2 Fair -Morse Models 5C-6A

FINAL ASSEMBLY~ The Radio is completed!
