## International Restoration Recap

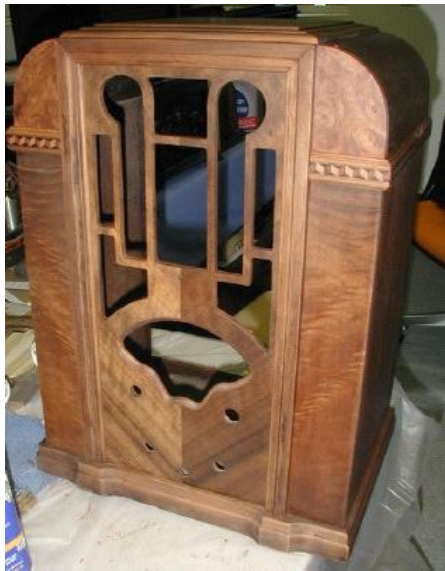
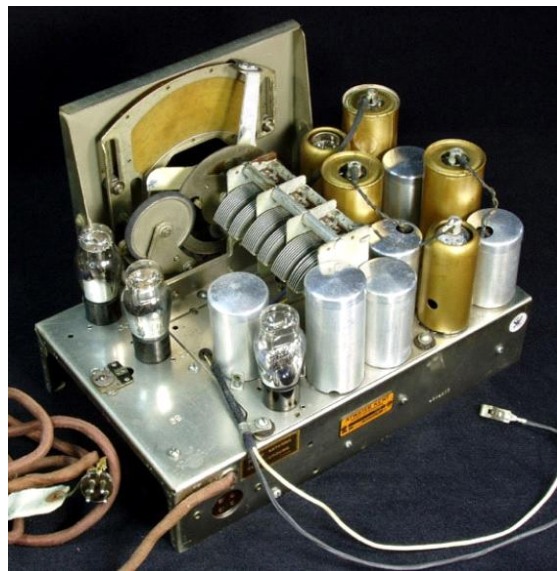
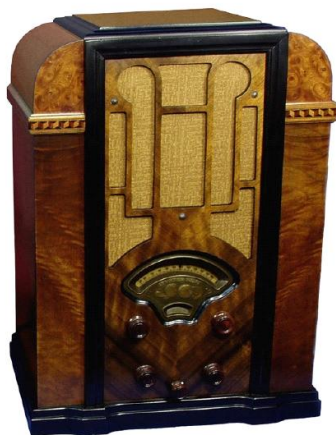
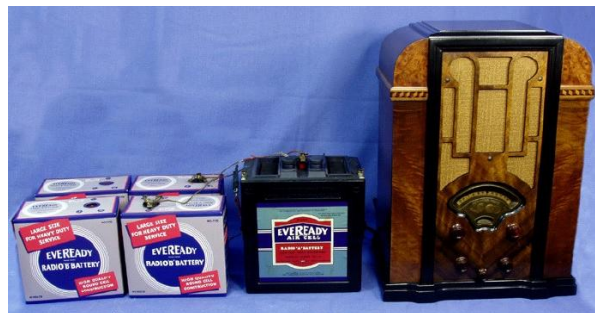
The Mid Atlantic Antique Radio Club (MAARC) presented us a visually spectacular battery operated set, an Atwater Kent 768Q. M. Lozier begins his report with an exposé on his vision of a restoration at museum level. In consequence appearance is everything in order to show what such a radio really looked like coming out of the manufacture. Non visible parts have kept their appearance and left pretty much untouched, most wires were left as is except for more visible ones which were replaced in as much original look as possible. Rare and special 'Air Cell' batteries were reproduced, a process which took M. Lozier many years of research and dedicated work.

Unfortunately, the report lacked pictures of the cabinet before restoration (we could only witness it's stripped state) and not enough of the chassis at start in order to properly evaluate it. This penalizes the score quite a lot as approximately a third of points awarded is for the state of the radio as found. However, a good picture of under the chassis showed the badly dried wiring which the contestant chose not to touch for historical preservation. The cabinet restoration and the batteries reproduction are excellent demonstrating museum quality work. All these elements combined relegated this radio's score at the bottom. Still a stunning radio.

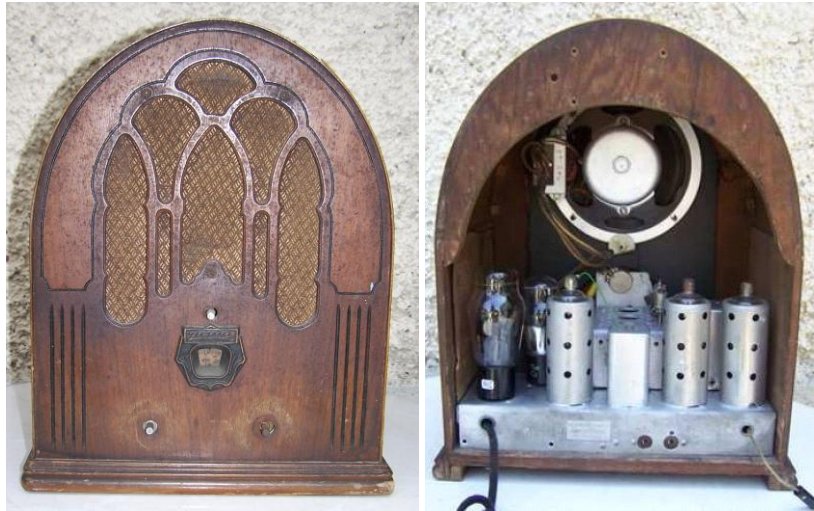
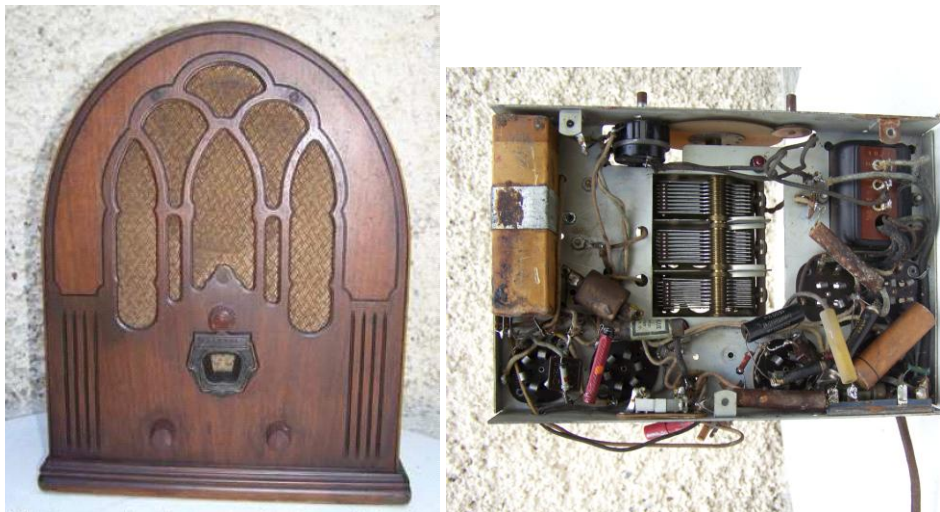
The French association Club Histoire et Collection Radio (CHCR) entered the contest with an American Zenith Zenette cathedral style radio by member Walter Krieg which is at his second participation in this contest. This radio which was not a real basket case still needed a fair amount of work in order to look and perform closer to what it was when new. So out of the ordinary work was executed on damaged coils, rewind with authentic original look. Small pictures made it difficult for the panel of judges to properly evaluate the scope of the work done. Good technical work was done to get the set going again. A video would have allowed the judges to witness the working set. In any case, a pretty radio came back to life. Good work on the part of M. Krieg.

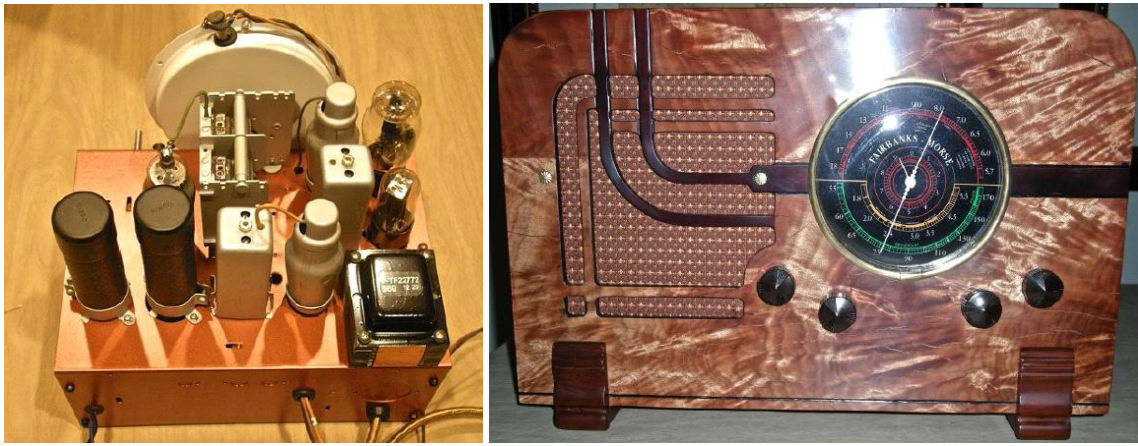
Luckily, the chassis originally sported a hammered paint scheme which was well reproduced, saving the fastidious work of replating. Reproduced stickers complete the aesthetics of the chassis.

Electronically, a replacement of the power transformer was necessary. All capacitors were replaced and all resistors checked for tolerance, most checking out. A proper alignment and excellent sound came out of the speaker witnessed by a video.

The very nice dial is a reproduction and gives pride to the set.

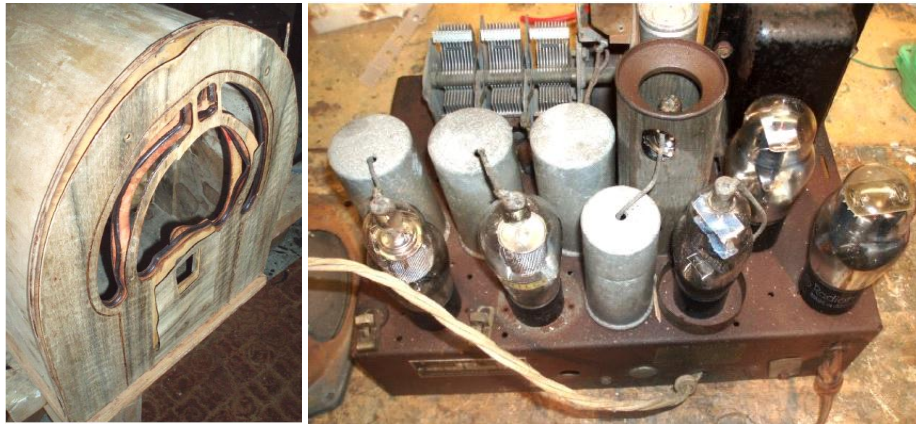
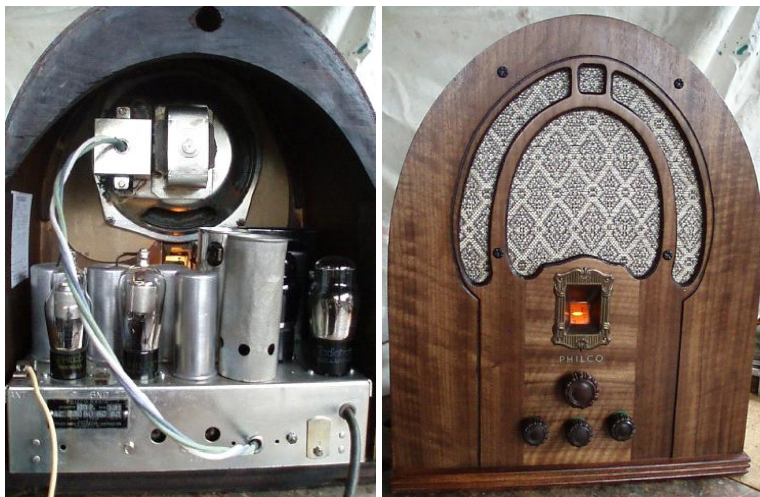
The New Zealand Vintage Radio Society (NZVRS) came up with another American set, a Philco 89E. Now this is a definitive basket case. Final results demonstrate above average work. Remaking the face plate, the replated chassis and speaker are highlights of this restoration. Those who've worked on Philcos' of that era know well the tar filed, Bakelite encapsulated capacitors which needed replacement are a task to restore. Resistors kept their original look and replaced wire was cotton covered.

The polyurethane finish even if good looking was criticized by many judges. Modern products should be avoided if old style products still exist like Shellac and lacquers.

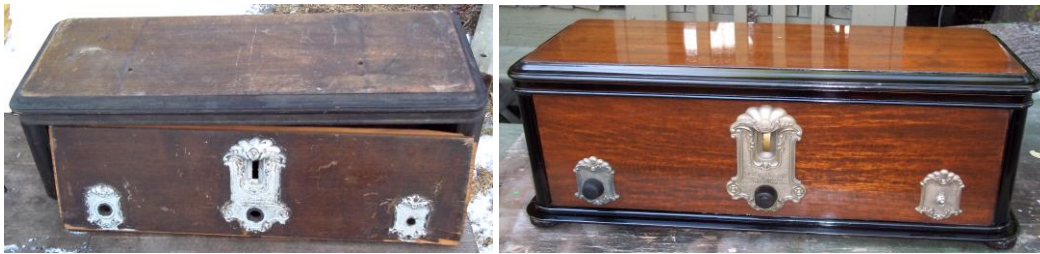
The SQCRA, your host for this contest presented a Radiola in extreme poor shape. Reproduction of many wood parts was necessary as they were missing or scrap. Judges recognized this and points award reflected this for the cabinet. The repainted chassis did not prove to be a tough challenge and a lack of photos of the underside of the chassis was noticed and marked down.

With the participant conceding that the set did not perform perfectly plus video lacking made the set lose points on that criteria, ranking in fourth place.

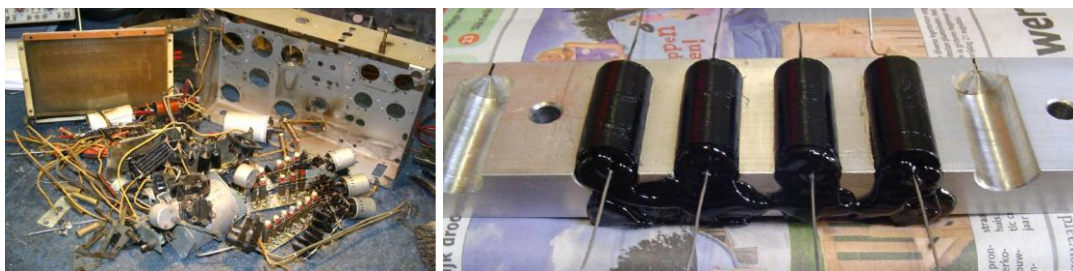
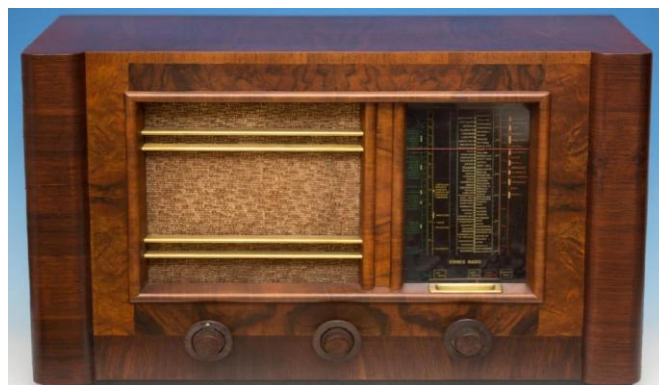
For a first time, NVHR from the Netherlands presented us the only European set, an Erres KY159 from 1936. Again, no initial pictures prevented the judges from scoring adequately on the 'as found' cabinet criteria.

The highlights of this restoration is without a doubt the labour involved in removing every single piece of electronics from the chassis in order to fix heavy oxidation caused by chemicals from the perforated electrolytic capacitor cans.

More than 350 photos were taken during dismantling in order to replace every single component and wires in the exact same spot and position just like initially. God videos allowed for everyone to witness the proper working of the set.

Another neat trick is the fabrication of aluminum molds in order to recreate tar capacitor envelopes concealing new ones. Identification was added like the old ones.

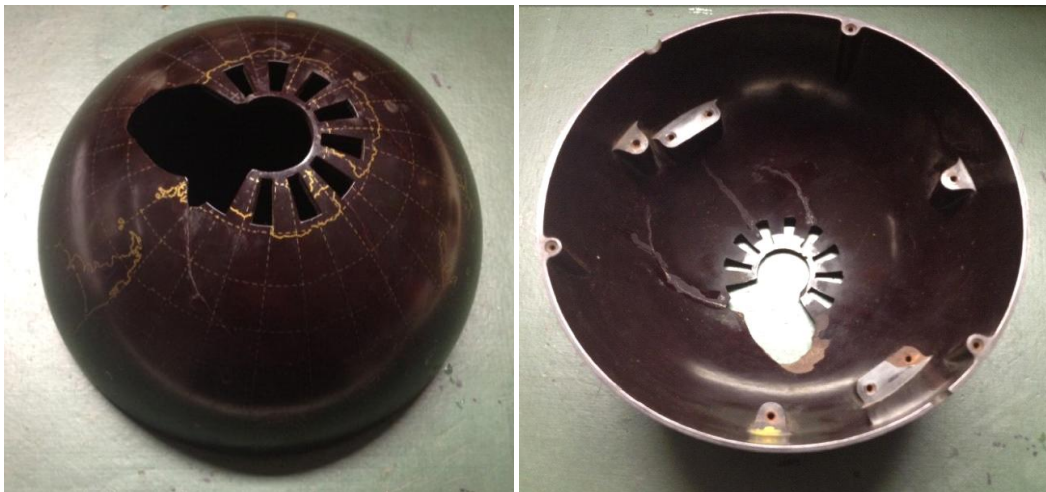
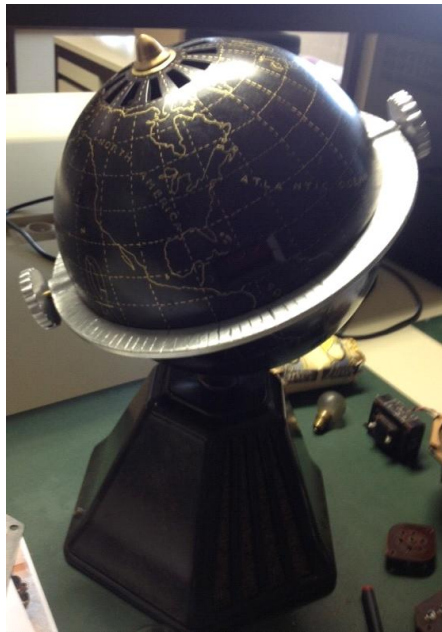
Nice presentation from the Belgium association Limburgse Radiovriend and their member M. David Agresti with Colonial Globe radio. Bakelite being relatively easy to repair, usually, has had quite a challenge because of the shape and technique used. M. Agresti used the Bakelite from a donor radio with similar color and reduced it in a powder. For the shape, clay was used and pressed against a good part of the globe and hardened in position to fix the shape in the clay. Removed it was applied to the large gaping hole. Then the hole was filed with a mixture of the Bakelite and glue in excessive amount. Once dried, sanding and polishing completed the structural repair. Continents were reproduced using a gold ink pen and looks as good as new when done.

Many parts were missing, so machining and sheet steel workmanship were necessary to reproduce them. The work is quite stunning. Moreover, more electronic parts were missing and a second radio from a friend was used to figure out what was missing, measure and copy the other parts. Original capacitors were stuffed with new ones.

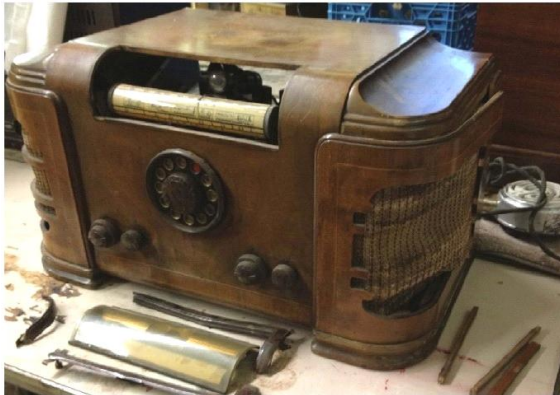
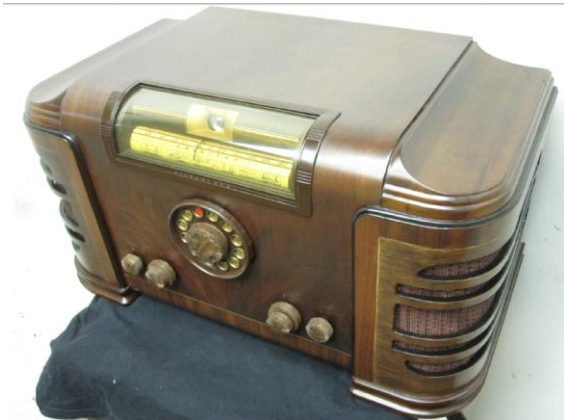
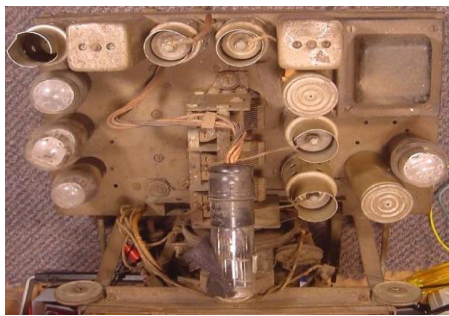
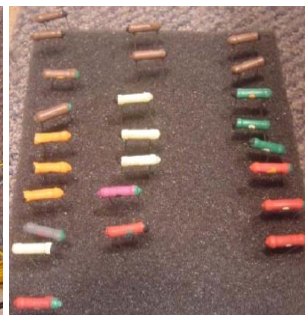
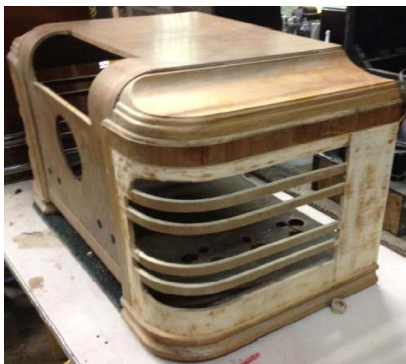
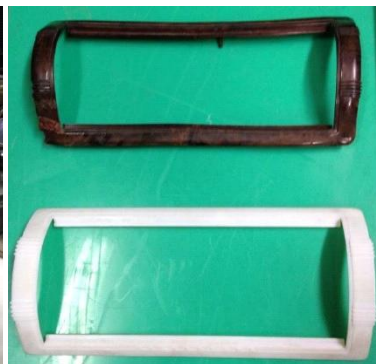
The Society for Preservation of Antique Radio in Canada (SPARC) located in a museum in British Columbia with a team effort went on to present us a peculiar Silvertone 4766 wood table radio. With its telephone dial and curved shapes and large size, it makes an unusual radio.

Extensive work was necessary to restore the rough cabinet. The very dirty chassis received all the necessary cleaning and a lot of attention to details was applied to the capacitors, originals stuffed with new ones in order to put it back to work and keep the original look.

One of the strongest points and novel technique of all the entries was the reproduction of the escutcheon surrounding the round lens. As many people know, this type of plastic was non durable, twisted and broke with time. The unstable formula which had faux wood motifs is very hard to reproduce and reproductions are seldom seen from the resellers. One of the members had access to a 3D printer and worked to reproduce this complex shaped piece. It's really fun to see the latest technology come to the rescue of the hobbyist.

The extremely dirty chassis received necessary amends to make beautiful again, detailed cap renewal with new ones going in the originals. An interesting technique was used to reproduce resistors with a fibreglass fishing pole, cut to length, stuffed and painted like the original colors make for an authentic look.

Missing pieces of wood for holding the speaker and were reproduced, copied from another set the museum has in store. Authentic finish made the cabinet stand out and the museum will benefit with this nearly brand new radio.
