# Restoring a Patterson Model 308 – Gerry O’Hara for SPARC

### **The Patterson Model 308**

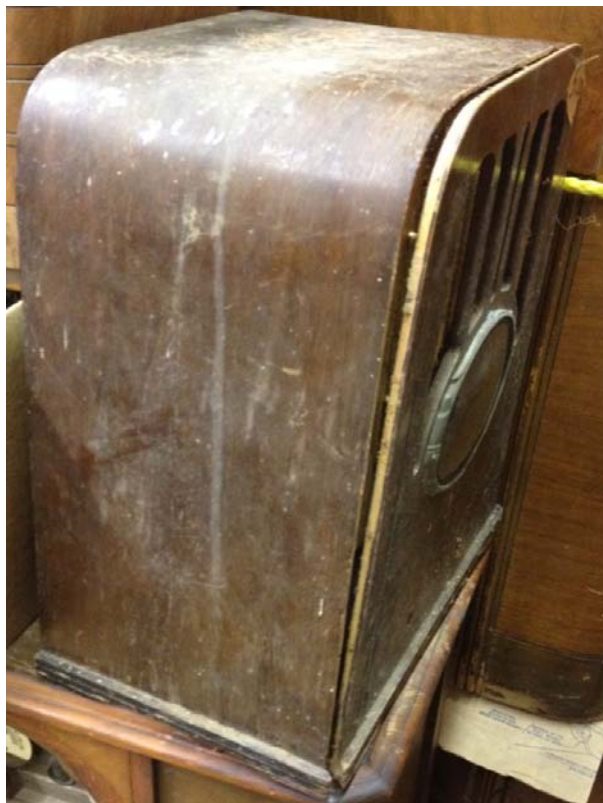
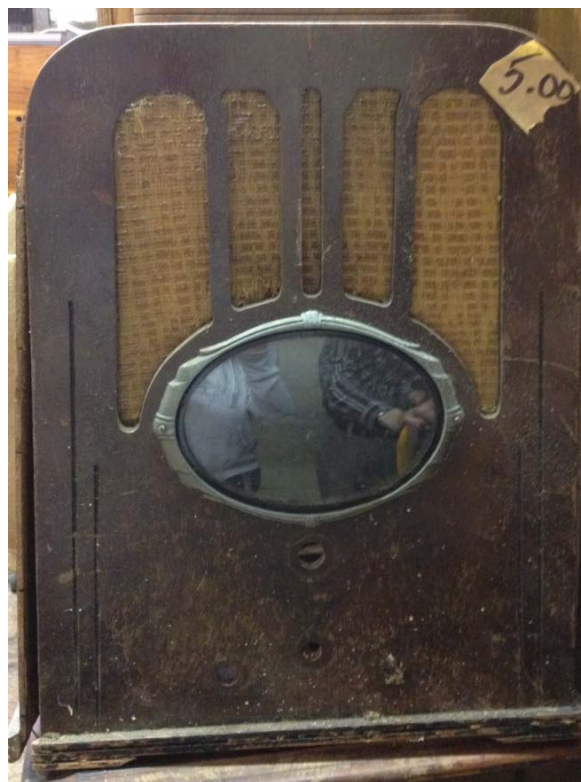
The Patterson Model 308 arrived at SPARC in an extremely dilapidated condition (photos below and right). The cabinet was literally falling apart at the seams with little of its

original finish remaining – so, did someone get a bargain at the marked price of \$5?... The chassis was very badly corroded and was covered in a thick layer of spider webs, mouse droppings and what looked like rotted straw. Removal of the chassis bottom plate revealed why – it had played host to a family of mice for a number of years: the inside of the chassis was littered with straw and other nesting materials,

mouse droppings and more rusty metal – mouse urine had taken its toll on the inside of the chassis also, but not to the same extent as the chassis top. The tubes that were present, all metal envelope types bar one, were mostly equally as corroded, as was the power transformer. The dial scales were so warped as to prevent the tuning mechanism acting at all – not helped by the slow-motion dial being almost seized solid.

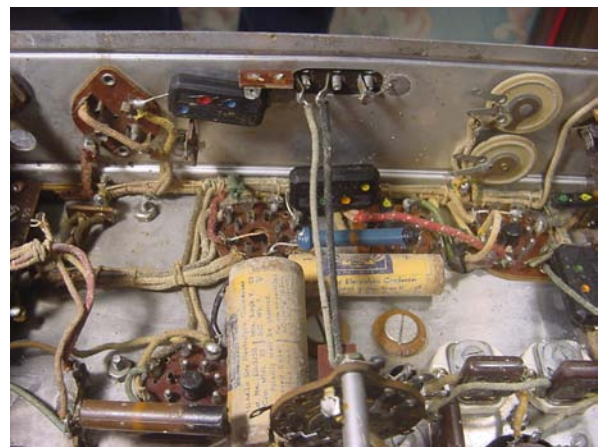
Inspection of the underside of the cleaned-up chassis (photos below and on next page) showed that some thought and care went into its construction and layout, with most wiring being contained in a loom skirting around the edge of the chassis.

Unfortunately, most of the paper capacitors that Patterson (Gilfillan) used in this set were of the 'Micamold' variety – a type not noted for their longevity. These are arranged in a rather regimental way around the edge/across the base of the chassis.

Some historic repair work was evident, including replacement of the two 16uF 450vw tubular can electrolytic capacitors with a dual 16uF 450vw part, unfortunately with the original two tubular can capacitors having been removed from the chassis, thus

leaving two gaping holes (ideal for mouse doors!). Further inspection revealed some clipped wires, including a green wire emerging from the wiring loom at the front and rear of the chassis, running to a tagstrip near the front of the chassis. Also noted on this initial inspection was that there were two wirewound pre-set potentiometers and a switch mounted on the rear panel that were not shown on the Model 308 schematic.

It was also noted that the tuning gang fitted was only a two-gang part, whereas the schematic calls for a three-gang part, i.e. one section for the antenna coils, one for the converter (mixer grid) and one for the converter (oscillator). After some head scratching and circuit-tracing, it seemed that the 6K7 'RF' tube (a 6J7 was actually fitted when the set arrived at SPARC) was a dummy – it apparently did nothing useful in the circuit. This tube had its anode and screen grid tied together to HT through a resistor, the grid coupled directly to the AGC line and the heater connected – but no connections to the antenna or to the converter tube, and likely never were, with the antenna being coupled to the converter (grid) tuned circuits with what looks like all-original wiring. All the wiring around the converter tube also looked original, as did the two-gang tuning capacitor (and matching connection holes in the chassis) and wiring to the various coils. We were not

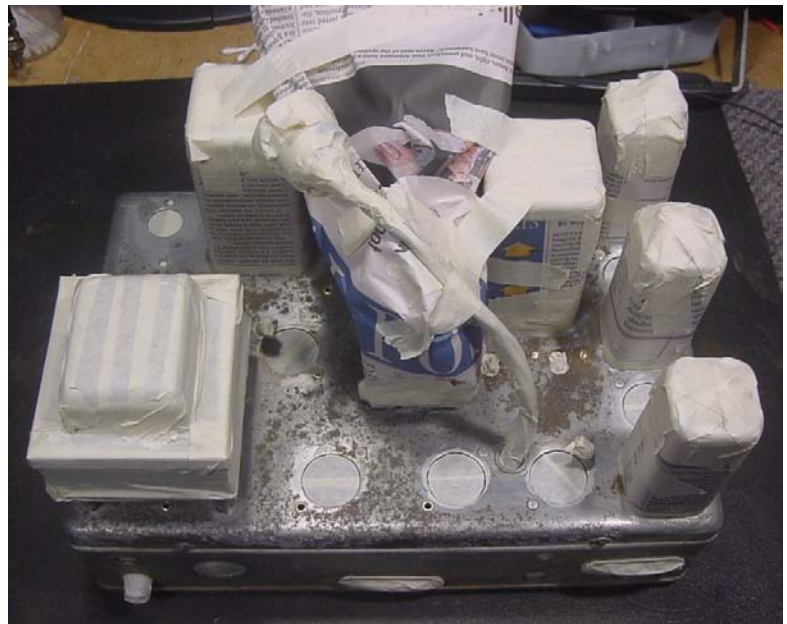
The chassis was in such a poor state that it was originally thought that the only way to restore it was to strip everything off, sandblast it and rebuild the radio from scratch. However, this is not the preferred solution if it can be avoided as what you have in the

end is a rebuilt radio, not a restored radio. So, instead, a partial strip-down was undertaken, with the tuning gang and mechanism being removed from above the chassis, along with all the Micamold, tubular paper and electrolytic capacitors (temporary labels being placed in the chassis – photo, left), the switch and pre-set potentiometers from below the chassis. With these parts removed, along with the twin 16uF 450vV capacitor, itself a service

replacement, the rust was removed from the chassis and transformer using wire brush/sandpaper and then neutralized with 'Naval Jelly' before masking the remaining parts, priming and spraying with metallic-finish paint. The IF cans were cleaned and polished and the power transformer painted black. The badly-corroded tuning gang was then painstakingly cleaned, re-assembled, lubricated and re-installed on the chassis.

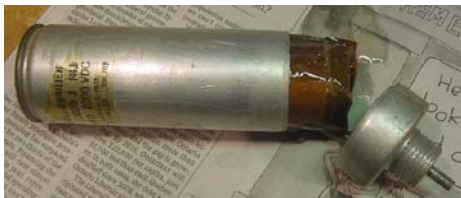
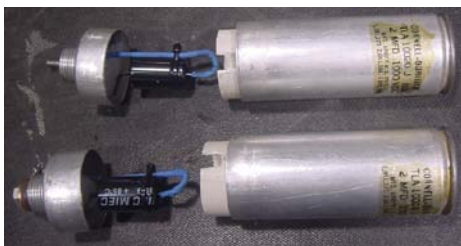
Two matching tubular can capacitors were found in the SPARC stock and these were re-stuffed with new 16uF 450v electrolytic capacitors, and fitted to the chassis in the holes previously occupied by the originals. Reproduction labels were made (Cornell-Dubilier) based on their 1936 catalogue illustrations and fitted to the capacitor cans. The re-stuffed tubular can electrolytics (photos, below and end of article) were then wired into the circuit.

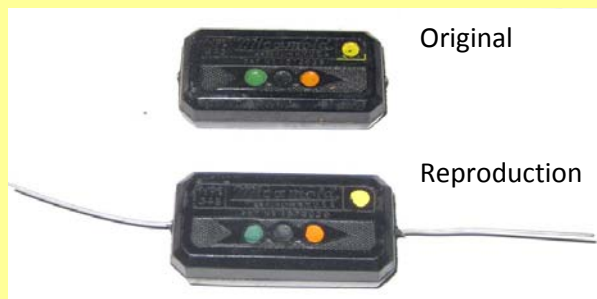
### Steps used to Reproduce 'MicaMold' Capacitors

- cut the leads off the original capacitor
- using Lego blocks build an enclosure slightly larger than the original capacitor
- place a thin layer of contact cement on one side of the original capacitor
- lay the original capacitor in the base of the enclosure using the cemented side to affix to the Lego blocks
- pour Smooth-On Mold Star 30 material over the original capacitor

- let dry over night and remove the original capacitor
- place the replacement capacitor in the mold

new 630vw poly film capacitors embedded in the mould (sidebar, previous page). These replacement parts (13 in all) were then installed in the original locations, maintaining the original orientations, paint markings and lead dressing. An extra Micamold capacitor reproduction was manufactured to serve as the converter stage AGC bypass capacitor that had been removed from the circuit sometime in the past.

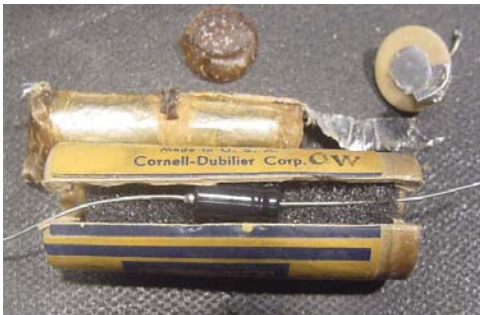
The two tubular paper capacitors were re-stuffed, as were the two tubular electrolytics (photo, below) located under the chassis.

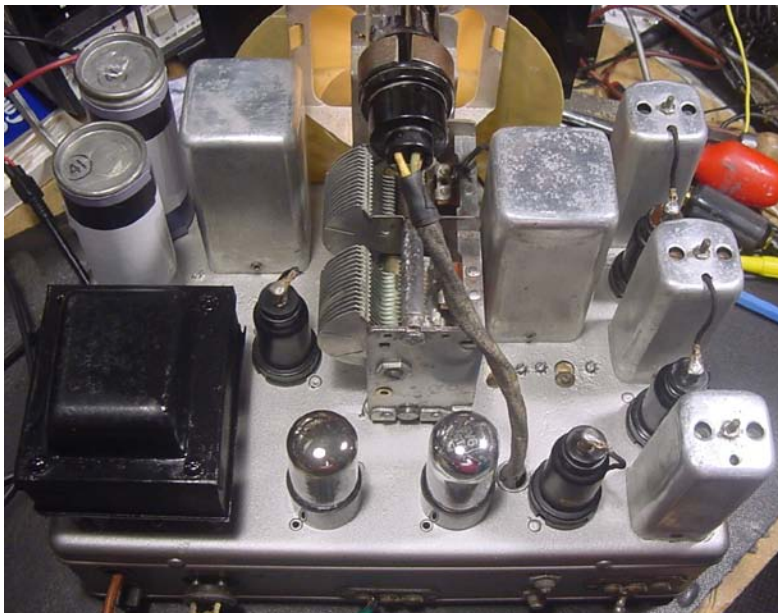
The chassis was initially tested with the 'cold' end of the converter (grid) coils connected to ground as it was wired when received. However, this resulted in the set overloading on strong signals. Connecting the cold end of the converter coils to the AGC via the 500Kohm resistor noted above and bypassing with a 0.1uF capacitor (a reproduction

Micamold part) resulted in the AGC working as it should, i.e. on the first IF and converter, with no overloading, even on very strong signals. It was also found that the set occasionally 'motorboated' ('put-put' sound), depending on the strength of the received signal. This problem was traced to instability in the RF stages, being the result of a 0.25uF bypass capacitor being reconnected as it was

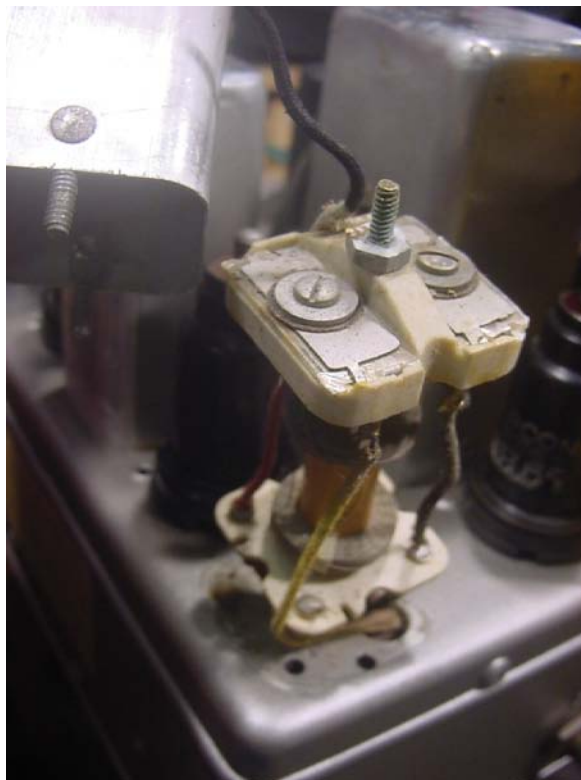
During an initial soak test, the set started to crackle intermittently. This was traced to the 1st IF transformer – moving the grid wire emerging from the top of the transformer can started or stopped the noise, accompanied by a change in the set's sensitivity. The screening can was removed and the fault was identified as a dry joint where the grid lead joins to the trimmer/transformer secondary winding (photo, right). This joint was cleaned and re-soldered to effect a cure. It was noted that this IF can also housed two resistors not shown on the schematic (perhaps not surprisingly given the other variations found in the circuit...).

As noted above, the output tube fitted on arrival was a 6F6 (should be a 6V6 per the schematic). The 6F6 draws more current and thus generated 35v on its cathode and ran very hot, with the audio becoming distorted after a few minutes. The 6F6 was replaced with a 6V6 and the audio then worked well, with around 13 volts on the 6V6 cathode (close to the 15 volts specified in the Riders information) with no audible distortion.

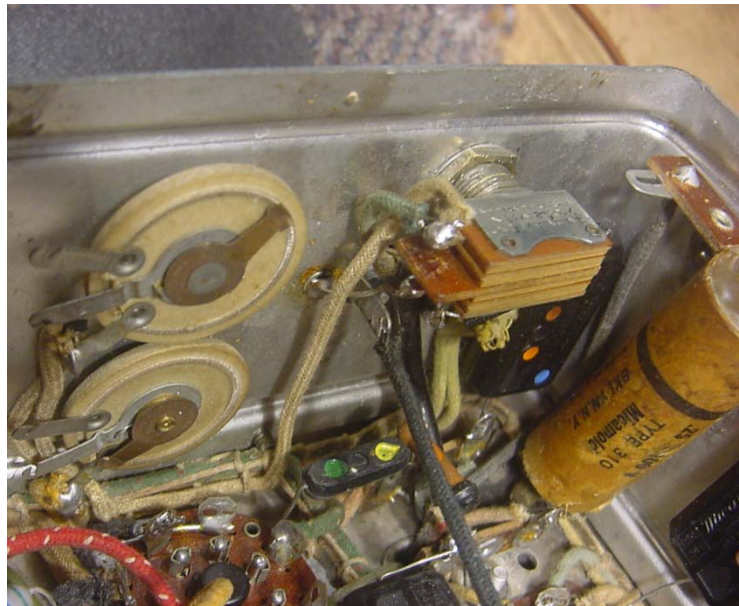
Now it was time to try to resolve some of the mysteries. Someone at the Museum noted that the pre-set potentiometers (photo, below) may have grounded wiper arms (grounded through the chassis mounting thread). This was checked and was indeed the case – so they were probably performing a function after all. The wires from the upper

However, after some careful checking with an ohmmeter set on its lowest range, it was found that it was connected to the switch on the rear panel (the other side of the switch being grounded), as well as to the cathode of the previously-thought 'dummy RF tube' and the cathode of the first audio tube (6Q7) via a connection into the third IF can.

Checking the schematic for the twelve-tube model, it was noted that the wiring was similar (though not the same) as the 'silent tuning' tube in that model (6J7), although there was no variable adjustment or override switch shown on the twelve-tube schematic. With the set switched on, sure-enough, the potentiometer adjusted what signal strength was needed to mute the receiver. The switch was meant to override this by grounding the 6Q7 cathode – but did not as the switch was found to be open circuit. Replacing the switch with the correctly-working period part cured this issue and the circuit now worked well: the AGC varies the current through the 6J7 tube, which develops a positive voltage across the 1Kohm potentiometer. With the 6J7 and 6Q7 tube cathodes being connected, this in turn biases the 6Q7 off until a strong-enough signal allows the tube to operate. This function probably also explains the use of a 6J7 instead of a 6K7 in this application (sharp cut-off vs. variable-mu), though a 6K7 was found to work best and was left in the set. First mystery solved...

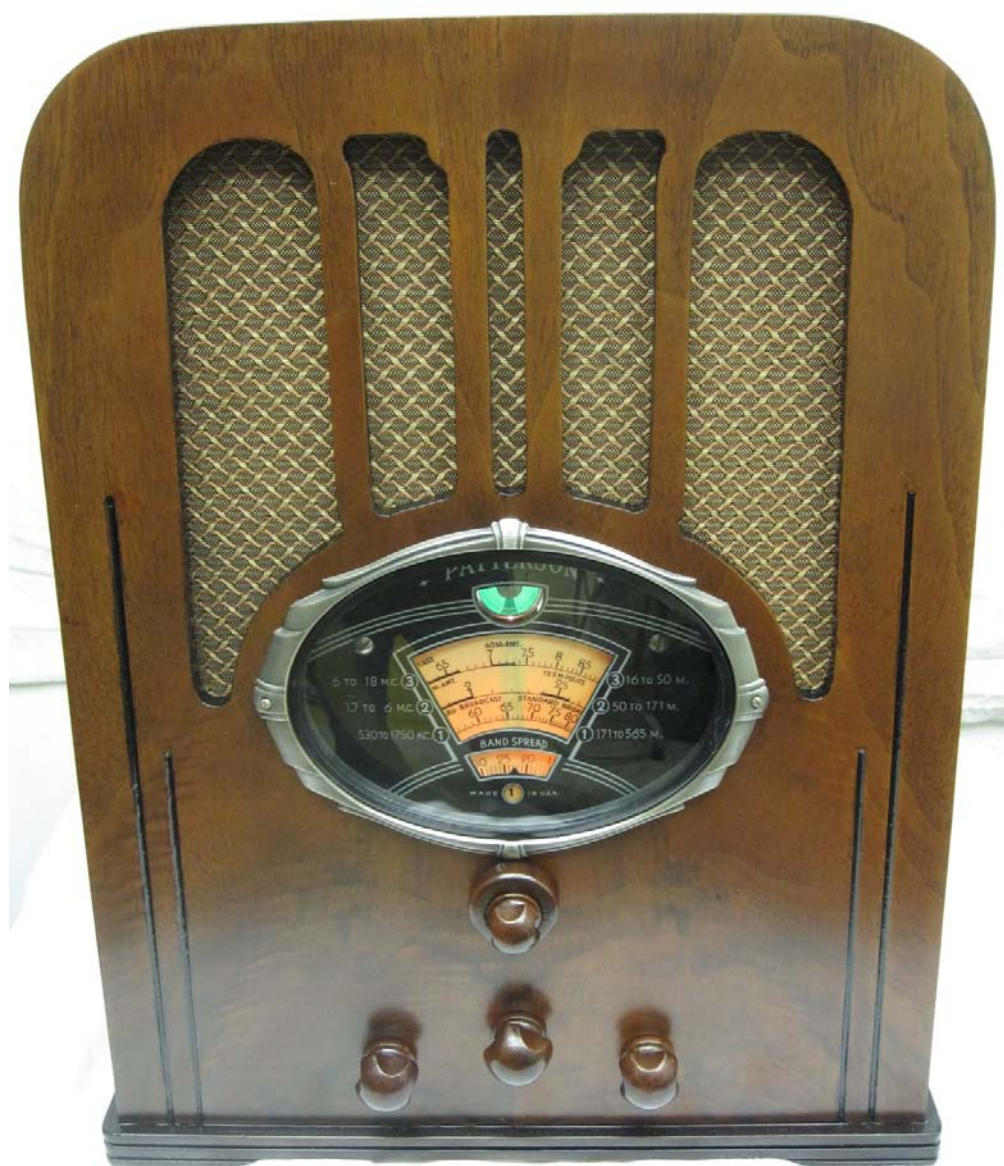
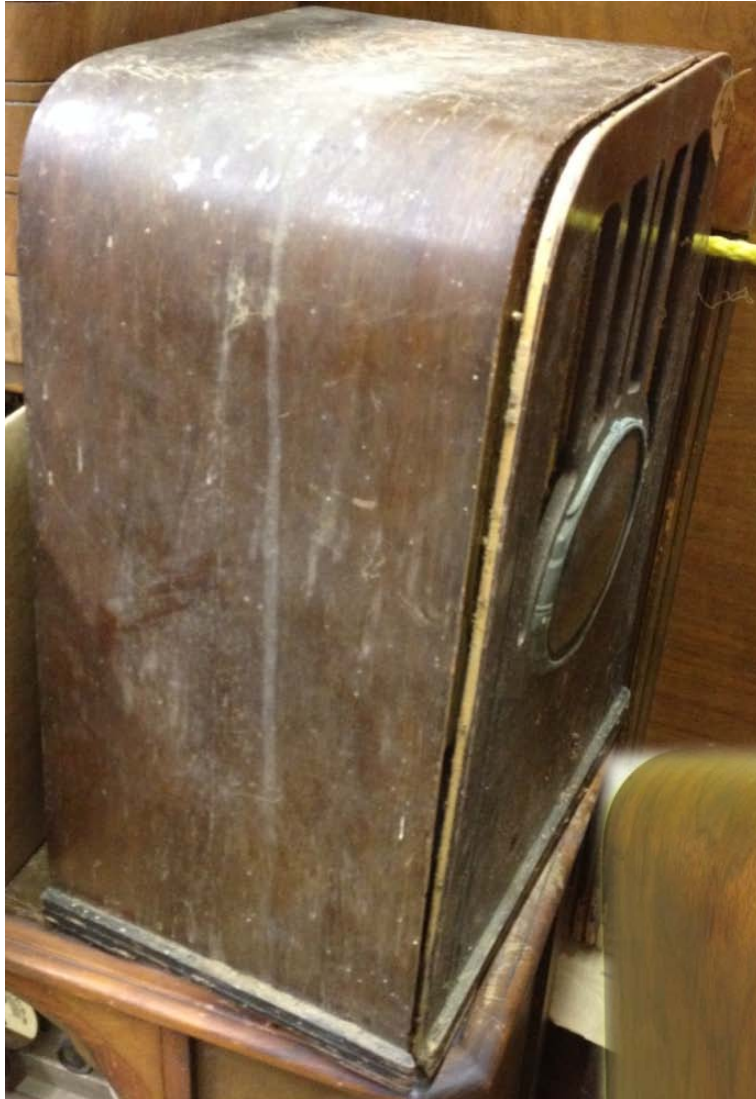
The cabinet on arrival at SPARC was only just holding together. Re-finishing proved a challenge as the veneer – beautiful as it is – kept wanting to part company with the underlying plywood. A reaction of the original glue used and solvents in the lacquer or the lemon oil treatment is suspected. Careful attention to this eventually proved successful, with the cabinet finally realizing its full potential.

The first job was to clean the filth off the inside and then re-glue the plywood where it had delaminated – several operations were needed to complete this. Next the front, bottom and top of the cabinet were reunited and glued/pinned firmly together.

undertaken using wood putty prior to being sanded down with 600-grit 'wet and dry' emery paper lubricated with lemon oil, grain-filled, and then finished in tinted lacquers, starting with the darker trim, the remainder of the cabinet being masked-off in stages until the desired contrasting tones were achieved. The entire cabinet was then given several coats of clear semi-gloss lacquer.

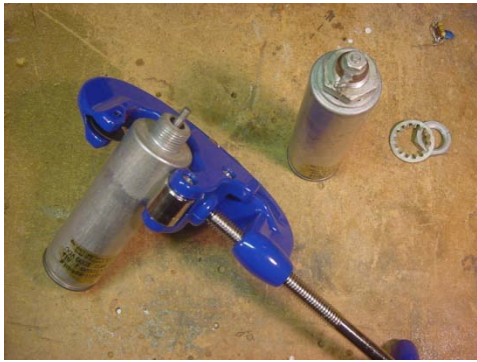
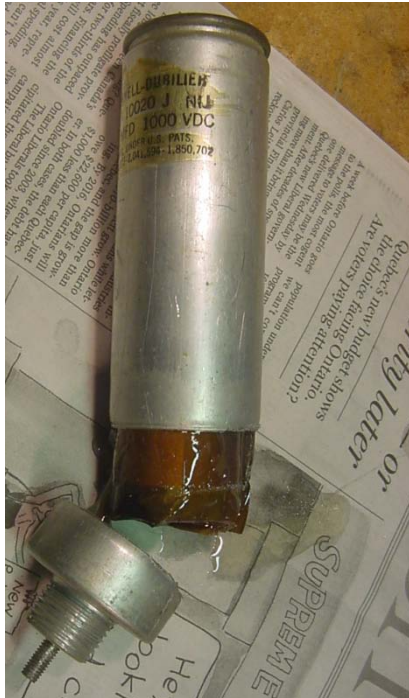
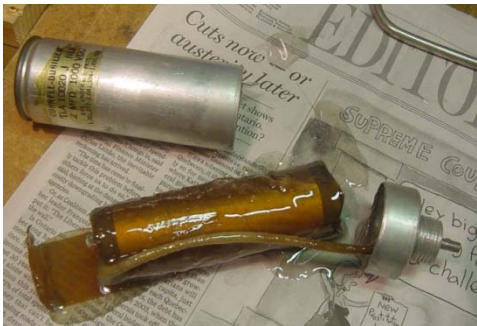
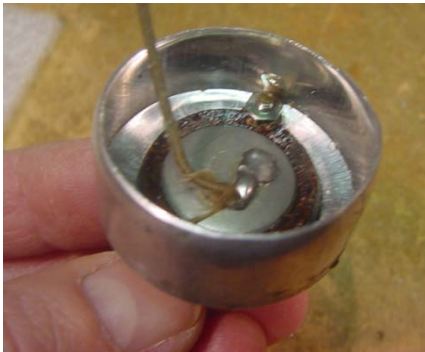
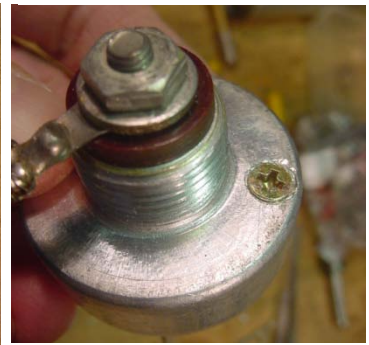
Step-by-step photos of can-type electrolytic stuffing: the original can electrolytics were missing from the chassis, so a suitable pair of can capacitors were selected from SPARC stock. These turned out to be high-voltage 2uF oil-filled paper types as can be seen in the photos. A plastic sleeve (PVC plumbing pipe) was epoxied into the top of the can and is a push-fit into the base - this adds rigidity to the assembly as well as insulation. The last photo shows a couple of label mock-ups.

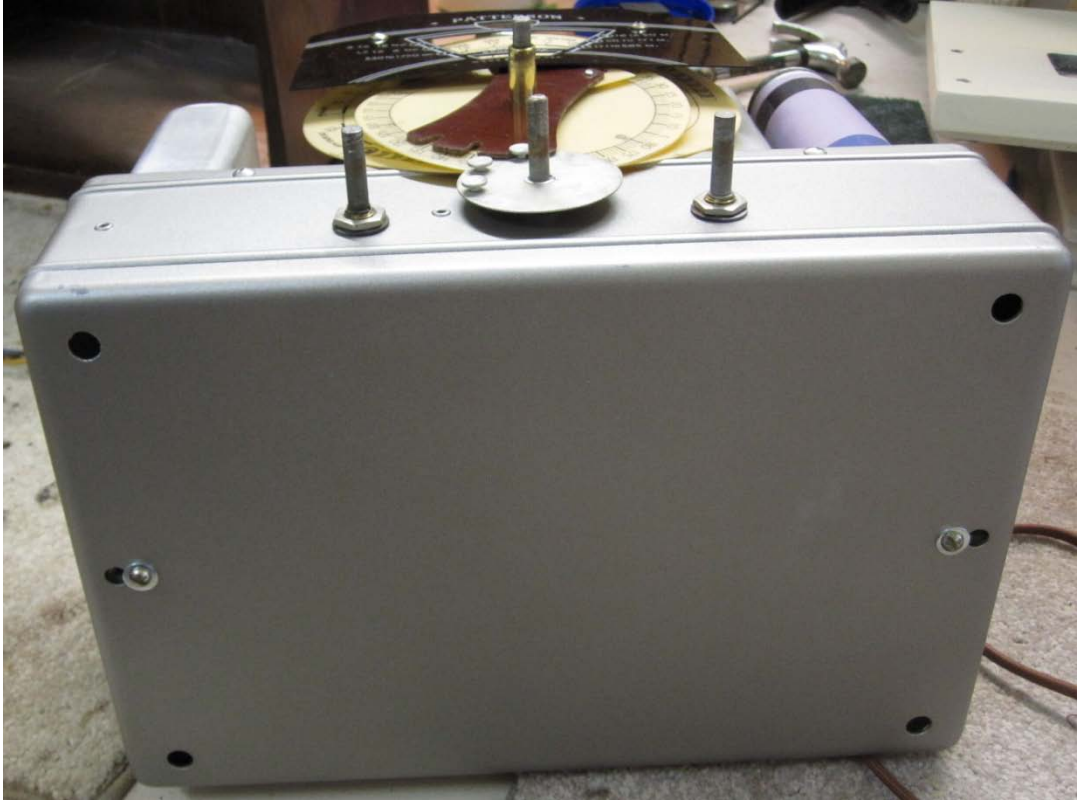
Above: chassis bottom plate re-fitted before installation of the chassis in the refinished cabinet,  
Below: the distinctive, functional, yet beautiful Patterson 308 dial – tuning eye glowing nicely

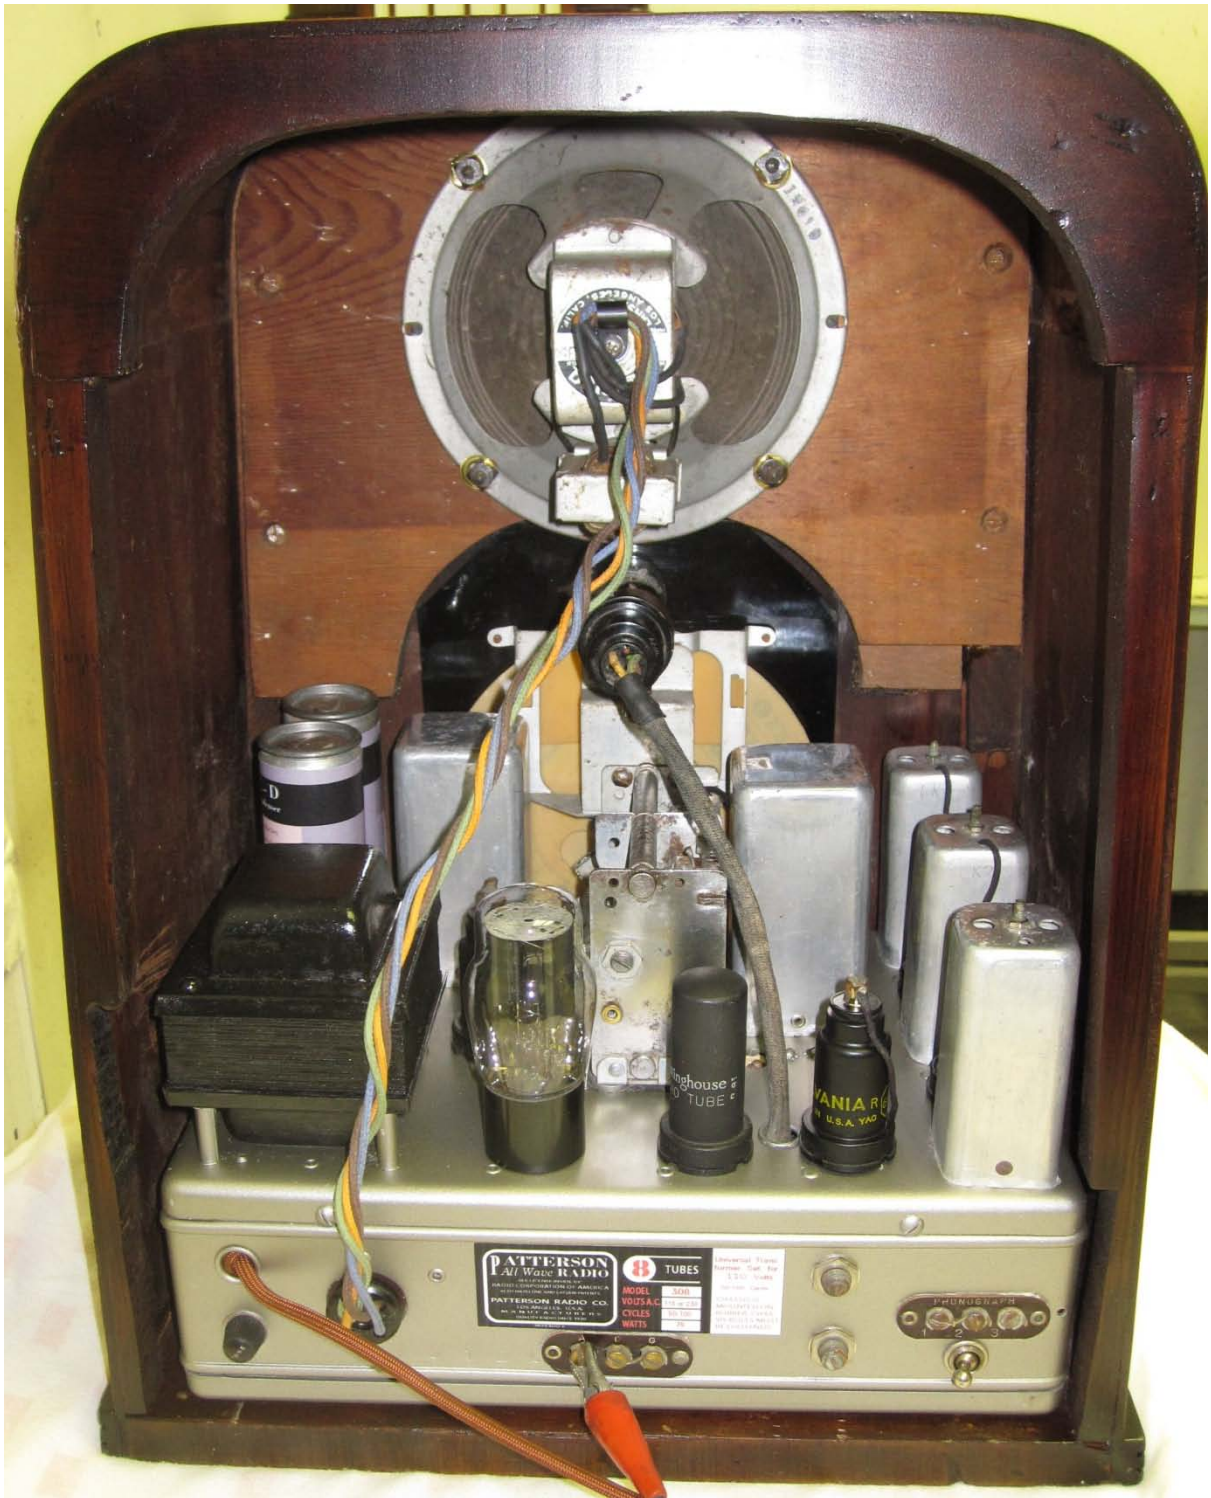
Above: restored chassis installed in the re-finished cabinet
