ATWATER KENT MODEL 708 RESTORATION

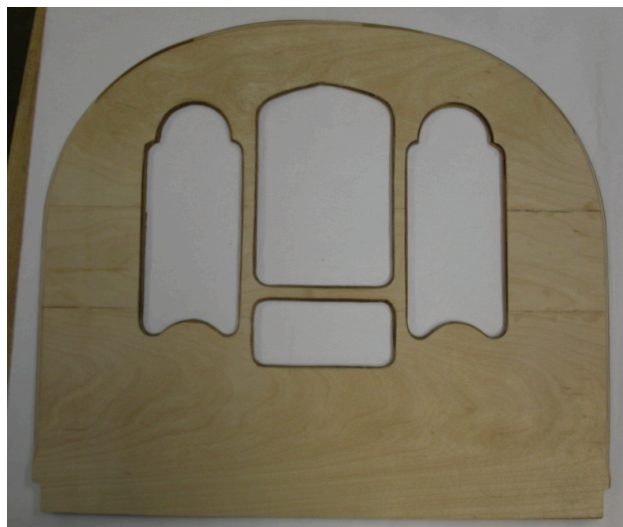
New Front Core Showing Added Birch Veneer

The next phase addressed the front panel core. The top layer of the core (just under the veneer) had nearly completely separated from the core, so I finished the job, removing this layer and all the veneer. The rest of the core was pretty solid. The removed top layer was replaced with a birch veneer and the grill cutouts made.

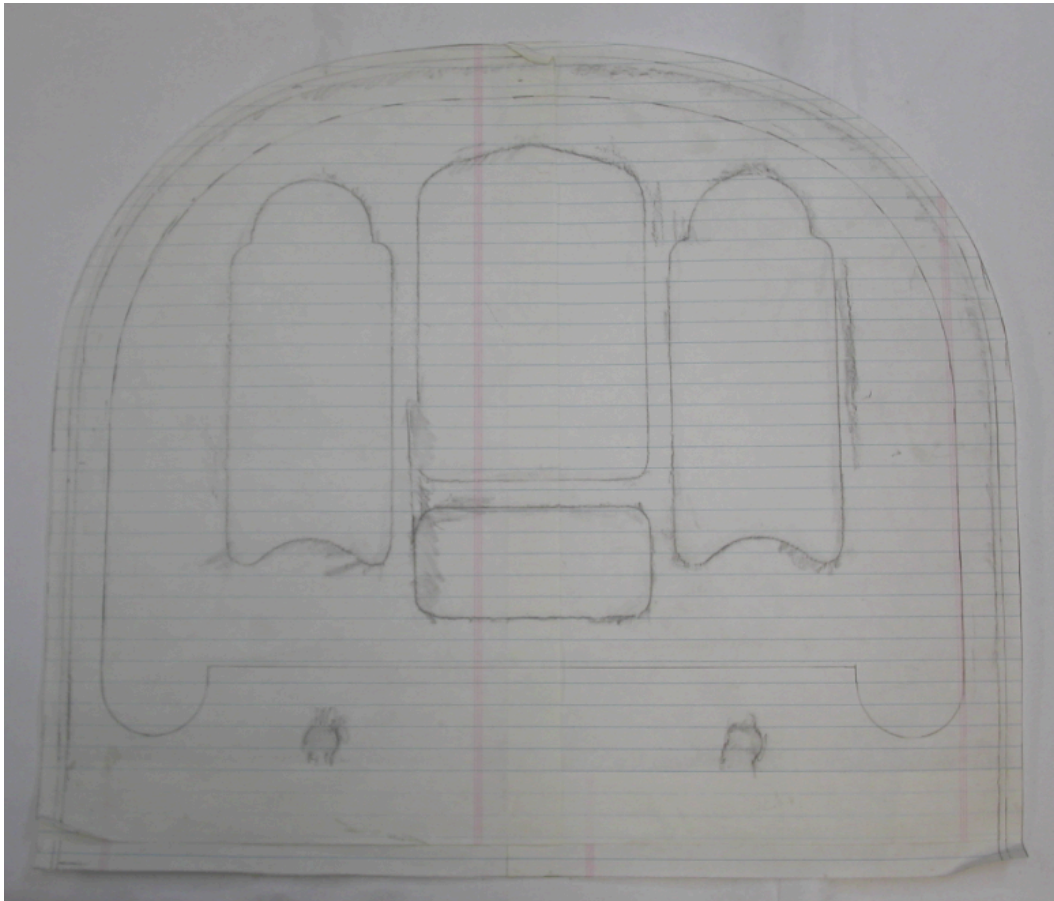
Tracing of Front Panel

The front panel veneer consisted of six different veneer pieces. The center piece surrounding the speaker cutouts was mahogany. The lower section was walnut burl or crotch. Of the four pieces surrounding the center section, the two side pieces appeared to be mahogany crotch and the two top pieces appeared to be mahogany straight grain cut with the grain running at about a 60 degree angle. Separating these veneers is a 1/16" wide groove that is black in color and slightly penetrates the first layer of the core. A tracing of the front panel was made by using tracing paper and rubbing the edges of the original front panel with the point of a pencil to produce an outline.

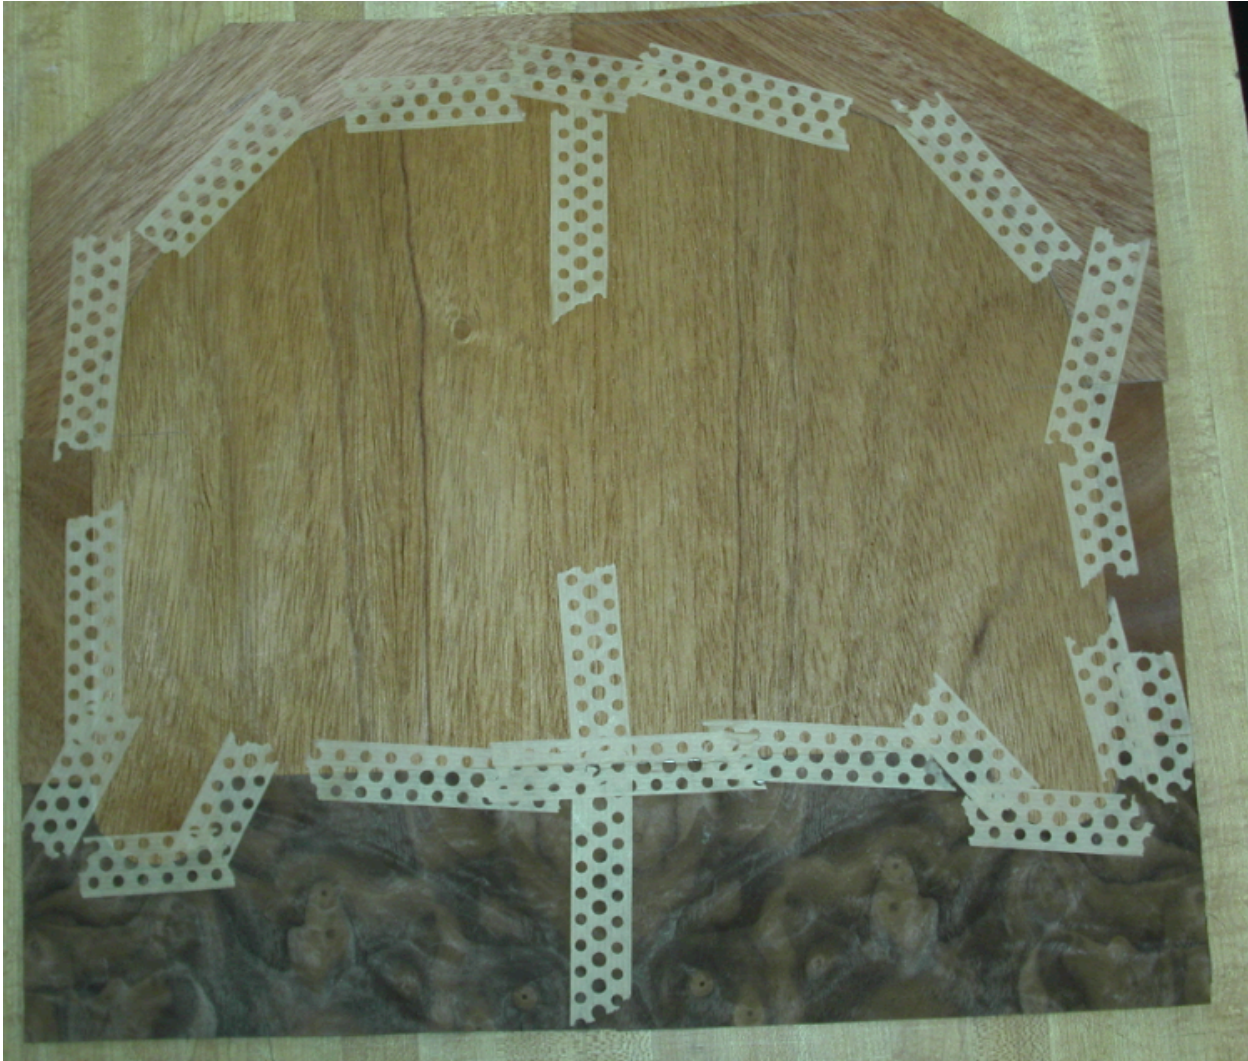
Veneer Pieces All Taped And Glued To Front Panel

For those portions that were missing, a flexible curve was used to match a corresponding section on the front panel and then transferred to the tracing. The veneer pieces were all cut to match the tracing and veneer tape was used to hold them all together for gluing to the front panel core.

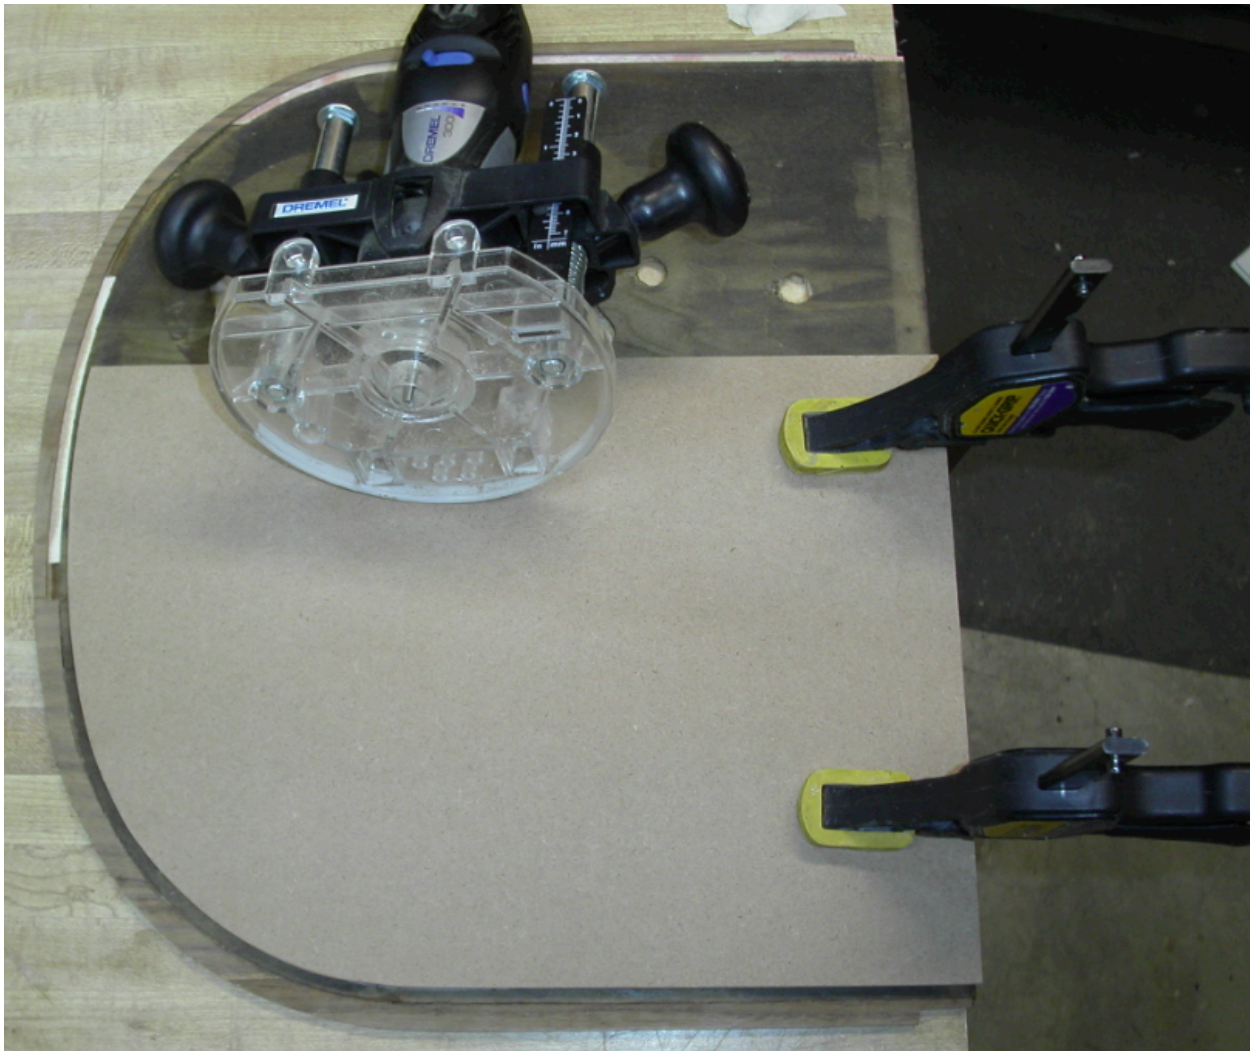
Routing Groove In Back Of Front Panel

The back of the front panel needed repair to the core and veneer that exists outside the groove for the case. The core in this area was build up with birch veneer and a walnut finish veneer to match the rest of the back veneer. A template was made from 1/4" hardboard to act as a guide to use the Dremel router with a 3/16" bit to route the groove in the back of the front panel to accept the cabinet case.

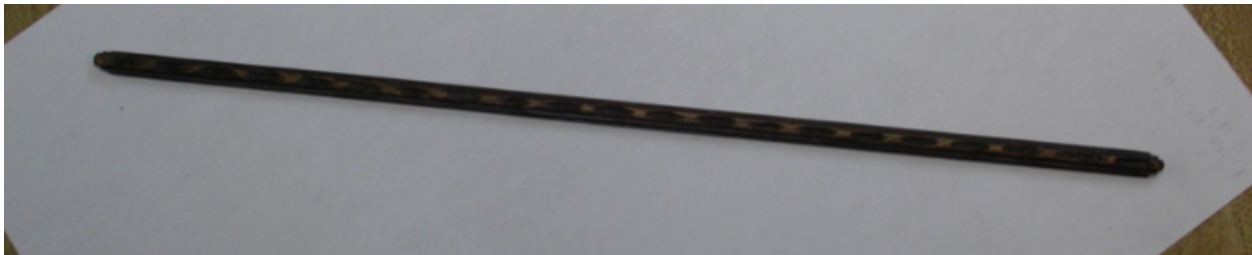
Completed Trim Piece

I decided based on these measurements to create the piece by building it up from four separate pieces of wood cut to the required dimensions and glued together. The top edge was rounded over by sanding and the semi-circular grooves were made in the rounded edge using a small X-Acto U gouge. This piece was sprayed dark walnut lacquer, the top edge sanded lightly to remove the dark lacquer and provide the highlights and finally finished with a gloss clear spray lacquer.

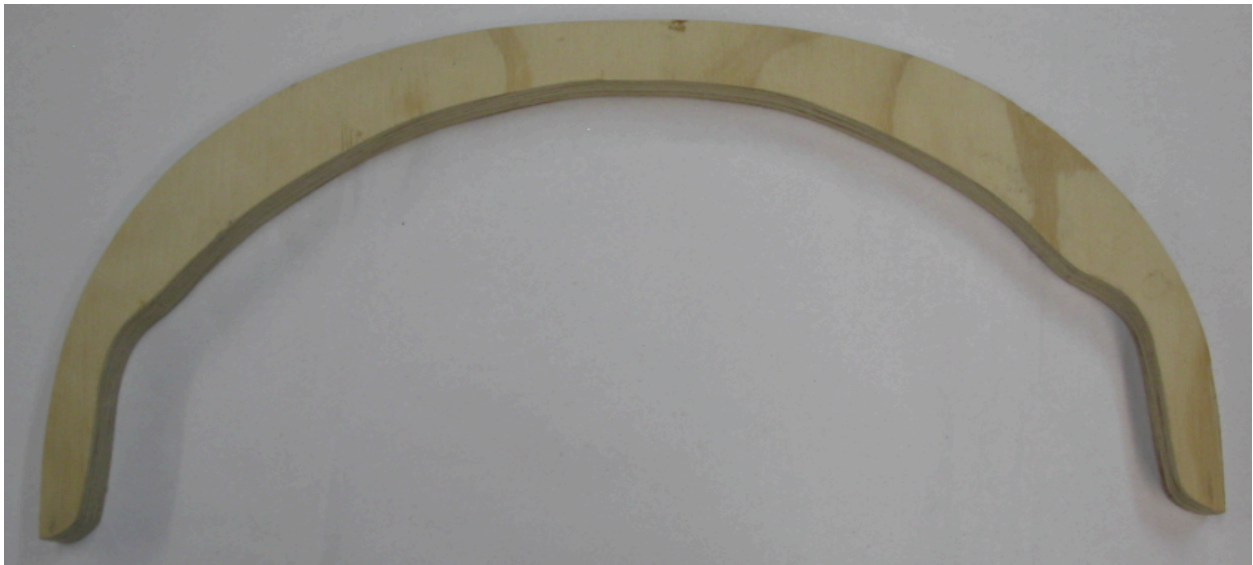
New Rear Cabinet Brace

The next step involved making a new base, which was the simplest of all the repairs. A piece of five ply $\frac{3}{4}$ " birch plywood was cut to the dimensions of the original base. The rear brace was next made by using the previous tracing of the front panel to trace the outline of the curve on another piece of $\frac{3}{4}$ " plywood. A $\frac{3}{16}$ " offset was drawn inside this curve to provide for the back of the cabinet shell. The bottom edge design of the brace was defined by using cabinet photos and estimating dimensions by using ratios from the length and width of the cabinet. This piece was then cut out on a bandsaw.

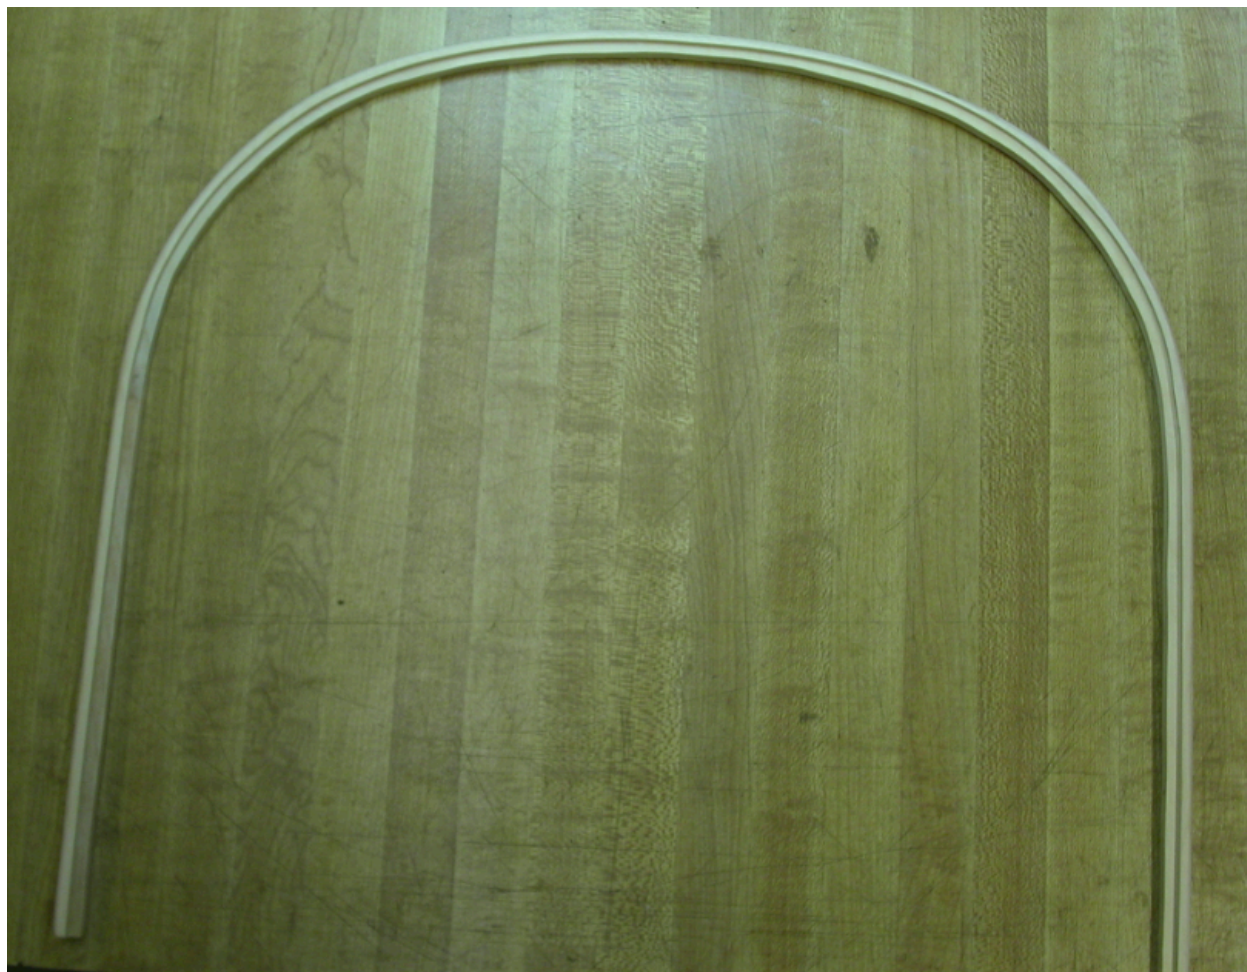
Rear Cabinet Trim Piece

Next the rear trim was made by using the same tracing of the front panel. The outside edge was traced onto a piece of $\frac{3}{8}$ " plywood. The hardwood template was positioned to provide for a $\frac{1}{4}$ " edging outside the top of the cabinet shell, a $\frac{3}{16}$ " groove for the cabinet shell and also account for the $\frac{5}{8}$ " router guide. A $\frac{3}{16}$ " straight router bit was set to provide a $\frac{1}{8}$ " deep groove and routed using the template. The outside edge of this piece was then cut out on the bandsaw and the inside edge was cut on a scroll saw exactly along the inside edge of the groove. The outside edge was then rounded over to match the profile in the AK708 pictures seen on the internet.

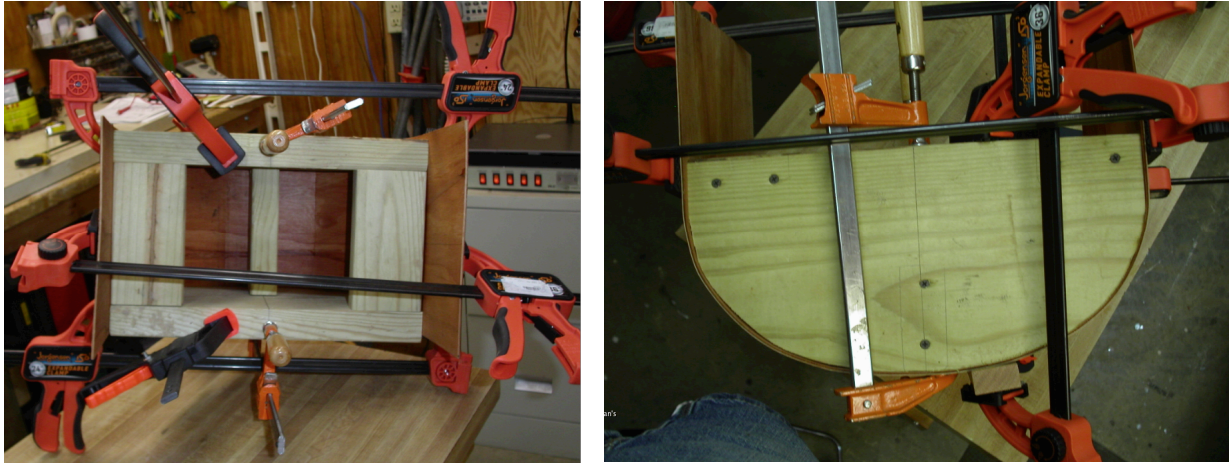
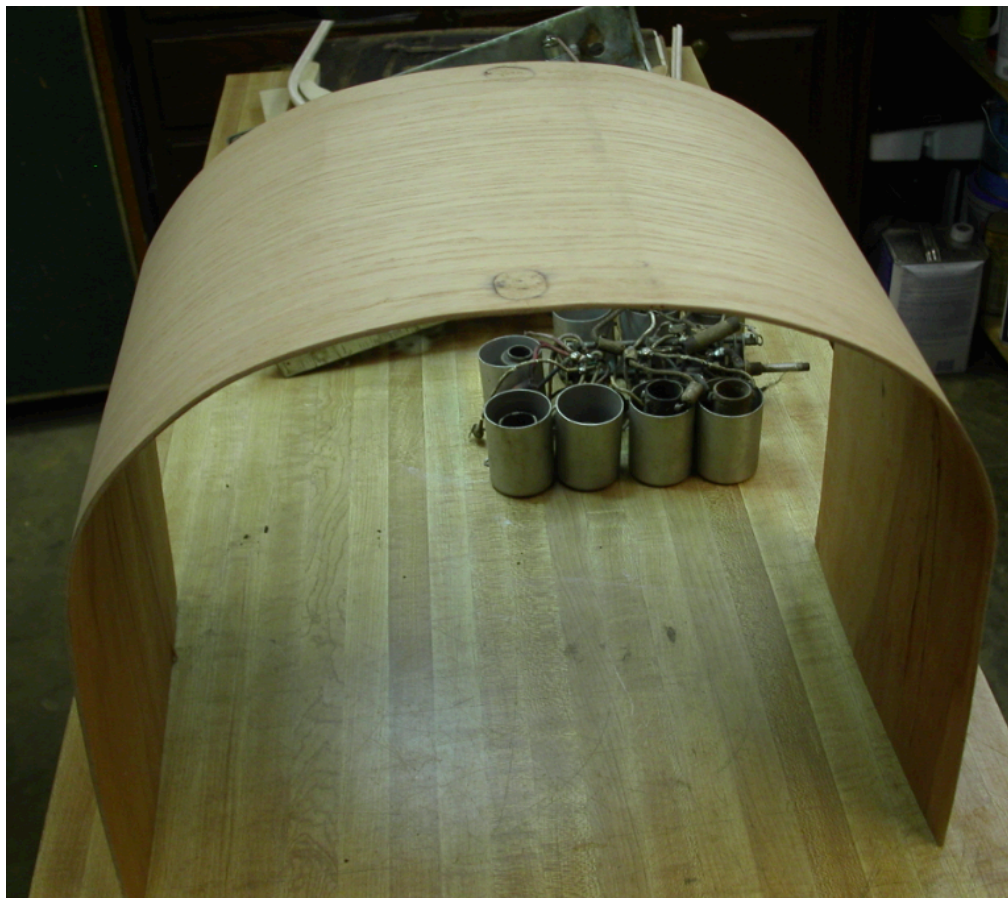
Forming Cabinet Shell

Formed Cabinet Shell

A piece of 1/8" plywood was cut to 9" x 35" to form the cabinet shell. A form was made from 1-1/2" dimensional lumber. The plywood piece was soaked for about an hour or so in hot water in the bath tub after verifying on a test piece that water would not cause the plywood to delaminate and that it provided enough flexibility to bend. The plywood was then clamped around the lumber form and left to dry for several days. When unclamped the form remained and matched the grooves in the front and back edging.

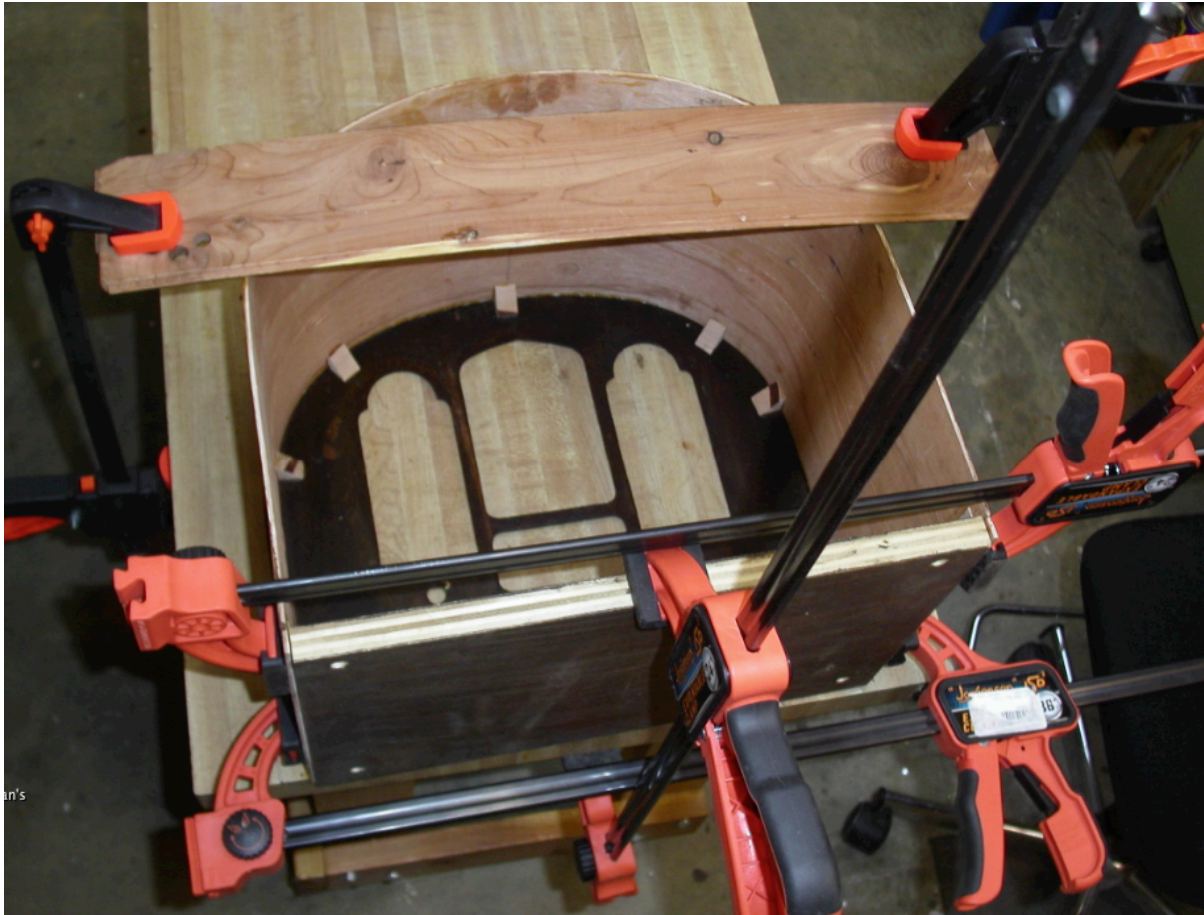
Gluing Cabinet Front To Shell

The veneered shell was glued to the base and front and when dry the rear brace and trim piece were glued to the shell. I wasn't able to do it all at the same time (not enough big clamps).

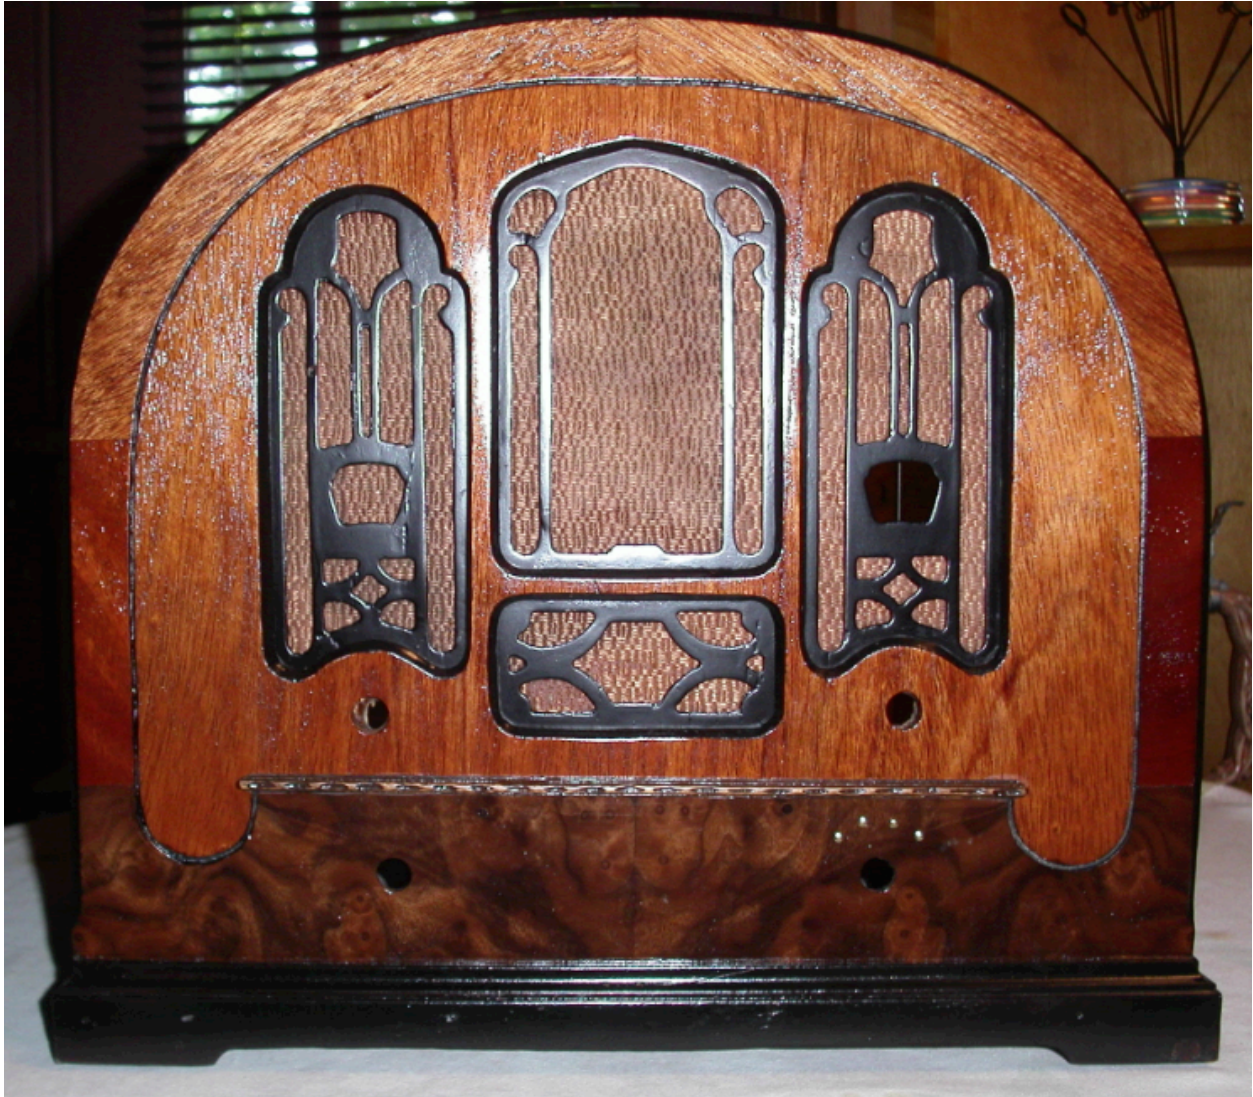
Completed Cabinet

The entire cabinet received several spray coats of lacquer sanding sealer and sanded with 320 grit paper between each coat. The cabinet was masked and the molding and edges then sprayed with several coats of extra dark walnut lacquer. The entire cabinet was then finished with several coats of gloss spray lacquer.

I removed four feet from another Atwater Kent cabinet, replaced the felt cushions and installed these on the base of the cabinet. Four brass nails were cut down and installed around the band switch shaft opening. The final finishing touches included stripping and refinishing the knobs in walnut stain and gloss lacquer, and reinstalling the refinished grillwork and grill cloth. The speaker grill cloth was in pretty good shape. It had no tears but was only a little faded, so I decided to re-install it as is after a little brushing and cleaning with water.

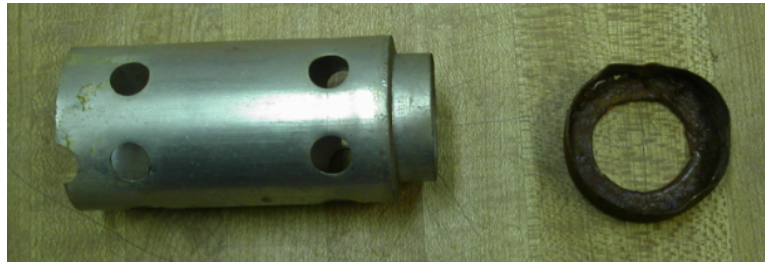
The transformer was disconnected next and then the volume control and switch. This cleared the top of the chassis. The tube shield for the 2A6 tube was rusted to the mounting bracket. In attempting to remove the tube shield the mounting bracket separated from the chassis. The bottom of the tube shield mounting bracket had rusted through. The diameter of the mounting bracket and tube shield was 1-5/8 inches. I had no replacement, so I looked for an alternative. An unused aluminum tube shield of unknown origin was found to have the same diameter. I cut off the top of the tube shield and was able to form two tabs which allowed me to insert the tube shield between the top of the tube socket and bottom of the chassis. While this mechanical connection is pretty firm, I intend to provide a positive electrical connection between the tube shield and chassis with a copper wire to ensure the tube shield will be electrically connected to the chassis when installed.

Tube Shield Used To Make New Tube Shield Mounting Bracket

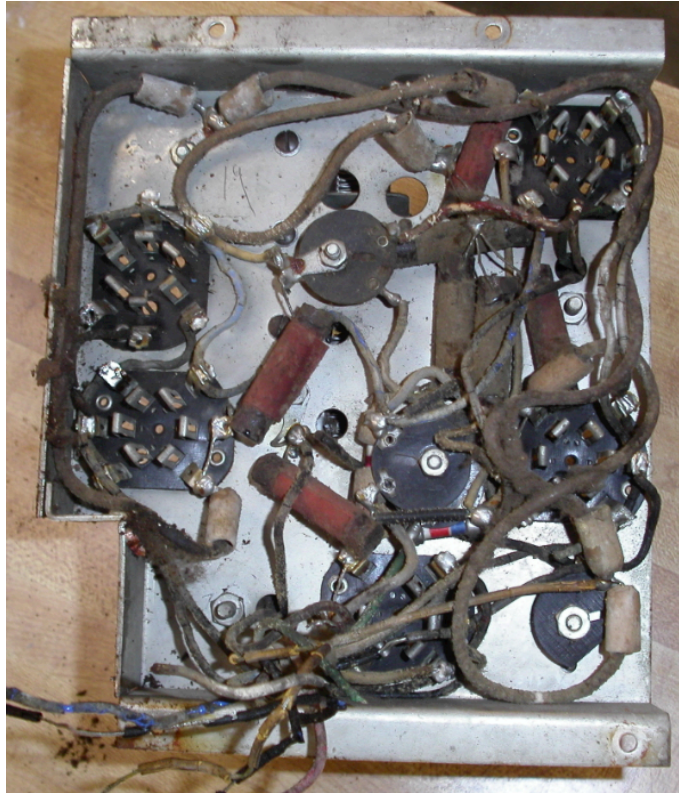
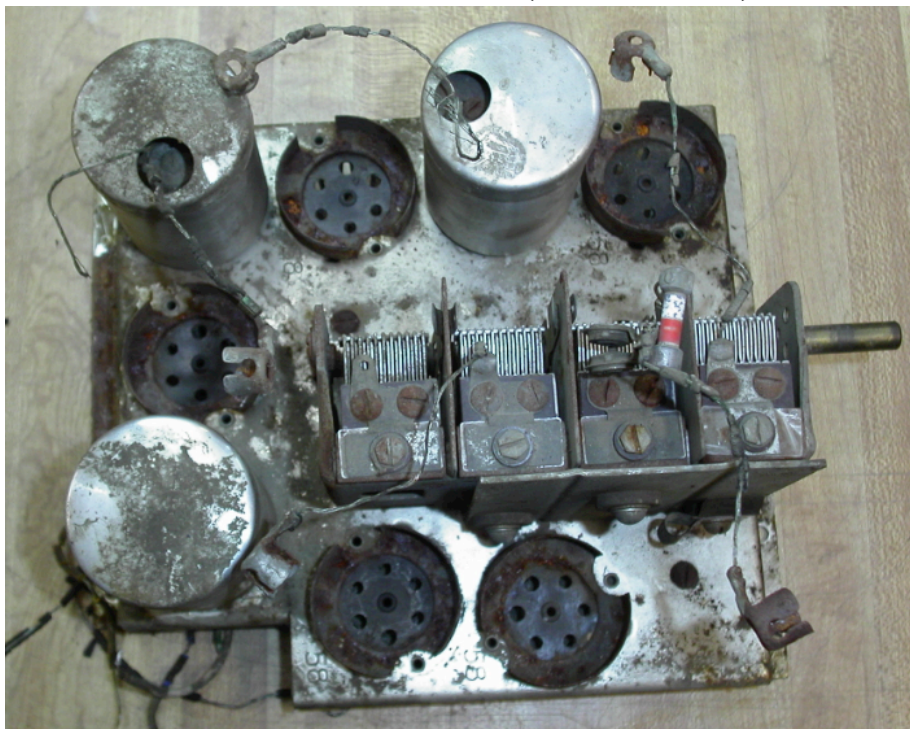
Removed Sub-chassis (Bottom View)

Sub-Chassis Top View

Looking at the sub-chassis, R11 was 200 Ohms vice 800 ohms but was not connected to the cathode of the 1st IF tube as indicated on the AK 708/808 schematic, instead it was connected to a flexible resistor (R11A ?) and a yellow wire that was connected to the cathode of the 2nd Det Cont/1st AF (2A6) on the main chassis. This flexible resistor (R11A ?) was connected to the cathode of the 1st IF. This resistor was open, so I couldn't determine its value, so I am guessing it was R11A which matched the AK 808 schematic. But the AK808 schematic had R11A connected to the cathode of the 2nd IF, to R11B, and to C12A. The existing arrangement matched neither the AK 708/808 nor AK 808A schematic. The remainder of the components and wiring appeared to match the AK708/808. There was no R11B flexible resistor or C12A installed on the sub-chassis.

Rewiring of the sub-chassis was begun. First I removed all the flex resistors and the paper capacitors. I removed the variable capacitor from the sub-chassis. This was cleaned using a degreaser and then flushed with hot water and dried using a heat gun. All the grid cap wires were replaced and the grid caps cleaned and polished to bright metal with a wire brush on the Dremel. The rubber mounting grommets were still in good shape so were not replaced. A little wheel bearing grease was placed in the front bearing. The sub-chassis was cleaned and re-plated in a similar manner to the main chassis. The effort was much less extensive and the plating actually stayed shiny vice darkening as it did on the main chassis.

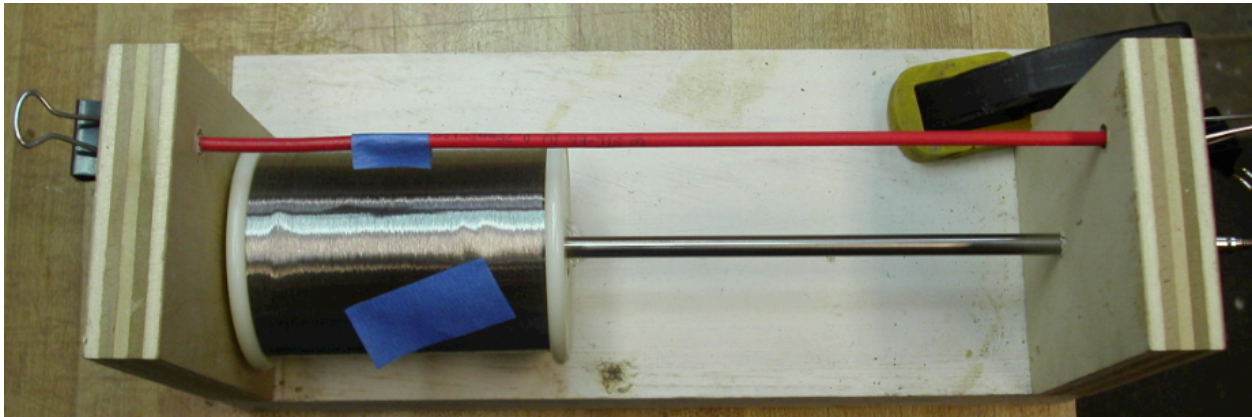
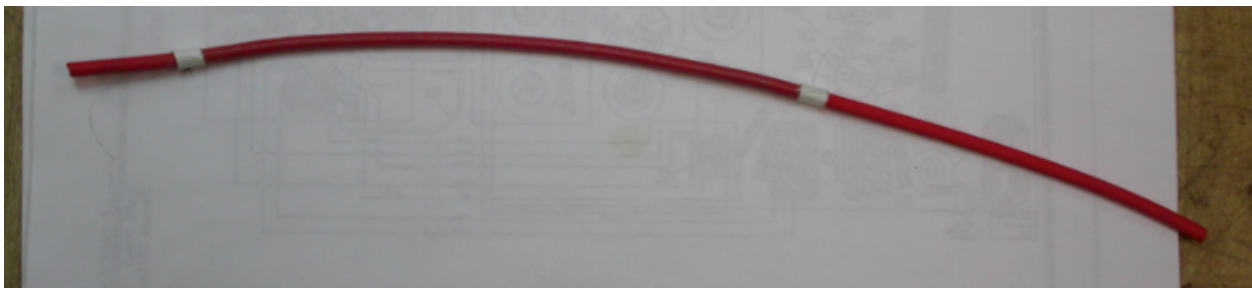
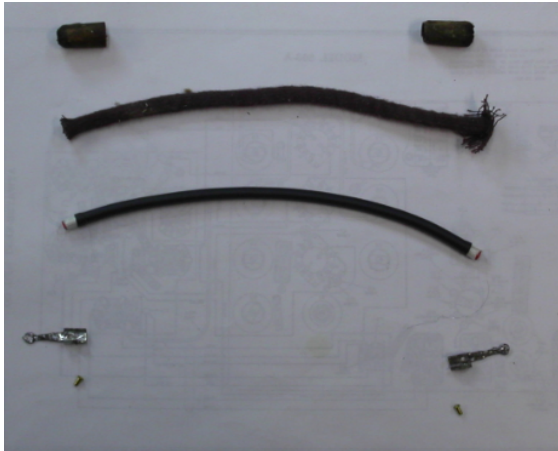
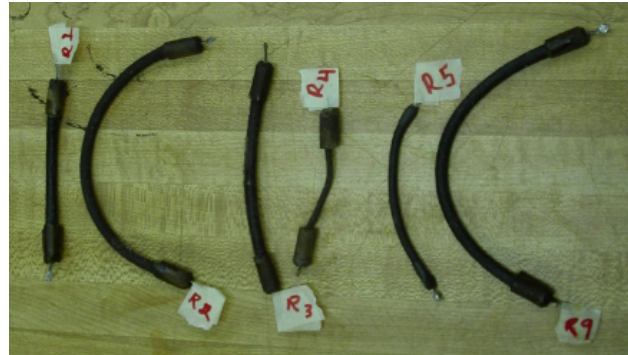
Next came the flexible resistors. I had previously read most of these fail because the nichrome wire is only crimped in the terminals. I removed the terminals by first splitting the lead collar and then prying open the crimped terminal. Measuring resistance on the bare nichrome wire still indicated the resistor was open. I decided to try and recreate a flexible resistor. I had a spool of nichrome wire with a resistance of 128 ohms/ft. I build a simple jig that enabled me to stretch a piece of silicone covered stranded 18 gauge wire about 1 ft long through a hole in two end wooden support pieces which also had an axle to hold the spool of nichrome wire. The 18 gauge wire was held in place using two “bulldog” clips which allowed the wire to rotate. I wound the nichrome wire over the silicone core wire. I periodically measured the resistance until I reached the value needed. I then removed the core wire from the jig and taped over the nichrome wire with glass cloth electrical tape. I cut the ends of a brown shoelace, opened it up and threaded it over the taped wire. I crimped a new electrical terminal on each end, wrapped the nichrome wire around each terminal and used silver solder to make a permanent connection. A piece of shrink tubing was secured over each terminal and over the ends of the cloth shoelace covering. The cloth covering was then dipped in beeswax. While the resistor is slightly larger in diameter than the original, it is a very fair reproduction. This process, with minor variations based on the learning experience, was used to redo all the flexible resistors which were reading open. Instead of wrapping in glass cloth electrical tape, I covered the nichrome wire with heat shrink tubing. I drilled a small hole in each connector that I removed from the original flexible resistors and used a very small rivet in the hole, wrapped the nichrome wire around it, secured the rivet and then silvered soldered it to ensure a good connection.

Winding Jig

Rubber Core After Winding with Nichrome wire

**Flexible Resistor Components
Ready To Be Assembled**

Assembled Flexible Resistors

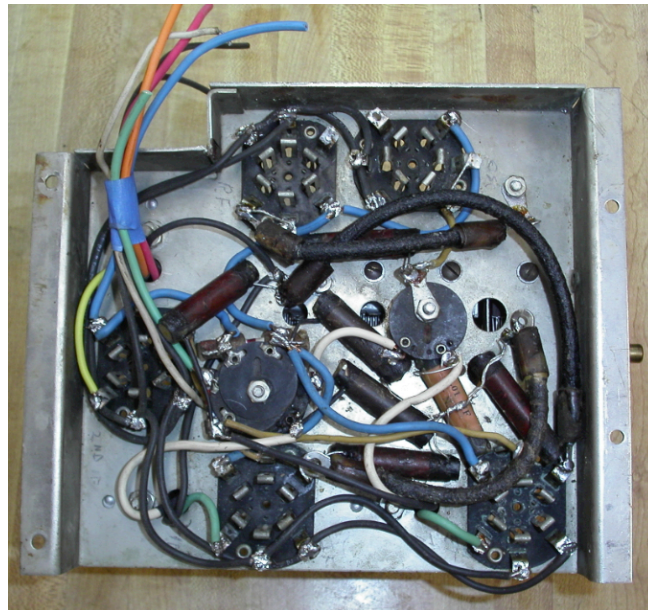
The rubber coated wiring that had become brittle was all replaced. The leads to the three I.F. transformers were either completely replaced by soldering new leads on where possible or by soldering a splice inside the can and covering the splice with shrink tubing. Because the reproduction flexible resistors had a slightly larger diameter and were longer than the originals, they had to be rerouted to fit, but hopefully this will not affect performance.

Completed Sub-chassis Restoration

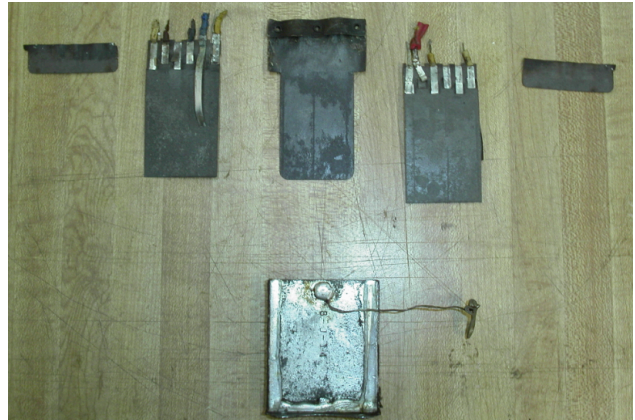
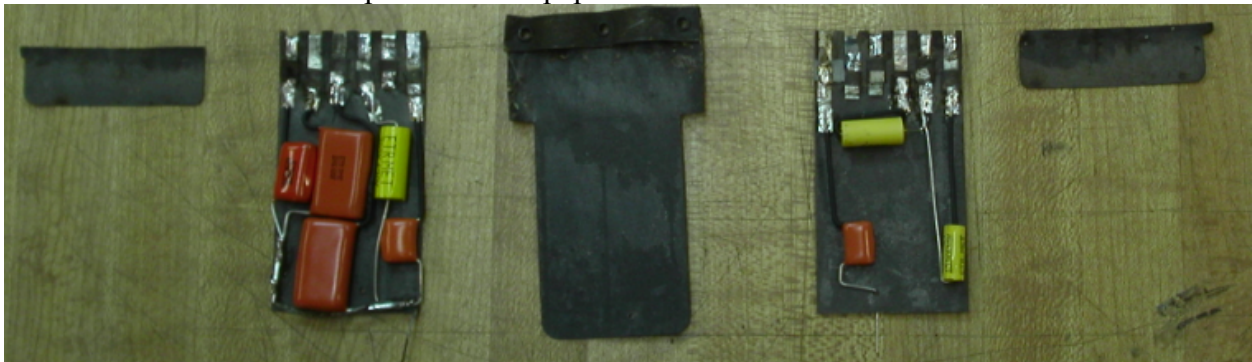
Disassembled Bypass Capacitor

New Bypass Capacitors Installed

The capacitor was rebuilt using polypropylene and “Orange Dip” capacitors. Since capacitors (D), (C) and (G) - .04 MFD, .007MFD and .04 MFD respectively are not used, I left them out. Even then the space was tight and the capacitors installed barely fit. I was able to use the original fish paper and mount the capacitors on it soldering their leads to the appropriate connectors installed on the two outside pieces of fish paper.

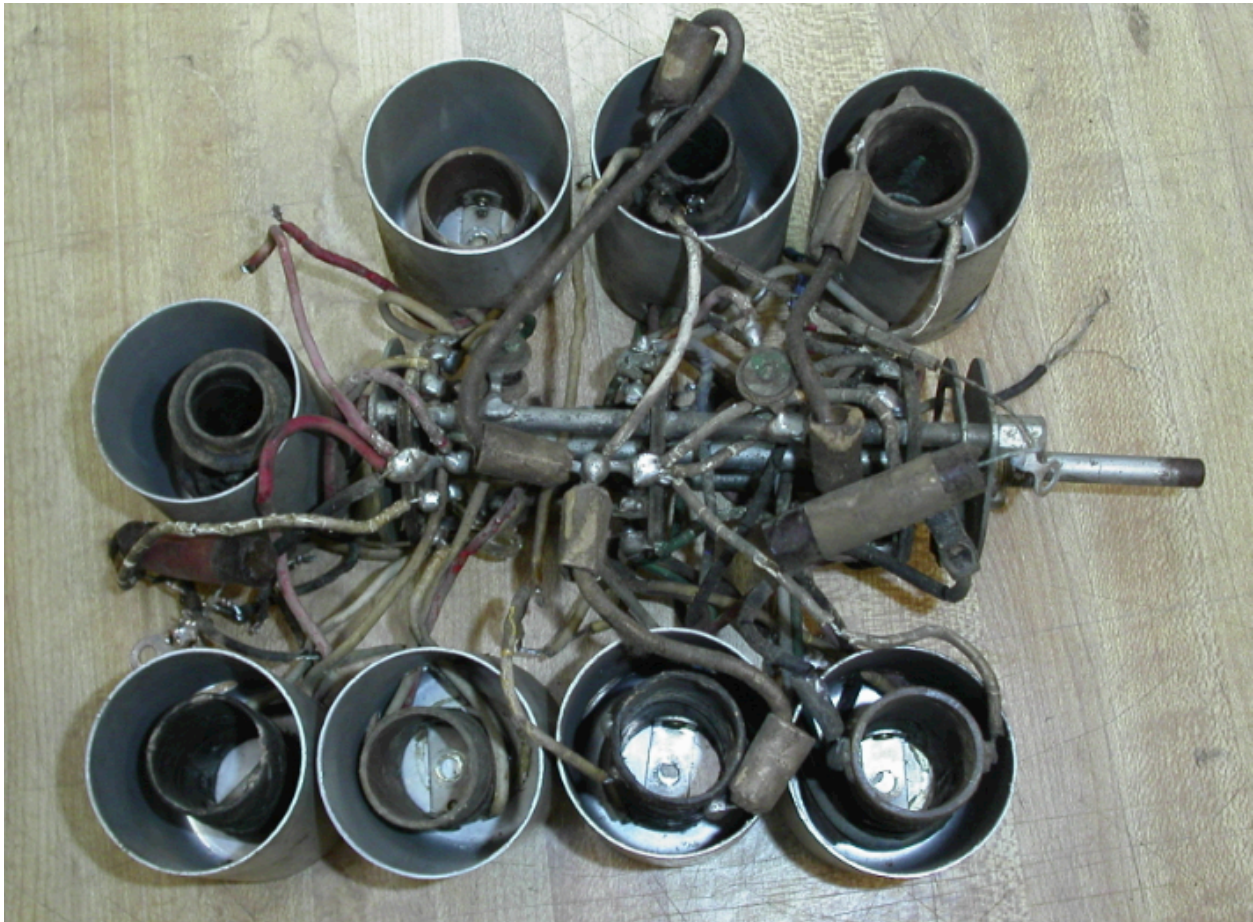
There were only two wires still connecting the switch and coils to the main chassis so that wasn't a problem. Removing all coil mounting screws and two screws holding the switch allowed me to remove the entire switch/coil assembly intact.

Removed Band Switch and Coils

I carefully drew wiring diagrams for each switch segment and coil combination before disconnecting anything more. I then started with the rearmost segment and disconnected the wires both from the switch and coil/etc. and replaced them with new rubber coated wires after I cleaned this segment's switch contacts, and followed a similar repair on the rest of the coils and switch segments. In this process another discrepancy between the AK 708/808 and AK 808A schematic became evident. Two of the windings on T8 (No.2 H.F. coil, 3rd range) had their connections reversed on the two schematics. The connections as found matched the AK 808A schematic. I remade these connections in the as found conditions after conferring with members from the Mid-Atlantic Antique Radio Club (MAARC). Testing after completion will show if this was the right decision.

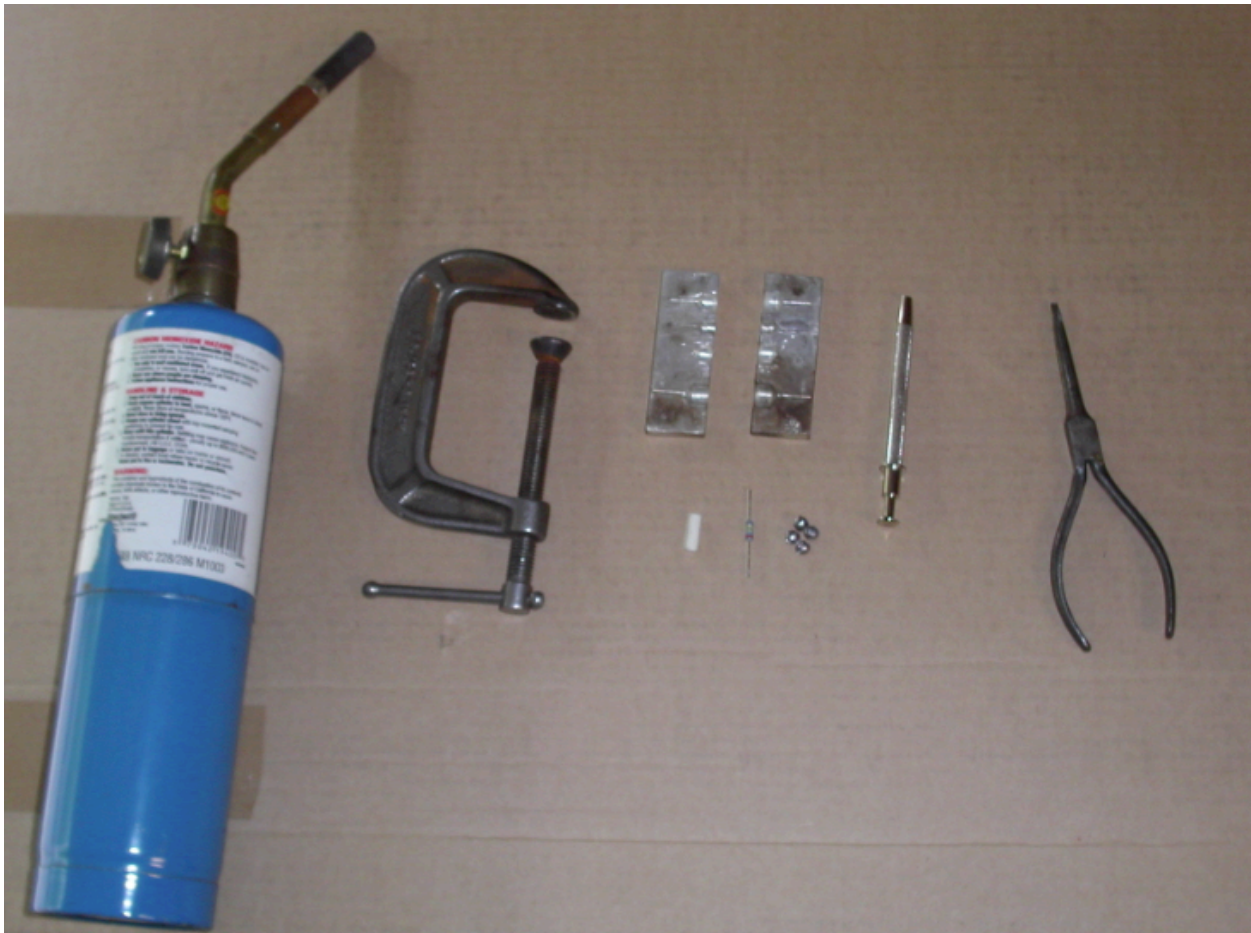
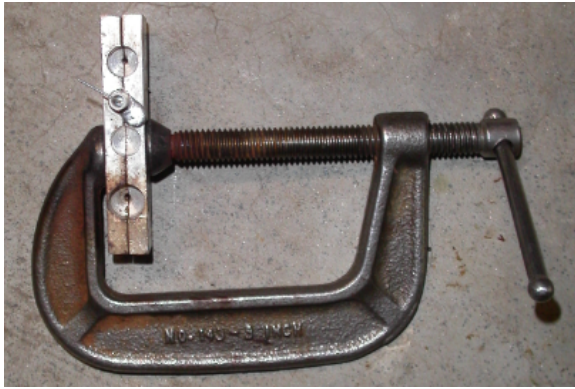
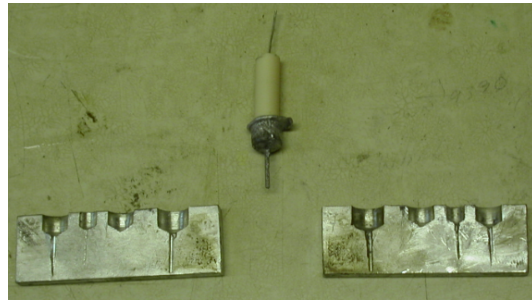
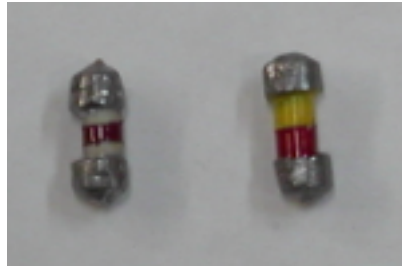
The rubber coated wiring and the paper capacitors on the rest of the main chassis were replaced in a similar manner as previously described. Resistor R17 was discovered to be 1 Megohm

Materials Used To Make Reproduction AK Ceramic Resistors

First Resistor End Poured

First Resistor End Out Of Mold

Completed Resistors Painted To Match Originals

(matching the AK 808A schematic/parts list) vice the 250K ohm (matching the AK 708/808 schematic/parts list). Again I decided to return to the AK 780/808 schematic and therefore needed to build a new resistor. This was accomplished by using a piece of ceramic tubing with an I.D. of 0.156" and a 250K ohm metal film ½ watt resistor. I built a mold out of two pieces of ¼" aluminum plate. I clamped the two pieces together and drilled a 19/64" hole in the joint between the two pieces that matched the size of the metal end cap on the original resistor. I then placed lead fishing shot in the drilled hole and used a blowtorch to melt the lead. When the lead was molten, I inserted the resistor in the ceramic tube and quickly plunged one end of the ceramic tube into the center of the molten lead. When cooled, I unclamped the two halves and removed the ceramic tube with a nearly perfectly formed metal end cap. I repeated this process for the other end using small files cleaned up and shaped the end caps. I used hobby paints to paint the ceramic with the proper stripes for the resistance value. The resistor that had to be added for the modification to improve the tone quality as specified in the AK708/808 schematic was made in a similar manner.

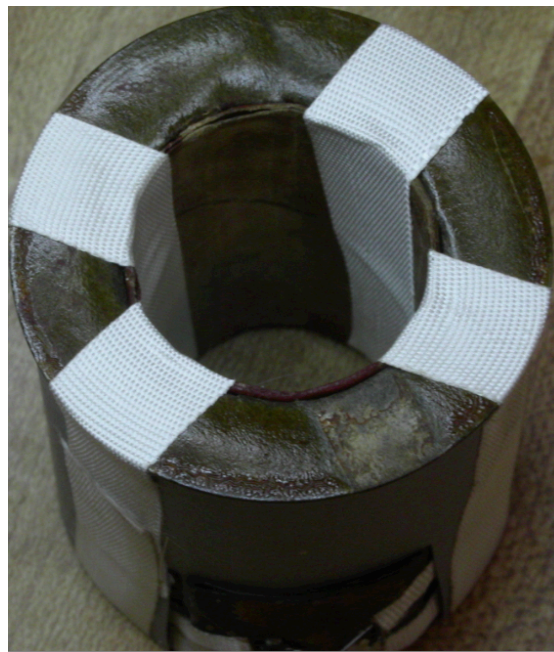
Previously, I have found that sometimes the solder connection between the coil and the connecting wires is corroded. After removing disconnecting the wires from the audio transformer, unsoldering the voice coil leads, removing the speaker cone, and unbolting the frame, the field coil was slid out. Inspecting the connections to the field coil revealed they were all good. I removed all the paper covering from the coil and the coil looked good. Another problem I found during some of my previous repair efforts was that the winding had corroded wires on one of the ends of the coil. I carefully removed the top and bottom cardboard pieces covering the ends of the coil. The top side of the coil had several tiny blue/green spots indicating copper corrosion. I used some copper cleaner (Copperbrill) to clean the corrosion off using a Q-tip stick (stiff, but not hard enough to damage the fine wire). This revealed 3 broken wires. I cleaned the broken ends, and soldered a short piece of enameled copper wire to bridge the

Restored Field Coil

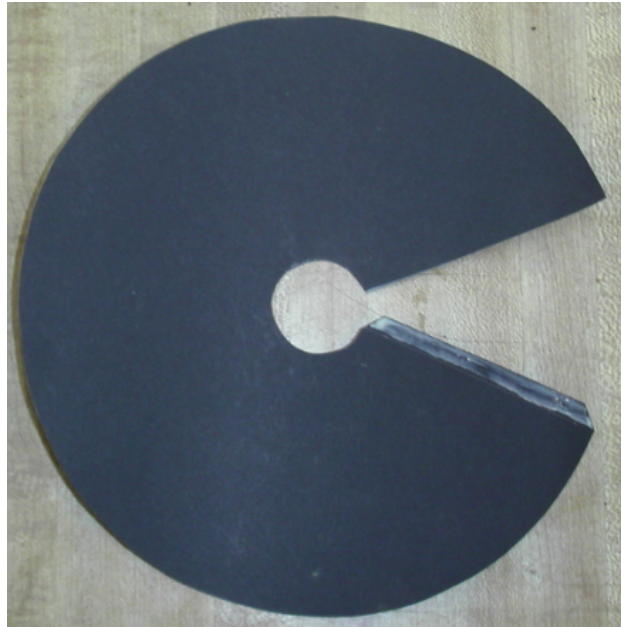
New Speaker Cone

Since I had the cone out, I decided to also re-cone the speaker. I calculated the dimensions of the new cone following the procedure described by Larry Weide in the article “Replacing early Paper Speaker Cones” which was published in the Colorado Radio Collector’s “The *Flash!!*”. This was found in the Resources section of *Nostalgia Air*. I also made a second set of

calculations following the procedure described by Mark Palmquist in an article entitled “Speaker Cone Math” which was published by the Southeast Antique Radio Society. The calculations

came out with slightly different results. I made a cone using each set of calculations and placed each over the original cone to see which matched best. Both were close, but the cone angle was a little off. I opened one of the test cones, firmly held it against the original cone, taped it together and then used this cone to cut a duplicated one out of black .0114 thickness poster board paper. I carefully removed the spider and voice coil from the old speaker cone. The glue and paper were cleaned from the metal edges. The new cone was glued together and left to dry overnight. The voice coil and spider were glued into the new cone. The frame, speaker outer edge mounting brackets, and field coil housing were cleaned and repainted. A new cardboard ring for mounting the outer edge of the speaker was cut out. The audio transformer resistance readings were good. It was cleaned and then sprayed with insulating varnish as a precaution. The black and white rubber coating on the wires to the bucking coil were replaced with rubber tubing. The yellow rubber wire was replaced. Silk athletic adhesive tape was used to secure the outer edge of the cone. This was painted black. The speaker was reassembled using six 1/32” thick wood shims to center the electromagnet in the housing. The voice coil was glued into the speaker cone and when dry the voice coil and cone was centered in the gap in the electromagnetic using .0044” thick celluloid shims. I then attached the spider and glued it to the cone. When it was dry, I temporarily attached the cardboard ring to the frame and then attached the silk adhesive tape pieces to the speaker cone and cardboard ring using some extra glue. When this was dry I attached the cardboard ring to the frame with the metal segments and attached the mounting brackets. This enabled me to keep the voice coil centered in the electromagnet. The shims were then removed and the cone gently pressed to ensure it was free and the voice coil was not rubbing. All appeared good. The audio transformer was mounted to the frame and the voice coil, audio transformer, electromagnet leads, and speaker plug were all connected.
