ATWATER KENT MODEL 708 RESTORATION

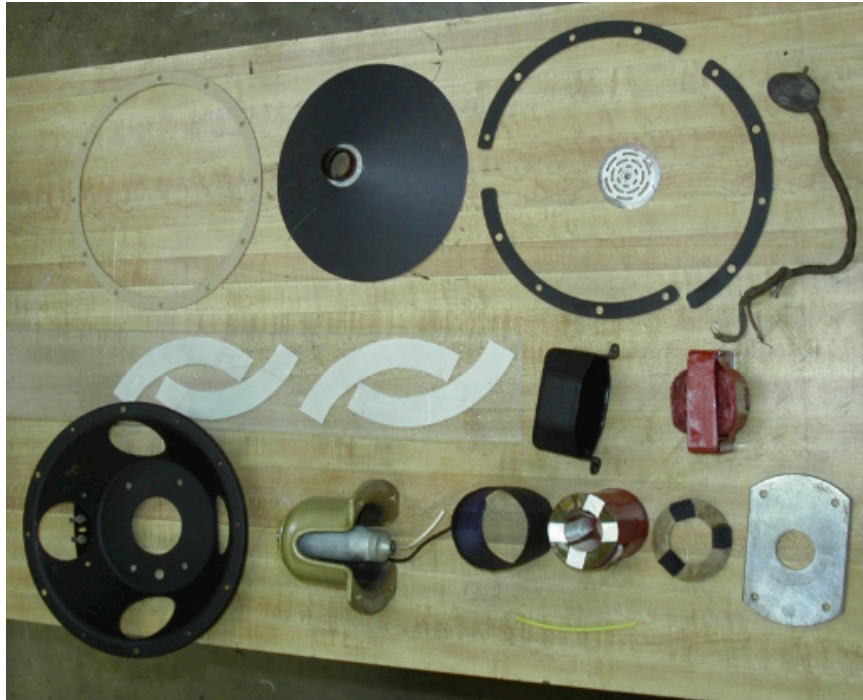
Restored Speaker Parts Ready For Reassembly

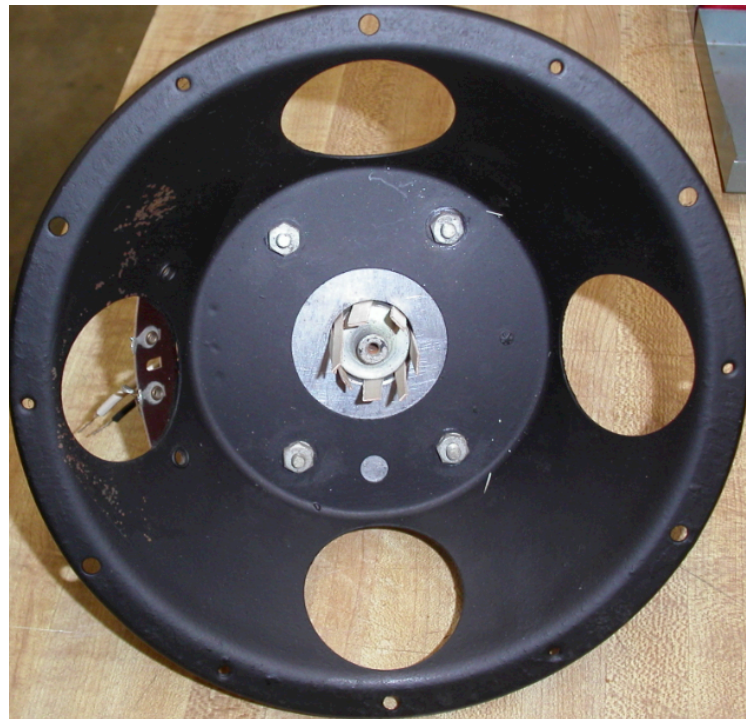
Speaker Electromagnet Centered In Housing

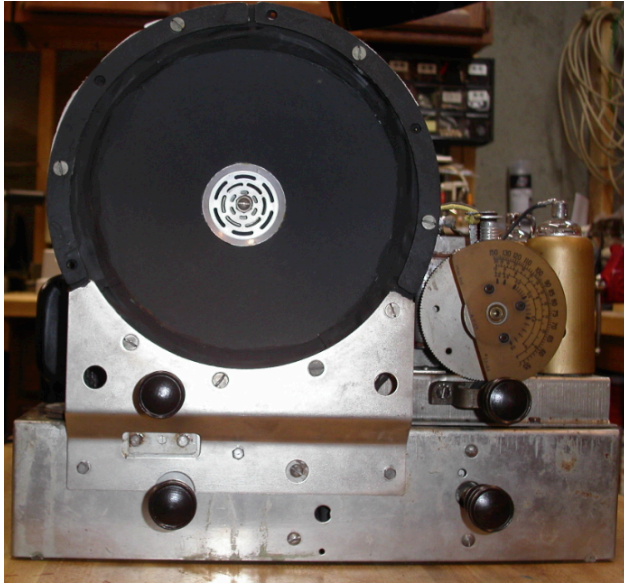
Completed Chassis-Front View

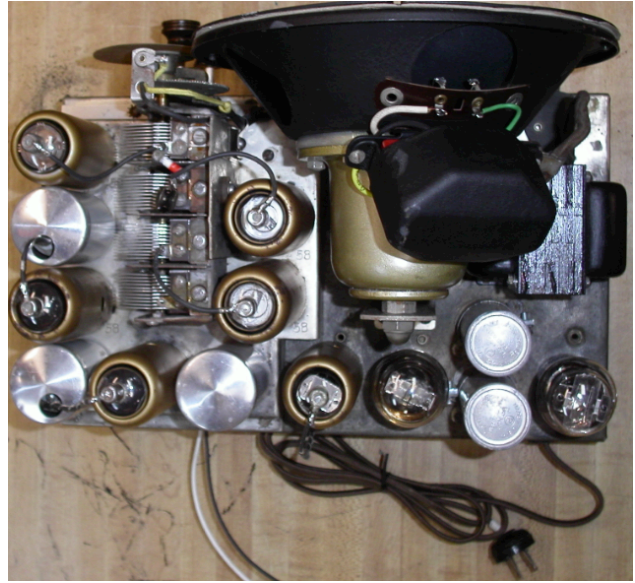
Completed Chassis-Top View

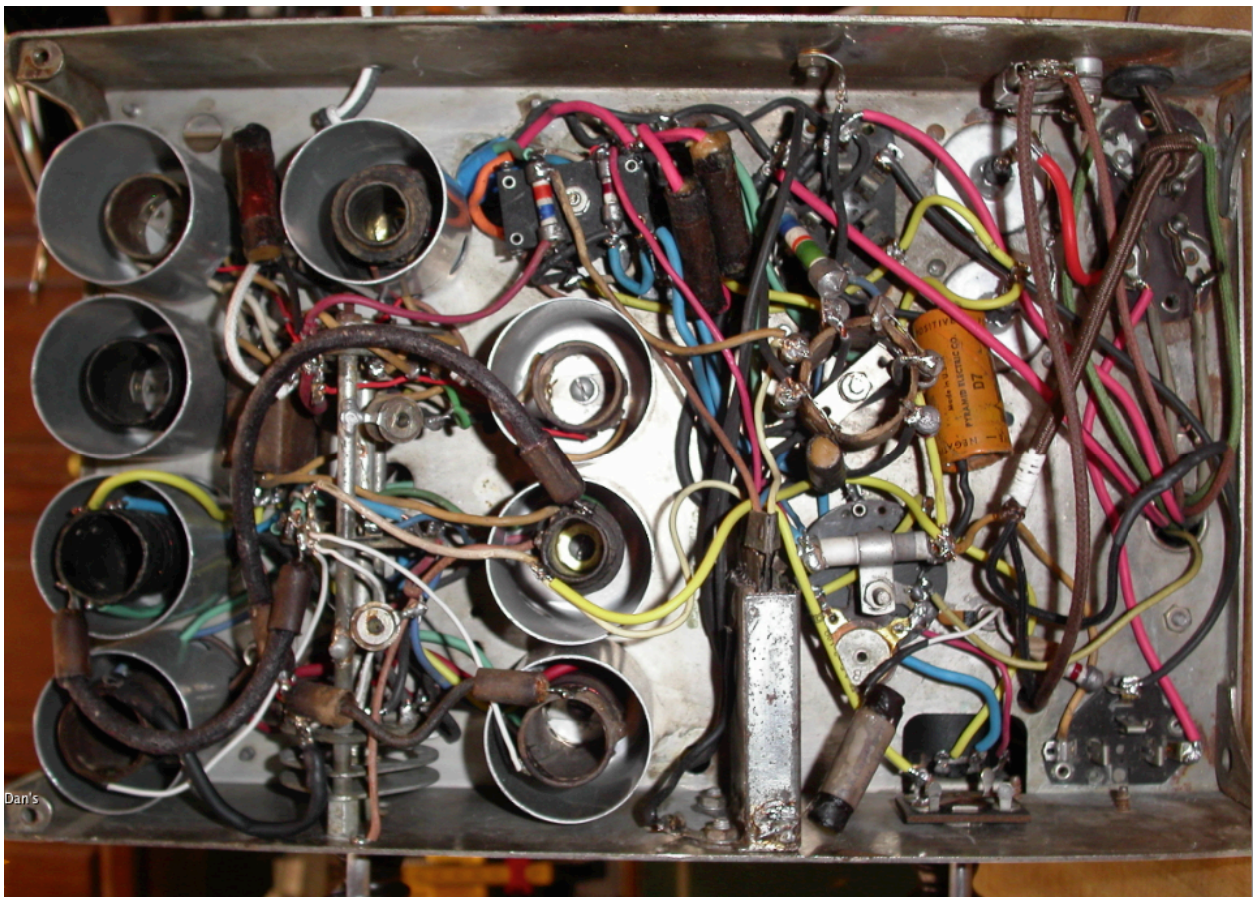
Completed Chassis-Bottom View

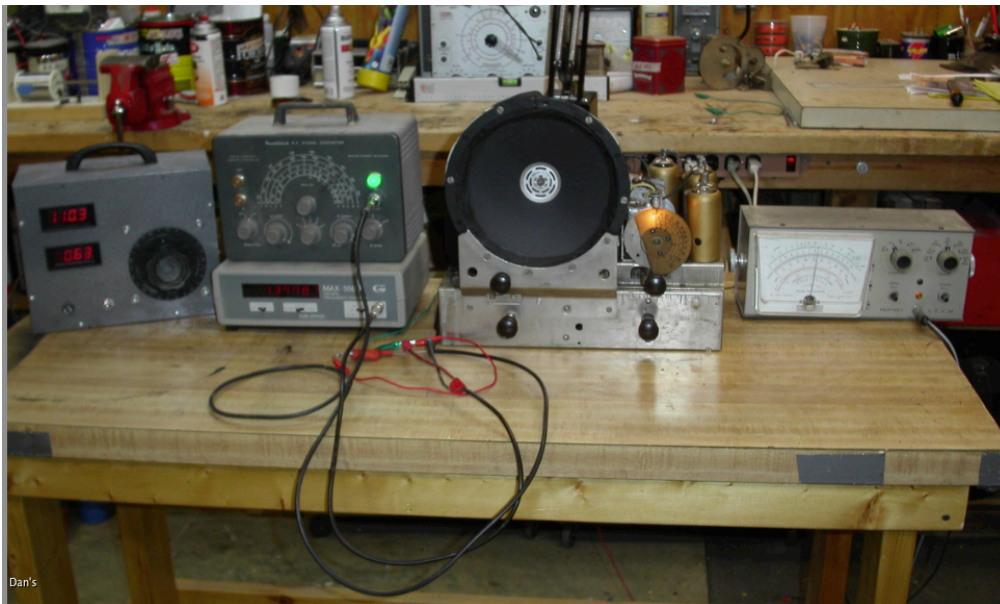
Testing Setup

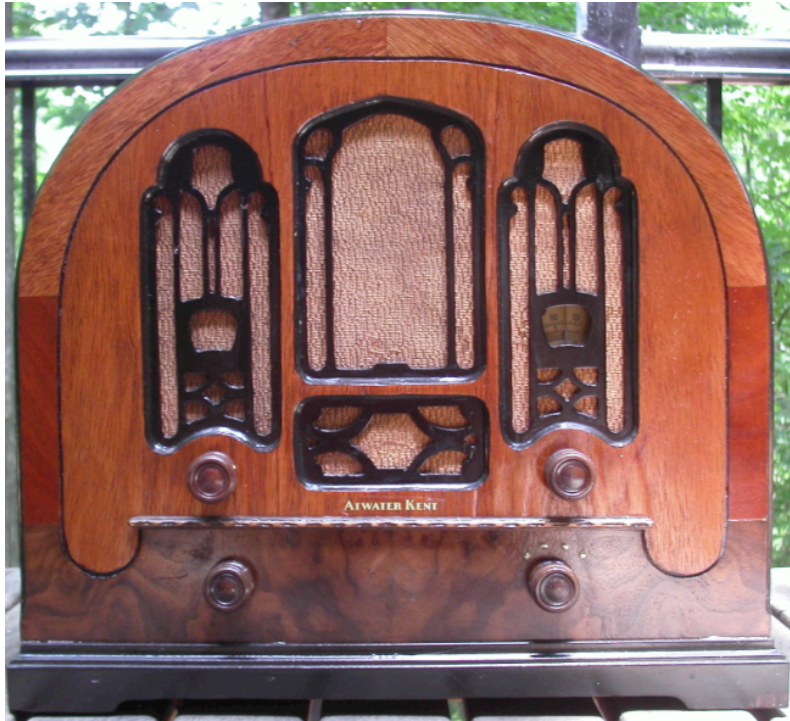
Restored Atwater Kent 708 - Front

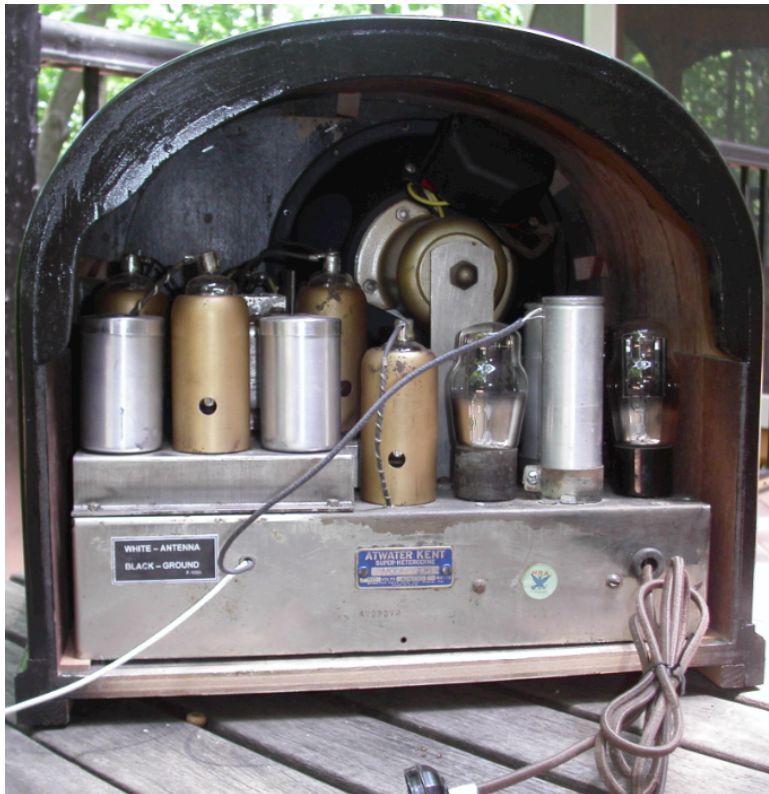
Restored Atwater Kent 708 – Back

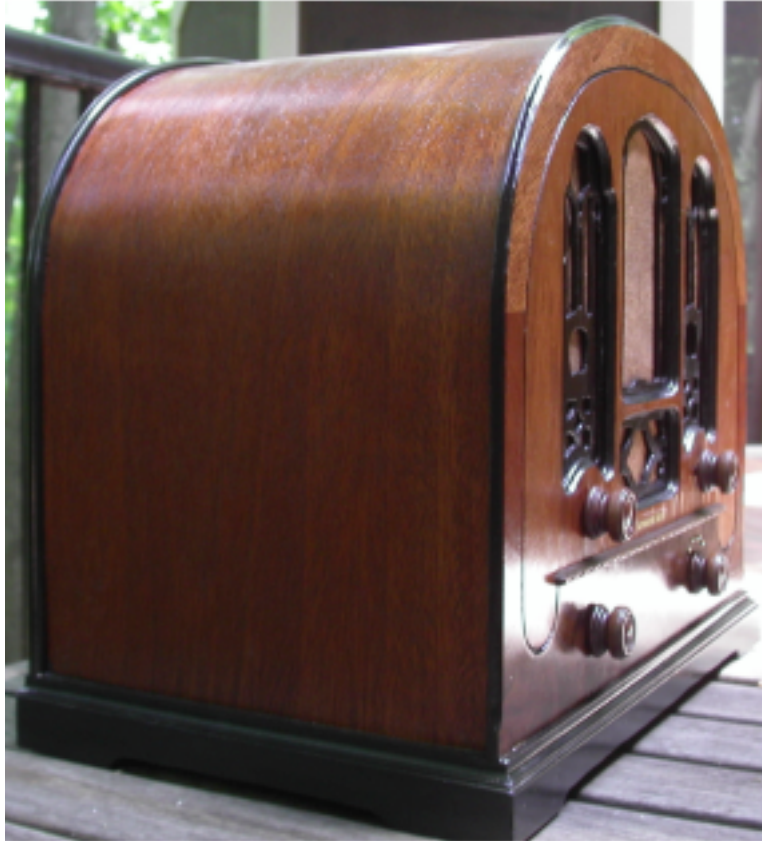
Restored Atwater Kent 708 - Left Front Side

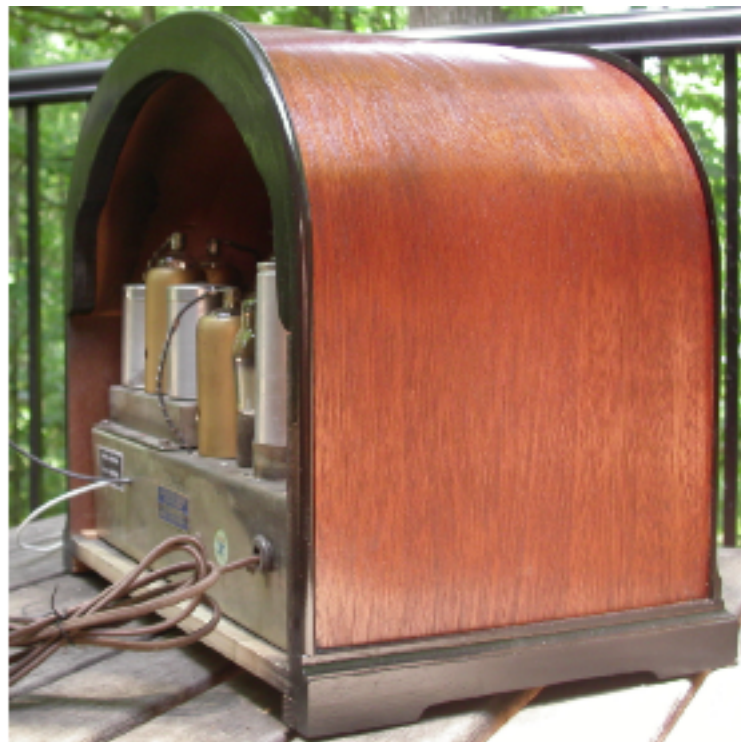
Restored Atwater Kent 708 – Left Back Side
