Remler Model 72

Restoration Project

Elmo Giovannetti

January 2012

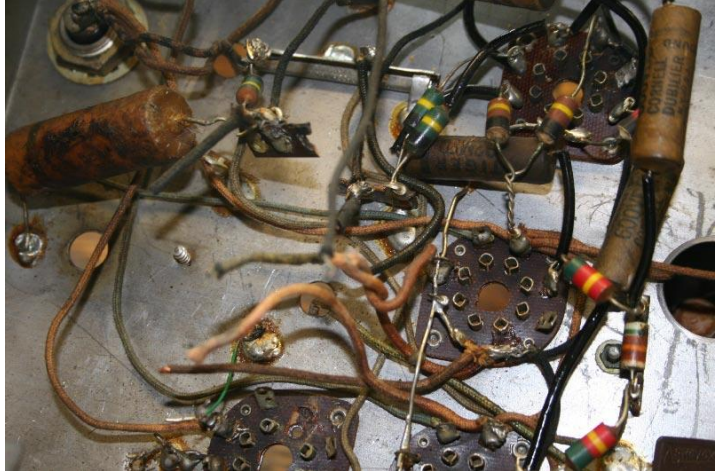
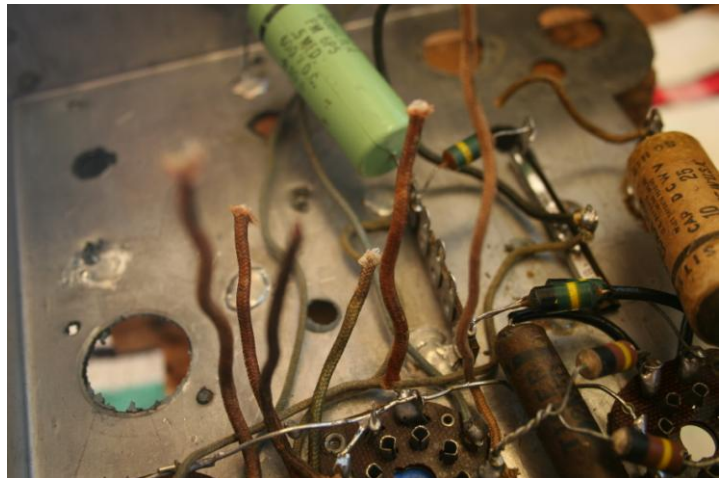
Cut Wires Under Chassis

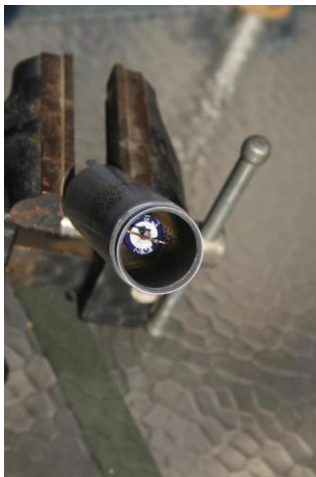
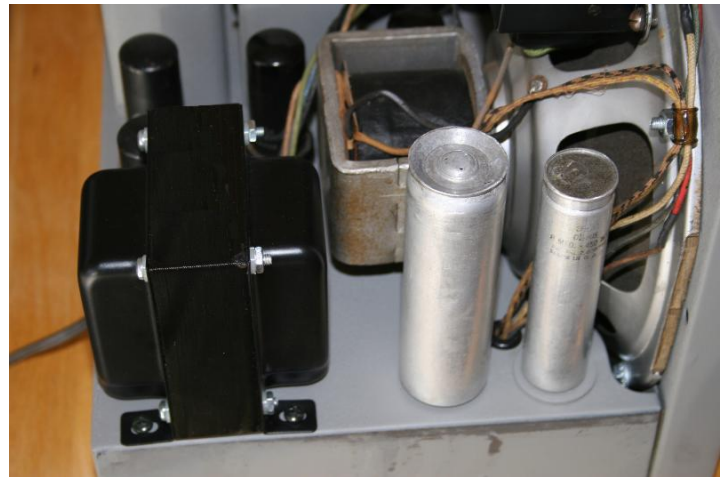
New Capacitor Installed in Can

Both Rebuilt Caps Installed

The major components of the power supply in this radio were missing. This includes the power supply capacitors. One of the filters was missing. The remaining capacitor was unusable. After finding a suitable replacement I decided to empty the containers and replace the innards with axial lead 22 mf 450v caps.

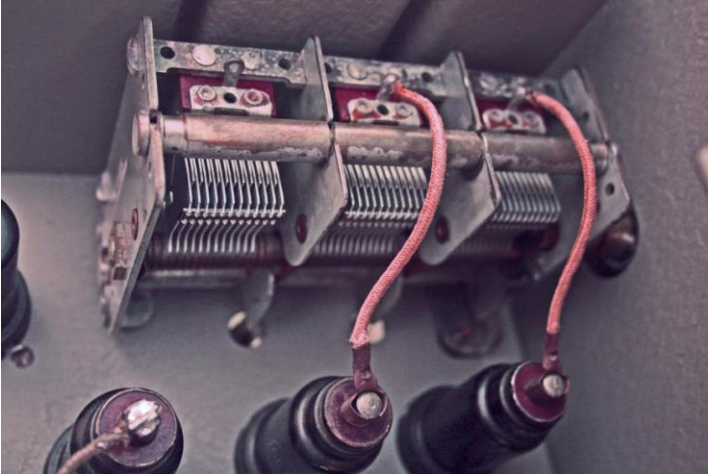
Cleaned Capacitor Installed

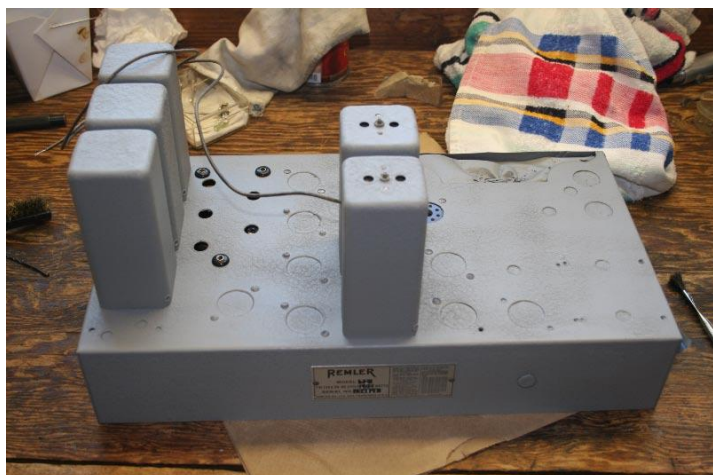
Chassis being prep for painting

Chassis painted

Chassis painting completed

As the pictures show this chassis had seen better days. I started by washing the chassis. I removed the tuning coil and IF cans and any other sensitive components. I protected the coils by putting them in plastic bags and sealed them the best I could. I then sprayed the top and bottom of the chassis with *Super Clean* then lightly hosed it off. The amount of grime removed was impressive. I dried the chassis using low-pressure compressed air and the sun. Repainting the chassis was the next step. The original finish was a gray wrinkle paint that was not available. What I did use was a black wrinkle paint which I used as an under coat then applied a gray topcoat finish. In order to avoid painting the tube socket rivets or having to drill them out I put a drop of wood glue on each rivet head. After painting, the glue was easily removed with an exacto knife.

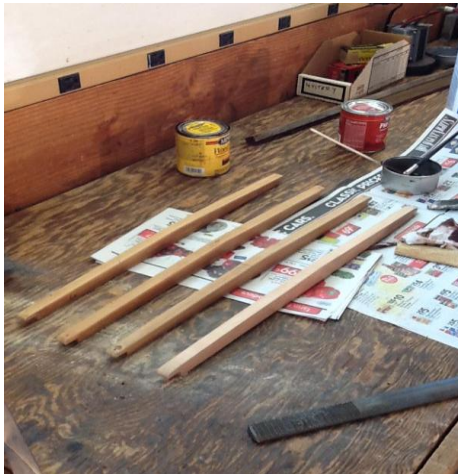
Stripped Grill Elements

In order to replace the missing element, I had to fabricate one. I took one of the grill pieces to a local woodworking shop and tried to match the wood species. I found a piece that closely matched the grain and density of my sample. I then traced the outline of my sample on to the wood and did a rough cut out using a band saw. I contoured the piece to shape using a wood rasp, electric sander and sandpaper.
