Restoration of a Philco Model 18 (Code 124) Cathedral Radio

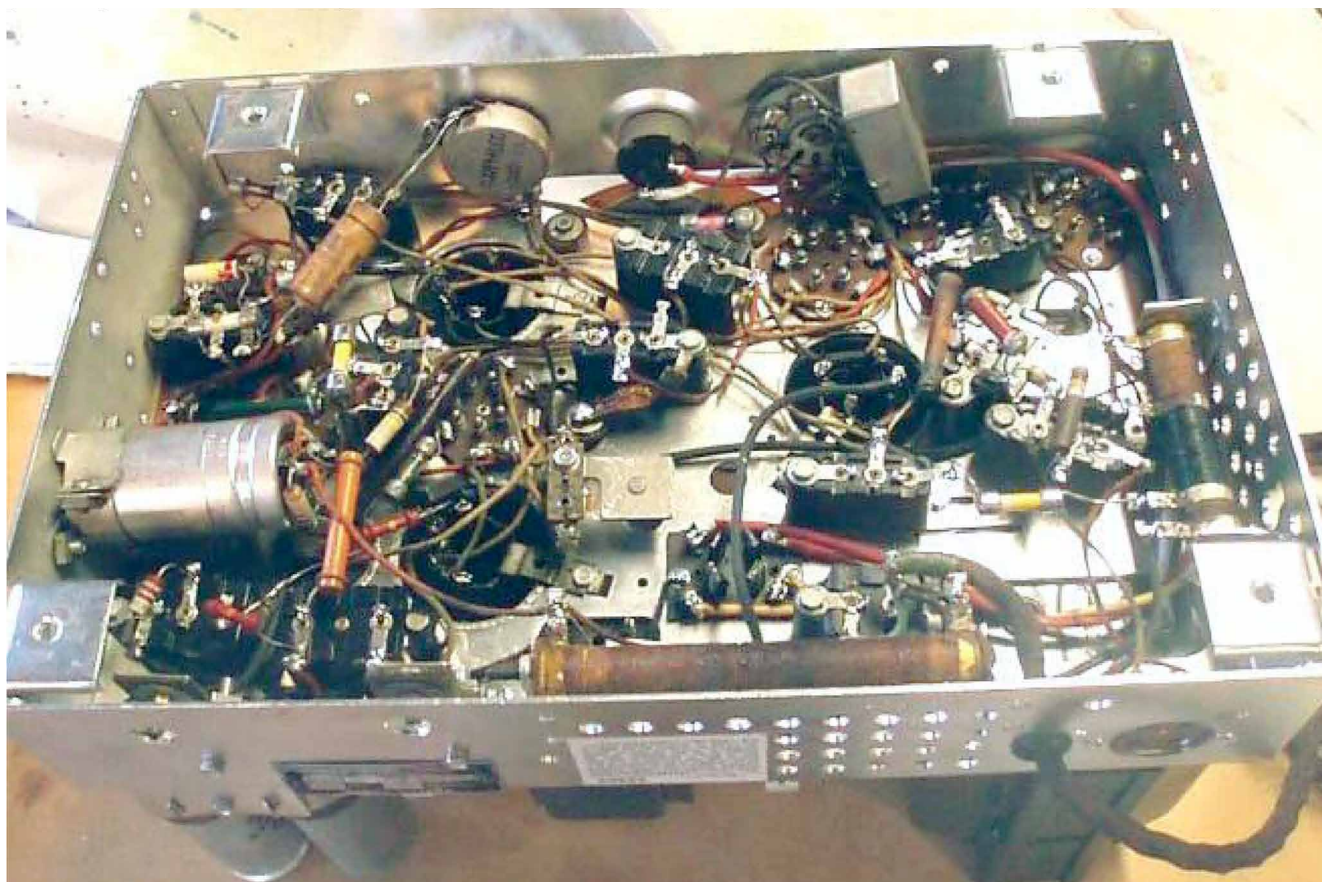
On return of the brand new looking chassis, re-assembly began with the installation of the valve sockets, cans, transformers and tuning condenser on new rubber mounts. Then, many hours of pouring over the circuit, photos

and notes, disappeared before the chassis was again complete. Yes, the waxed paper capacitor connected to the volume control is the only non-block capacitor in the whole set. I was able to rewind the bias wire-wound resistor but not the HT one which has been replaced with a ceramic wire wound resistor although the original is still in place. The speaker was reassembled and this proved to be a time-consuming, precise job. After the fitting of a new power cord, with an earth this time, it was switch-on time.

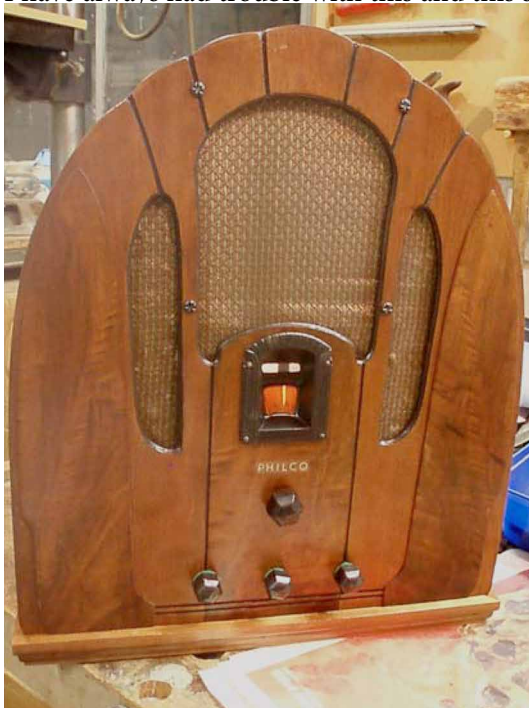
I had left the hardest and in my view the worst job till last. – fitting the new grille cloth to the cardboard backing. I have always had trouble with this and this set was no exception. I wrote off a piece of cloth in my efforts. I then

found that ADOS F2 is, for me anyway, the best product to use. I painted a small section of the cardboard and pressed the cloth into it immediately. This way there is a short time to put some tension onto the cloth. After drying, the next section is glued and so on until complete. Lastly, a reproduced chassis layout diagram was stuck into place.
