RCA Gloria

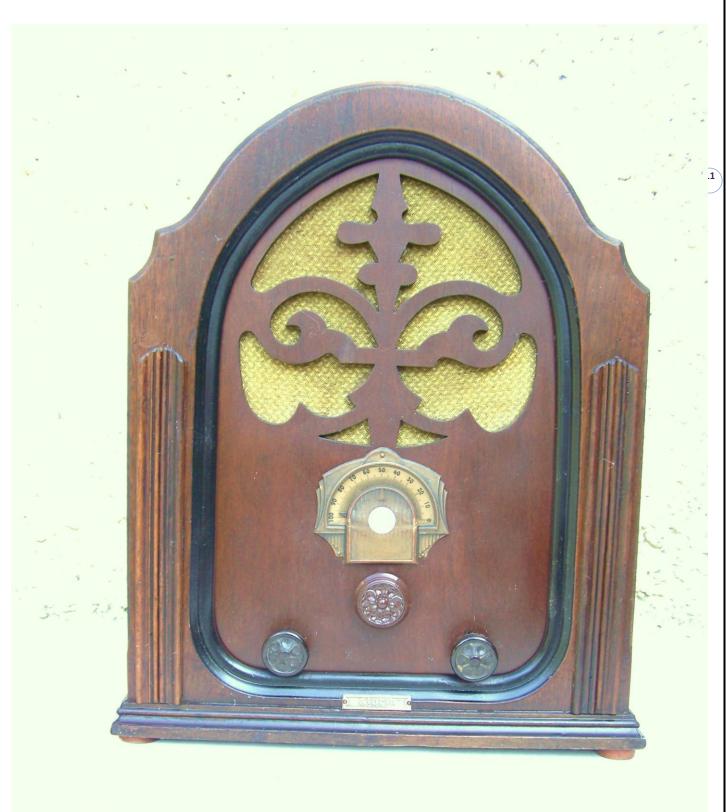
Fig 11

Looking at the final product (Fig. 11) it was worth it to have spent the time fort he restoration. At the front where part of the decoration was broken off it has taken a lot of time to restore it. The rest of the decoration was also removed and erplaced with fancy strips.
