3^{ème} Concours CHCR de restauration radio

ELITE-RADIO" Model: 191

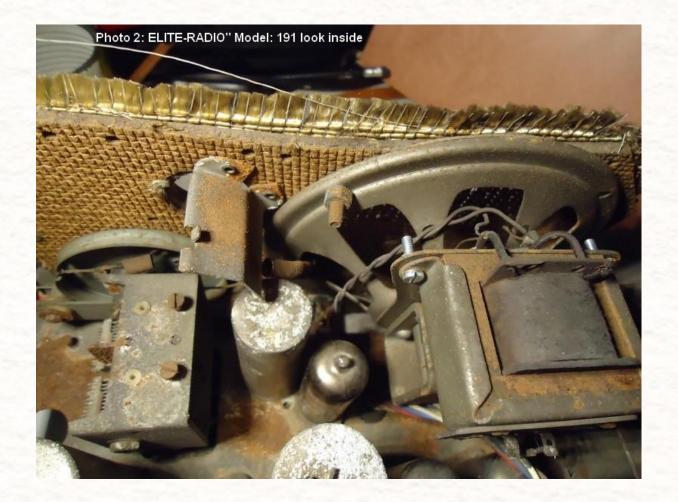
First of all, this small receiver from a little known brand was much damaged and not inspiring for even a restoration, but at least complete.
Some people would have used it to get some spare parts out of it

• The thing is, this receiver was given to me by an old friend with whom I spent a few years in a technical school, studying electricity and electronics. So, the competition of restoration was a good opportunity for its restoration. (Photos 2)

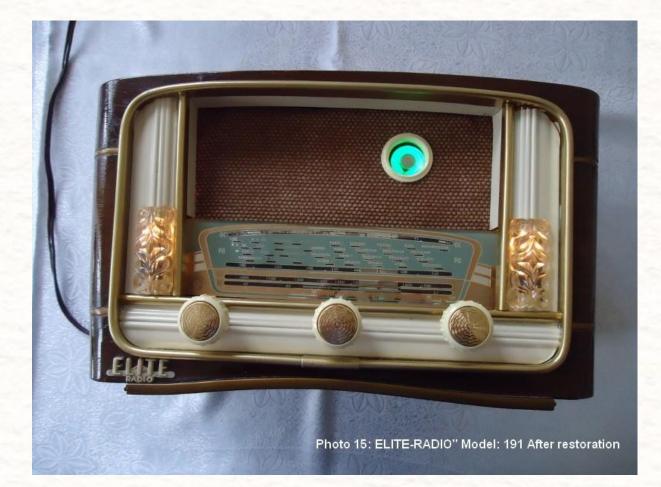
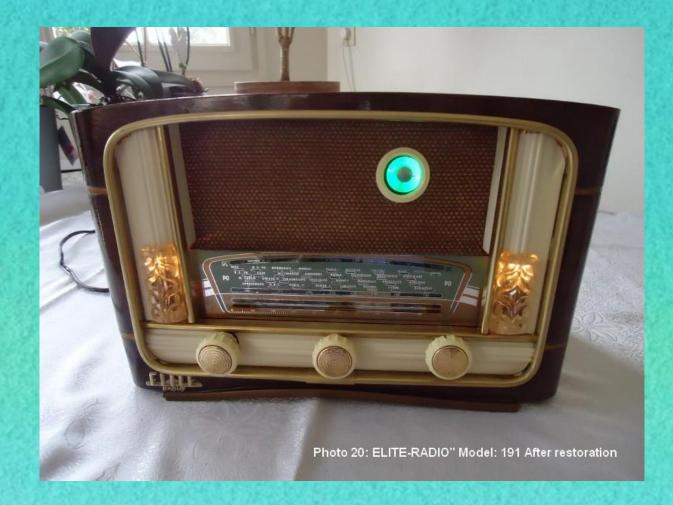
One month of intensive work, but a strong satisfaction when, connected to a good antenna, at the power-on time, and after a few minutes of suspense due to the heating of the lamps and searching for a station, the loudspeaker began emitting a pleasant and harmonious sound. (Photos 15, 20)
