# Atwater Kent 768Q

Atwater Kent Manufacturing Co. Philadelphia, Pennsylvania

1935 model year.

### A challenge to preserve and properly exhibit this seldom seen 'farm radio'.

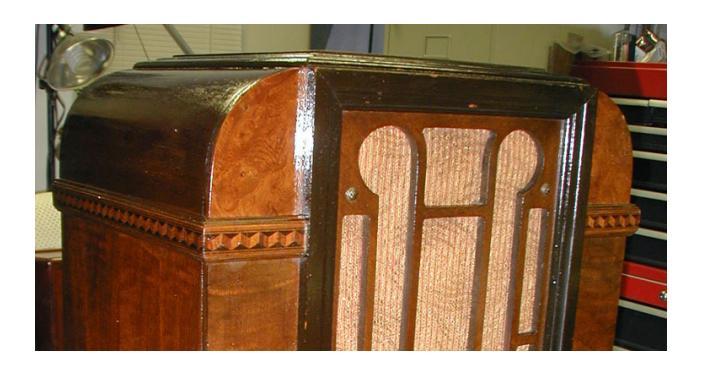
Many photos of the existing state of the finish were taken. This cabinet has walnut veneer with most of the secondary wood painted with black Japan color rather than the more common Van Dyke opaque brown.

The only practical remedy for removing the heavy polyurethane coating was to use the strongest grade of MEK solvent based paste stripper I could obtain. The bad news is that it takes everything off !!! The good news for me was that the cleaned wood did present a uniform coloration that absorbed mineral spirits uniformly. This told me that I would have little trouble in getting the wood to take stain and filler properly.

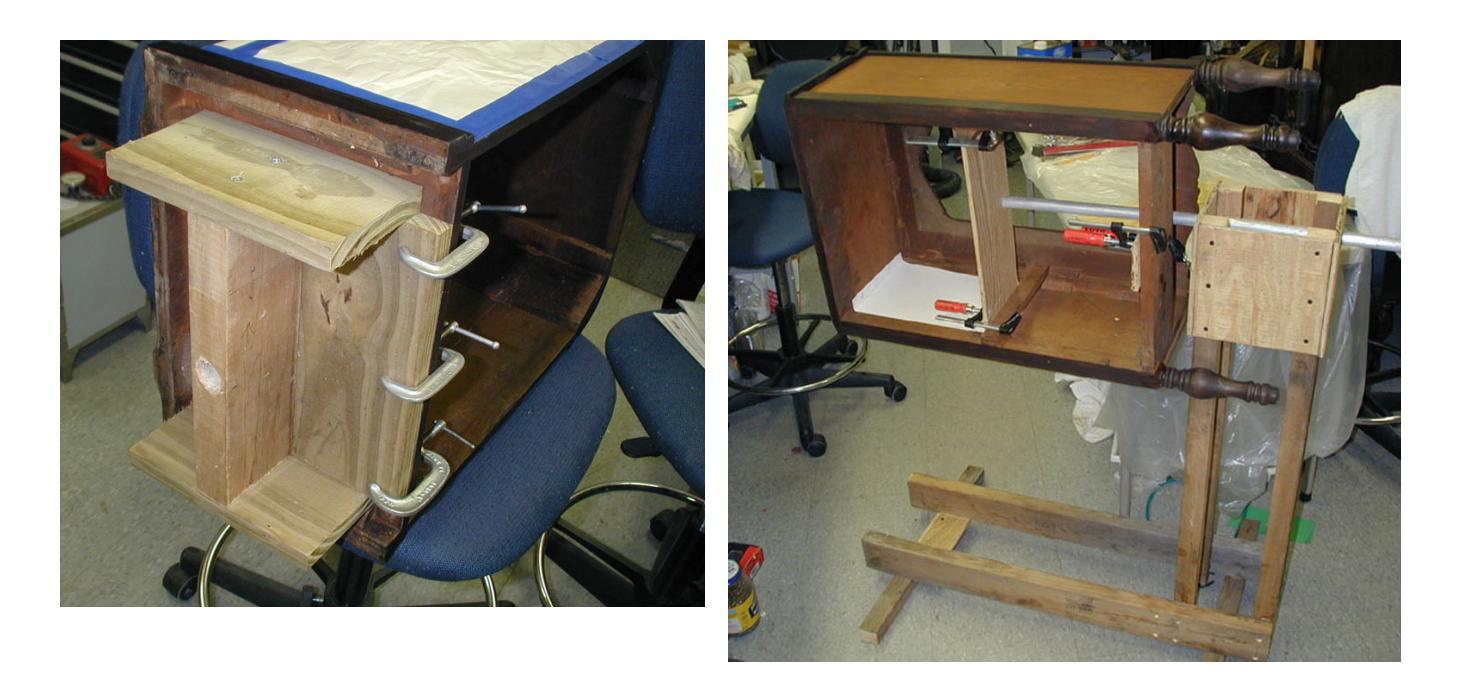
In order to spray the cabinet I attach a temporary mounting with clamps. In this case, it is clamped to the bottom of the cabinet and has a  $\frac{3}{4}$ " diameter hole at the center of the bottom.

This allows me to slip the cabinet onto this crude wood stand fitted with a horizontal <sup>3</sup>/<sub>4</sub>" diameter pipe. With this arrangement, I can easily rotate the cabinet so that I am always spraying on a horizontal surface.

The cabinet was then sprayed with two full coats of satin lacquer. (Gloss clear lacquer not being available at the time.) I will not commit this 'sin' again! On close inspection, knowledgeable people can tell that the sheen, while pleasing, is simply not as authentic as it could be. After several days to allow the coats to become fully hardened, the entire cabinet was rubbed down with rottenstone and then waxed.

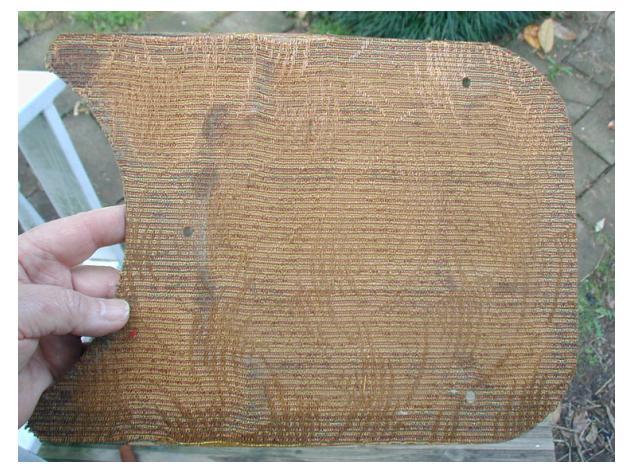
The original multicolor grill cloth has deteriorated to an almost uniform flat, dark yellow. The feather-like arcs in the weave are almost invisible in normal room light. They only show up at all when the cloth is rotated 90 degrees from the norm With such a deteriorated cloth returned to a newly finished cabinet, the contrast of old and new would be extreme. Too my knowledge; there is no similar cloth available today. I have installed a replacement grill cloth insert. I specifically selected a harmonious, understated fabric pattern that is not easily identifiable as being used by, for example,

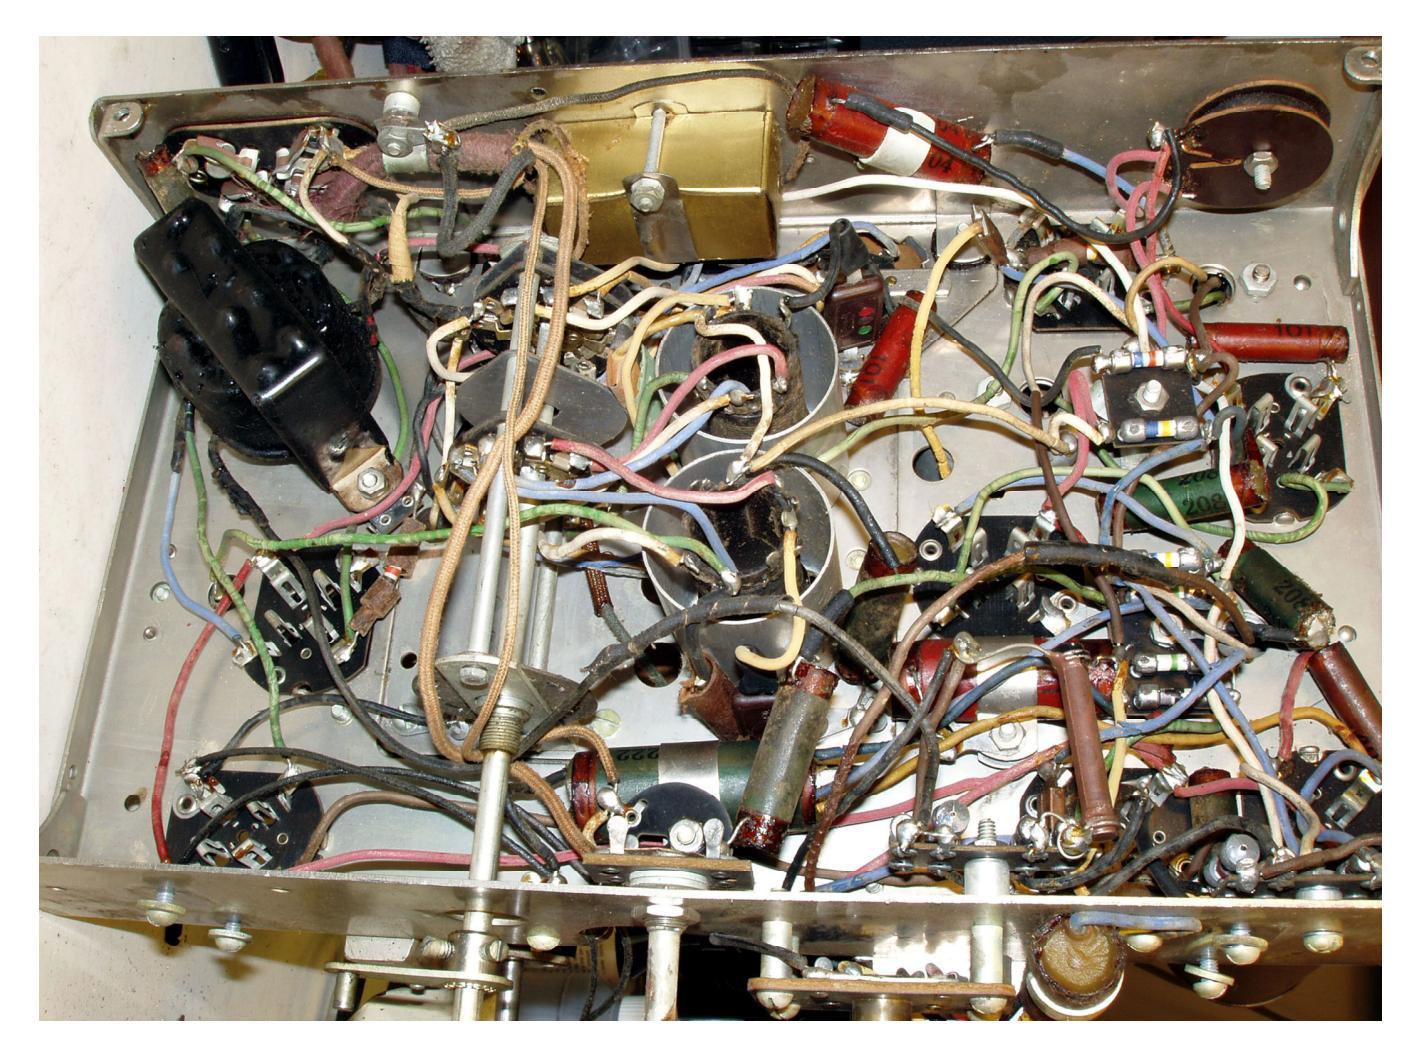
A near perfect example of what the chassis wiring looked like on the day of manufacture.

The underside wiring looks so good, in part, because this was a very low power dissipation battery powered chassis. A similar AC powered chassis would have left the wiring looking much worse for time.

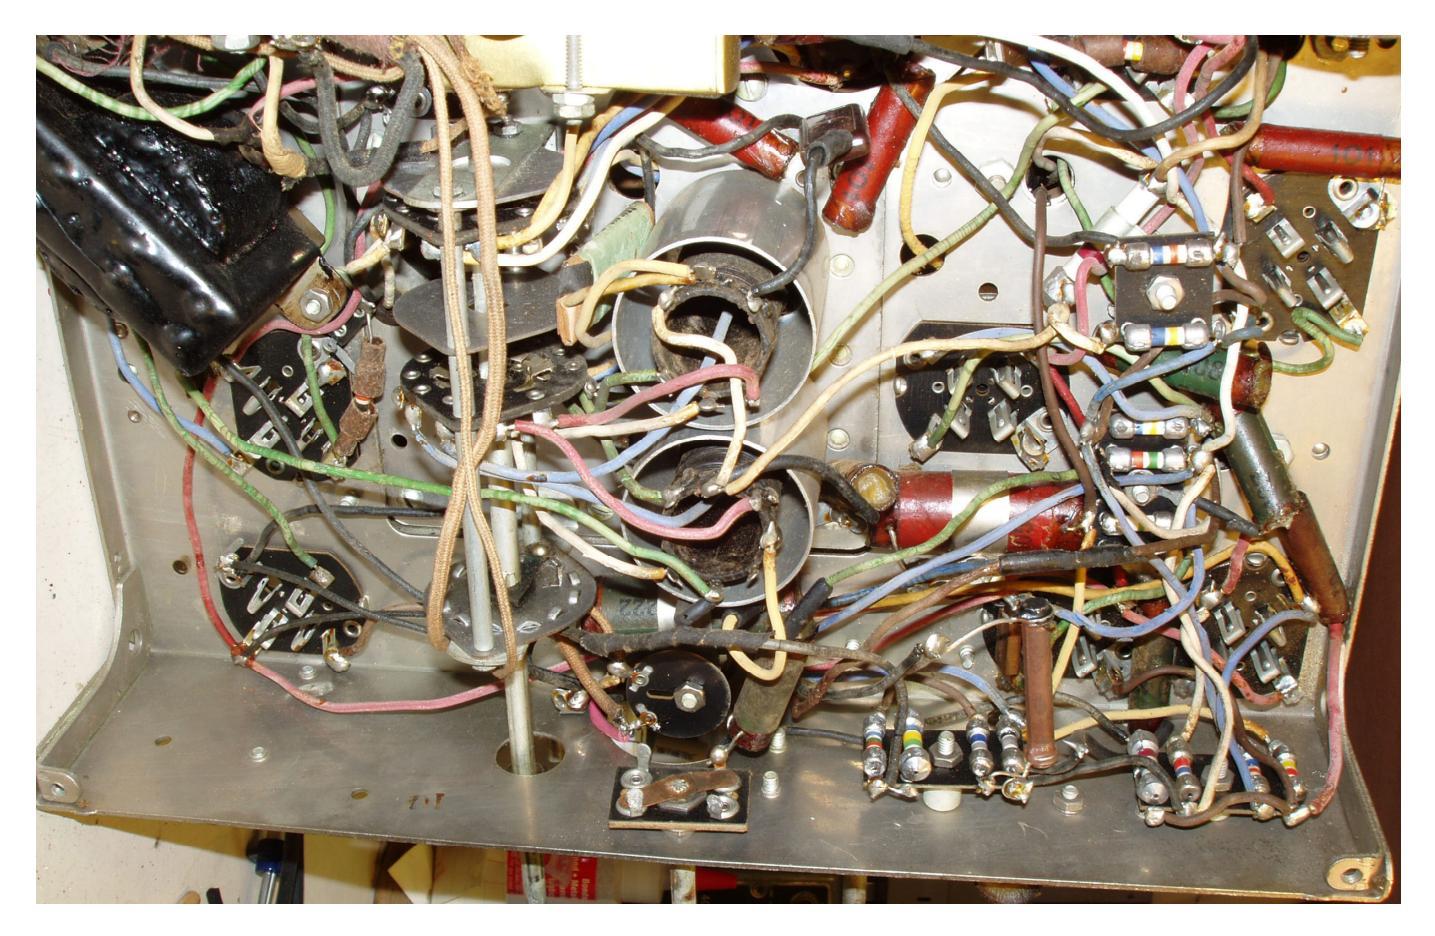
Imagine the consequences of rebuilding this chassis to operating condition.

Virtually any attempt to remove defective parts for rebuilding or replacement would result in destroyed wiring at every component attachment point. Tests with a multimeter indicate that virtually all the resistors of high value are double the indicated value to near open circuit. All paper dielectric capacitors would either be leaky or have high ESR due to corrosion between the foils and the leading-out wires. All 'dry' electrolytics would indeed be dry and therefore exhibit greatly reduced capacity. It would require a <u>wholesale scrapping</u>, rebuild and new wiring operation with a <u>radical loss</u> in historical value just to make this radio functional for a few more years.

In light of my analysis of the significance of this artifact, I chose to maintain as much of the historical accuracy as possible. Therefore the radio remains silent.

In order to make this radio more presentable, the most damaged wiring on the top side of the chassis was replaced with very similar looking rubber insulated wiring. In actuality, only five lengths of wire were replaced. A fellow collector, Steve Geary, was able to send me a photograph of the way the Antenna and Ground wires were terminated with Fahnestock Clips in Atwater Kent radios of this vintage so I could make replicas.

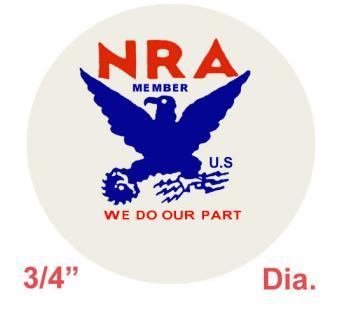
There was only a fragment of the NRA sticker remaining on the chassis.

There are variations on these stickers but a fellow collector, Ron Lawrence, sent me a photo of a complete sticker on another Atwater Kent radio of the same vintage that proved to be an exact overlay of my sticker fragment. From that information, I used Photoshop 7.0 to create an exact replica.

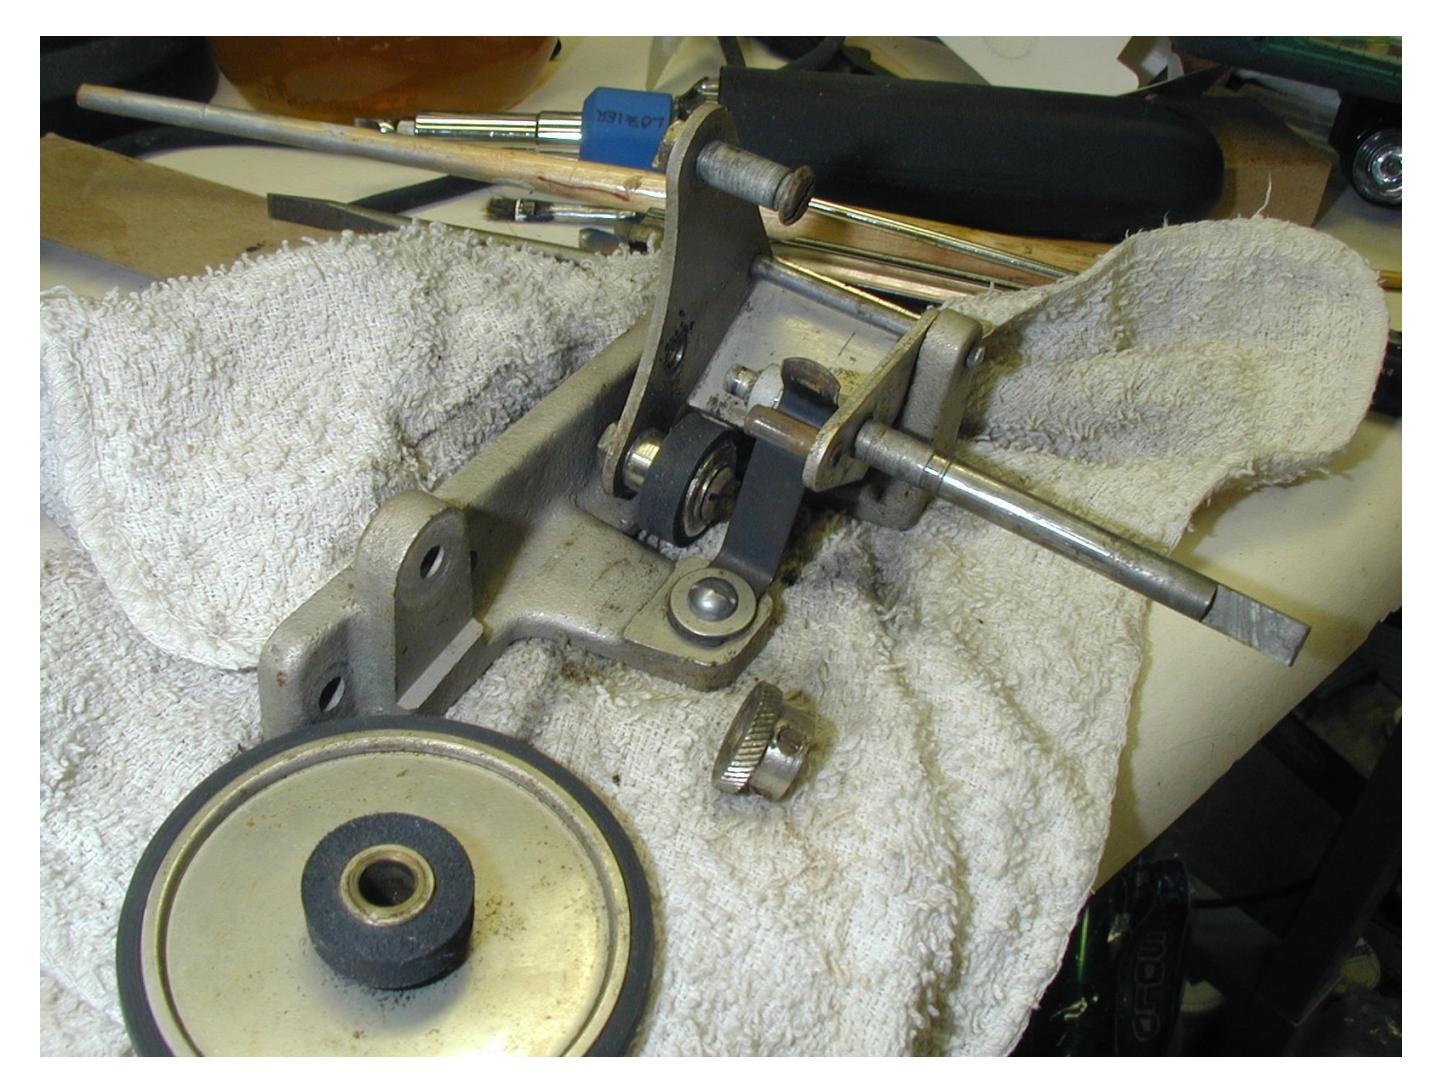
The tuning mechanism has three black rubber tire drive wheels. It is not a durable design. The rubber becomes useless probably in the first 10 years and must be replaced. I fabricated replacement tires with a modern rubber formulation that looks exactly like the old material but should remain stable for a very long time in moderate environments.

The replacement of these parts makes it possible to demonstrate the operation of the wave change linkage and the dual ratio tuning drive.

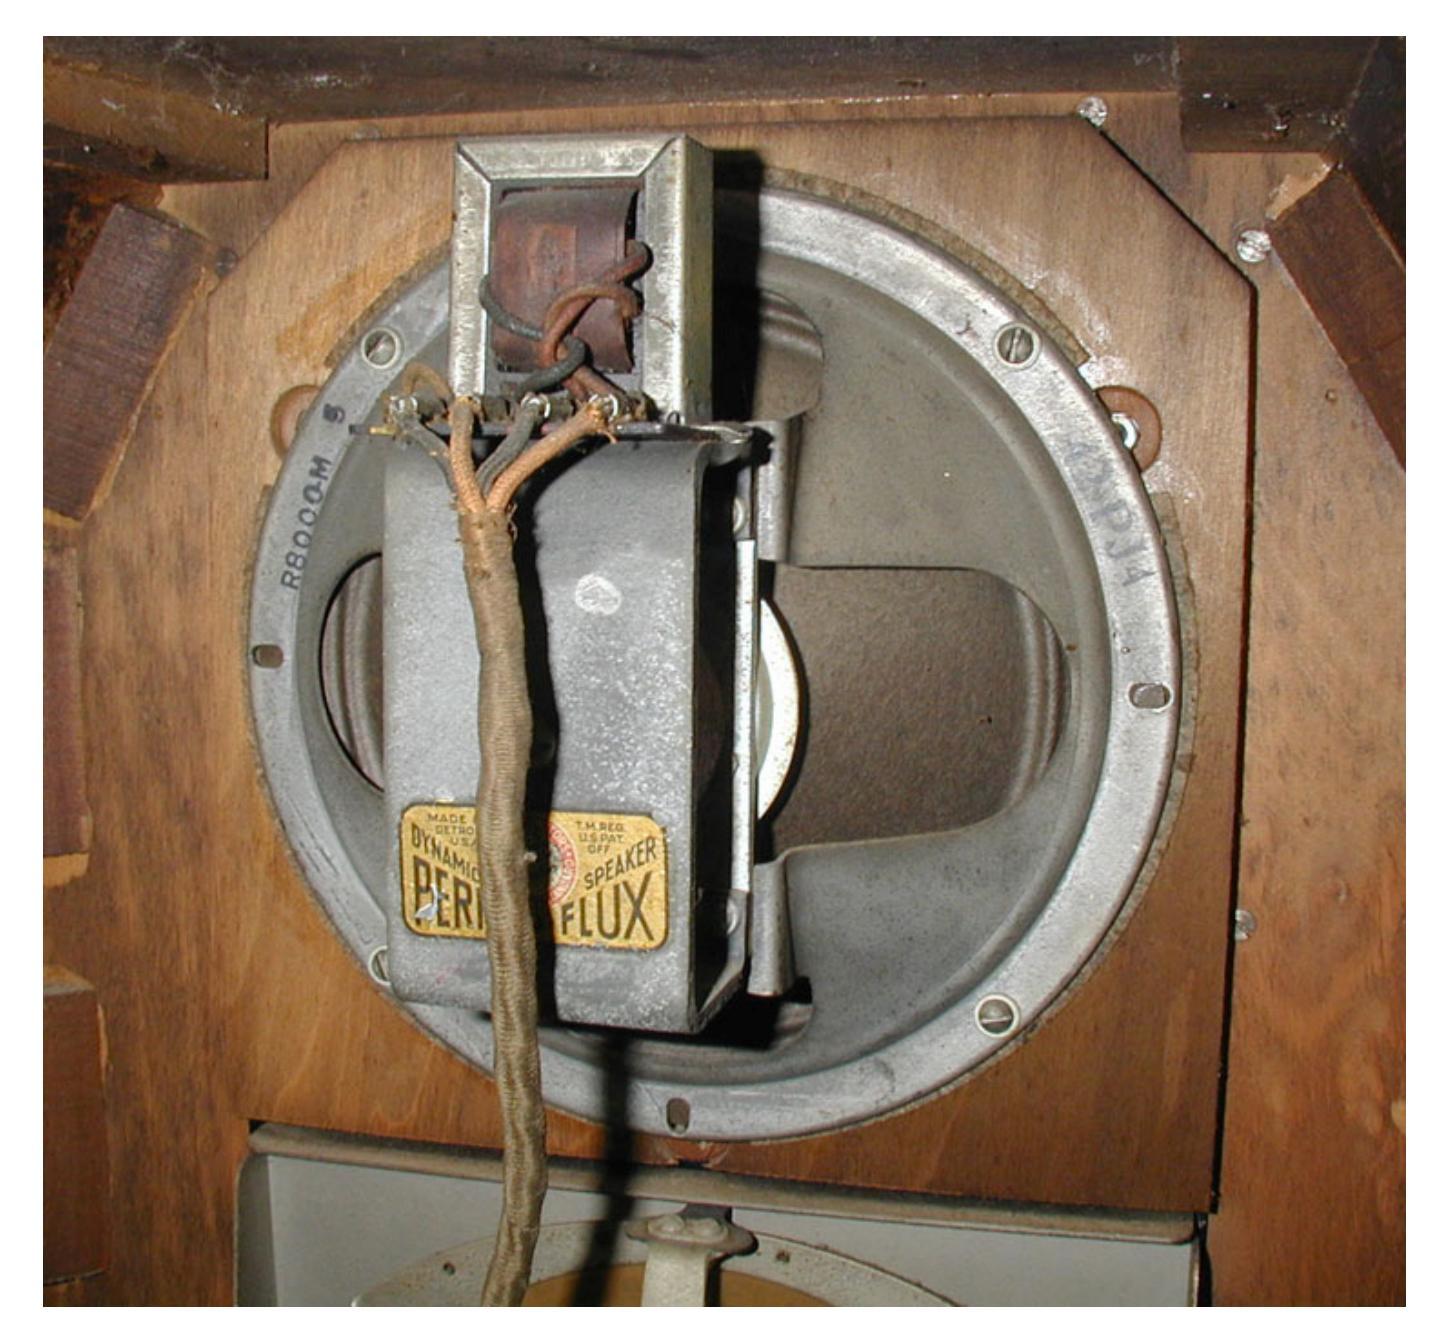
The loudspeaker found with this set is not the one shown in the AK service literature. The service literature shows a center tapped high impedance balanced armature (pin driver) speaker. I have seen this radio's *Perm-O-Flux* brand speaker advertised in 1936 issues of *RADIO TODAY*. Since the applied working voltage of this design was a surprising 160 Volts, it could be that the original high impedance balanced armature speaker did not last long in this service since these speakers were commonly used in circuits with 90 Volts 'B' Battery. It is obvious that any replacement, if made, was done many years ago and with the same workmanship exhibited in the wiring of the chassis.

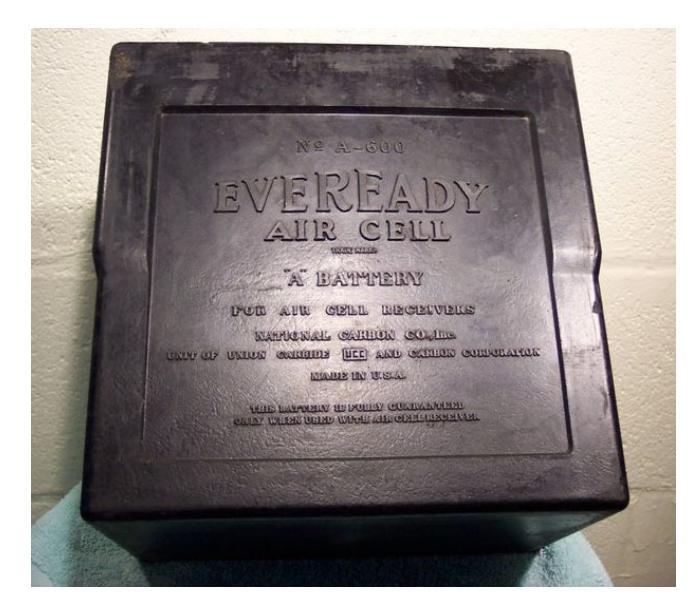
In late 2011, my eBay search criteria finally returned a hit! A person in Ohio had the bottom case of the battery. This seller specializes in automotive memorabilia and was not aware that this battery had anything to do with vintage radio. He therefore did not know to list it in the vintage radio categories. It turned out that I was the only bidder on the item!

This is one of the photos he posted on eBay.

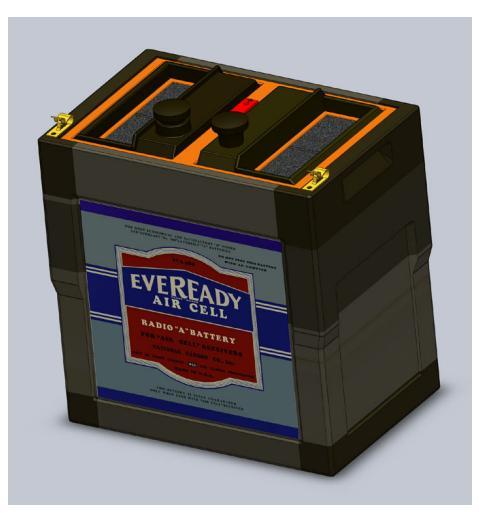
Create a 3D CAD model of the battery with *SolidWorks* software using dimensions obtained from the surviving bottom case and cut-away sales model.

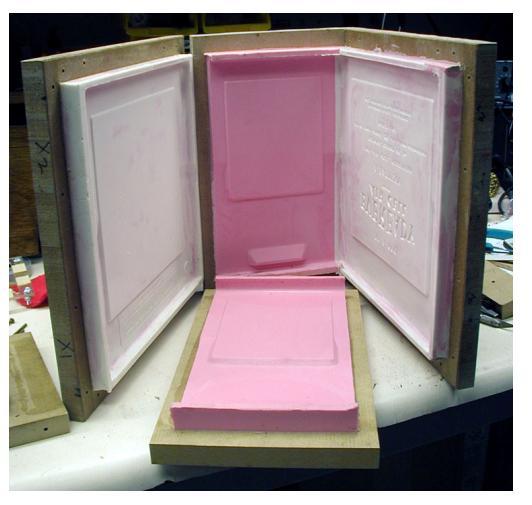
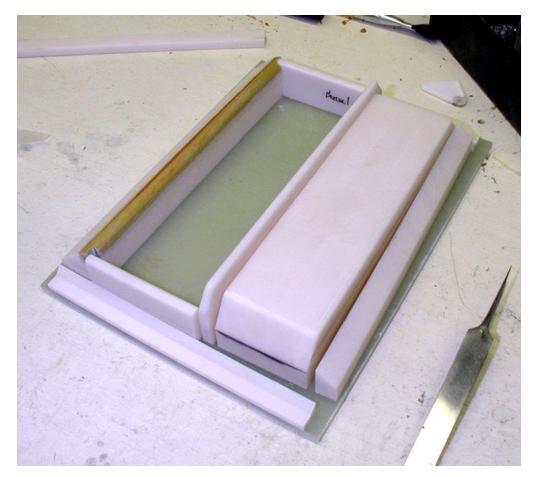
Build a multi-part silicone rubber mold from which to cast the bottom case of the battery using urethane resin.

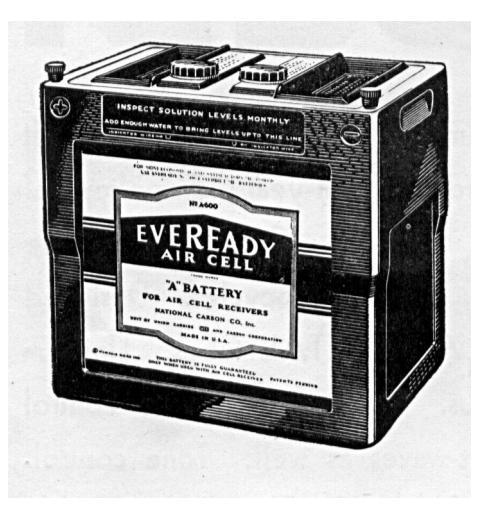
There are no known examples of this multi-color graphic pasted on one side of the battery. Fairly high resolution black and white photos were located in trade magazines such as *Radio Retailing* and *Radio Today*. Eveready advertised in a number of popular magazines such as *The Saturday Evening Post* and rural focus magazines such as *The Country Gentleman*. Some of these advertisements for the earlier version of this battery are in color. The B&W image became a perspective corrected template within a Photoshop image project and colors were chosen for use in the project. Traces of glue on the surviving case told me the exact size of the graphic.

Fortunate for me, I was able to identify that the majority of the text in the image was either Cooper Black, Times New Roman or Arial (with slight deviations). All these fonts within Photoshop 7.0 are fully customizable so that each character could be made to fit exactly over the text in the template image.

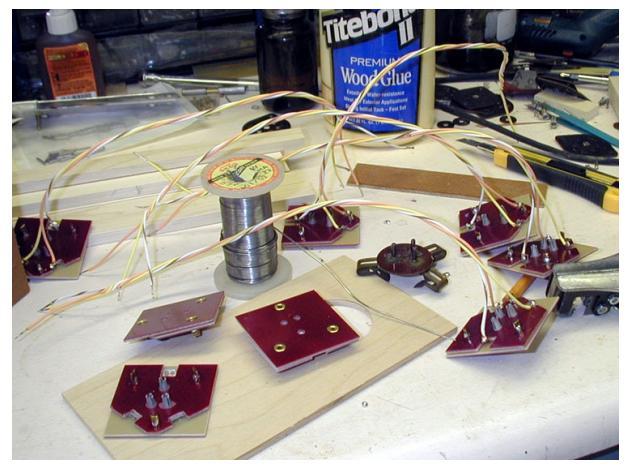
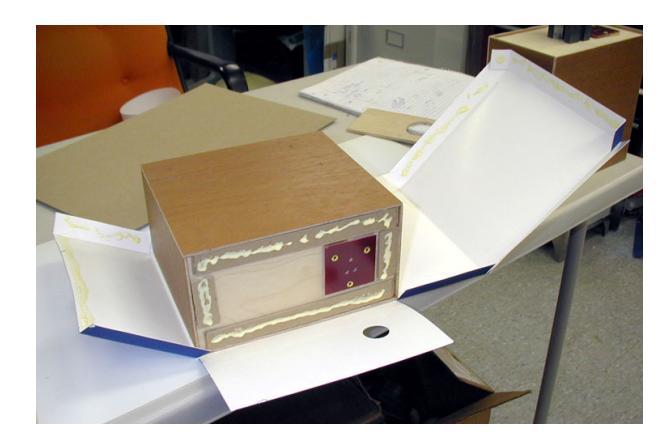
The receptacle is mounted and the graphic folded for gluing.
