A photo report from an little old historical radio. Problems and solutions at restoration.

Project NSF H54U part 1

Project NSF H54U Part 2

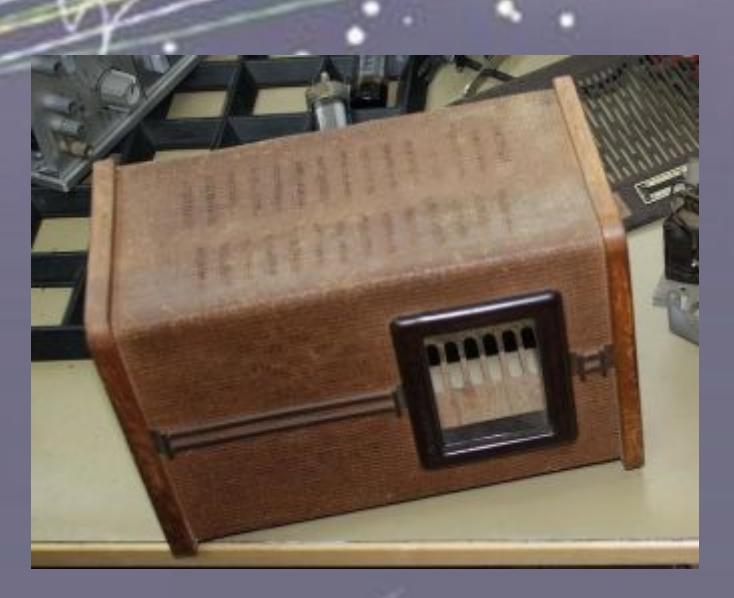
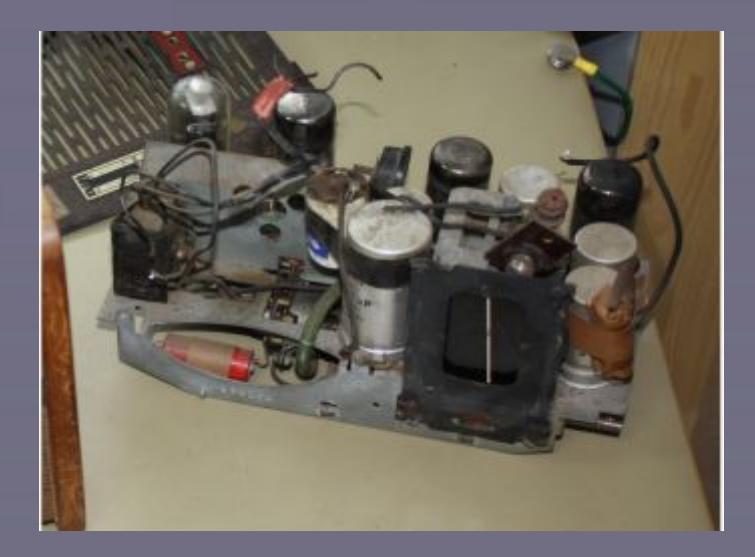
The cabinet and chassis

The cabinet looks reasonable in this picture, but it only hangs together. The paper rope looks dirty and greasy. The metal ornaments are rusty and the bakelite window has a dull color. At the bottom side is (not visible) a wooden bar of the ventilation grill broken off.

The chassis has no tuning-scale and is also very dirty and dusty. The "rattle" capacitor is broken and some other tar-capacitors are cracked. Volume control and power cord are missing. The tubes look like they ever have been very hot.

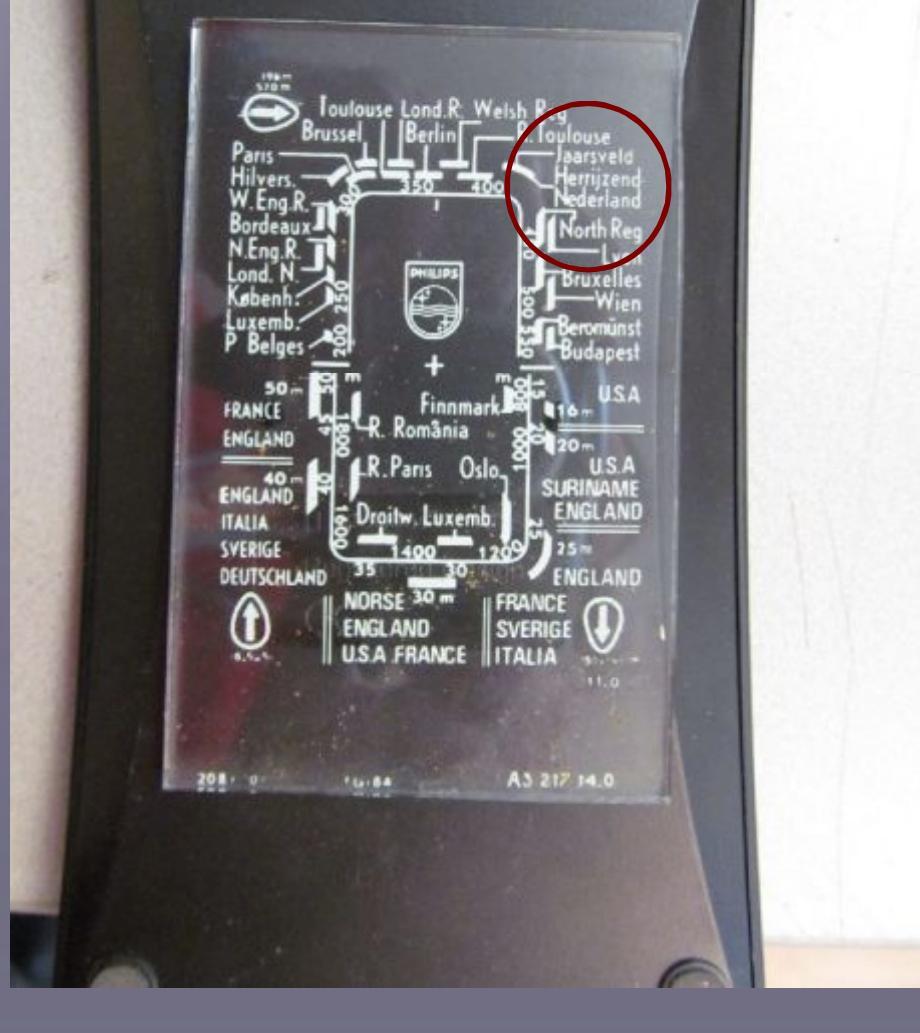
The tuning-scale

On the scale we see the radio station name "Herrijzend Nederland" "Netherlands Rising": It was the name of a radio station that operated for some after the war. "Radio Herrijzend Nederland" transmitted for the last time on Saturday 19th January 1946. The "Foundation Radio Netherlands in Transition Time" took over the broadcasts on Sunday 20th January 1946.

The scale was not original to this radio because of the Philips logo. (An NSF-logo would be there) The radio was built by NSF (Dutch Signaling equipment Factory) and was licensed by Philips. This original scale was purchased from a collector on a radio fair.

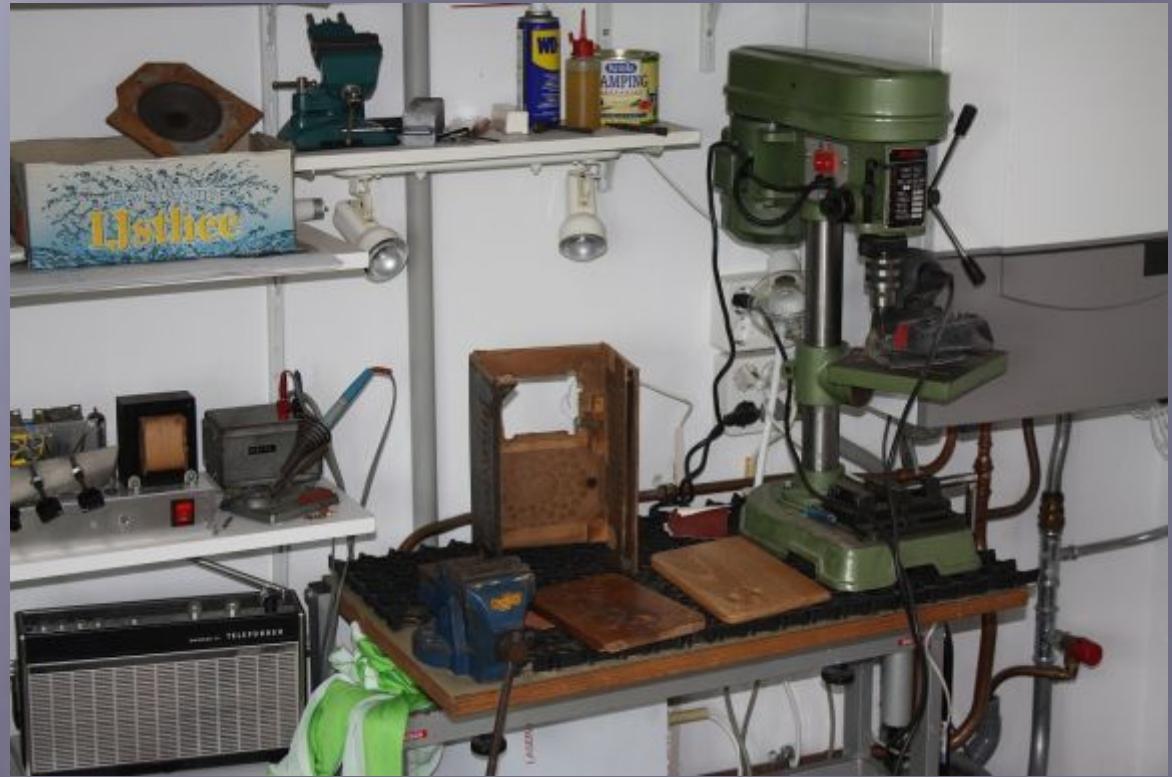
The cabinet in parts

All the parts of the cabinet are visible on the work bench. 4 of the 5 parts of the wooden connections pieces were removed because they were too bad to be used to glue all parts of the radio together again.

One of the sides with the holes for wave range switch and tuning control is already sanded. The speaker is lying above.

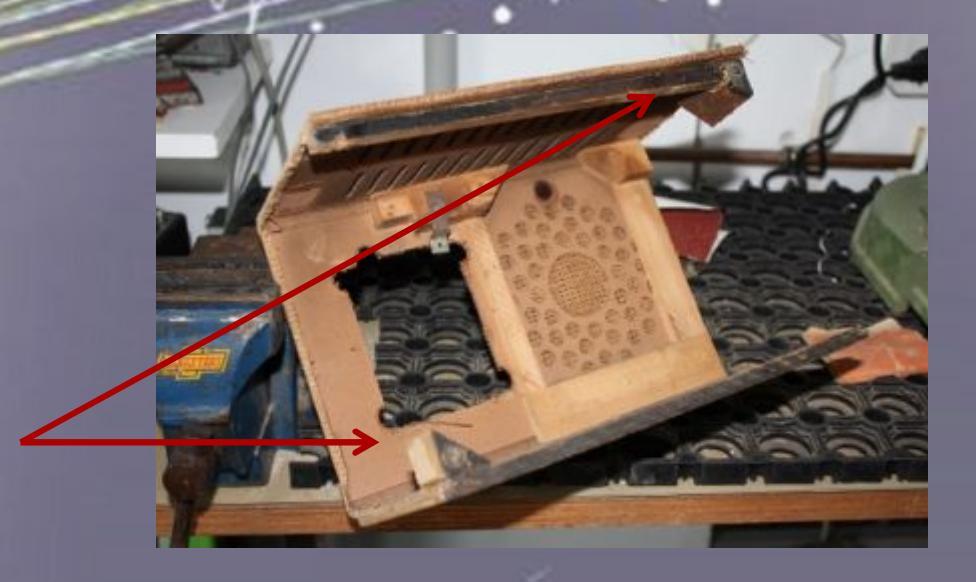
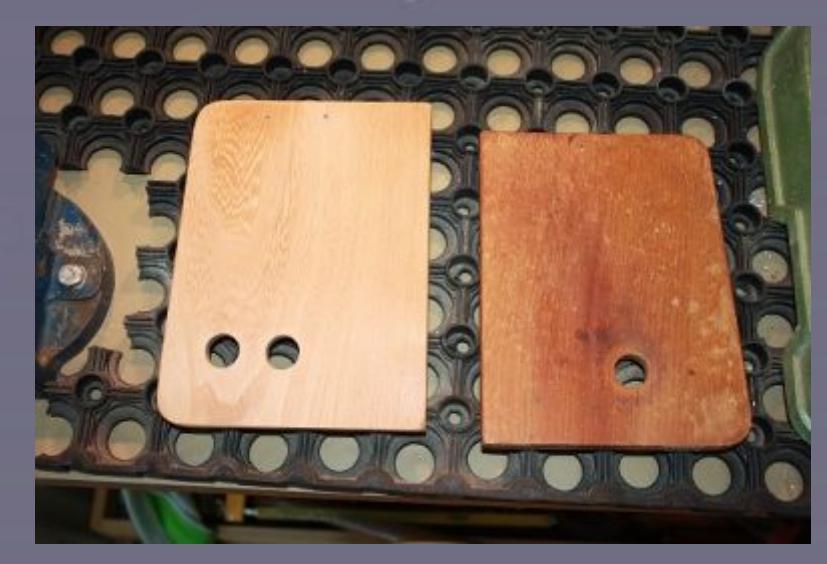
The cabinet in parts

On these pictures the parts are shown in detail. Two connections look intact, but even these will have to be repaired.

Here the differences between the two sides visible. The right hand side side still has to be cleaned.

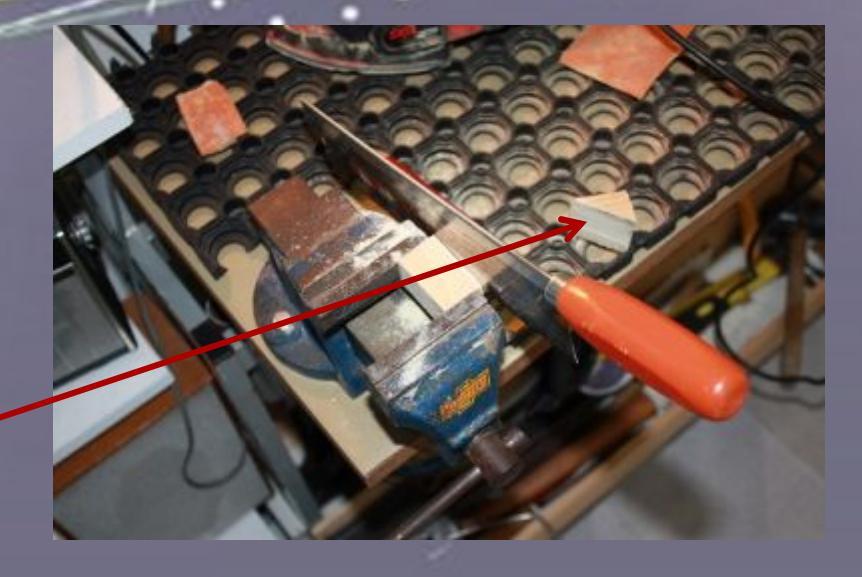
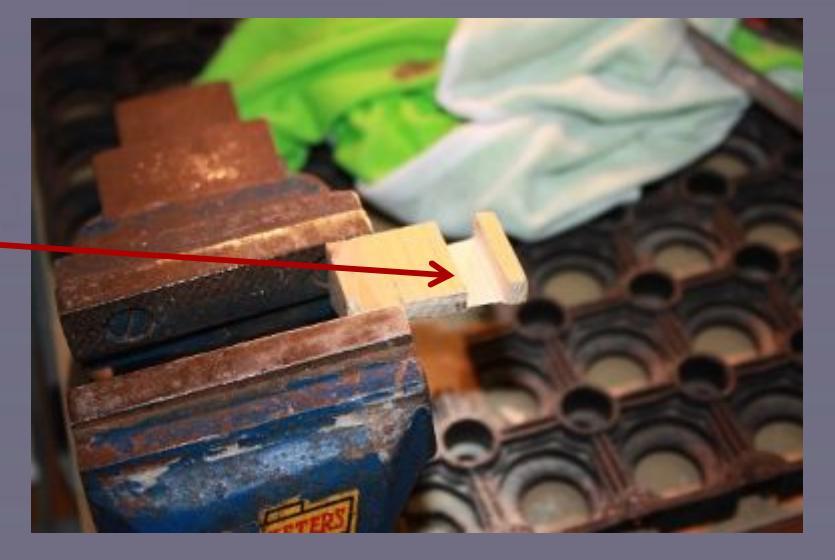
Making new joints

From a piece of wood the joints were sawn out.

There are two types: ordinary joints and joints with a slot in it.

The latter were placed behind on the upper side so that the reinforcement crossbar can pass through.

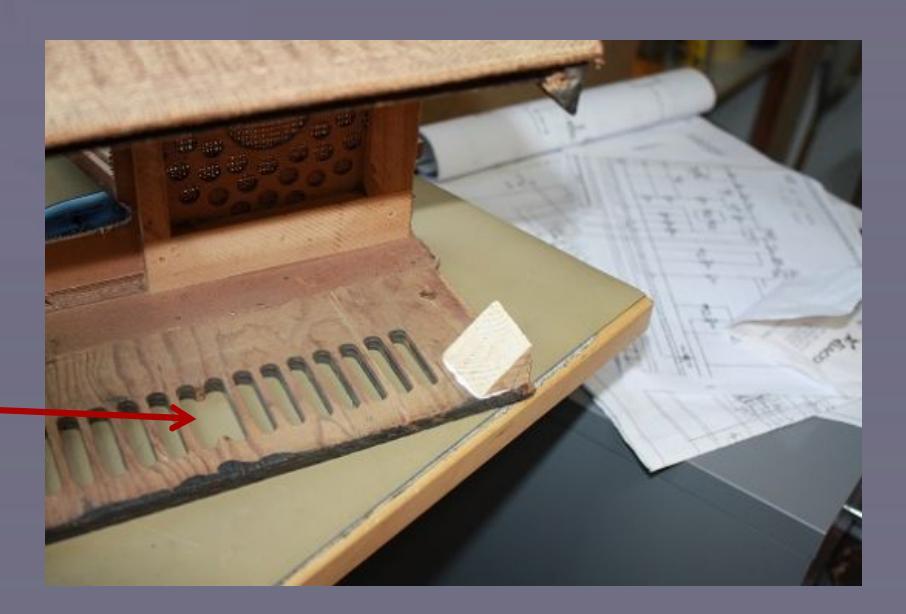
Making new joints

The ventilation grill has missing (broken) a bar.

The new joint is put into an exact position using the correct side.

After that, the joint was glued on the bottom plate.

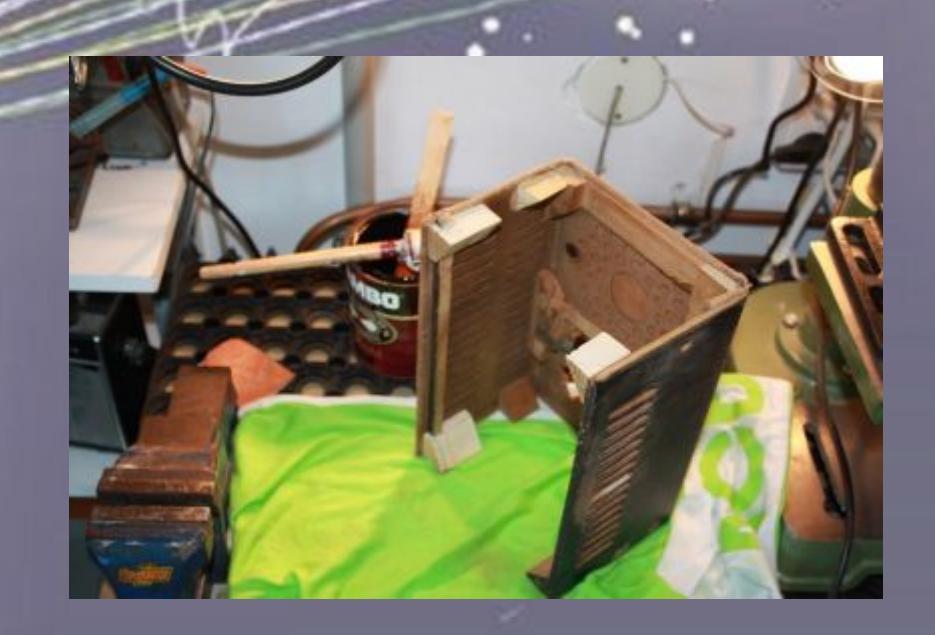
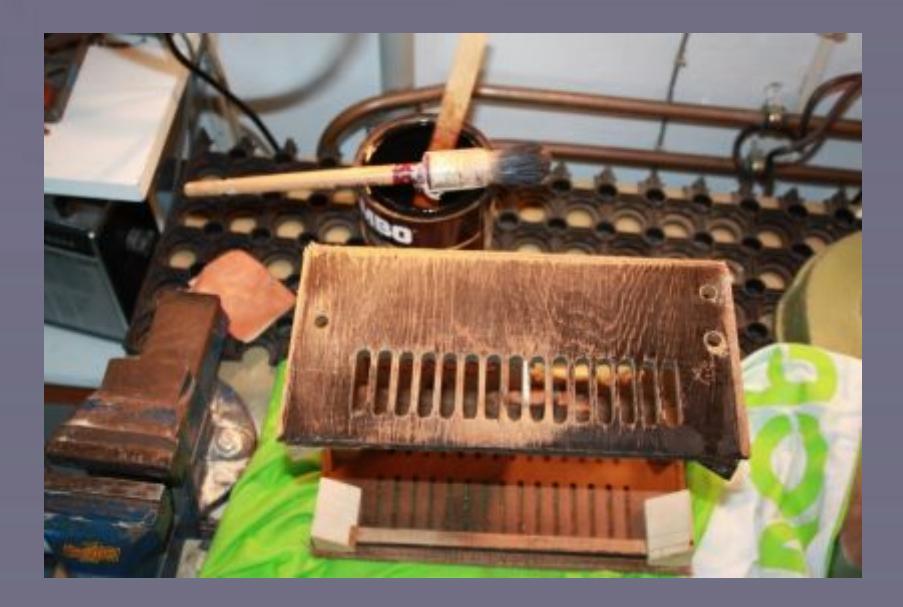
Painting of the cabinet

This picture gives an overview of the restoration of the corner connection pieces.

The bottom side is sanded and is ready to receive the original black color. The new wooden bar is now almost hidden from view.

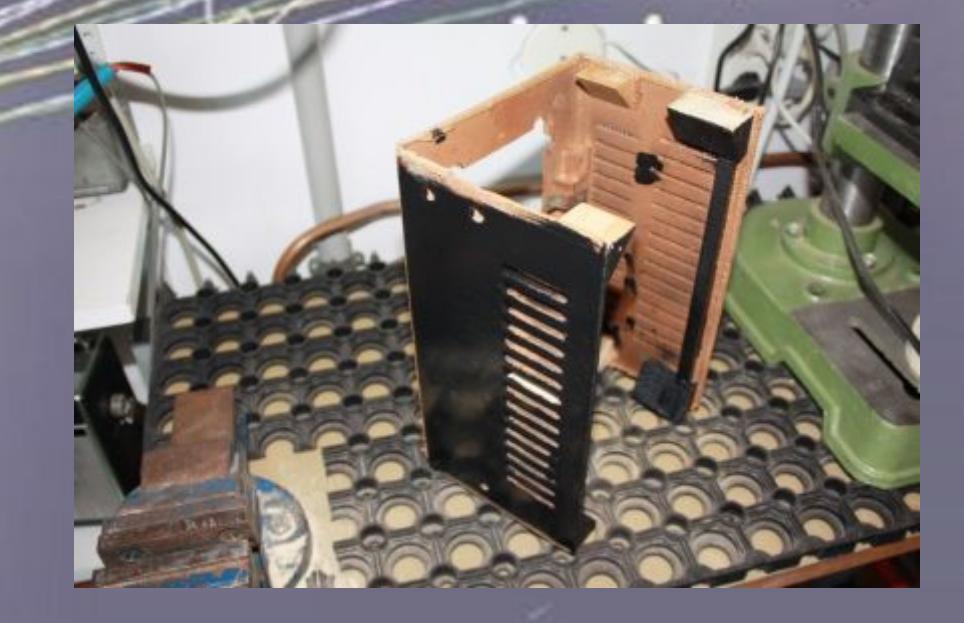
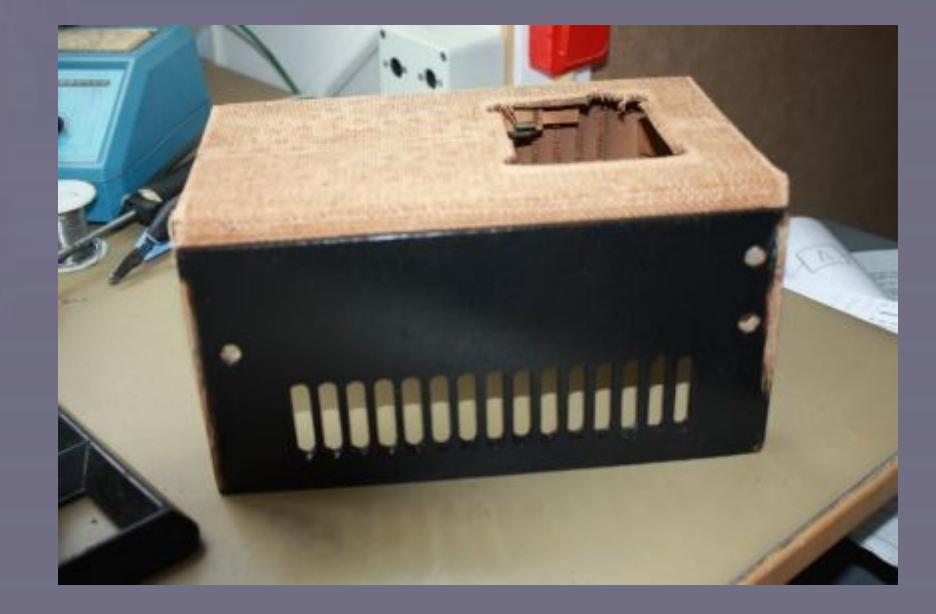
Painting of the cabinet

After one-layer paint. The ventilation grid still has to be painted on the inside.

After the second layer, the grill is also well covered. The restoration is almost invisible.

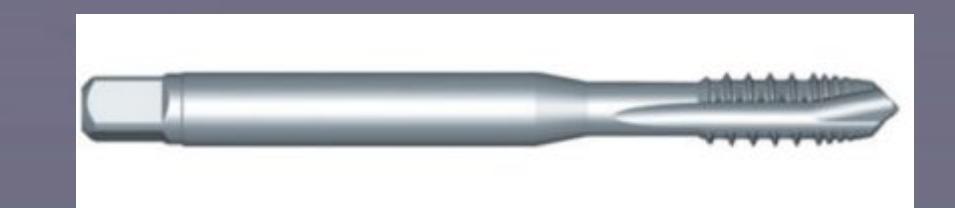
Chassis-sledges

The bakelite chassis-sledges have a screw hole at the rear for an 4 mm screw, securing the chassis. But there was a problem. It was not possible to screw clockwise, presumably due to dirt that had gathered in the hole

With a special tap that can be used in plastic, the hole was tapped again, ready for M4 screws. (With many thanks to Mr. Anton van den Oever.)

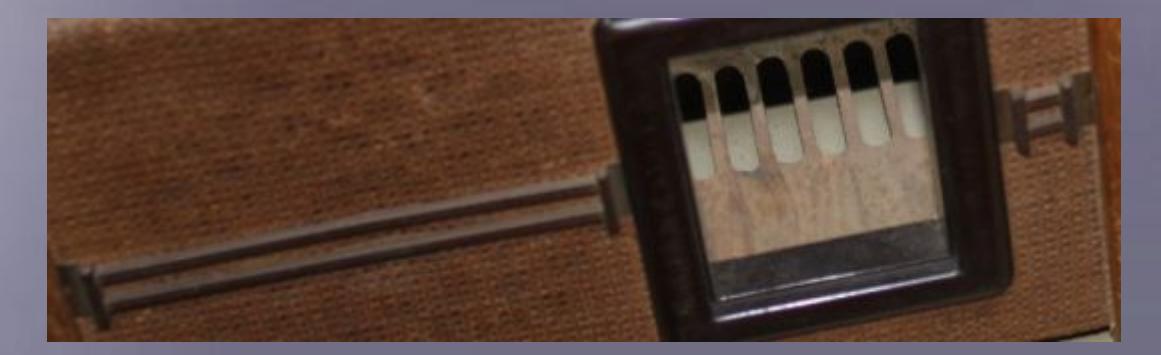
Ornaments

The picture shows the metal ornaments on the front. They were originally brass colored, but here they are rusty and very dirty.

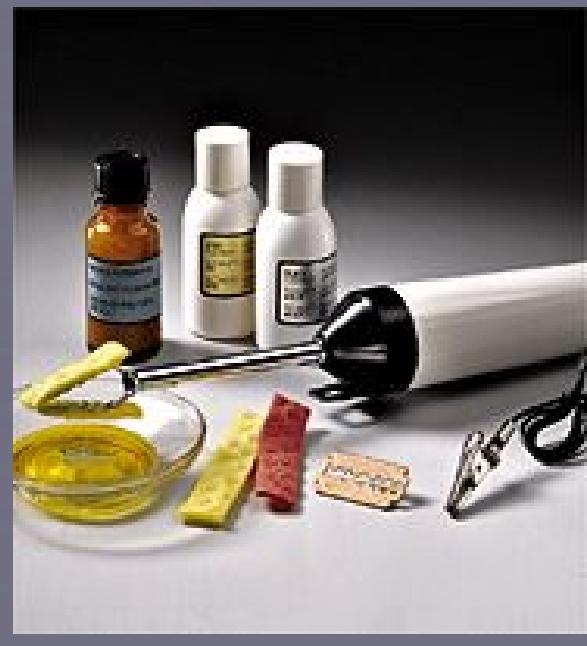
Plating kit

The plating kit contains an electrode with a battery-holder. These batteries deliver a voltage of 3 volts, with a current of max. 200 mA.

There are 3 bottles: one with silver and one with gold electrolyte. The brown bottle contains a fine abrasive. A damp sponge is hooked at the tip of the electrode and acts as a positive electrode. The black crocodile clip is fitted to the ornament. The sponge is dipped in the electrolyte and is then applied to the ornament.

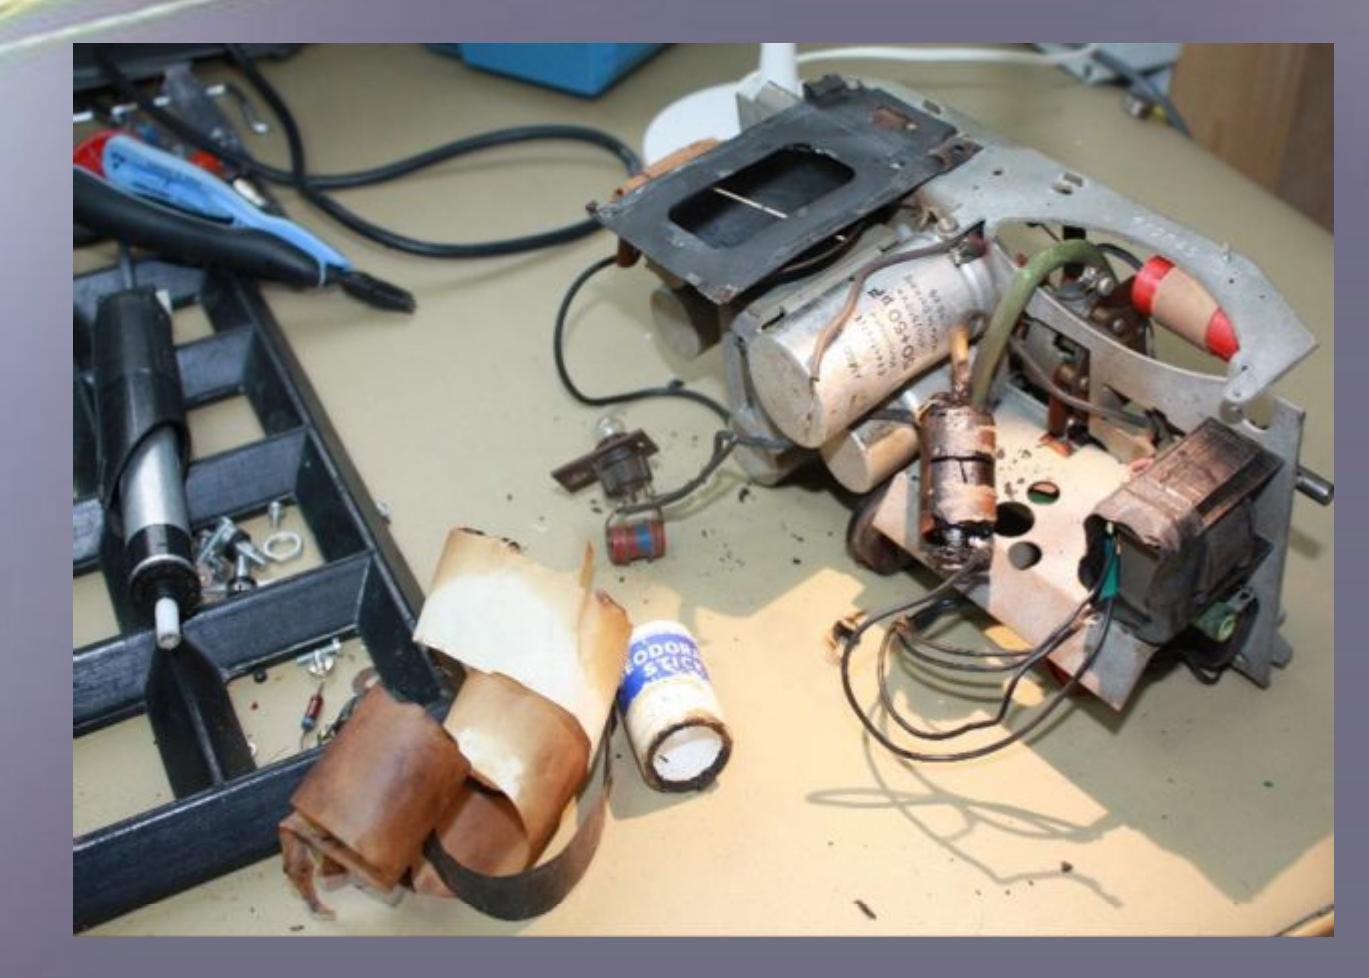
After the restoration of the cabinet, care of the chassis was needed. At first glance, the chassis looks damaged.

The "rattle" capacitor that had been placed in a deodorant tube against the elco had exploded. Also there was a provisionally made second speaker connector on the back panel.

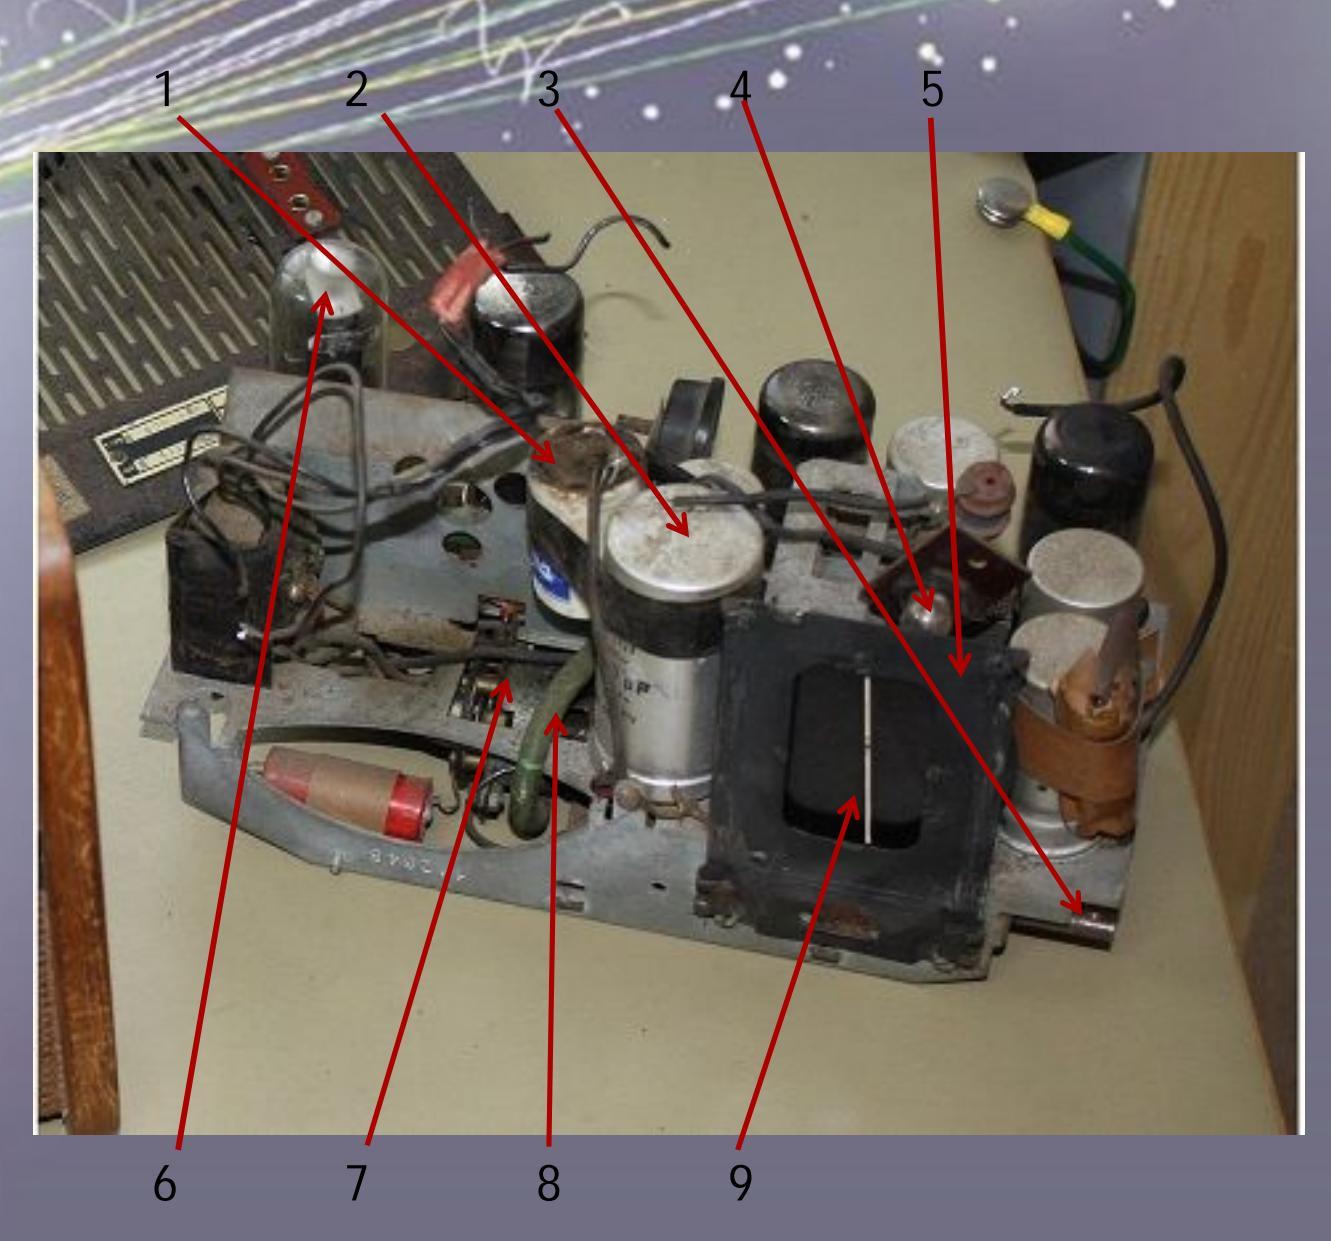
Problems at the top of the chassis

- "Rattle" capacitor damaged
 Elco's had to be reformed
 Scale cord broken
 Scale lamp defective
 Scale holder rusty
- 6. Tube feet damaged
- 7. Volume control crackles
- 8. Power cord is missing
- 9. Scale is missing

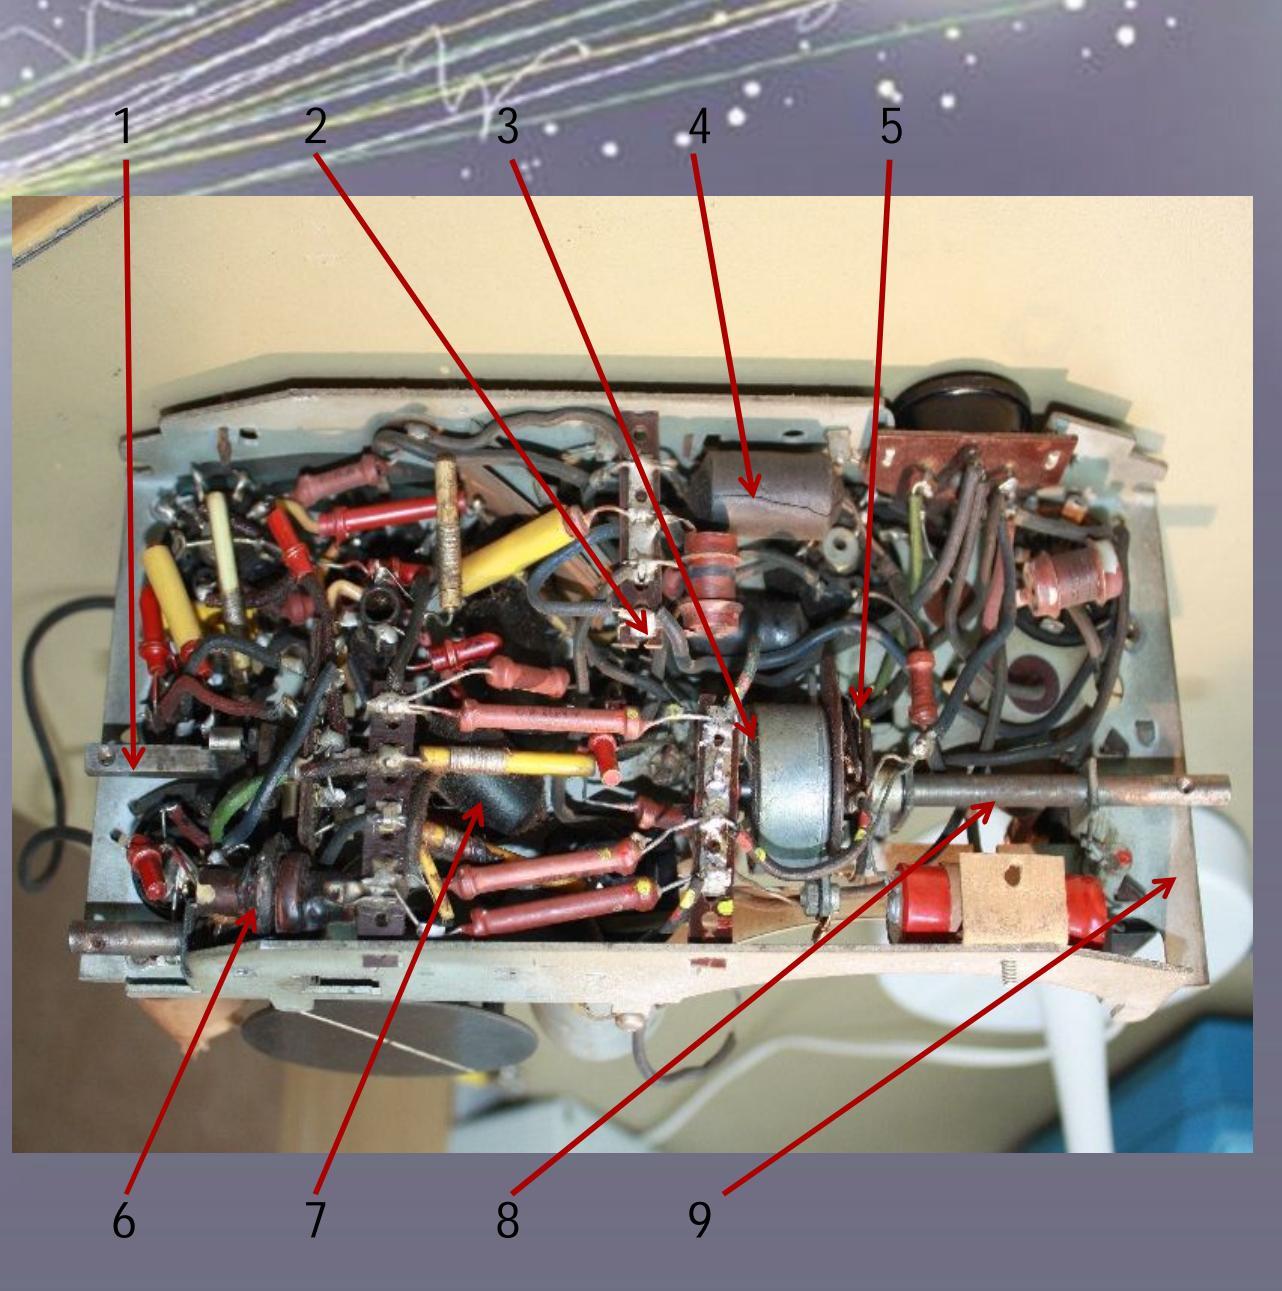
Problems below the chassis

- 1. Wave range switch crackles
- 2. Wiring crumbly
- 3. Volume control open
- 4. Capacitor cracked
- 5. Power cord had to be fitted
- 6. Coil in bad shape
- 7. Capacitors have to be checked
- 8. Spindle cleaning
- 9. Chassis cleaning

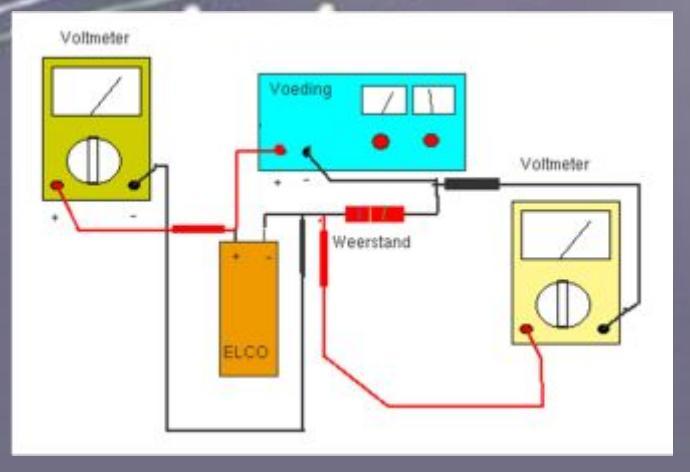
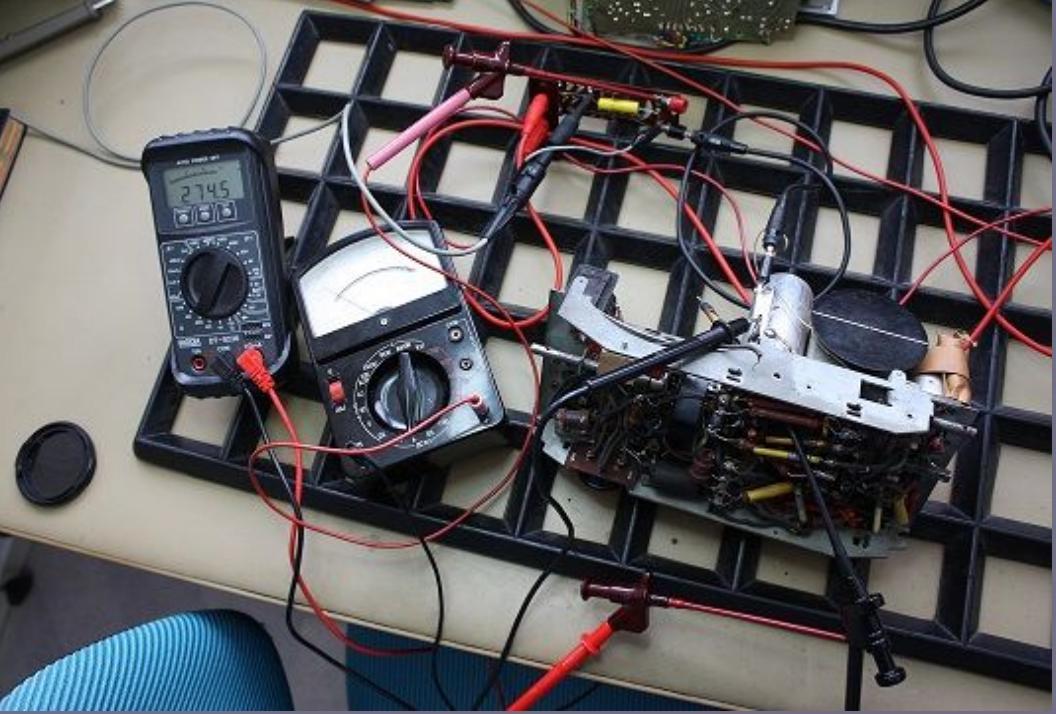
Elco reforming

If an electrolytic capacitor is not used for a long time, the dielectric oxide layer is very thin. The capacitor slowly builds that layer back. Usually it is unwise to apply the full high voltage of 250 volts. It is better to increase the voltage slowly with an adjustable power supply. (upper diagram)

The picture shows how the process look in practice. A line transformer is used as power supply with a DC-regulated network. The digital meter displays the voltage at the capacitor, while the analog meter displays the current. This stays lower than 0.5 mA . The whole process takes several hours.

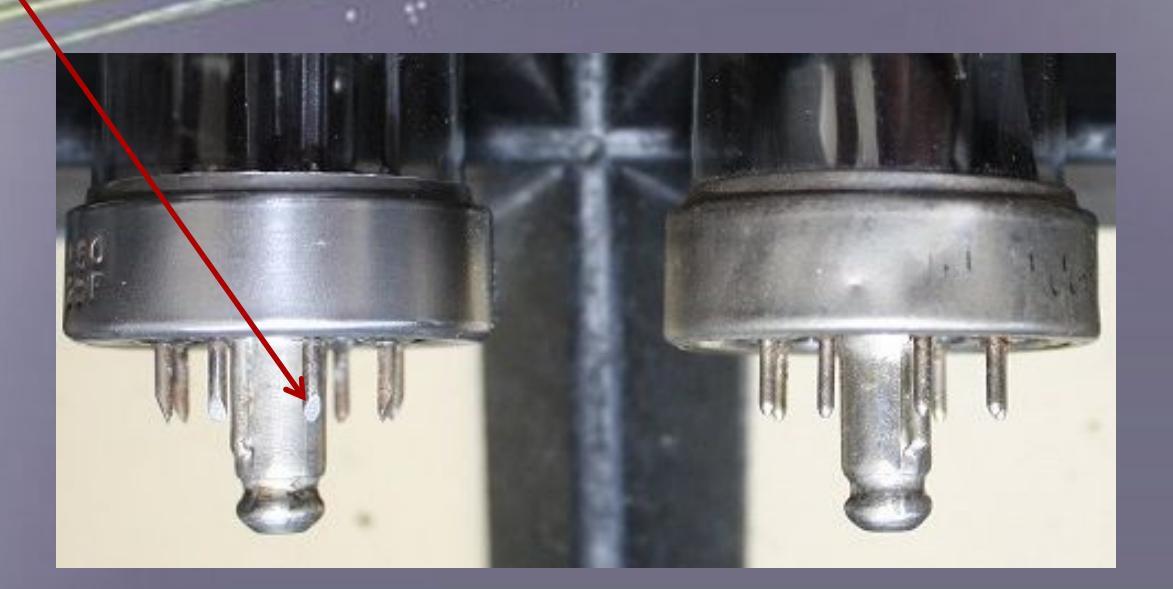
Tube pins damaged

The sound came back in the radio after that the necessary capacitors were replaced, but a strange error arose. The sensitivity increased, when the tube of the HF amplifier UCH21 was pressed with a finger.

The cause was a bad contact of the pins because the pins of the tubes had been

shortened by a file. (1) The error only occurred in this tube base, possible due to tolerance differences.

Supposedly it was done so the tubes were easier to place in the tube base. However, no one has taken into account that as a result, the pens could be too short. The UCH21 in the HF amplifier foot is replaced by another one

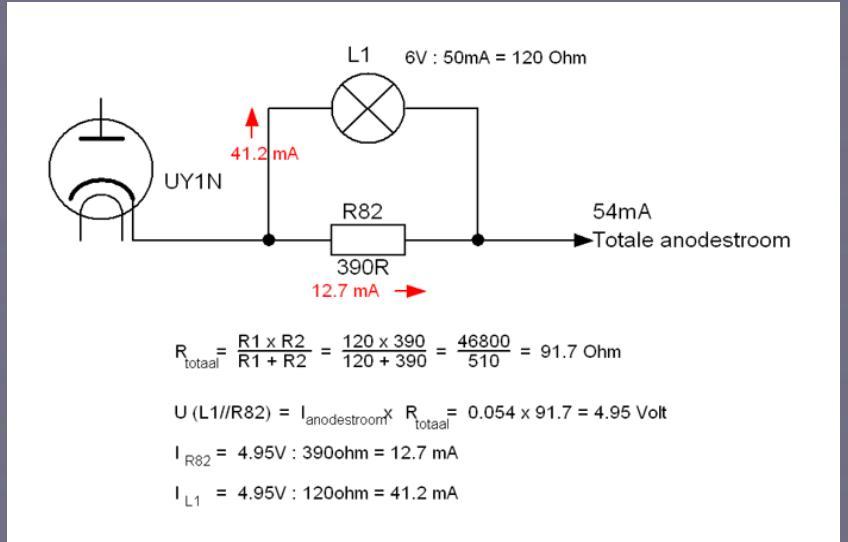
Scale light problems

The scale lighting is a provided by a 6 V, 50 mA bulb, parallel with a wire resistor or 390 Ω /1W. This is R82 according to the schedule below.

The resistor in the chassis (see the photo) has a value of 120 **Ω**. This explains why the light is so weak. This resistor is tentatively replaced by a carbon Resistor.

(This remains so in anticipation of further research into what may have been the reason.)

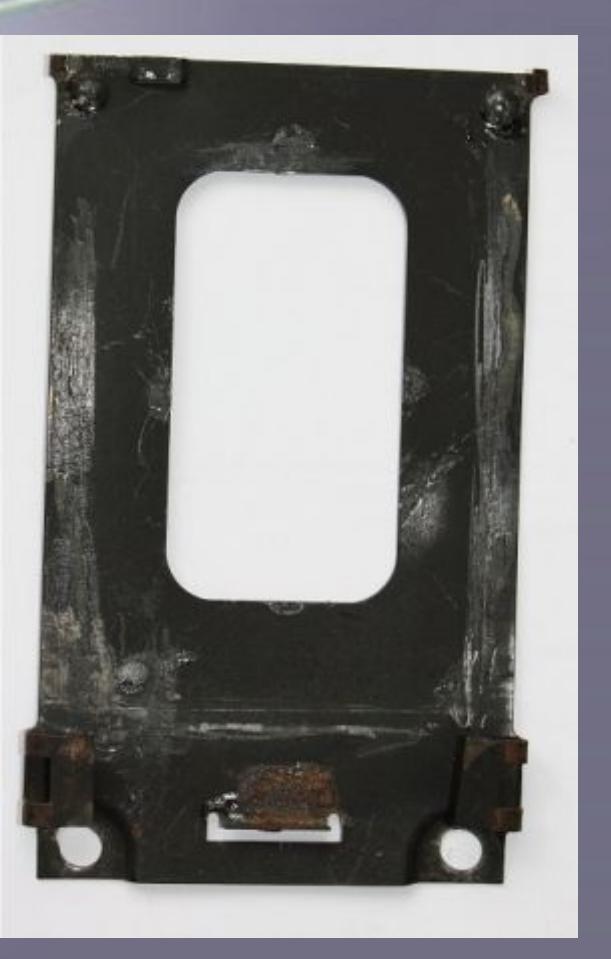
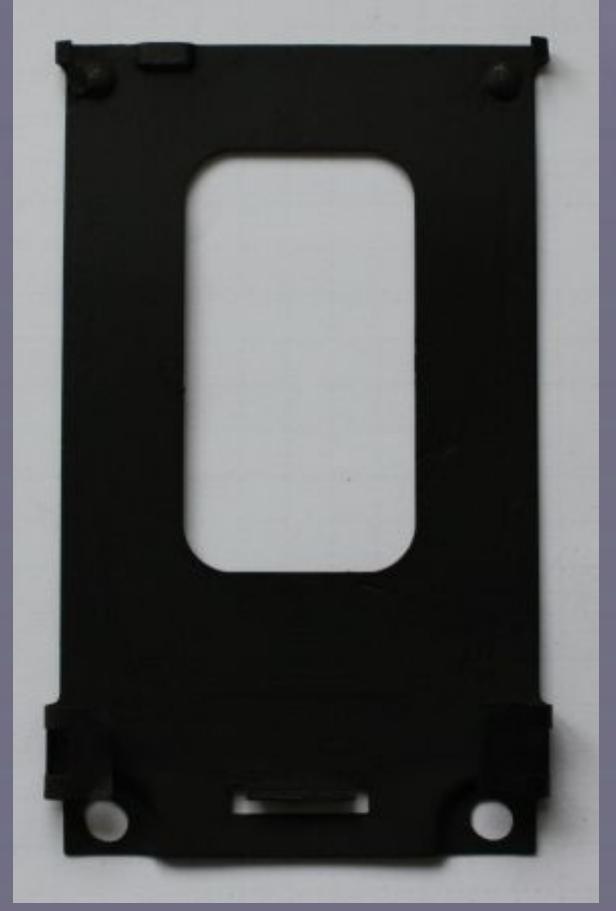
Restoration of the scale holder

The left photo shows the scale holder that has not yet been treated.

The picture on the right shows the holder, after it was sanded and covered with a matt black spray paint.

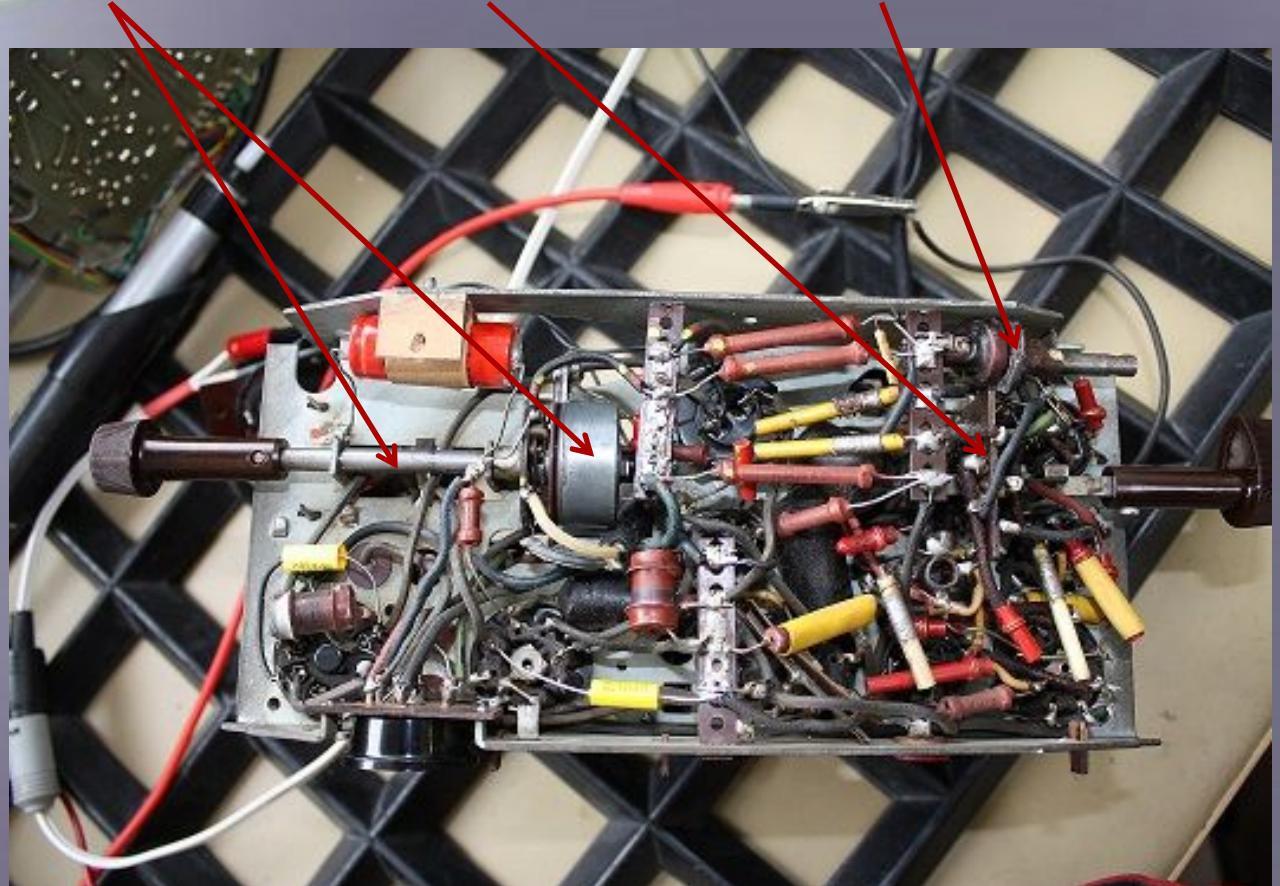
Bottom side ready

The oscillator coil for long and medium wave is in a vulnerable place and can be damaged easily. (3) (be careful)

The axis of the volume control knob has been cleaned and the regulator itself was cleaned with contact spray. (1)

Wave range switch contacts were cleaned with a little bit of brass polish. Many contact problems during switching were significantly reduced doing this. (2)
