Remler Model 72

Restoration Project

Elmo Giovannetti

January 2012

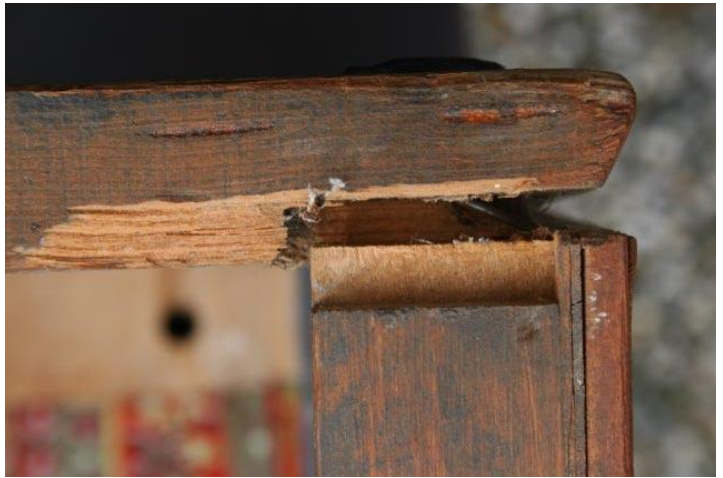
Split Back Left Corner

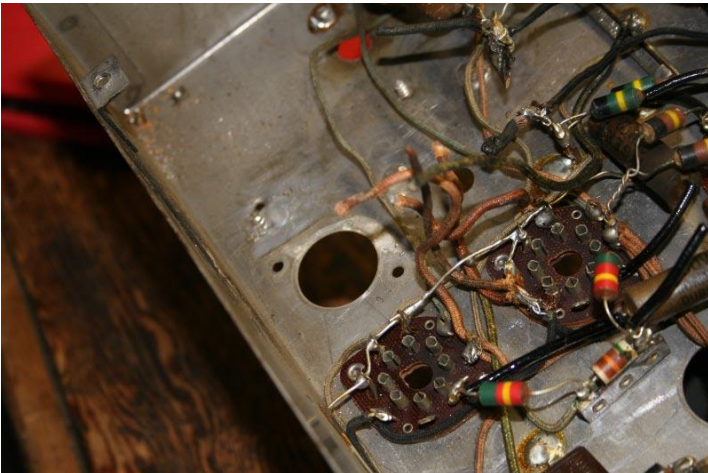
Socket Removed

The photos show the steps taken to replace the damaged rectifier socket.

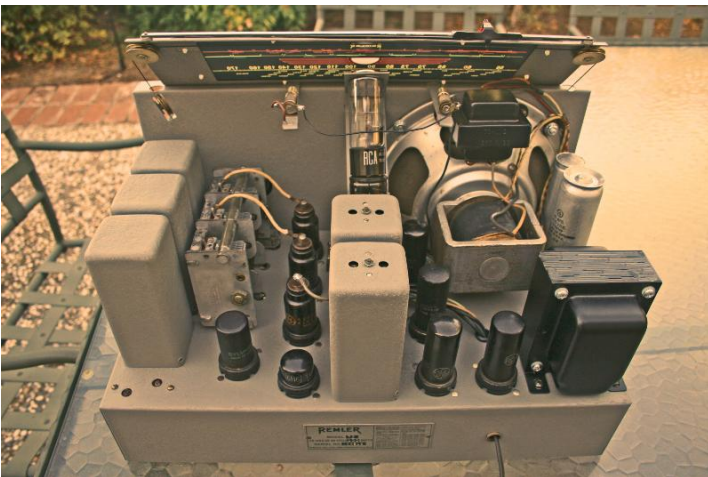
Tuning Eye Circuit Rebuilt

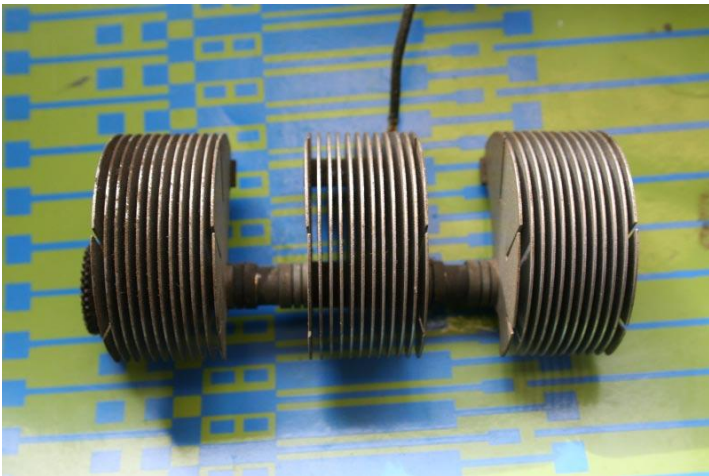
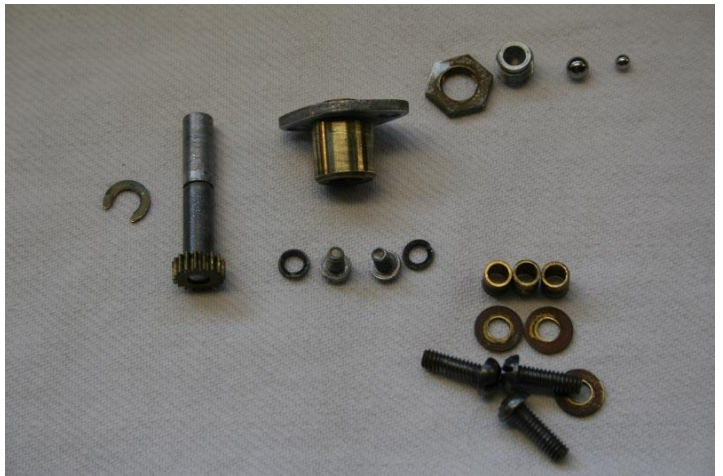
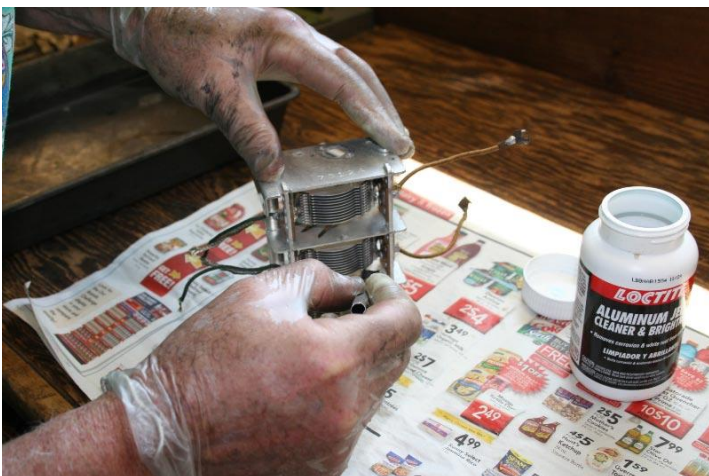
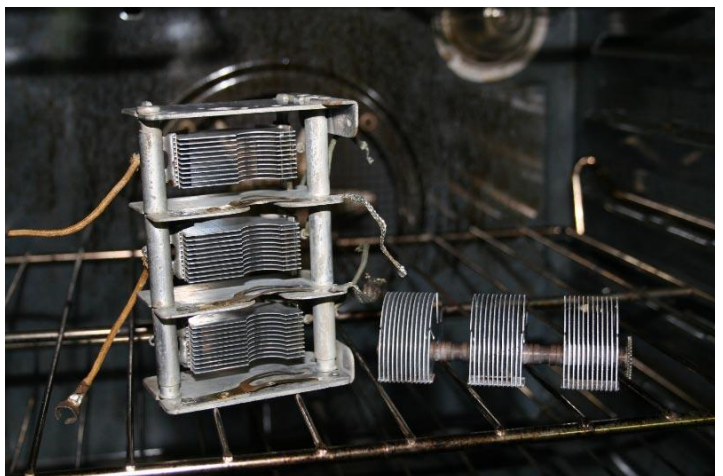
Capacitor disassembled

Dirty Rotor

Disassembled Rotor Drive

Capacitor Cleaning

Capacitor Drying

The tuning capacitor was electrically operational with no bent plates but was difficult to turn. The pictures show it was in need of cleaning. I removed the rotor, disassembled the drive mechanism, cleaned, lubed and reassembled.

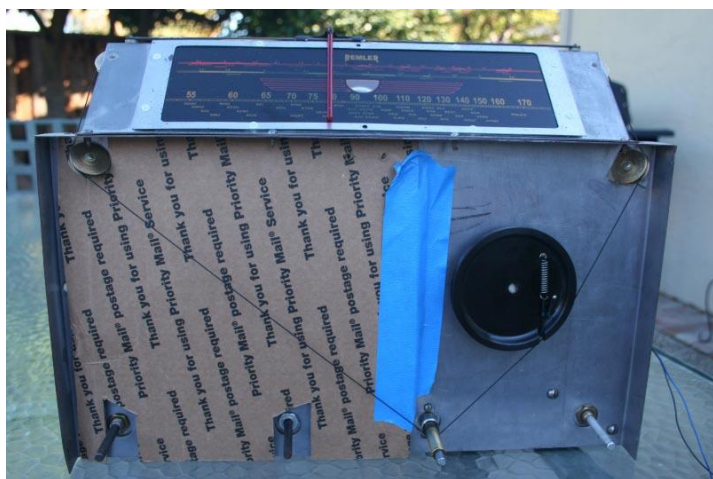
Tuning Mechanism Restored

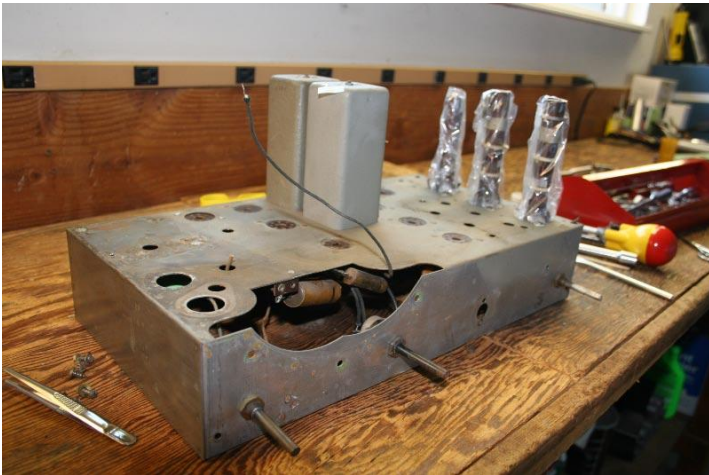
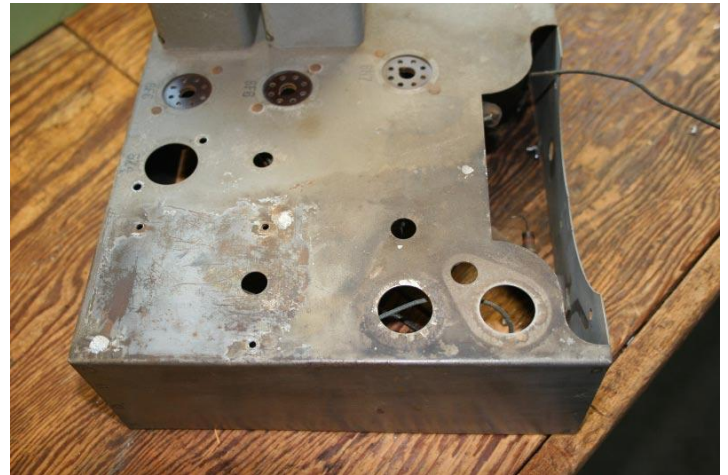
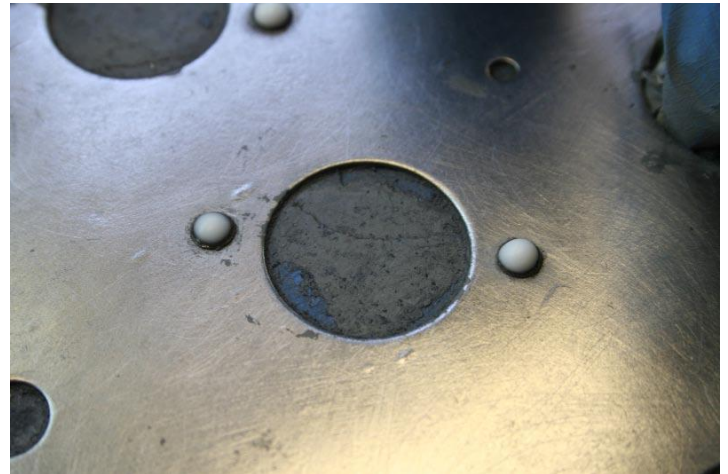
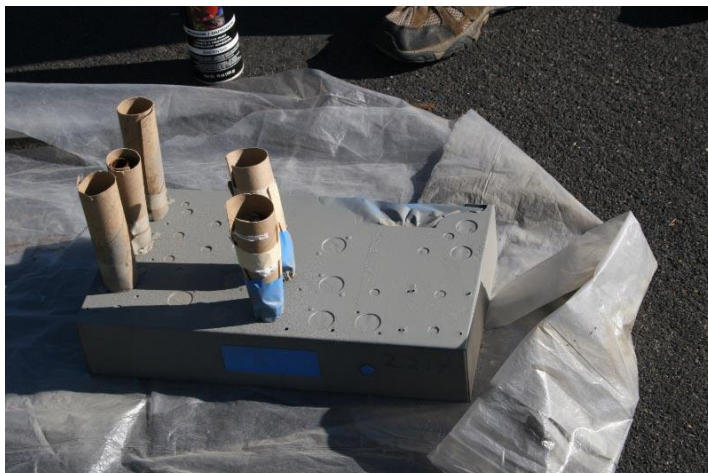
Chassis being prep for painting

Chassis painted

Chassis painting completed

As the pictures show this chassis had seen better days. I started by washing the chassis. I removed the tuning coil and IF cans and any other sensitive components. I protected the coils by putting them in plastic bags and sealed them the best I could. I then sprayed the top and bottom of the chassis with *Super Clean* then lightly hosed it off. The amount of grime removed was impressive. I dried the chassis using low-pressure compressed air and the sun. Repainting the chassis was the next step. The original finish was a gray wrinkle paint that was not available. What I did use was a black wrinkle paint which I used as an under coat then applied a gray topcoat finish. In order to avoid painting the tube socket rivets or having to drill them out I put a drop of wood glue on each rivet head. After painting, the glue was easily removed with an exacto knife.

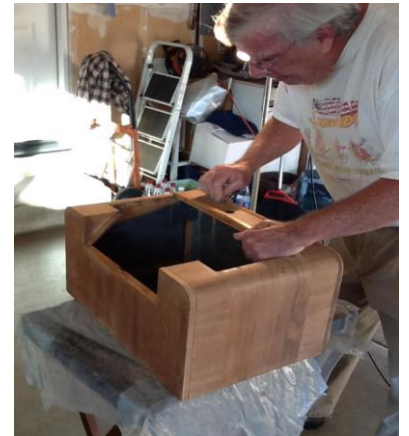
Cabinet Stripping

Don't know the history of this radio but it looked like at some time someone refinished the cabinet with an orange/reddish finish. Not sure what the finish actually was, but it was difficult to remove. In fact, I was never able to completely remove it. After using lacquer thinner, multiple applications of paint remover, sandpaper and steel wool, enough of the old finish had been removed so that the new finish could be applied. To help prevent blotchiness, I first applied a pre-stain wood conditioner followed by the finish stain. The stain used is a *Minwax Red Mahogany*. After a few days of drying I hand waxed the cabinet with *Minwax Paste Finishing Wax*.

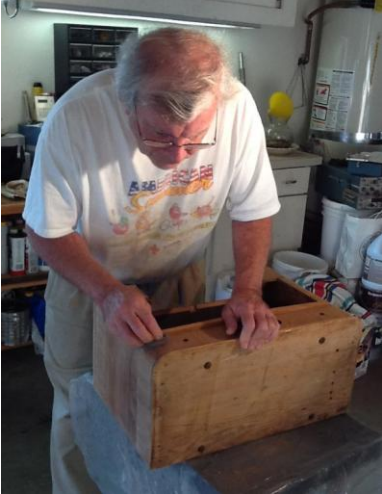
Cabinet Sanding

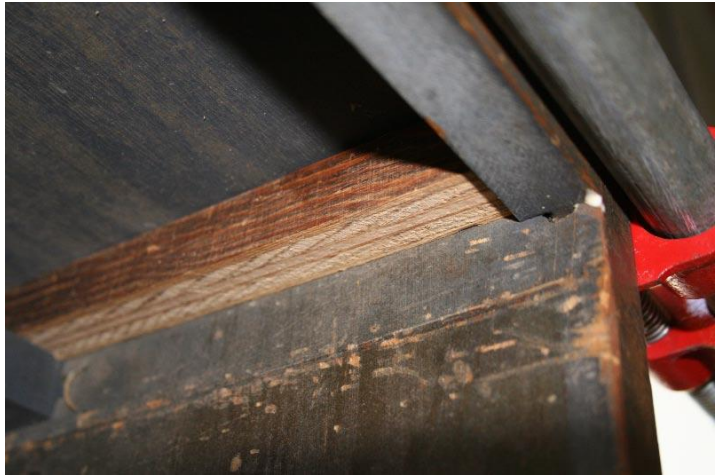
Back Bottom Right Runner

The two lower back corners of the cabinet had pulled away from the cabinet base. To repair this, I screwed two wooden runners to the inside base of the cabinet on the left and right sides. I then peeled back the veneer on both sides of the cabinet applied glue, compressed the joints then put screws through the sides of the cabinet into the runners. The final step was to glue the veneer back into place.

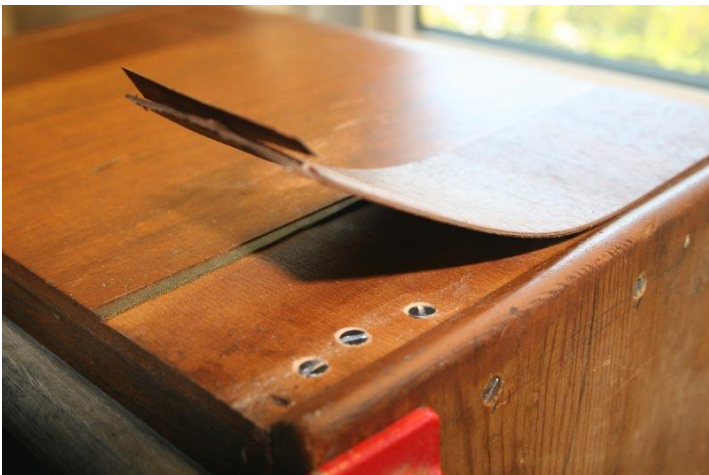
Back Right corner Screws

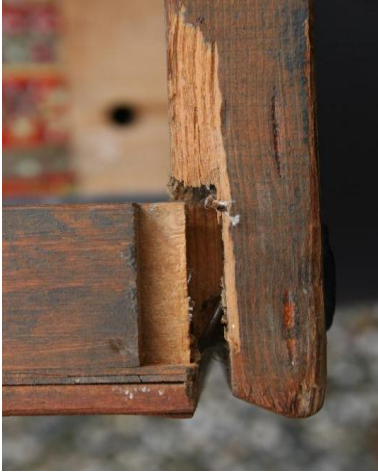
Back Left corner Split

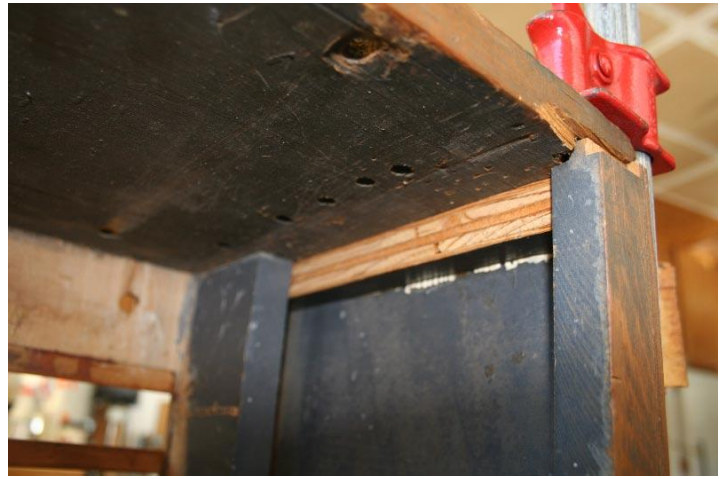
Left Corner Runner

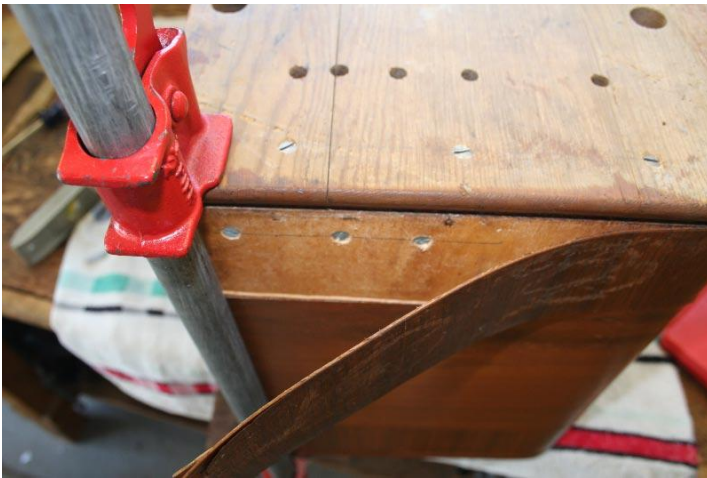
Back Left Corner Screws

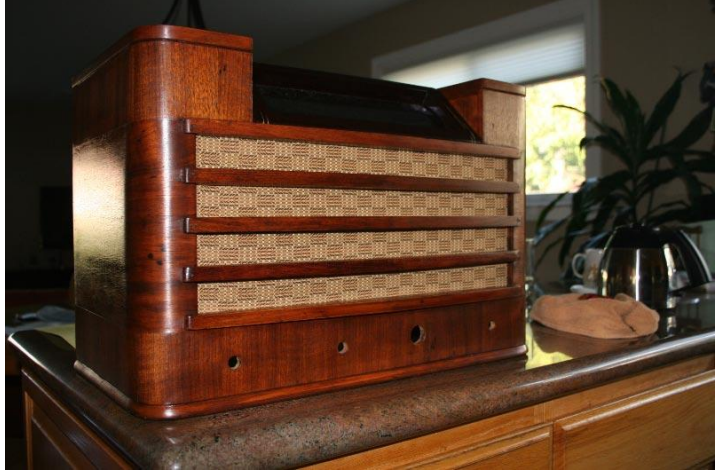
New Grill Cloth

The grill cloth that had been replaced sometime in the history of this radio gave the set a festive look but didn't seem period appropriate. On line my wife found a site that had a great selection of grill cloths. We picked one that we liked that complemented the cabinet.

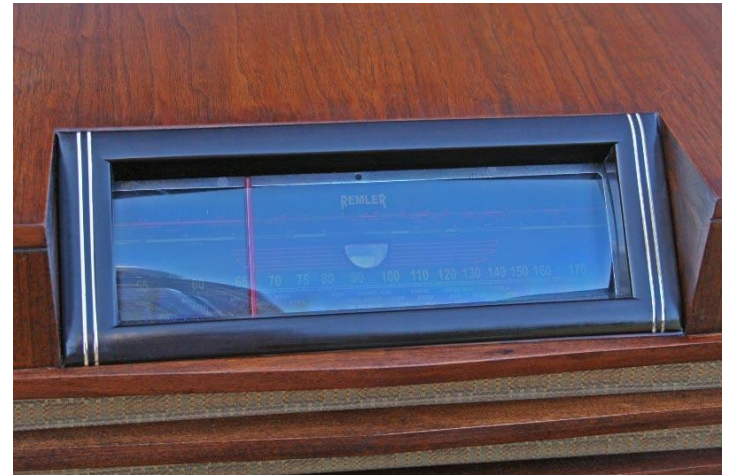
Restored Bezel

At sometime the bezel had been painted black. The paint was thick and not evenly applied. After giving some thought on how to remove the paint, I decided to test the bezel material to see if it could withstand paint remover. Much to my surprise the paint remover did not attack the plastic like material. After removing the paint and polishing the bezel, I replaced the missing window with a piece of 1/16" thick acrylic plastic. The final touch was to put gold leaf tape into the trim along the sides of the window.

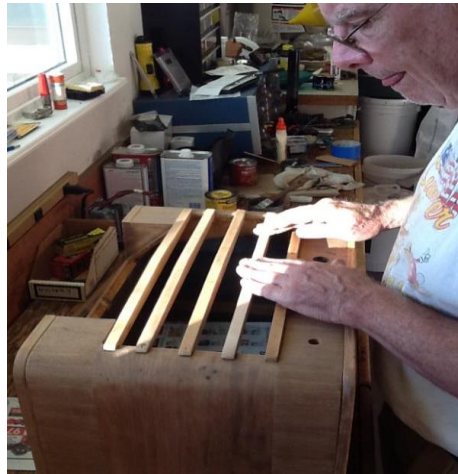
Positioning Grill Elements

In order to replace the missing element, I had to fabricate one. I took one of the grill pieces to a local woodworking shop and tried to match the wood species. I found a piece that closely matched the grain and density of my sample. I then traced the outline of my sample on to the wood and did a rough cut out using a band saw. I contoured the piece to shape using a wood rasp, electric sander and sandpaper.

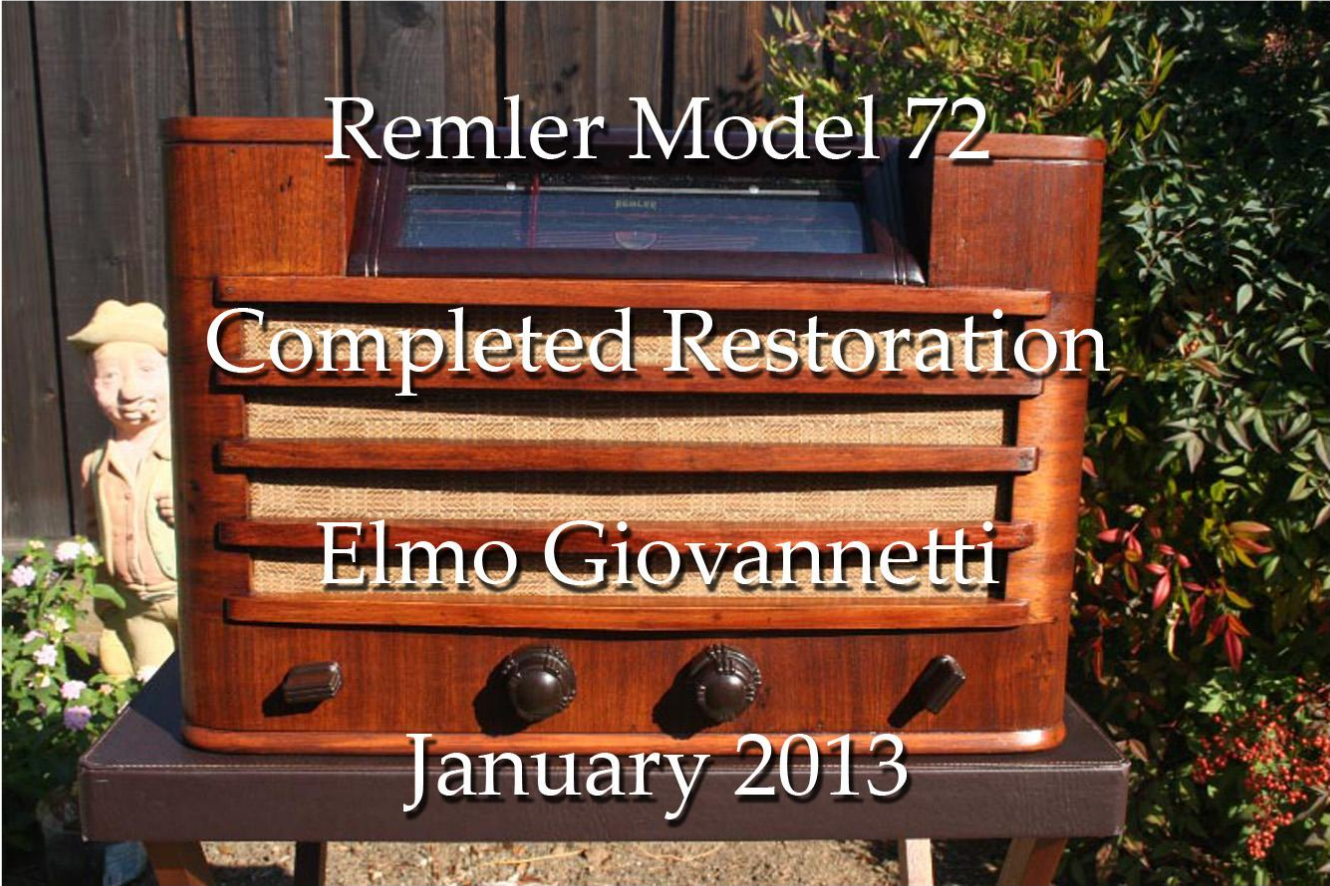
New Knobs Installed

One of the initial conditions was that all five knobs were missing from the radio. I was fortunate that a fellow CHRS member, Jamie Arbona, has a complete Model 72. Jamie was kind enough to allow me to use his knobs as masters for duplication. Jamie referred me to Larry Bordonaro who had previously cast knobs for other CHRS members. Unfortunately, when I contacted him, he had given up reproducing knobs due to health issues. I then searched the Internet looking for someone that could do castings. Again, I was fortunate that I found someone locally that was in the business of mould making and casting. It took less than a week and I had the replacement knobs I needed.
